3RP - 1011

ENTERPRISE PRODUCTS OPERATING, LLC

**Release Report/ General
Correspondence**

**RE: Confirmation Soil Sampling Results for Lateral H-37 Release
San Juan County, New Mexico**

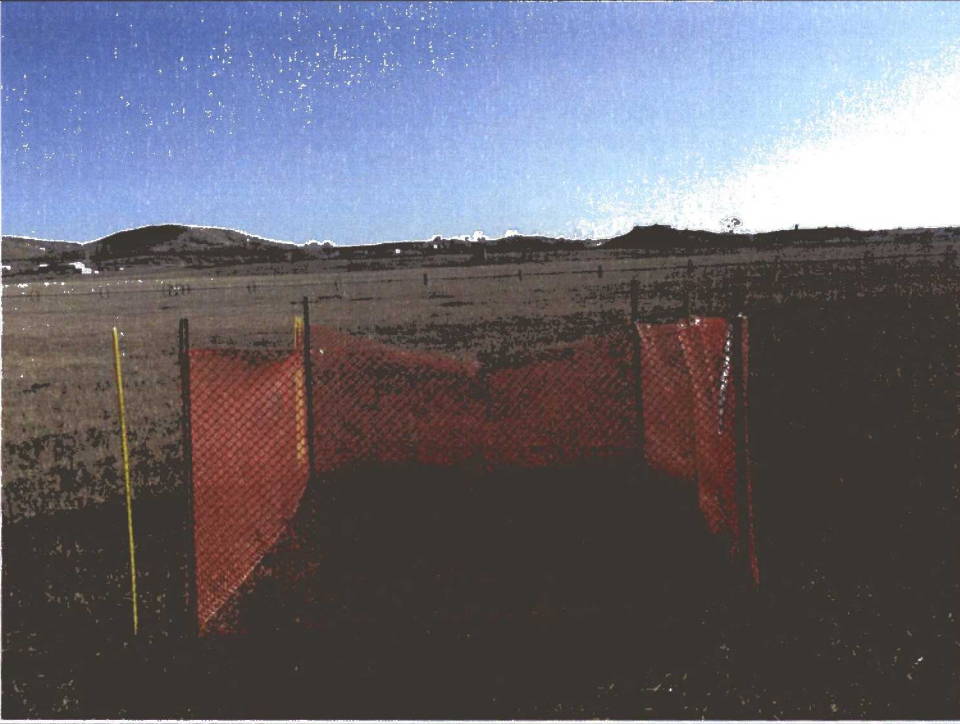
Photo #1

Client: Enterprise Products Company	
Project: Lateral H-37 Release	
Taken by: Ross Kennemer	
November 29, 2011	
AES Project No: 111116	Facility: Lateral H-37 Pipeline
	Location: Approximately 12 miles north of Farmington, NM
	Description: Facing E, general view of stained soils, prior to excavation.

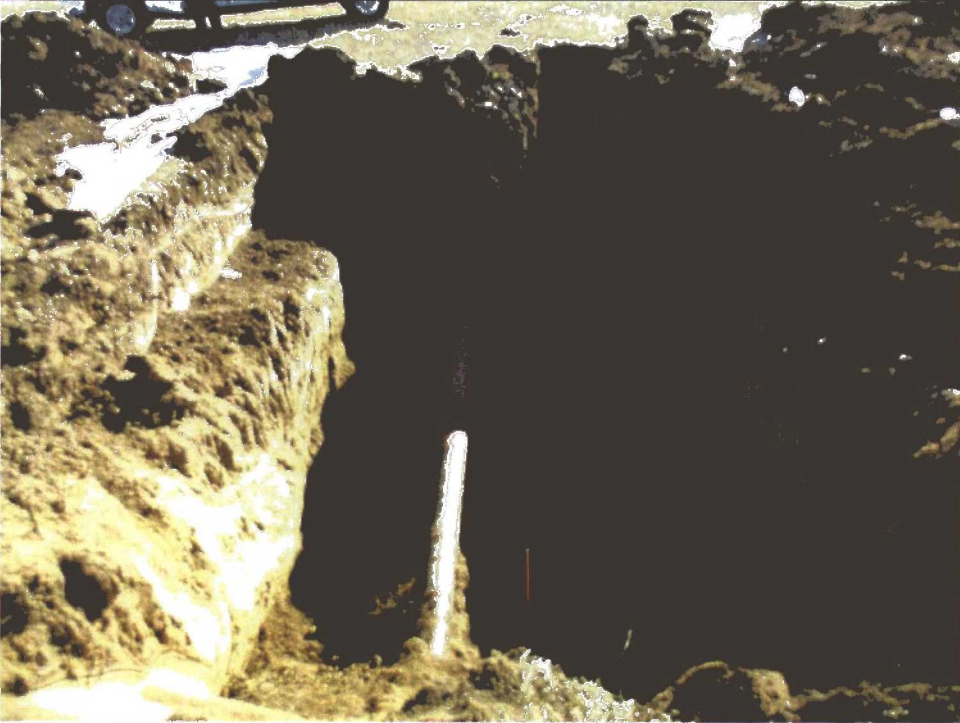
Photo #2

On November 29, 2011, Enterprise contractor Industrial Mechanical, Inc. (IMI) completed a small excavation to expose the pipeline, which was located at 5.7 feet bgs. Upon inspection, IMI determined that the release resulted from a 1/8 inch corrosion hole located at the underside of the pipe. IMI and Enterprise personnel worked late into the evening, and a new section of pipe was installed.

Client: Enterprise Products Company	
Project: Lateral H-37 Release	
Taken by: Ross Kennemer	
November 30, 2011	
AES Project No: 111116	Facility: Lateral H-37 Pipeline
	Location: Approximately 12 miles north of Farmington, NM
	Description: Facing W, Lateral H-37 following repair to the line.

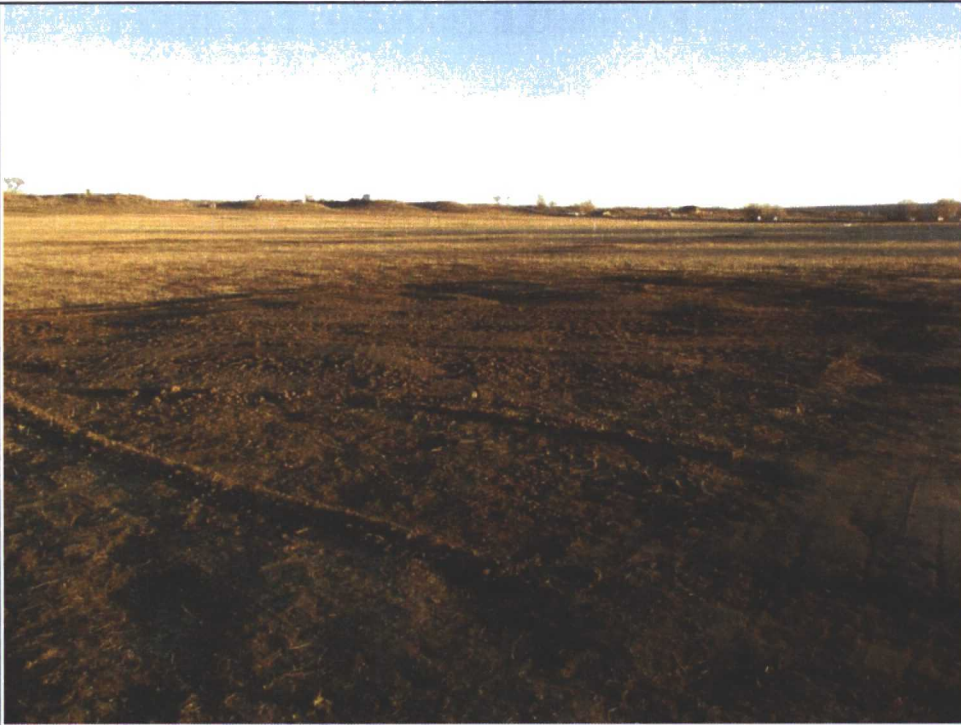
Photo #5

Client: Enterprise Products Company	
Project: Lateral H-37 Release	
Taken by: Ross Kennemer	
December 16, 2011	
AES Project No: 111116	Facility: Lateral H-37 Pipeline
	Location: Approximately 12 miles north of Farmington, NM
	Description: Facing SE, excavation backfilled and graded.

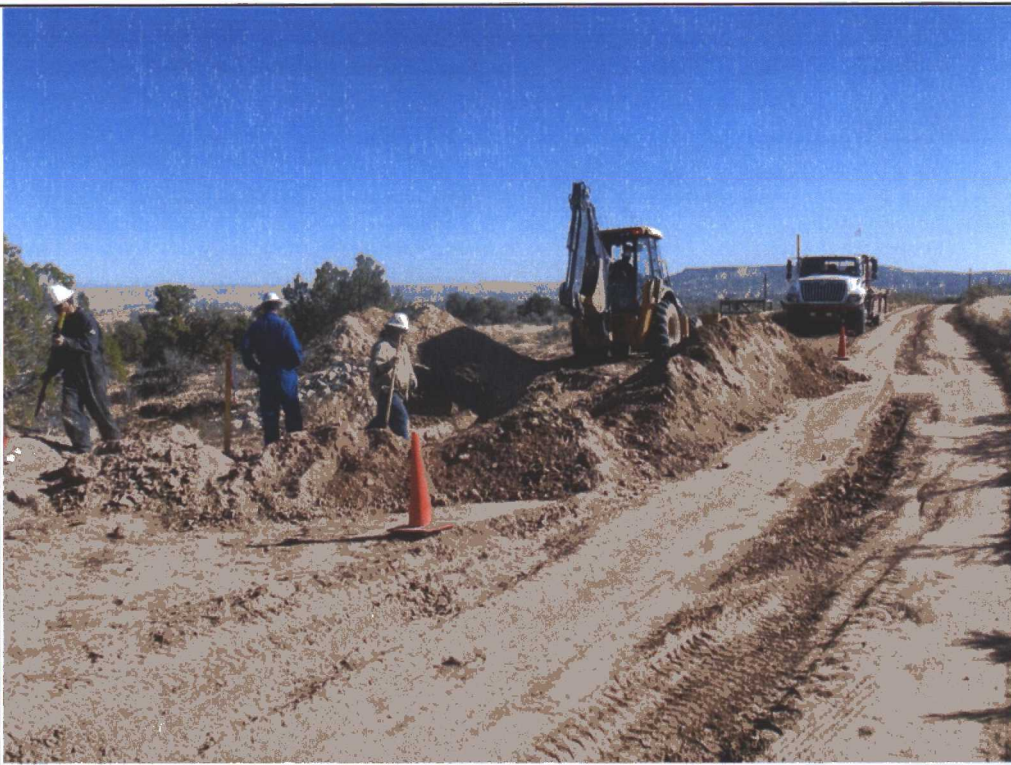
Photo #1

Client: Enterprise Products Company	
Project: Lateral 2B-24 October 2011 Release	
Taken by: Ross Kennemer	
October 14, 2011	
AES Project No: N/A	Facility: Lateral 2B-24 Pipeline Location: 7 miles southeast of Bloomfield, NM Description: Facing NE, general view of release work area along service road.

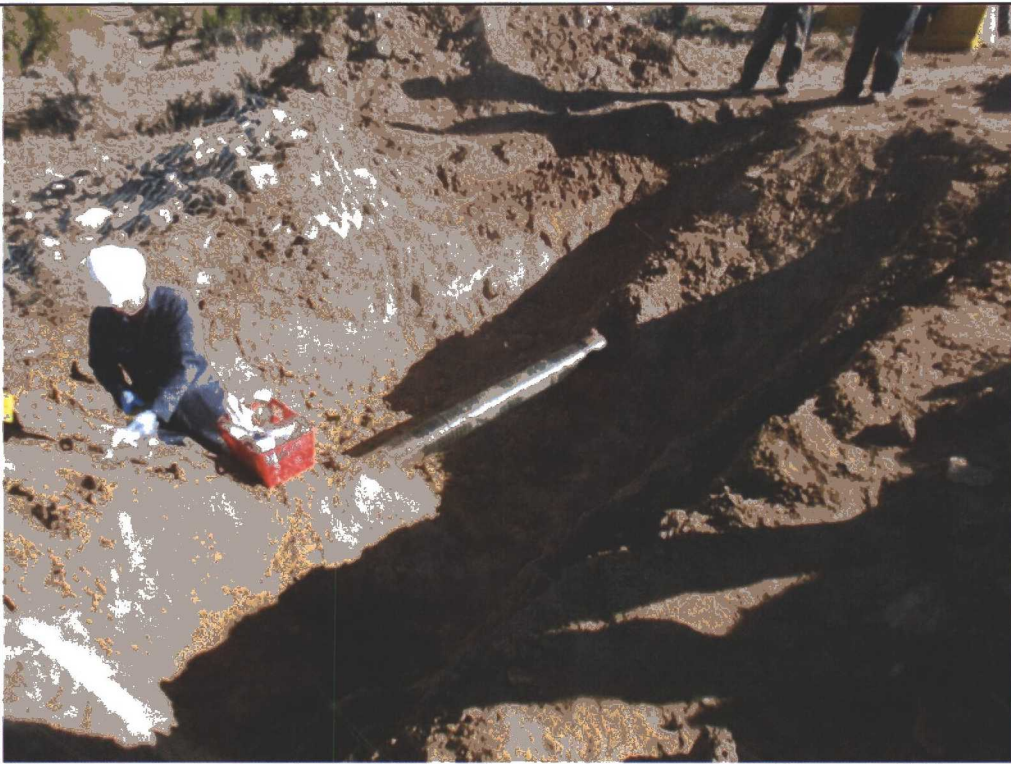
Photo #2

Client: Enterprise Products Company	
Project: Lateral 2B-24 October 2011 Release	
Taken by: Ross Kennemer	
October 14, 2011	
AES Project No: N/A	Facility: Lateral 2B-24 Pipeline Location: 7 miles southeast of Bloomfield, NM Description: Facing NE, collecting field screening soil samples from initial excavation.

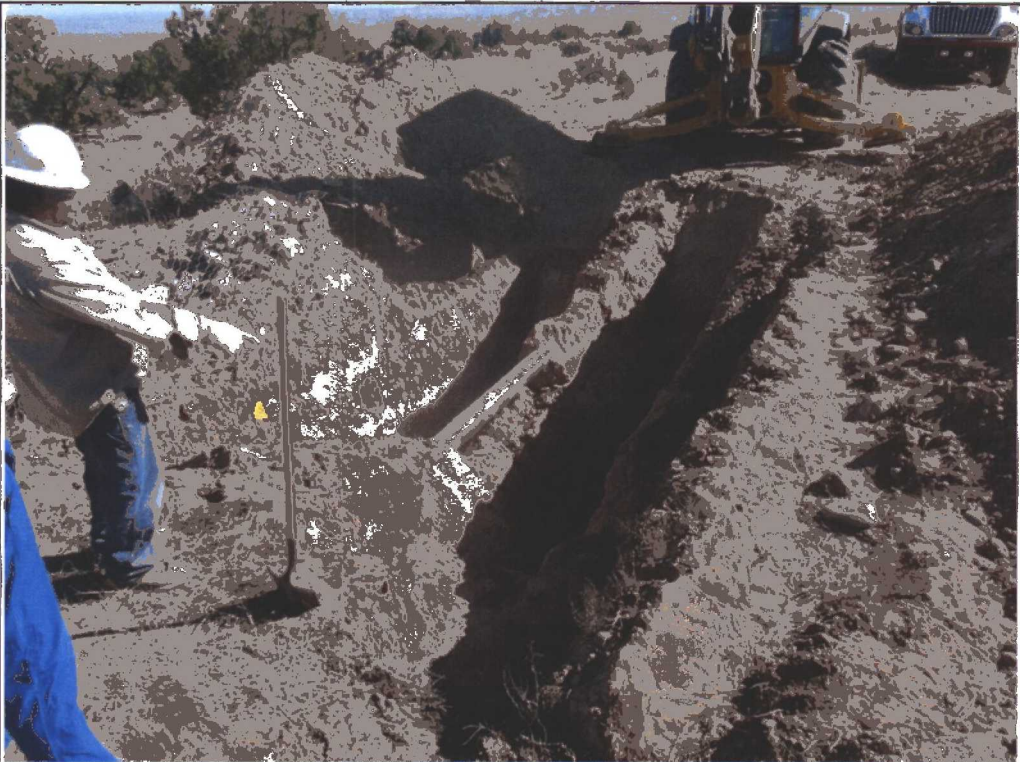
Photo #3

Client: Enterprise Products Company	
Project: Lateral 2B-24 October 2011 Release	
Taken by: Ross Kennemer	
October 14, 2011	
AES Project No: N/A	Facility: Lateral 2B-24 Pipeline
	Location: 7 miles southeast of Bloomfield, NM
	Description: Facing NE, excavating along north (left) side of pipeline to investigate vertical extent.

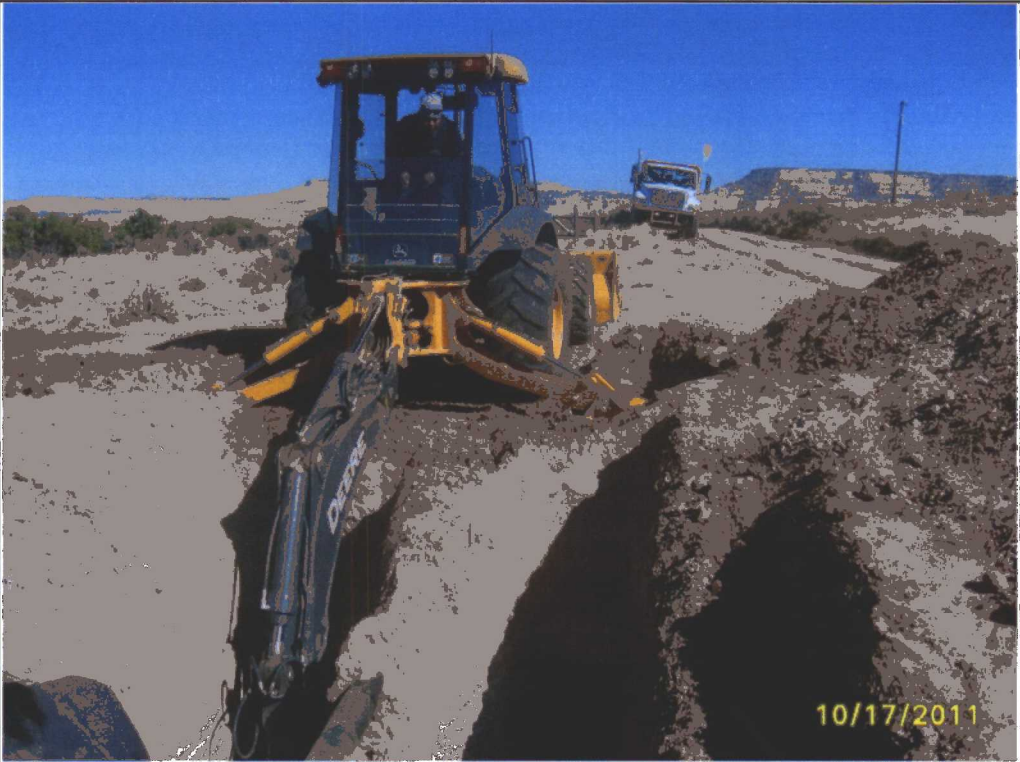
Photo #4

Client: Enterprise Products Company	
Project: Lateral 2B-24 October 2011 Release	
Taken by: Blaine Watson	
October 17, 2011	
AES Project No: N/A	Facility: Lateral 2B-24 Pipeline
	Location: 7 miles southeast of Bloomfield, NM
	Description: Facing E, backhoe arm/bucket at full reach (20 feet) on north side of pipeline.

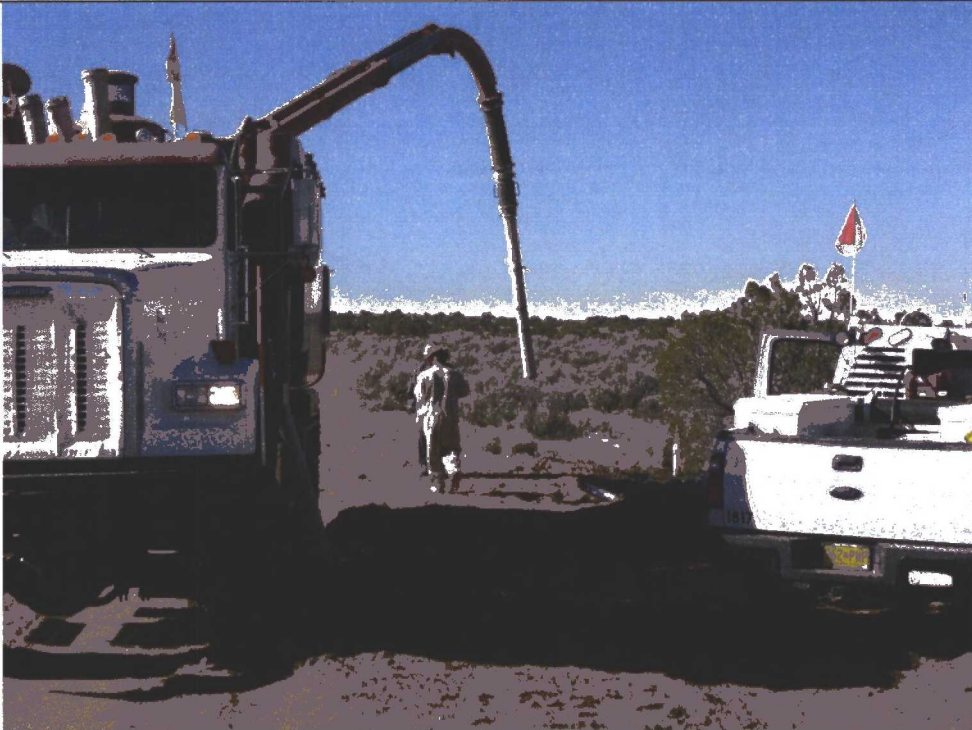
Photo #1

Client: Enterprise Products Company	
Project: 2B-24 October 2011 Release Biovent Well Installation	
Taken by: Tom Long	
January 4, 2012	
AES Project No: 110903	Description: View of the hydro-excavation activities around the pipeline.

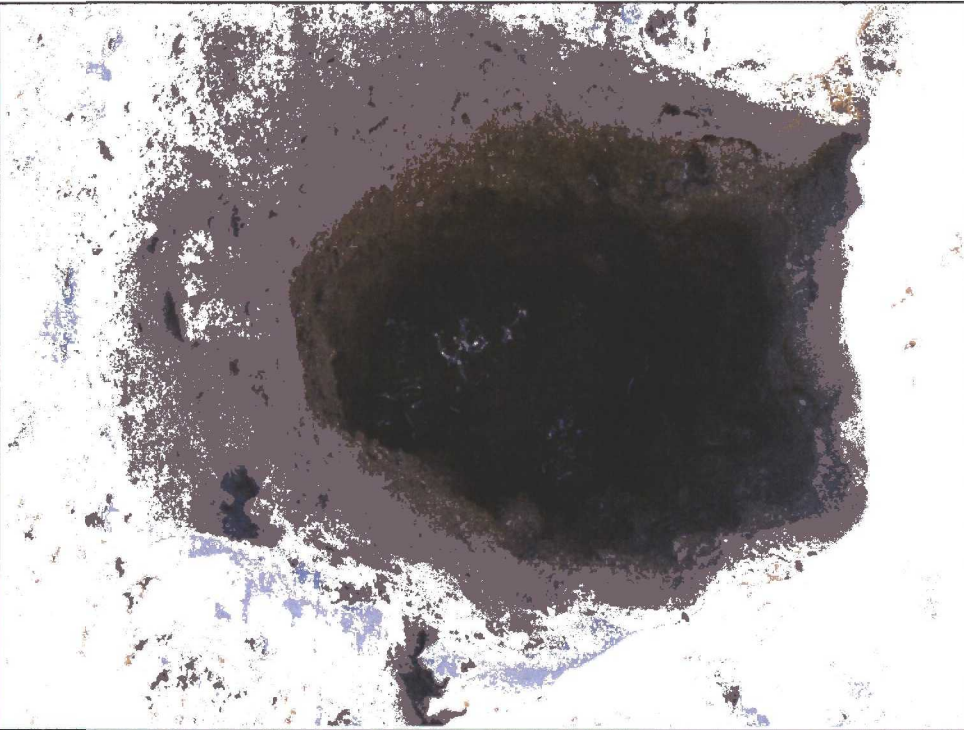
Photo #2

Client: Enterprise Products Company	
Project: 2B-24 October 2011 Release Biovent Well Installation	
Taken by: Tom Long	
January 4, 2012	
AES Project No: 110903	Description: View of the pothole that exposed the 2B-24 pipeline.

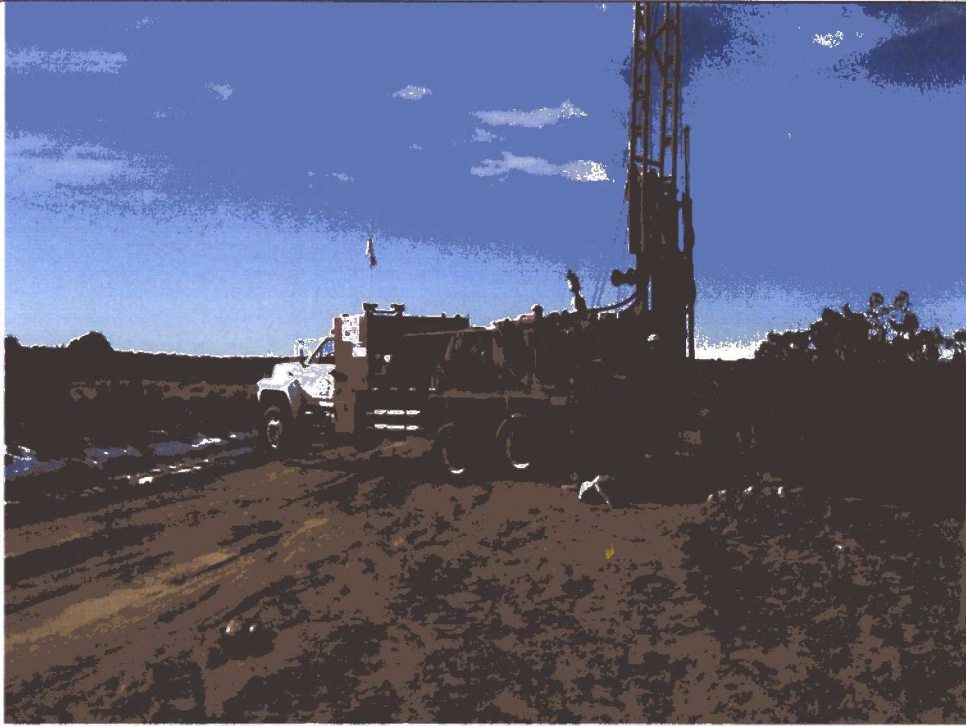
Photo #3

Client: Enterprise Products Company	
Project: 2B-24 October 2011 Release Biovent Well Installation	
Taken by: Tom Long	
January 4, 2012	
AES Project No: 110903	Description: View of the drilling activities for SVE-1.

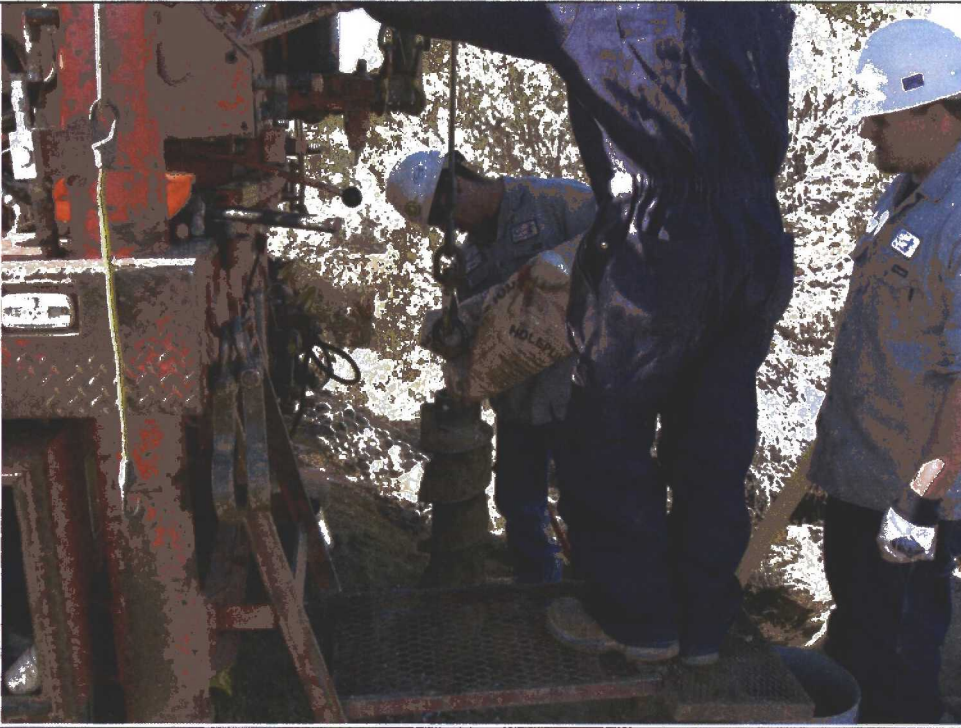
Photo #6

Client: Enterprise Products Company	
Project: 2B-24 October 2011 Release Biovent Well Installation	
Taken by: Tom Long	
January 4, 2012	
AES Project No: 110903	View of the well construction activities for SVE-1.

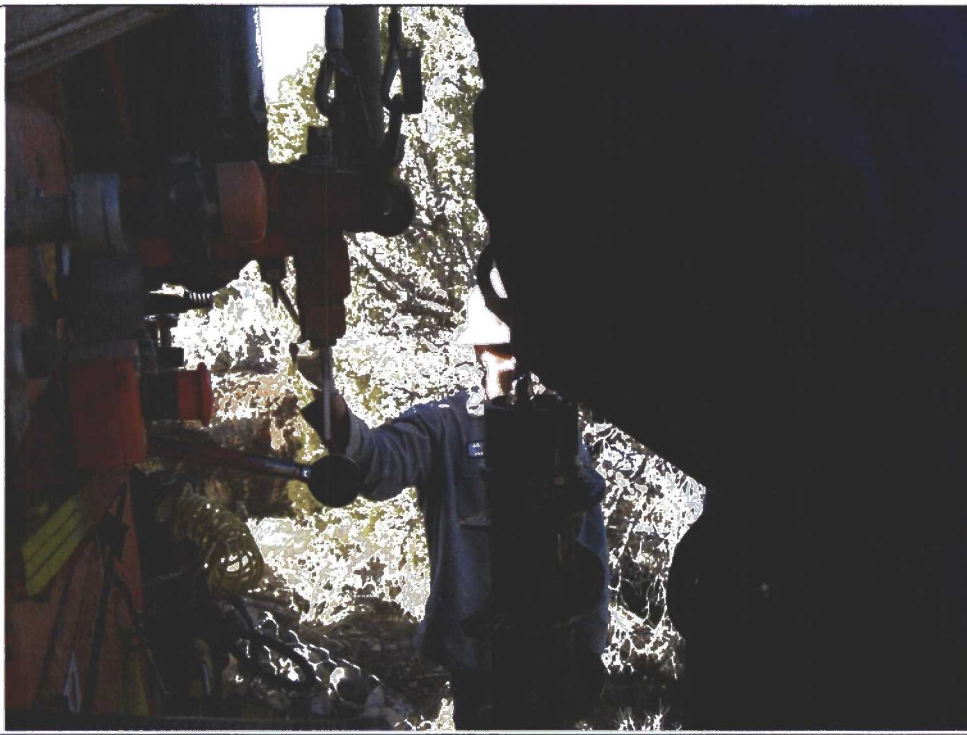
Photo #7

Client: Enterprise Products Company	
Project: 2B-24 October 2011 Release Biovent Well Installation	
Taken by: Tom Long	
January 4, 2012	
AES Project No: 110903	Description: View of the well construction activities for SVE-1.

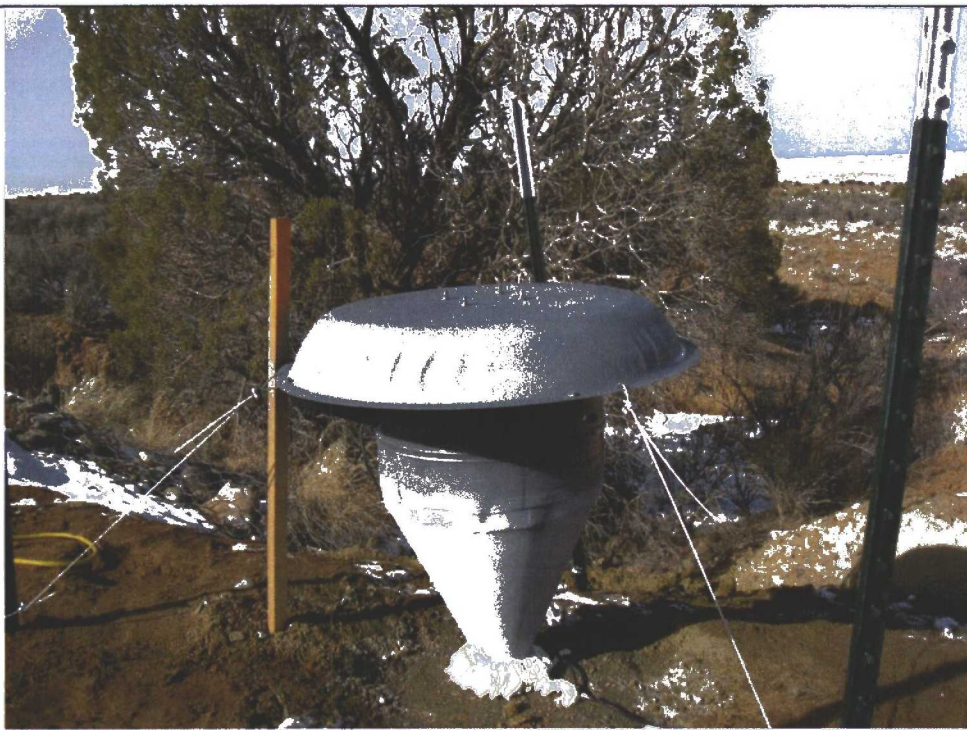
Photo #8

Client: Enterprise Products Company	
Project: 2B-24 October 2011 Release Biovent Well Installation	
Taken by: Tom Long	
January 18, 2012	
AES Project No: 110903	View of the installation of the soil bioventing system.

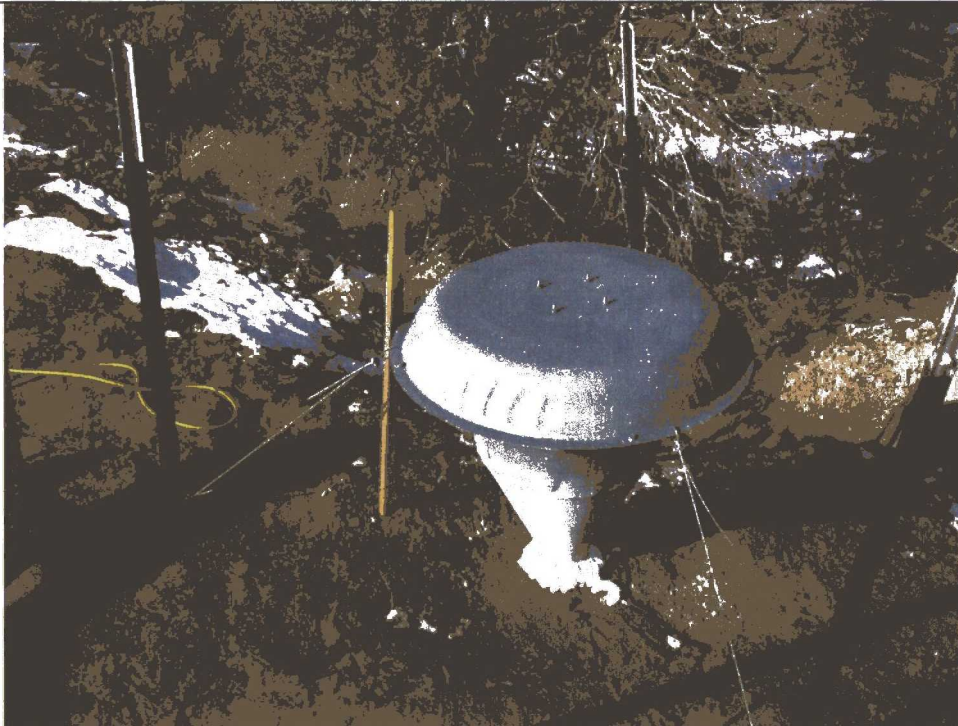
Photo #9

Client: Enterprise Products Company	
Project: 2B-24 October 2011 Release Biovent Well Installation	
Taken by: Tom Long	
January 18, 2012	
AES Project No: 110903	Description: View of the installation of the soil bioventing system.

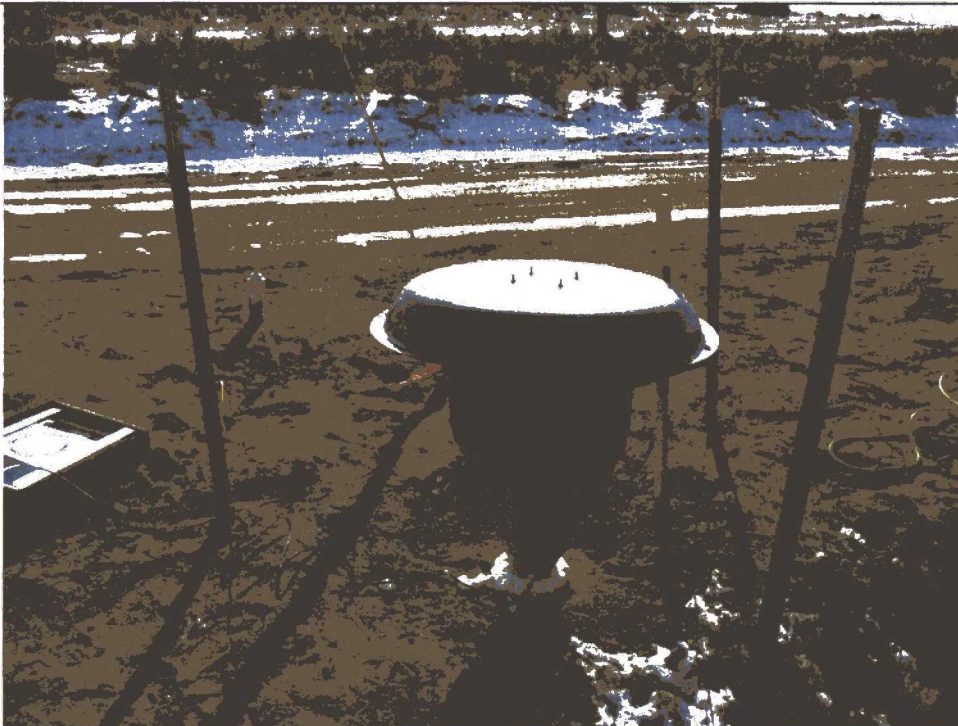
Photo #10

Client: Enterprise Products Company	
Project: 2B-24 October 2011 Release Biovent Well Installation	
Taken by: Tom Long	
January 18, 2012	
AES Project No: 110903	Description: View of the installation of the soil bioventing system.

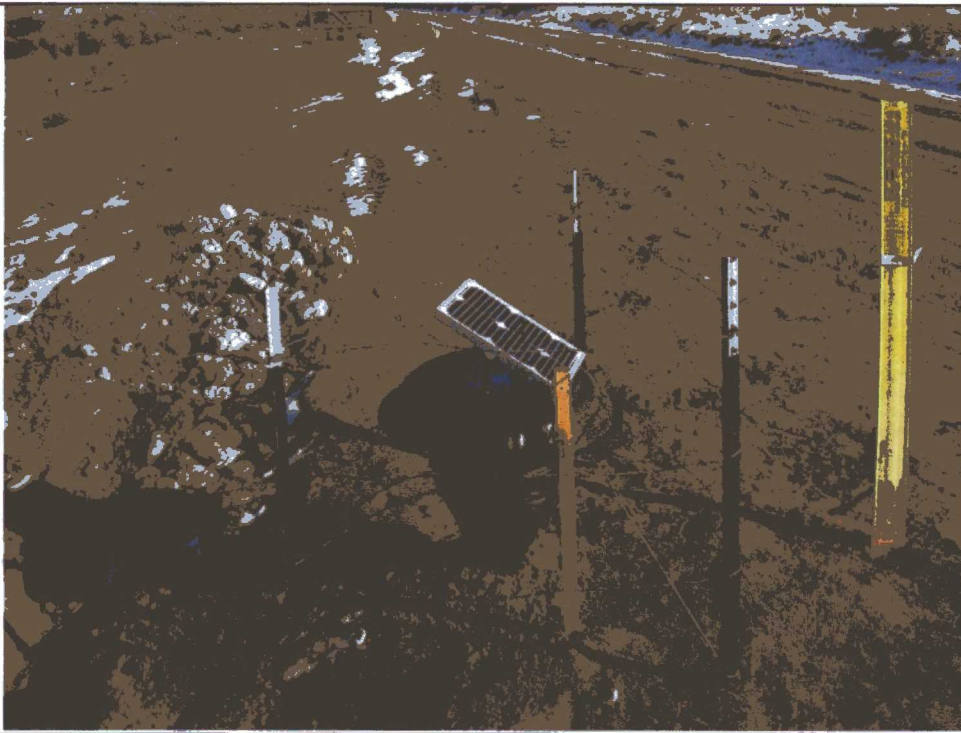
Photo #11

Client: Enterprise Products Company	
Project: 28-24 October 2011 Release Biovent Well Installation	
Taken by: Tom Long	
January 18, 2012	
AES Project No: 110903	Description: View of the installed soil bioventing system.

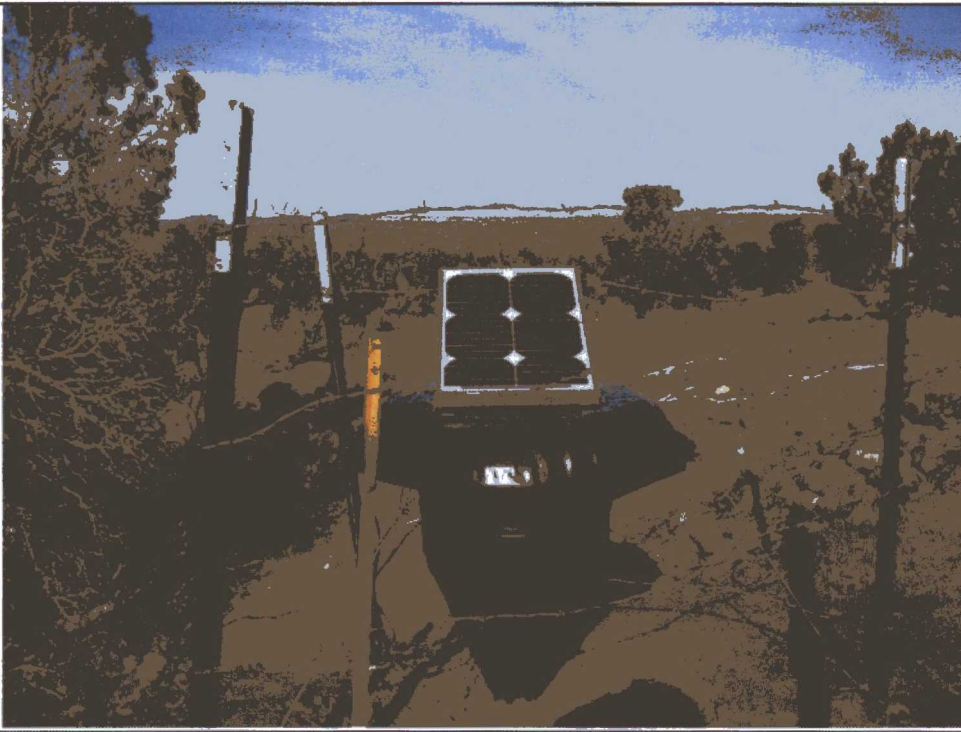
Photo #12

Client: Enterprise Products Company	
Project: 28-24 October 2011 Release Biovent Well Installation	
Taken by: Tom Long	
January 18, 2012	
AES Project No: 110903	Description: View of the installed soil bioventing system.

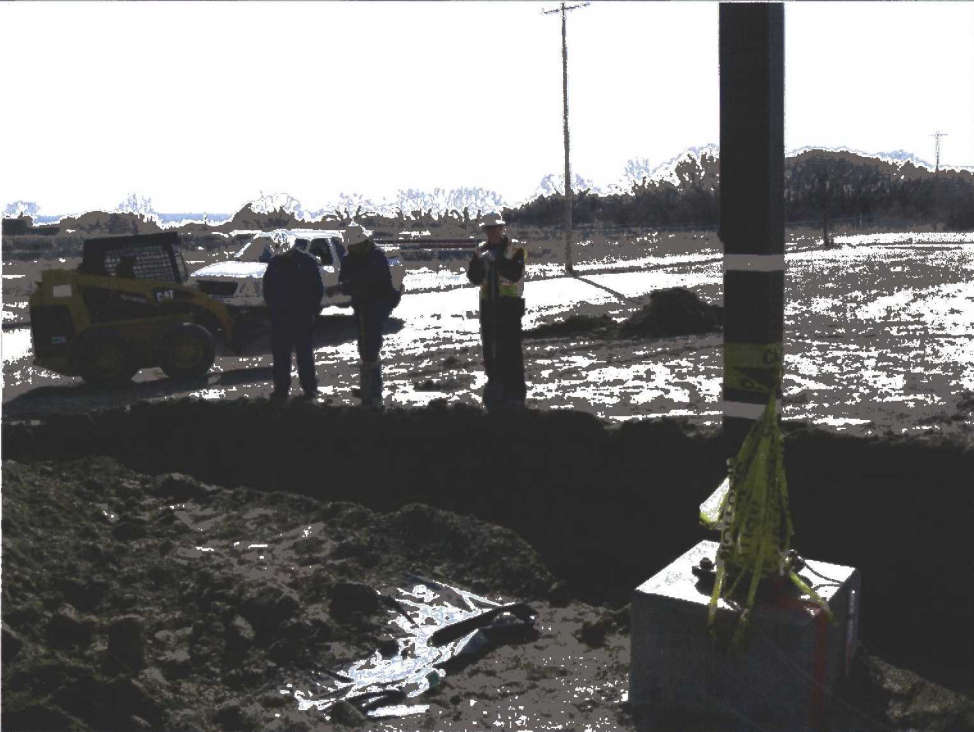
Client: Enterprise Products Company	
Project: Val Verde Plant Train 8 Sump Release	
Taken by: Tom Long	
February 27, 2012	
AES Project No: 120236	Description: View of the western leg of the excavation and the test hole to the west.
