**ENTERPRISE PRODUCTS OPERATING LP**

FINAL CLOSURE REPORT

KUTZ SEPARATOR &  
HYDROCARBON RECOVERY PLANT  
Off Arizona Road (CR 4900)  
Section 11, Township 29N, Range 11W  
San Juan County, New Mexico

March 22, 2011  
SWG Project No. 0210008

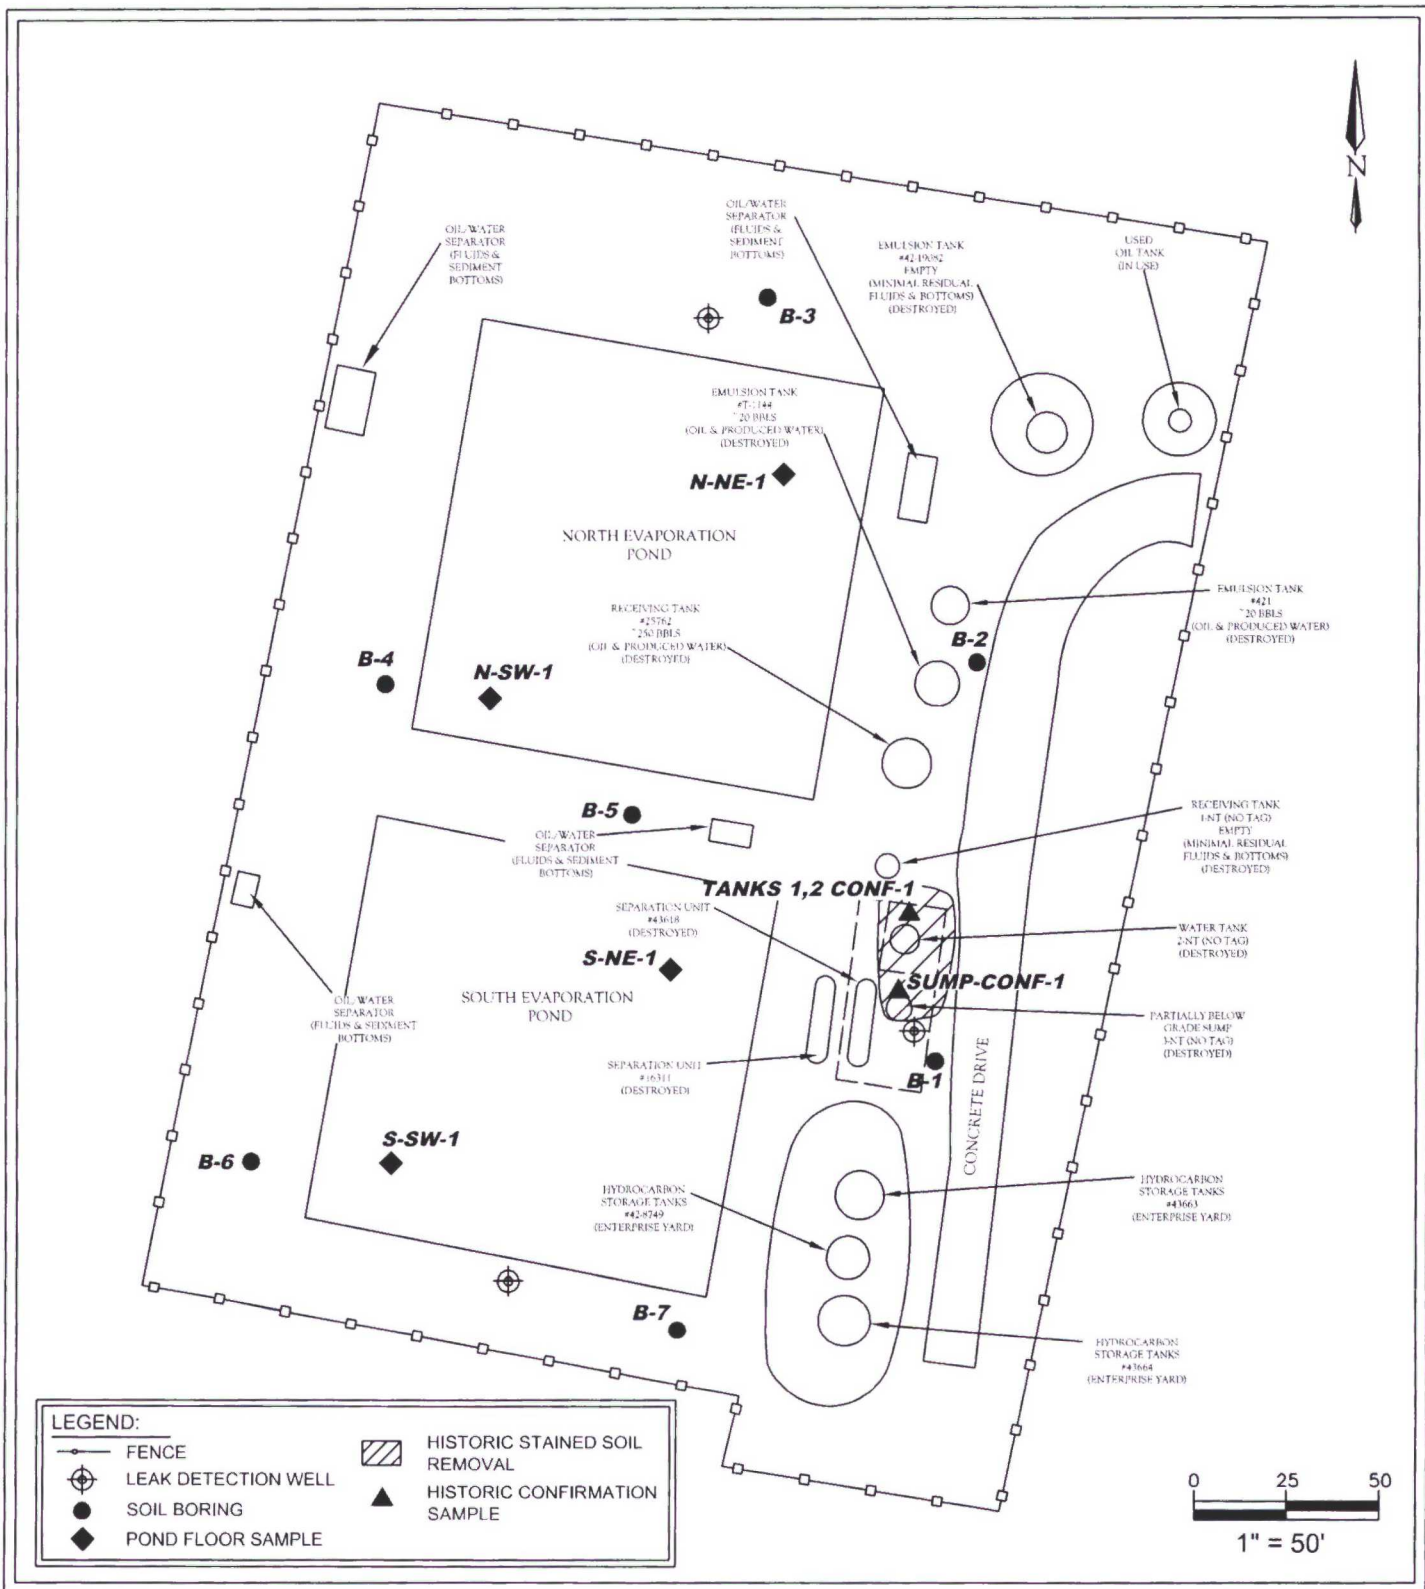
Figure 3 is a Site Plan that indicates the approximate location of the soil borings in relation to current and former pertinent structures and land features (Appendix A).

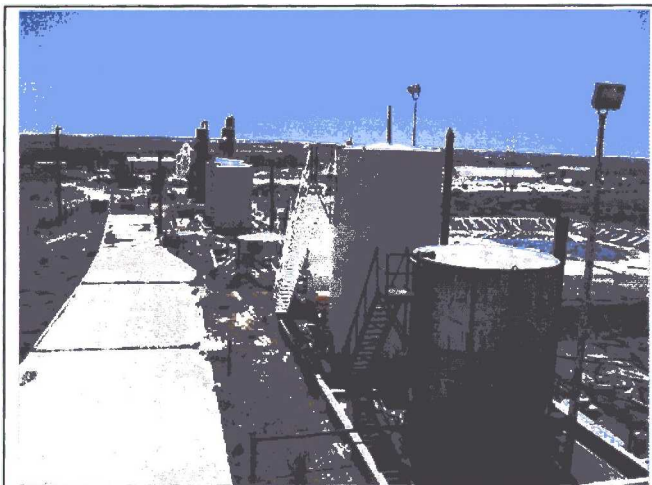
1.) View of tanks and fixtures (facing south) prior to removal.

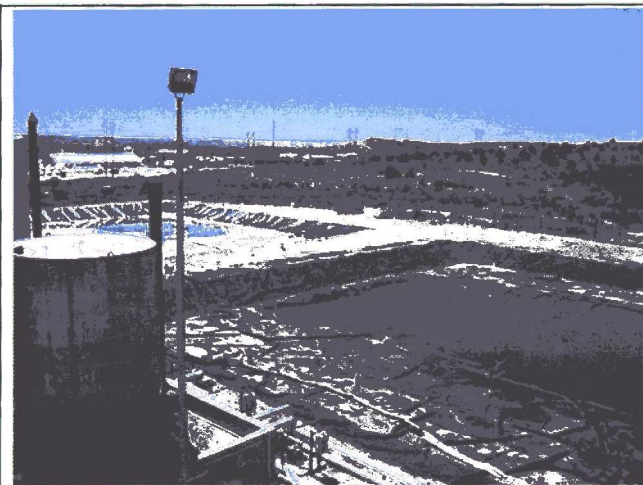
2.) View of evaporation ponds (facing southwest) prior to removal.

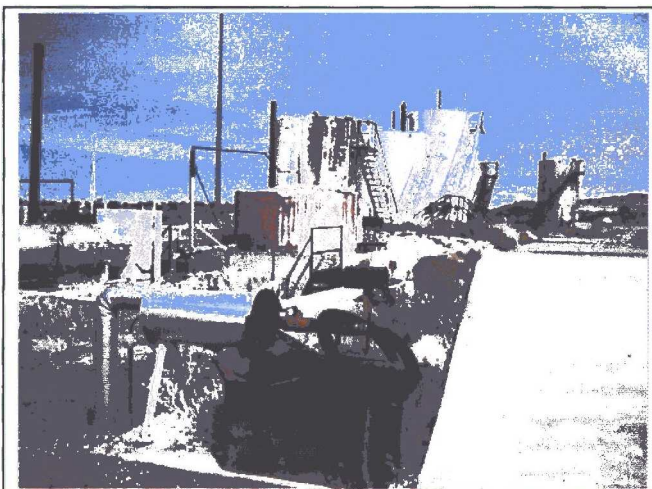
3.) View of northern tanks (facing north).

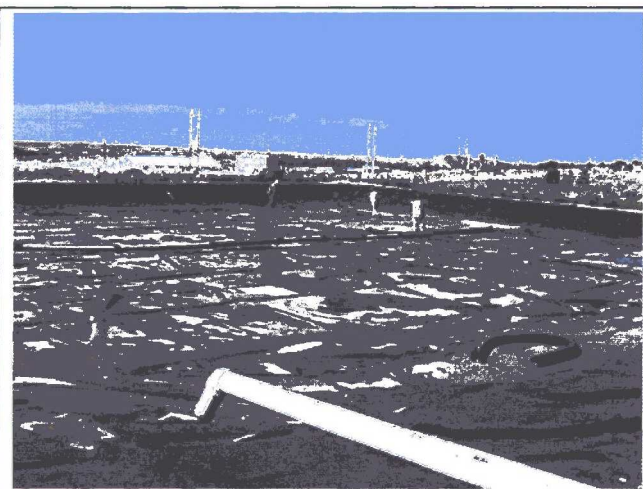
4.) General view of liner cleaning activities prior to removal.

Subsequent to the removal of solids and liquids from the evaporation ponds utilizing a vacuum truck and power washer, each of the liners were removed and either recycled or disposed off-site. Three (3) liners (40-mil, 20-mil, 10-mil) and two felt beds were present on the southern pond, while two (2) liners (40-mil and 20-mil), a felt bed and high density polyethylene (HDPE) webbing were present on the northern pond. The top-most or "primary" liners on both ponds were steam-cleaned prior to removal to allow recycling. The HDPE webbing was also recycled. The remaining liners were brushed free of solids and, along with the felt material, were properly disposed of at the Waste Management, Inc. San Juan Regional Landfill.

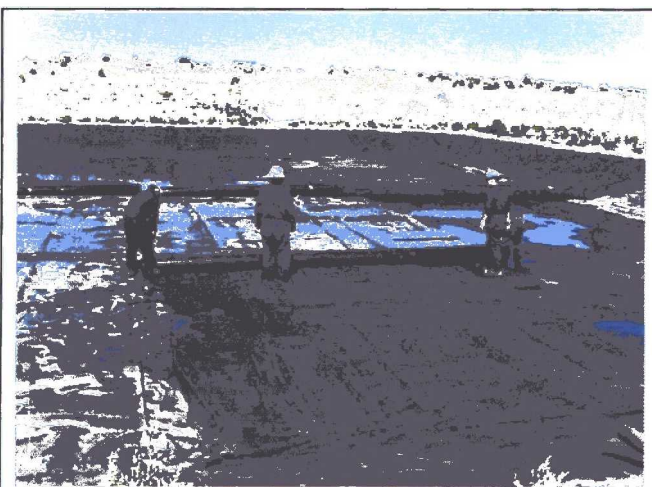
5.) General view of the removal of the primary or top liner from the southern pond.

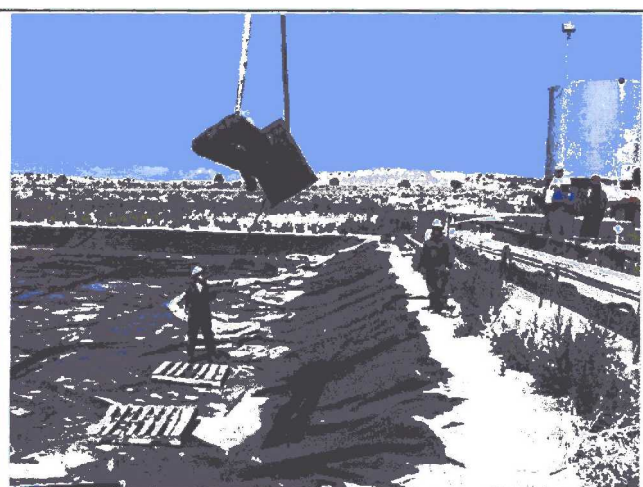
6.) View of the portion of the northern pond used as power-washing pad.

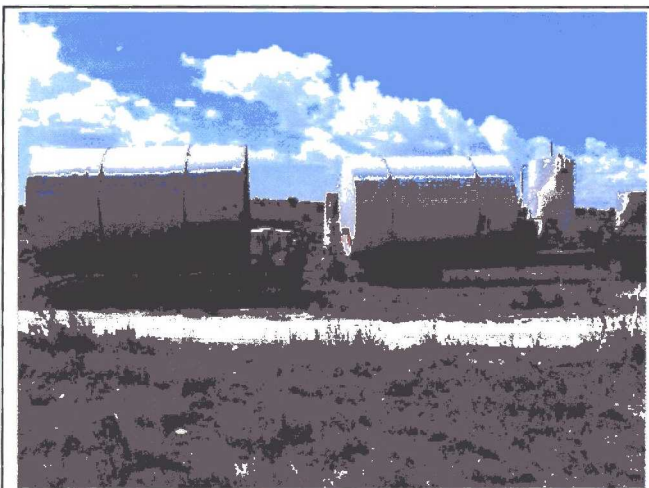
7.) Representative view of the storage tanks loaded for off-site disposal.

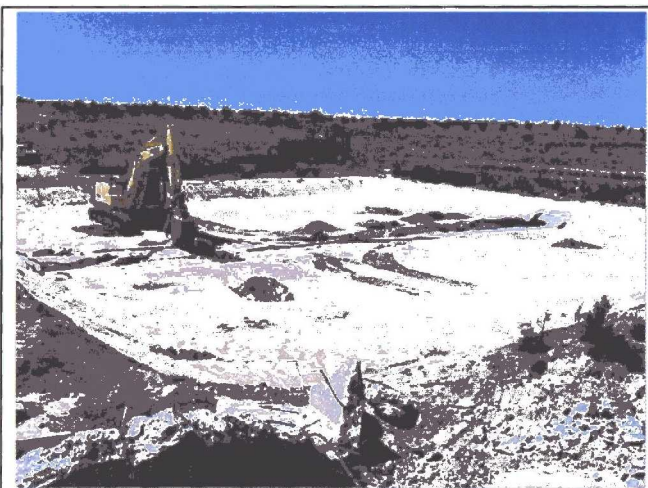
8.) General view of the soils underlying the bottom liner subsequent to the removal of all liners in the northern pond.

- Four (4) discrete confirmation soil samples were collected from the floor of the evaporation ponds (S-SW-1, S-NW-1, N-SW-1 and N-NE-1) based on visual, olfactory and/or PID evidence of impairment.
- Two (2) discrete confirmation soil samples (Sump Conf-1 and Tanks 1,2 Conf) were collected from the floor of the excavation in the vicinity of the former sump and storage tanks 1-NT, 2-NT, and 3-NT subsequent to the removal of the petroleum hydrocarbon stained soils.

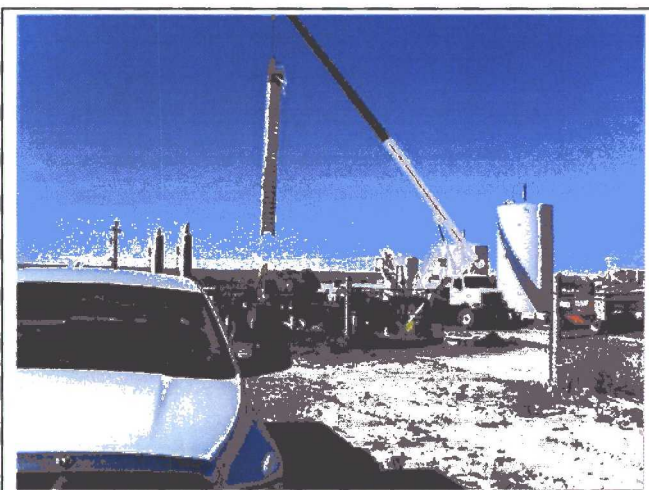
9.) View of the miscellaneous metal items being loaded for off-site recycling as scrap metal.

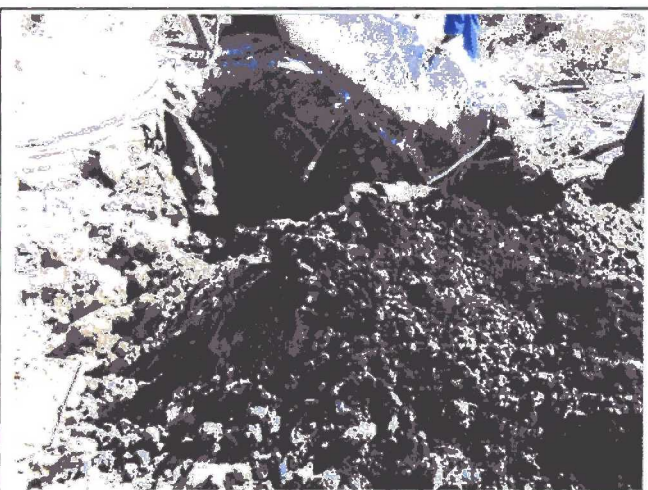
10.) View of the stained soil encountered on the eastern portion of the Site.

During the completion of closure activities, petroleum hydrocarbon stained soil was observed in the vicinity of storage tanks 1-NT, 2-NT, and 3-NT. In total, an estimated 60 cubic yards of soil and gravel were excavated and placed on 6-mil plastic sheeting on the concrete driveway. One (1) composite soil samples was subsequently collected from the stockpiled soils to characterize the soils for on-site reuse or off-site disposal. The soil sample collected from the stockpiled soil did not exhibit benzene, total BTEX and/or TPH concentrations above the applicable OCD *Remediation Action Levels*; therefore, the soils were reused/spread on-site.

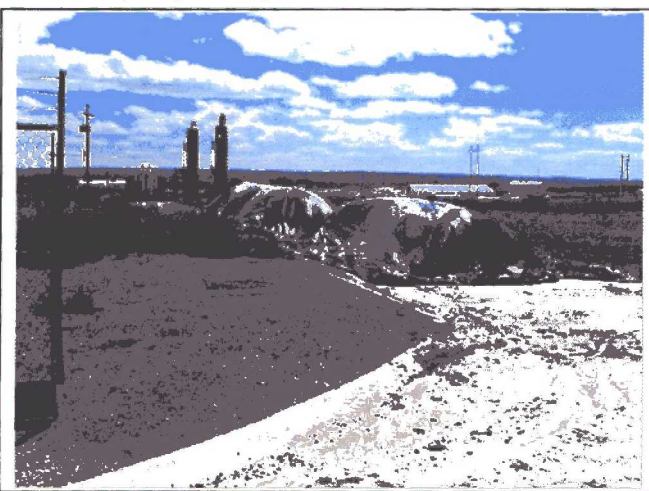
11.) General view of the stained potentially impacted soil stockpiled on-site prior to final characterization.

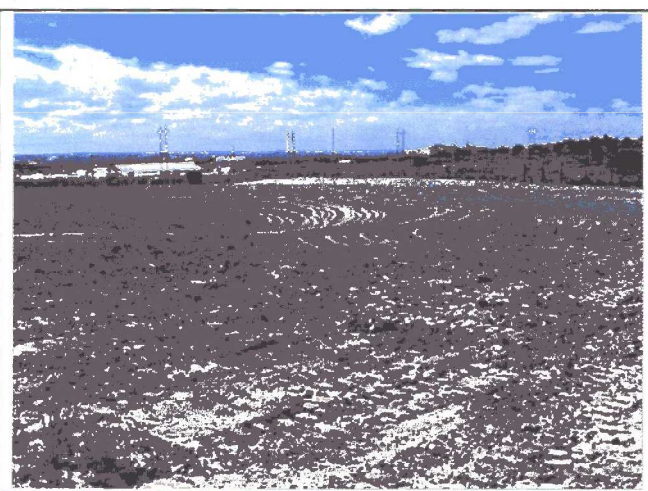
12.) Representative view during hydro-seeding after final site grading.

The concrete containment walls associated with the former storage tanks and treatment equipment were visually assessed and found to be free of hydrocarbon staining. Therefore, subsequent to the destruction utilizing on-site equipment, the resulting concrete rubble was placed on the floor of the north pond prior to site grading activities. The berms surrounding the evaporation ponds were then razed, returning the site to approximate natural grade. The Site was then hydro-seeded utilizing a blend of native seeds on September 9, 2010.
