Pit, Below-Grade Tank, or
Proposed Alternative Method Permit or Closure Plan Application

1.
Operator: Williams Four Corners LLC OGRID #: _____
Address: 1755 Arroyo Drive, Bloomfield, NM 87413
Facility or well name: 32-8#2 CDP Produced Water BGT (1)
API Number: _____ OCD Permit Number: _____
U/L or Qtr/Qtr SENW (F) Section 27 Township 32N Range 8W County: San Juan County
Center of Proposed Design: Latitude 36.956897 Longitude -107.664022 NAD: ☐ 1927 ☒ 1983
Surface Owner: ☒ Federal ☐ State ☐ Private ☐ Tribal Trust or Indian Allotment

**Williams Four Corners LLC
Closure Plan - Below Grade Tanks**

FIGURE 1
TOPOGRAPHIC MAP
32-8 #2 CDP - BGT 1
NW/SE (J) SEC 27 T32N R8W
SAN JUAN COUNTY, NEW MEXICO
WILLIAMS FOUR CORNERS

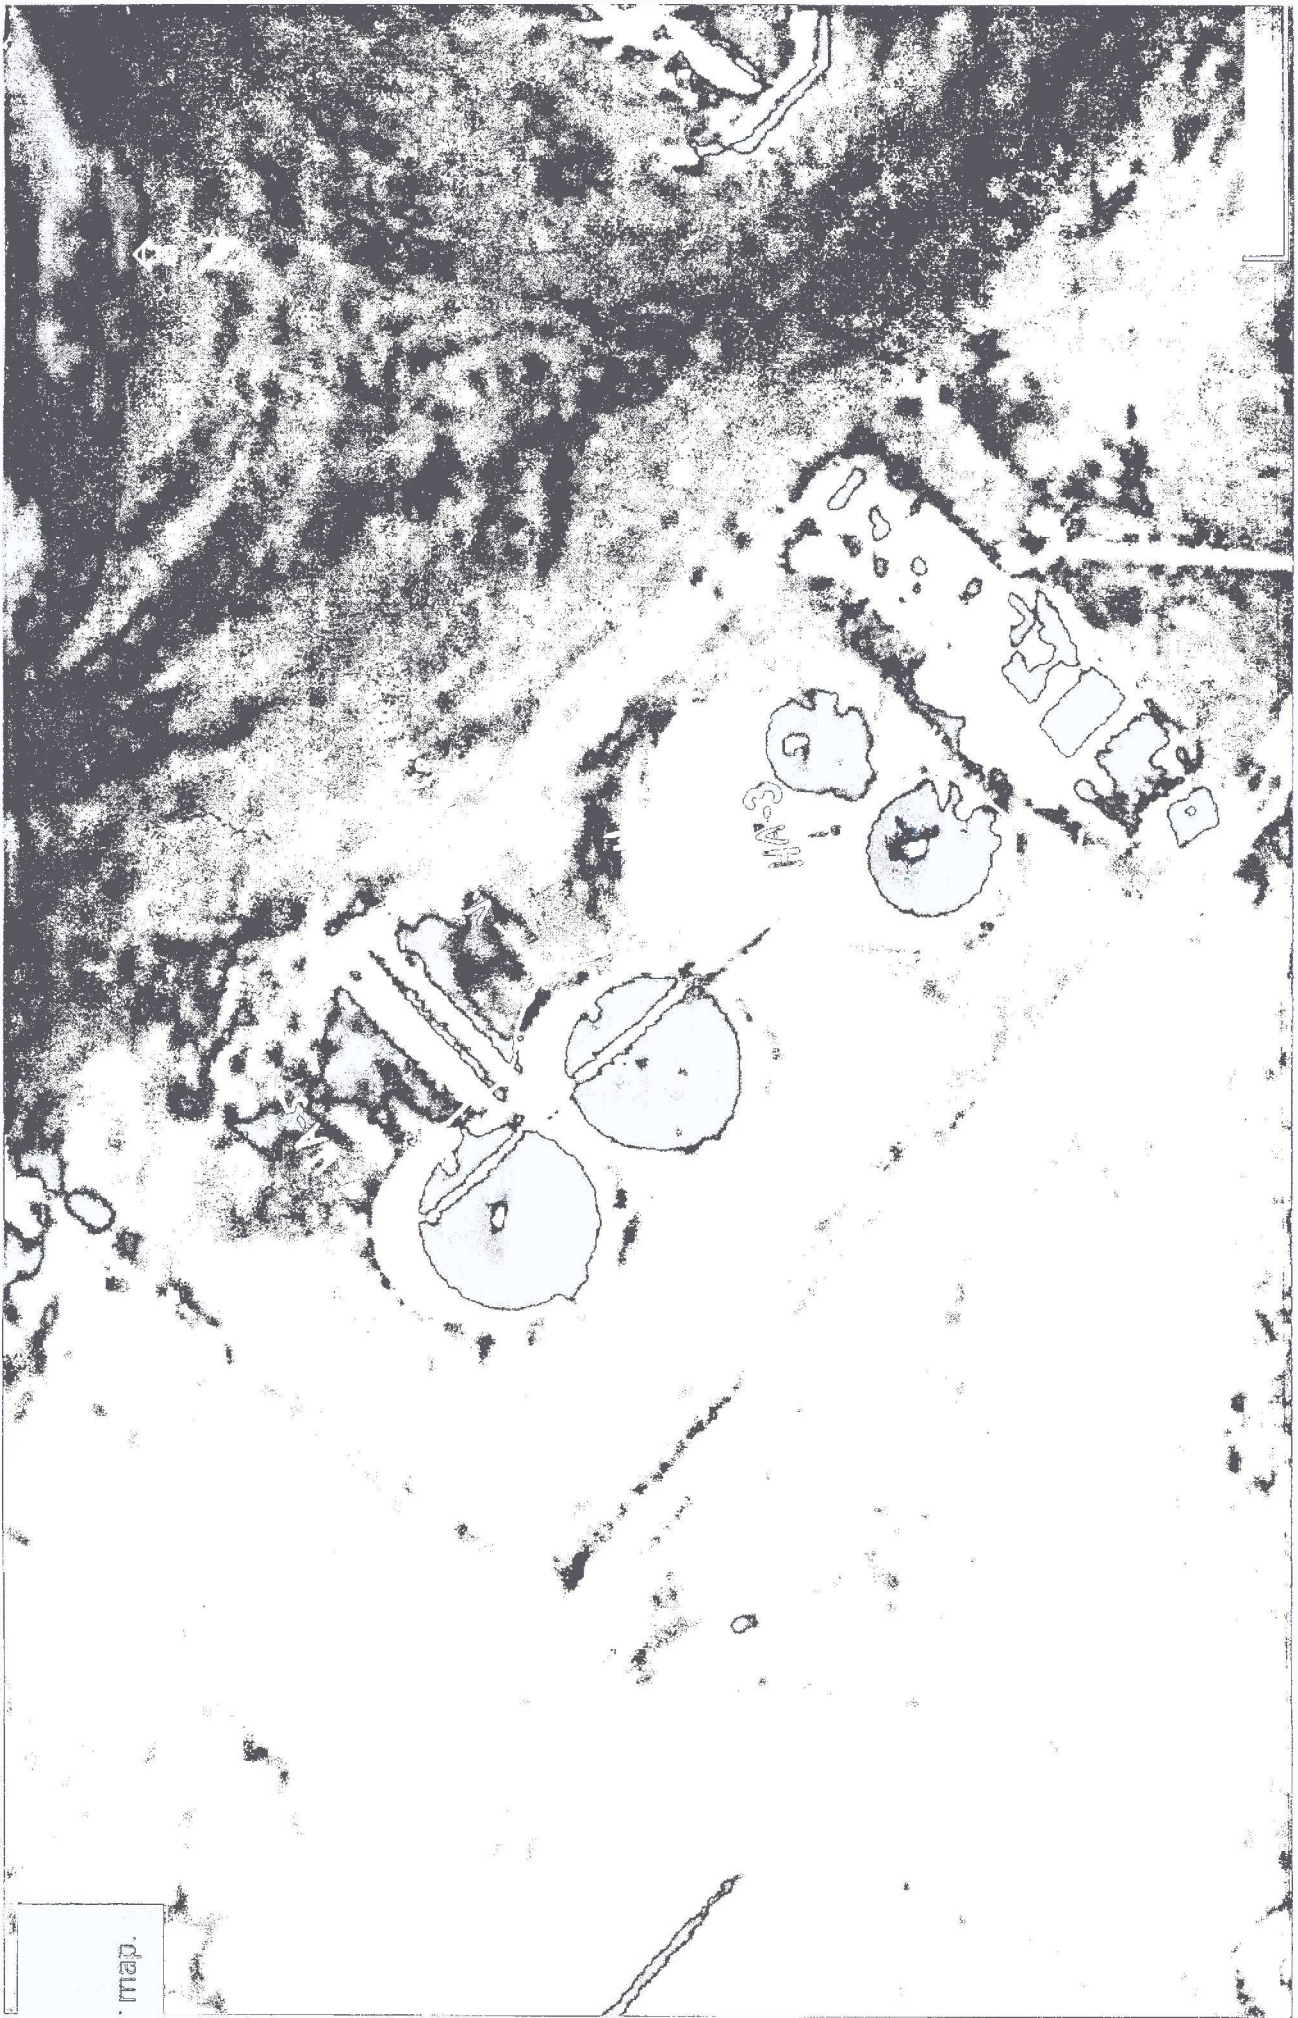
The attached figure documents the extent of the visible lube oil impacts during completion of the investigation. Seven hand auger borings (HA-1 through HA-7) were completed to evaluate the extent of impacts. It appears that heavy precipitation events following the release may have contributed to further migration of visible lube oil impacts within containment. The hand auger borings indicated the presence of a clay layer 19-inches below the containment floor that was non-impacted (impacts observed in soils above 19-inches). Remediation activities will be completed in the future to remove impacted soils from the containment. Confirmation soil samples from the excavation floor and sidewalls will be collected to demonstrate cleanup concentrations are achieved.
