**ENTERPRISE PRODUCTS OPERATING, LLC**

**Release Report/ General  
Correspondence**

**Release Notification and Corrective Action**

Name of Company: Enterprise Field Services LLC	Contact: Thomas Long
Address: 614 Reilly Ave, Farmington, NM 87401	Telephone No. 505-599-2286
Facility Name: <b>Lateral 2A-4</b>	Facility Type: <b>Natural Gas Gathering Pipeline</b>

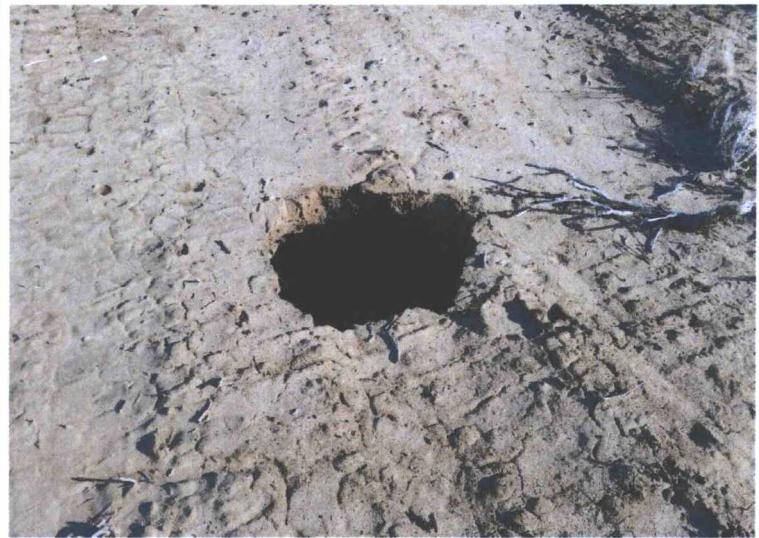
**Photograph 1**

View of the source area.

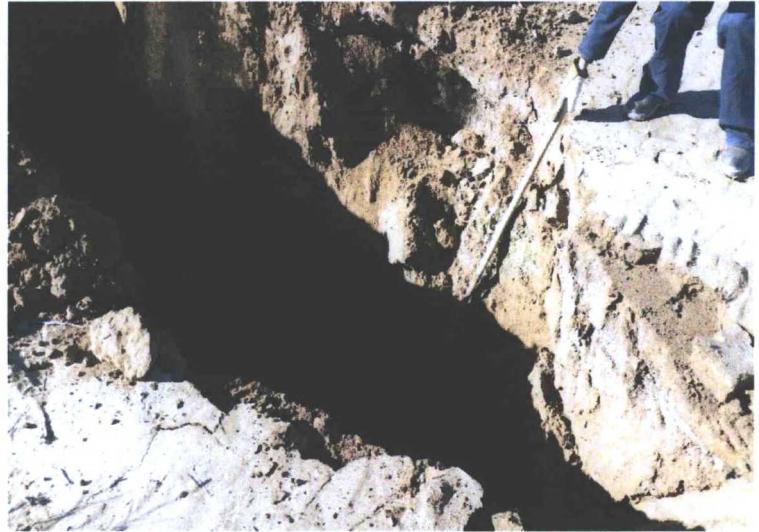
**Photograph 2**

Beginning of excavation activities.

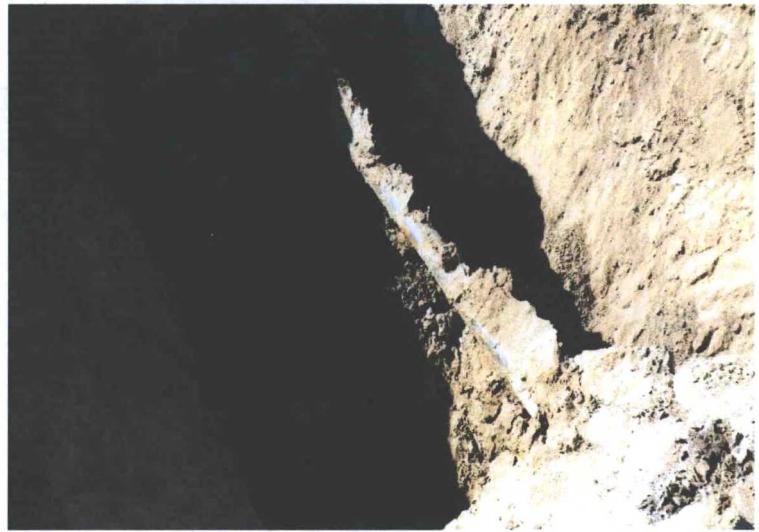
**Photograph 3**

View of the in-process excavation activities.

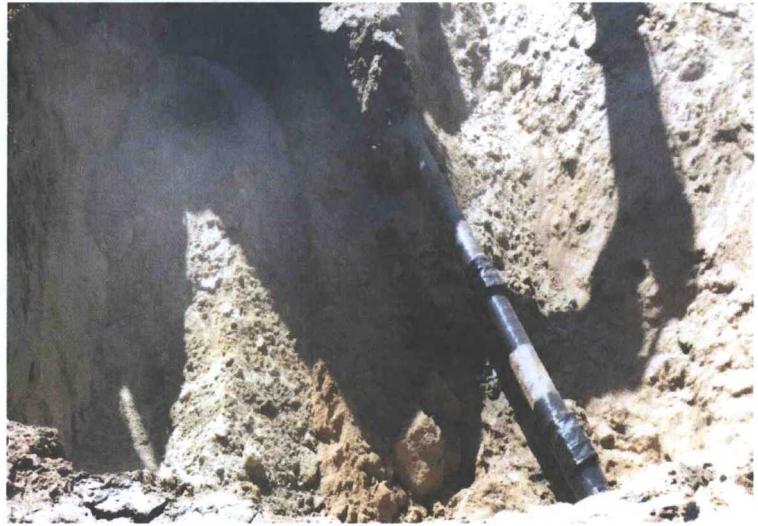
**Photograph 4**

View of the in-process excavation activities.

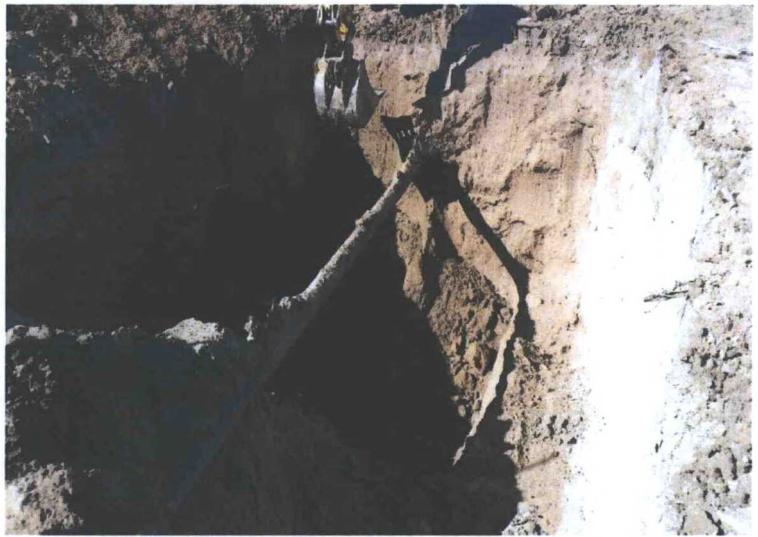
**Photograph 5**

View of the excavation, facing north.

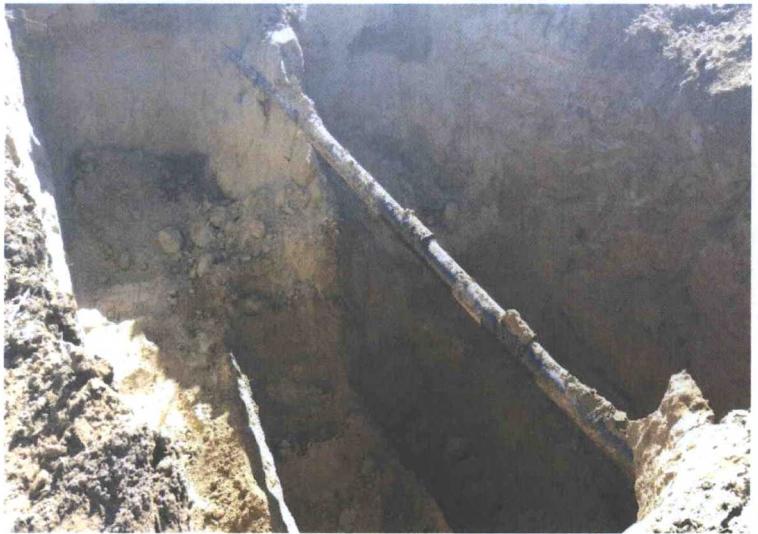
**Photograph 6**

View of the excavation, facing south.

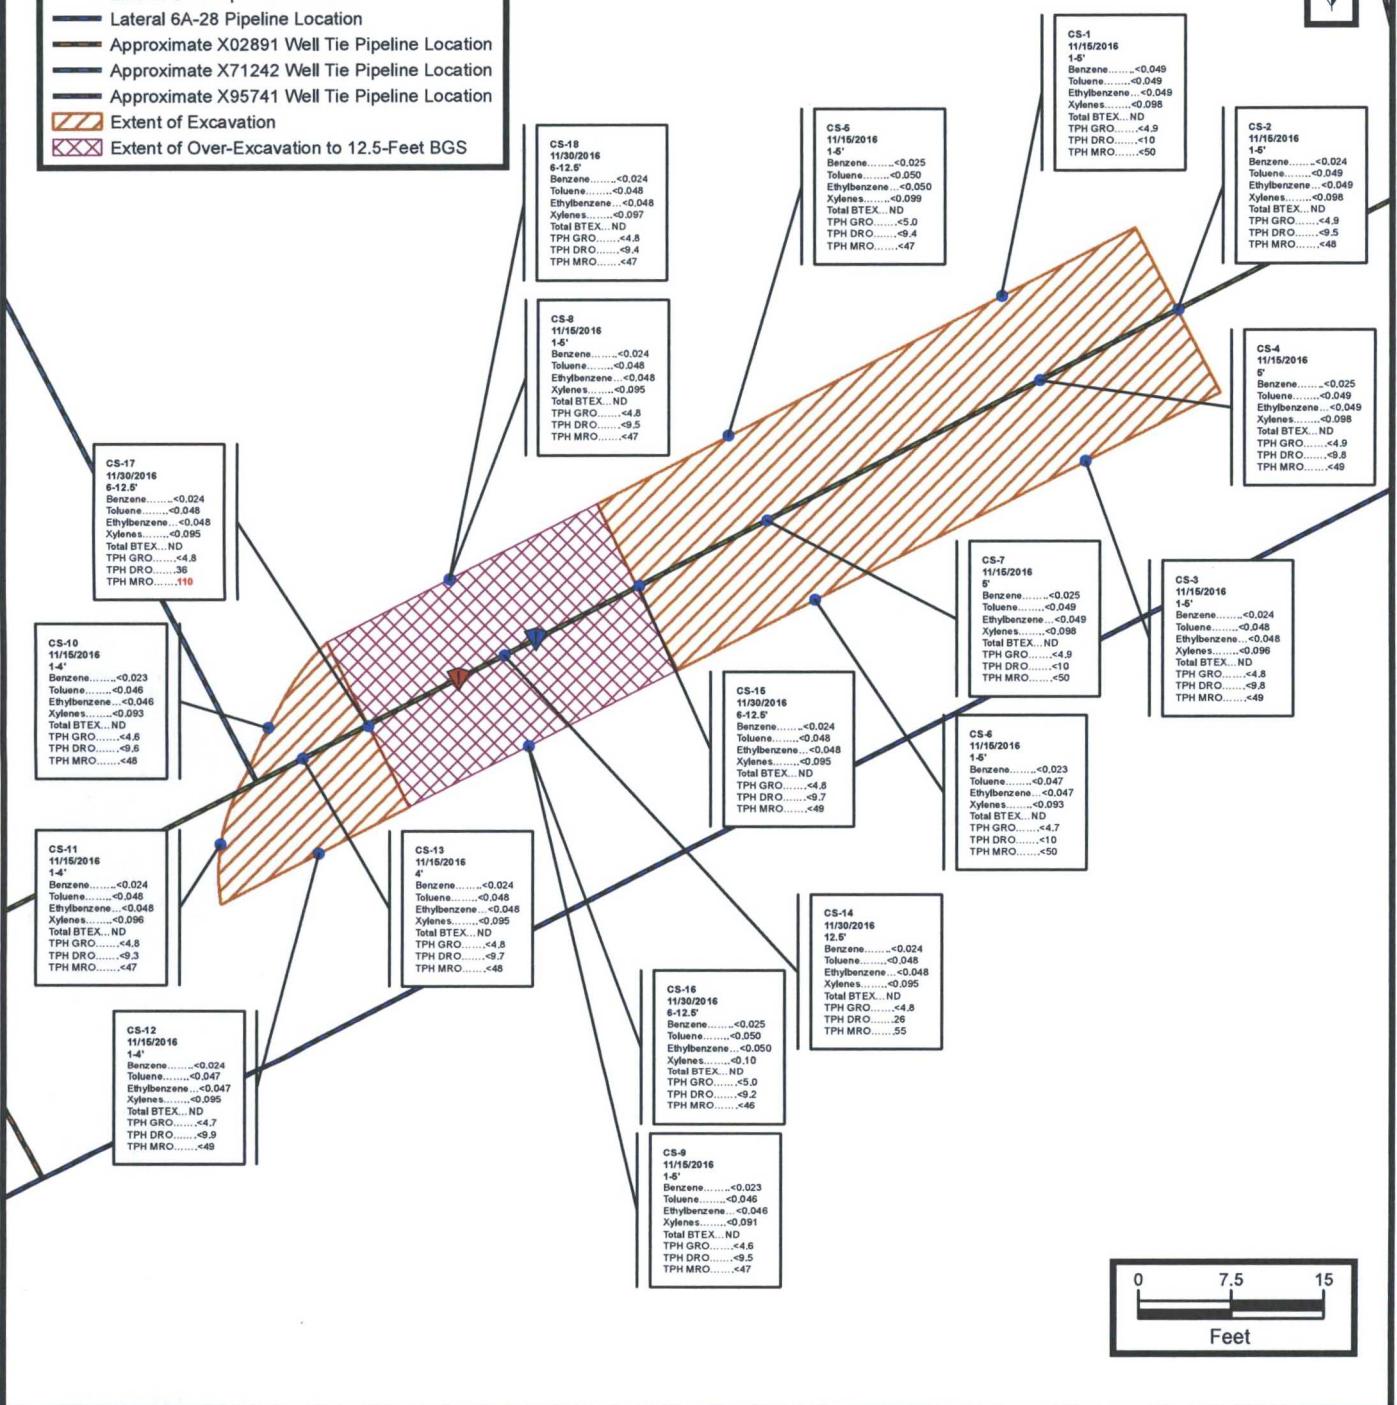
All Depths are Listed in Feet BGS.

Concentrations in **Red** Exceed the Applicable Remediation Action Level.

The final excavation measured approximately 91 feet long by 15 feet wide, with total depths ranging from four (4) feet bgs to 12.5 feet bgs. The initial excavation was extended approximately 50 feet to the east and 17 feet to the west to facilitate the replacement of 80 feet of pipe. The extended excavation to the east was approximately five (5) feet deep bgs and the extended excavation to the west was approximately four (4) feet deep bgs.

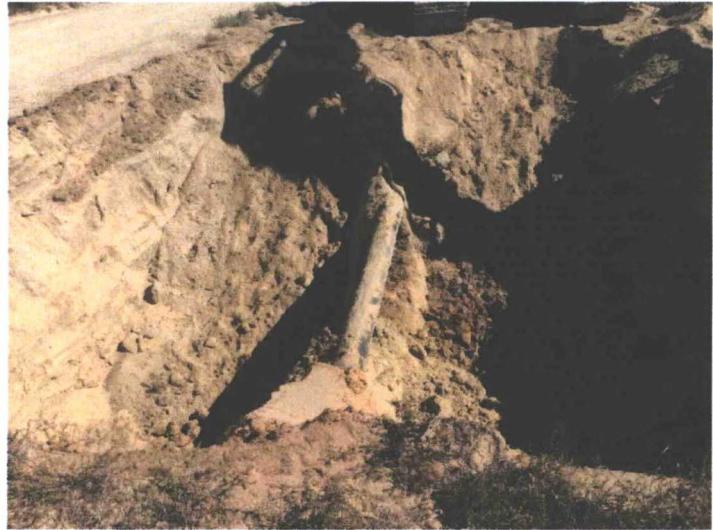
**Photograph 1**

View of the source area, facing north-east.

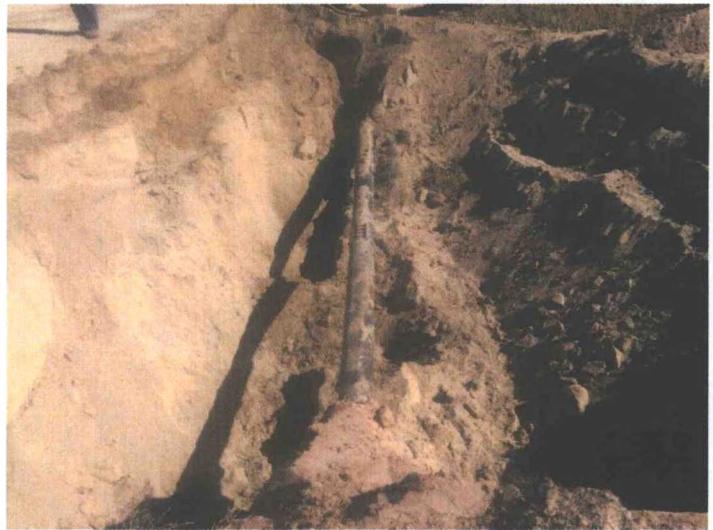
**Photograph 2**

View of the in-process excavation activities, facing northeast.

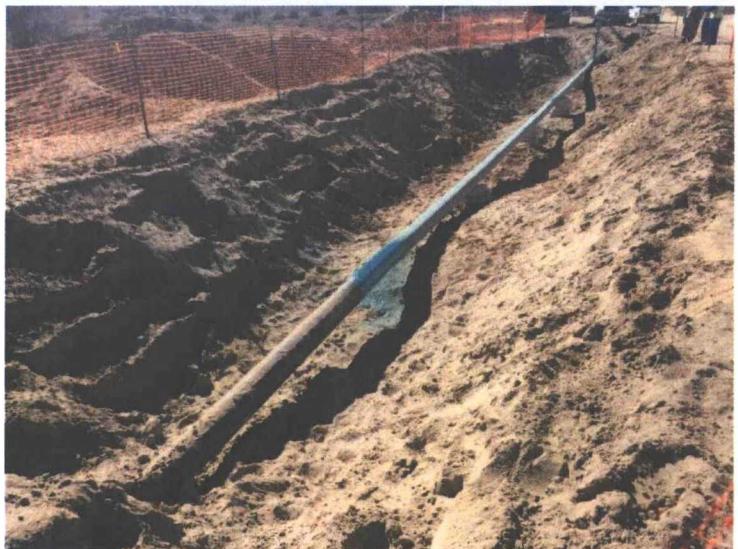
**Photograph 3**

View of the repaired pipe, facing south-west.

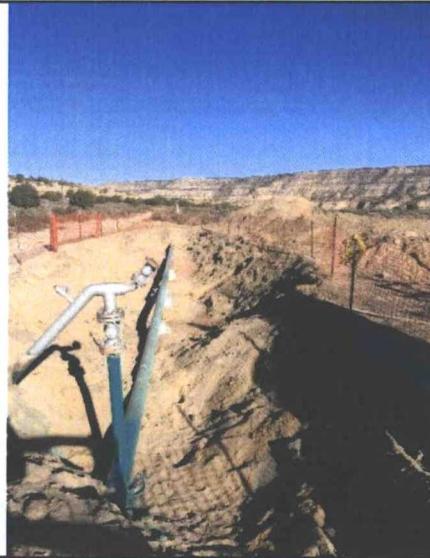
**Photograph 4**

View of the repaired pipe, facing northeast.

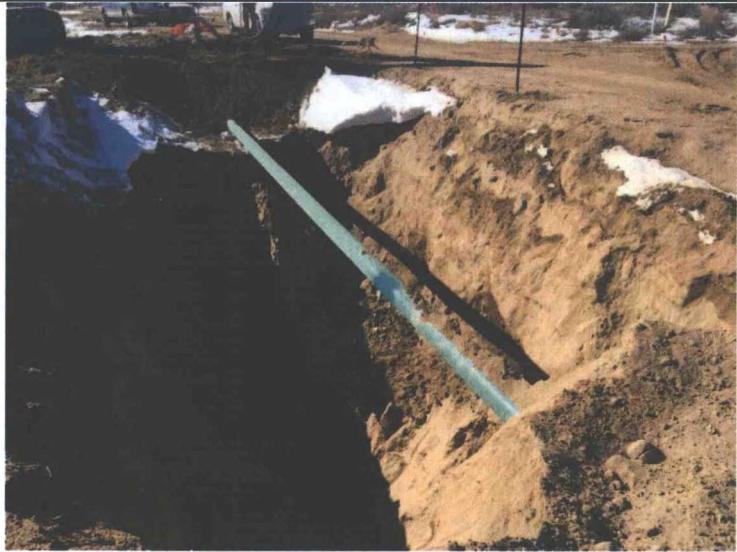
**Photograph 5**

View of the in-process over-excavation activities at the points of release, facing west. In this photo, the east-northeast portion of the unaffected extended pipeline replacement excavation has already been backfilled to facilitate the deeper excavation in the release area.
