**Release Report/ General
Correspondence**

Enterprise Products
San Juan 27-5 #133 Pipeline Releases
Latitude North 36.55656, Longitude West -107.40523
Latitude North 36.55685, Longitude West -107.40501
NE ¼, SW ¼ and NW ¼, SW ¼ Section 19 T27N R5W
Rio Arriba County, New Mexico

On behalf of Enterprise Products Operating, LLC. (Enterprise), SMA has prepared this report that describes remediation of two hydrocarbon releases associated with the San Juan 27-5 #133 pipeline. The San Juan 27-5 #133 pipeline releases were a result of internal corrosion of the steel pipeline. The releases were reported September 10, 2013. The releases are located approximately 130 feet apart, and are located in Units L (NW ¼, SW ¼) and K (NE ¼, SW ¼) Section 29 Township 27 North, Range 05 West, 36.55685, -107.40501 and 36.55656, -107.40523, Rio Arriba County, New Mexico. Figure 1, Vicinity Map, illustrates the location of the releases.

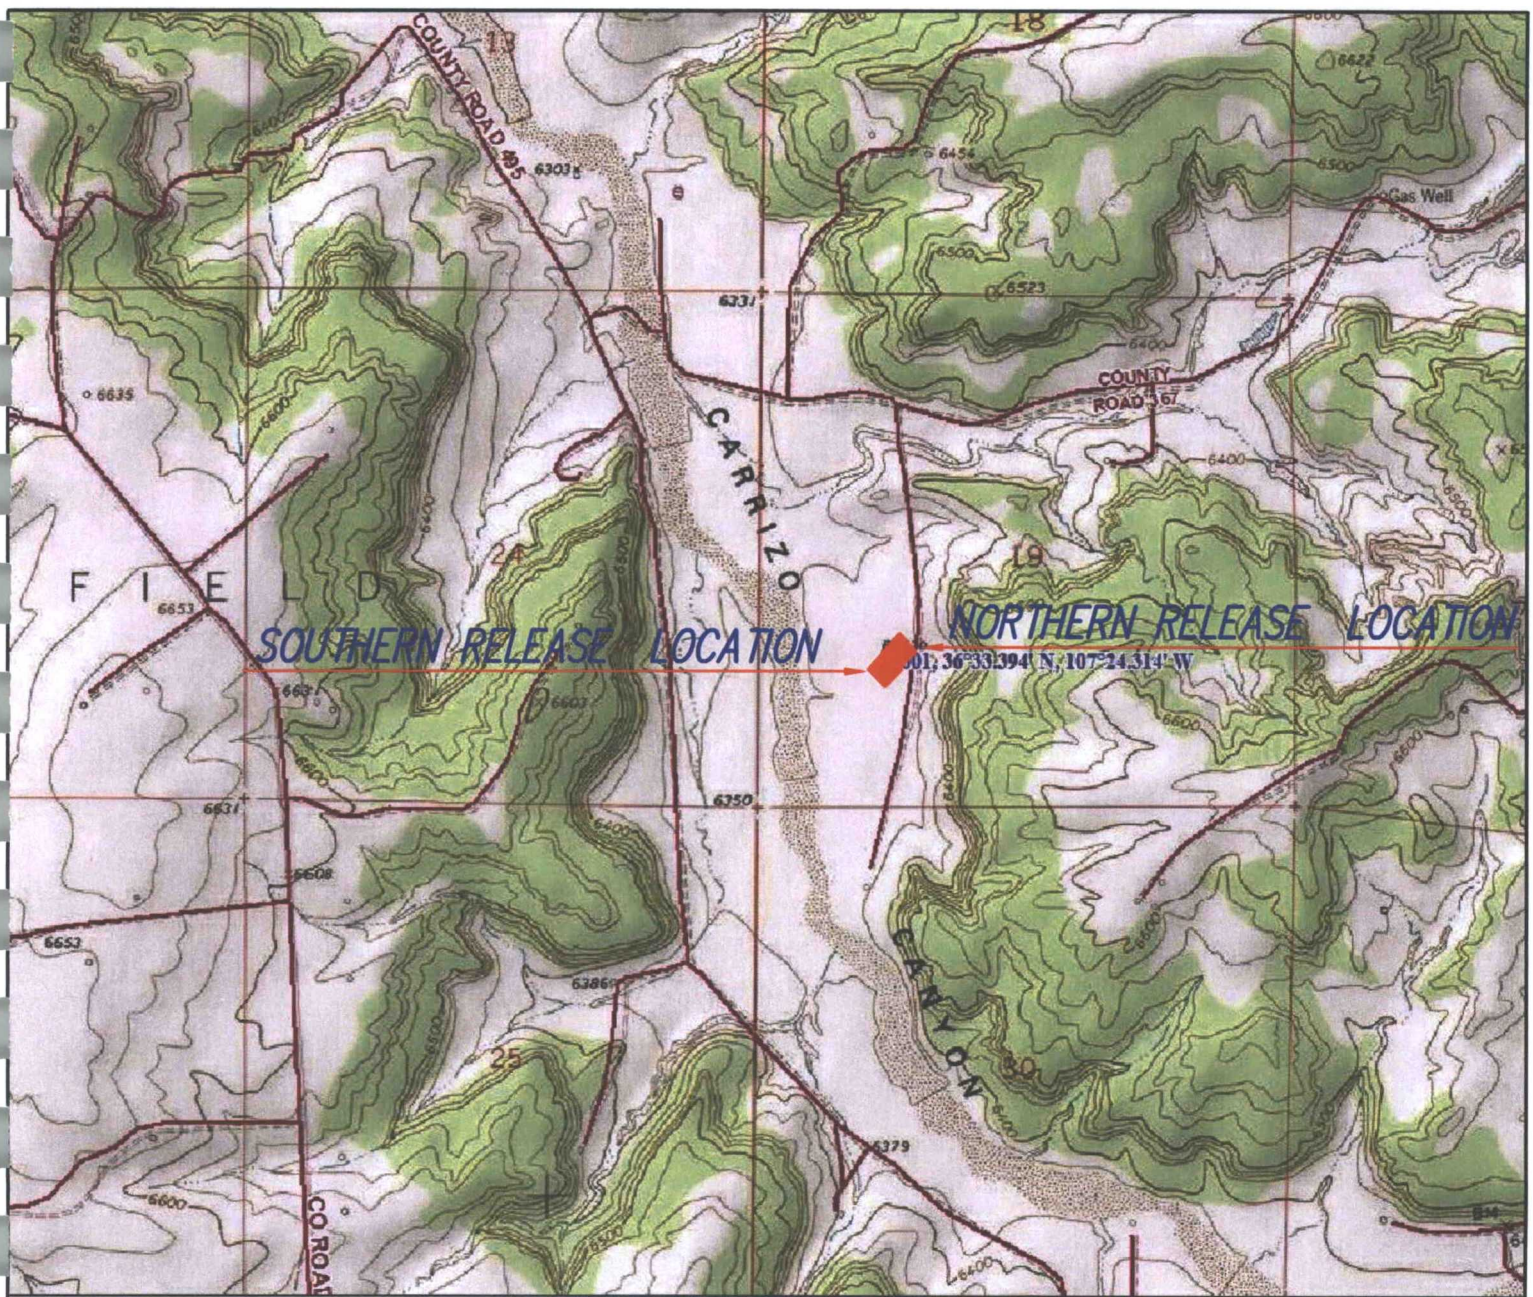
APPROVED: RSA	DATE: 11/26/2013
DRAWN BY: SMOSKAL	DATE: 11/22/2013
REVISIONS BY:	DATE:
PROJECT # 5122104	FIGURE: 1

VICINITY MAP
SJ 27-5 #133 RELEASE LOCATIONS
UNIT K SECTION 19 T27N R5W
& UNIT L SECTION 19 T27N R5W
RIO ARRIBA COUNTY, NEW MEXICO

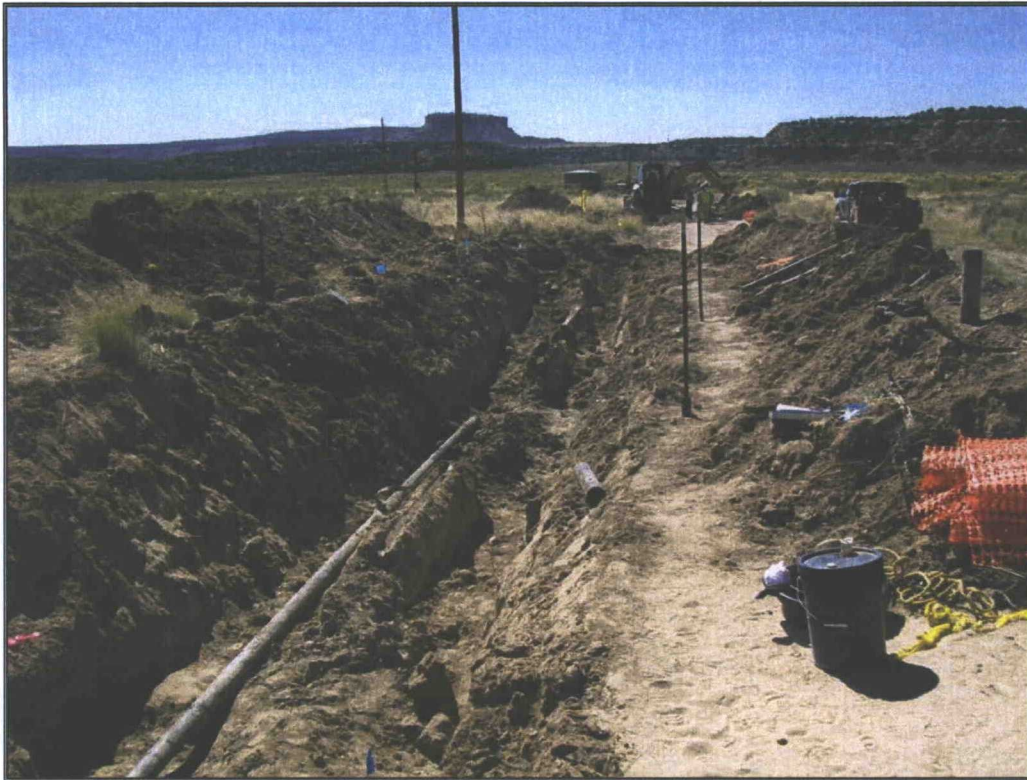
Photo 1: View of the pipeline and excavation for the northern release; southern release in background.

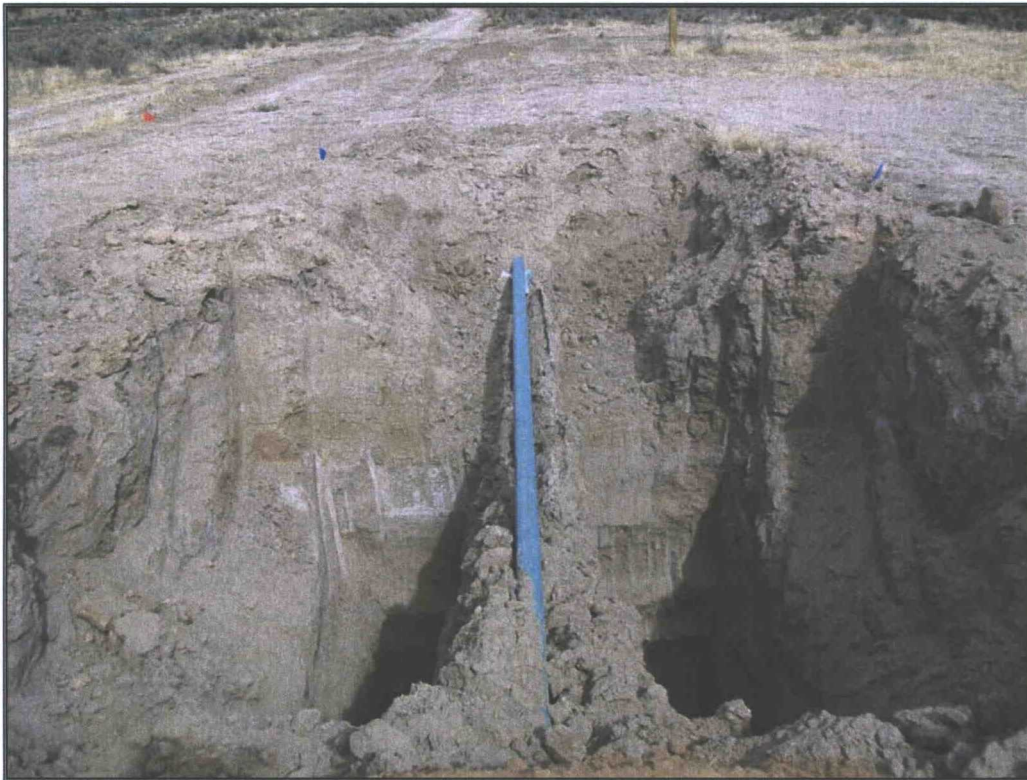
Photo 2: View of the total extent of excavation for the southern release.

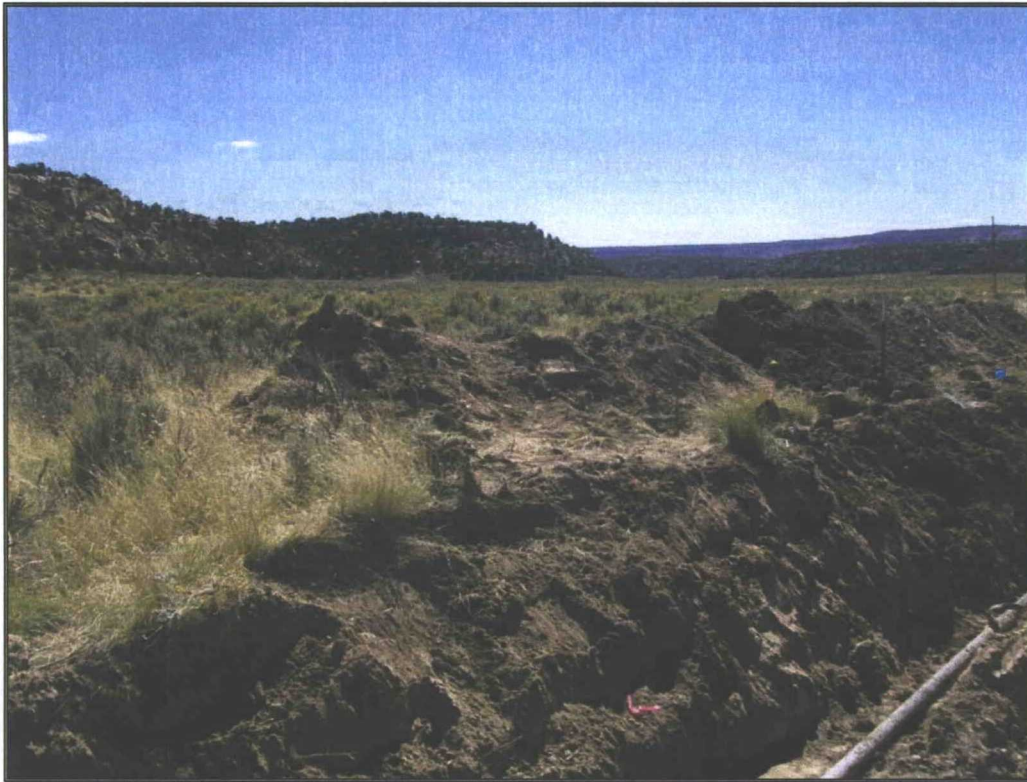
Photo 3: View of the excavation stockpile for the northern release.

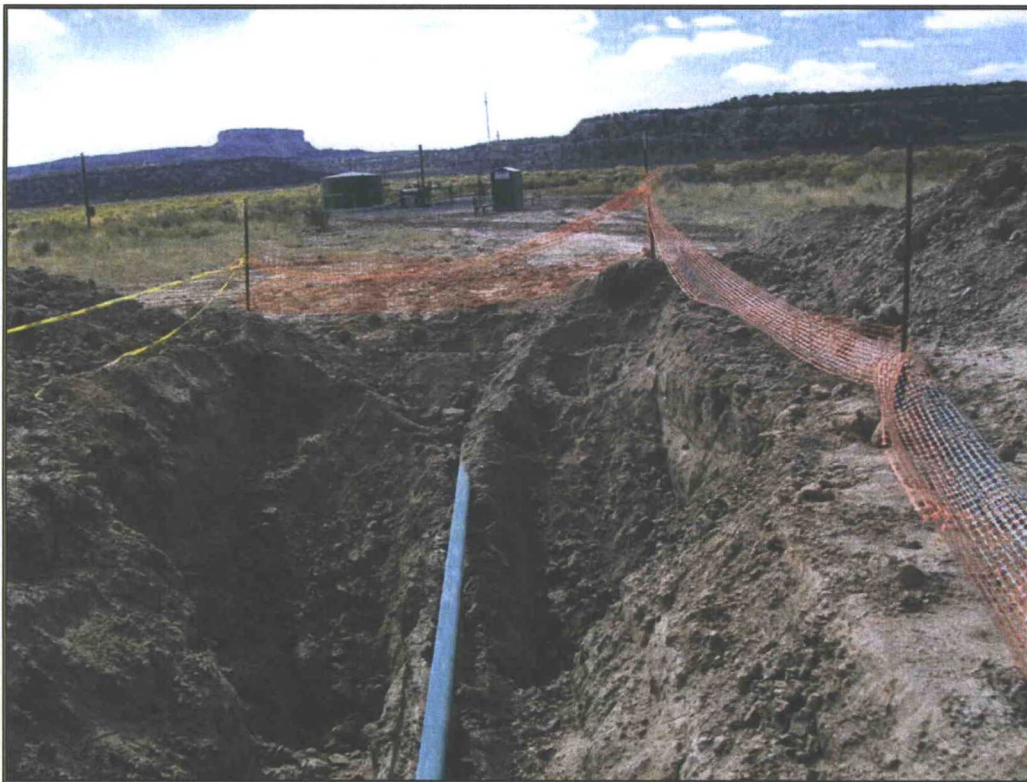
Photo 4: View of the excavation for the southern release.

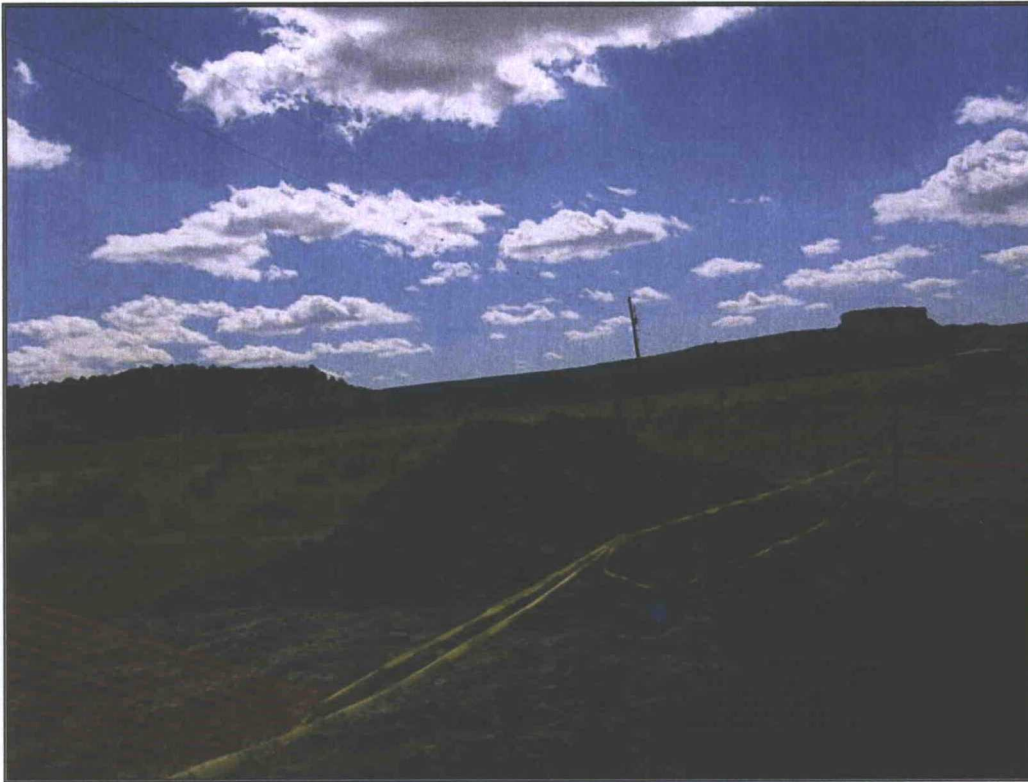
Photo 5: View of the excavation stockpile for the southern release.

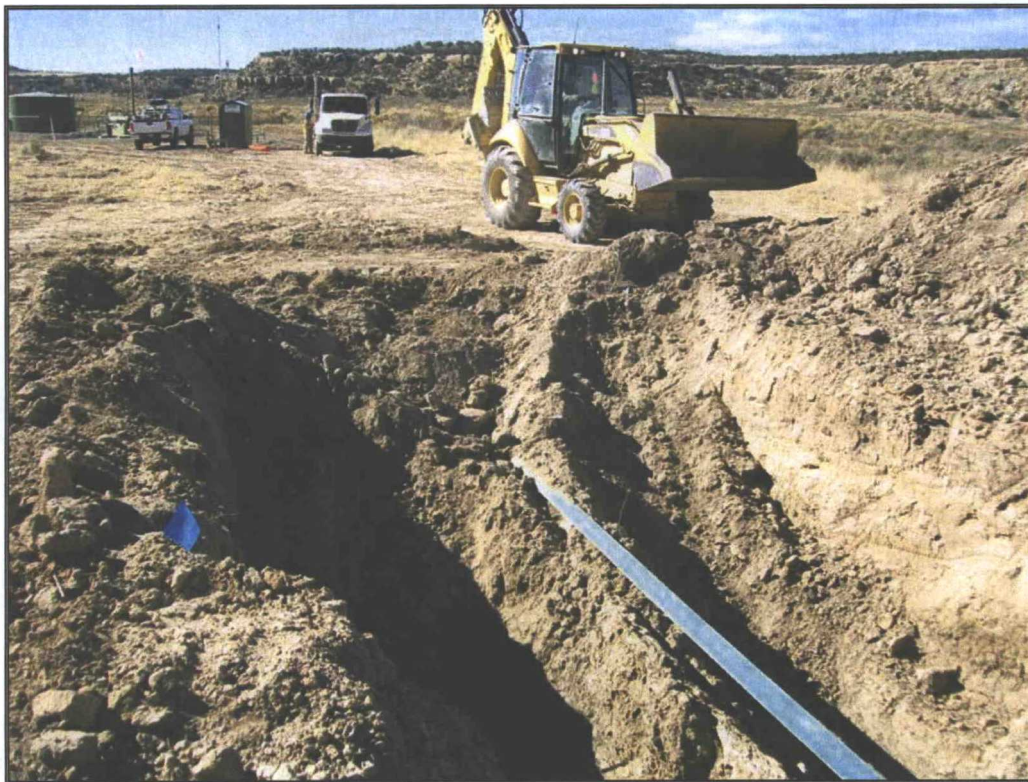
Photo 6: View of the excavation and loading of hydrocarbon impacted soils at the southern release.
