3RP - 1011

ENTERPRISE PRODUCTS OPERATING, LLC

Release Notification and Corrective Action

The Enterprise Field Services, LLC (Enterprise) Jicarilla Apache H Tract 2 #2 well tie pipeline release site is located in Unit Letter P, Section 4, Township 23 North, Range 2 West, in Rio Arriba County, New Mexico, on the Jicarilla Apache Nation. The release resulted from corrosion of pipeline discovered on August 1, 2017.

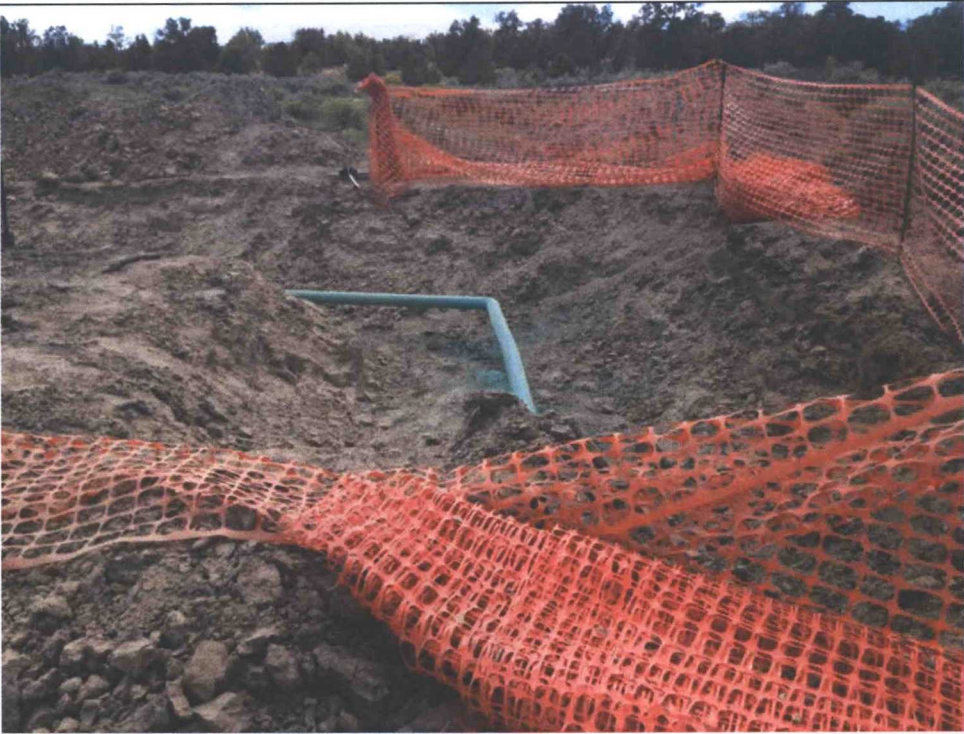
Photograph #1

Client: Enterprise	
Site Name: Jicarilla Apache H Tract 2 #2 Well Tie Pipeline Release	
Date Photo Taken: August 22, 2017	
Release Location: N36.24778, W107.04833 P-4-23N-2W Rio Arriba County, NM	
Photo Taken by: Heather Woods	Description: Facing southwest, view of the final excavation extents at the north end of the excavation.

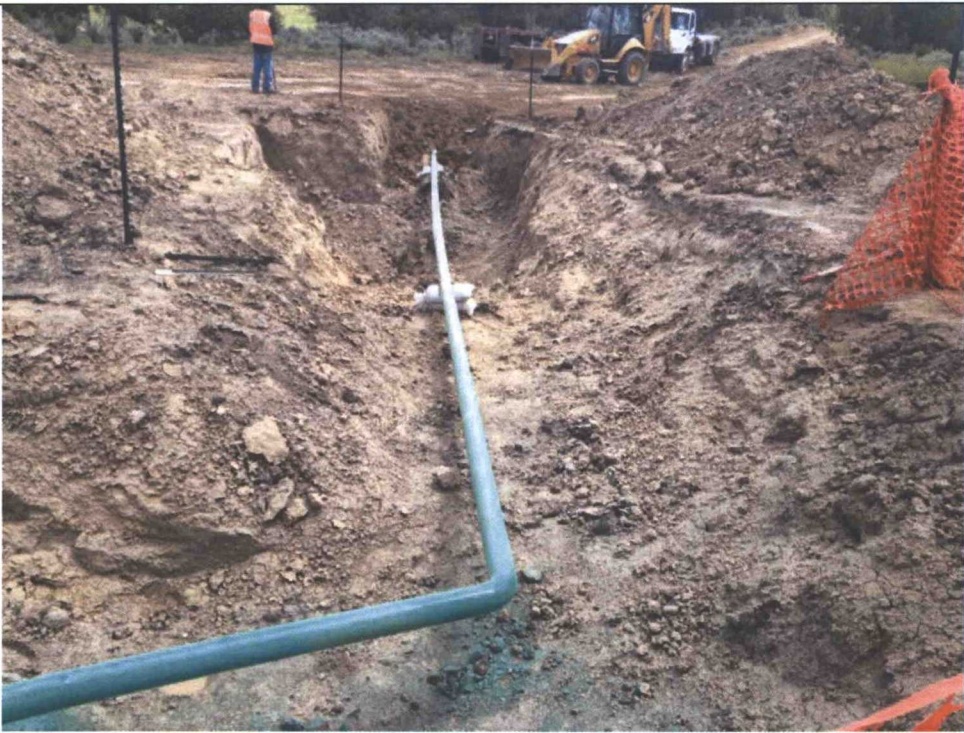
Photograph #2

Client: Enterprise	
Site Name: Jicarilla Apache H Tract 2 #2 Well Tie Pipeline Release	
Date Photo Taken: August 22, 2017	
Release Location: N36.24778, W107.04833 P-4-23N-2W Rio Arriba County, NM	
Photo Taken by: Heather Woods	Description: Facing southeast, view of the final excavation extents.

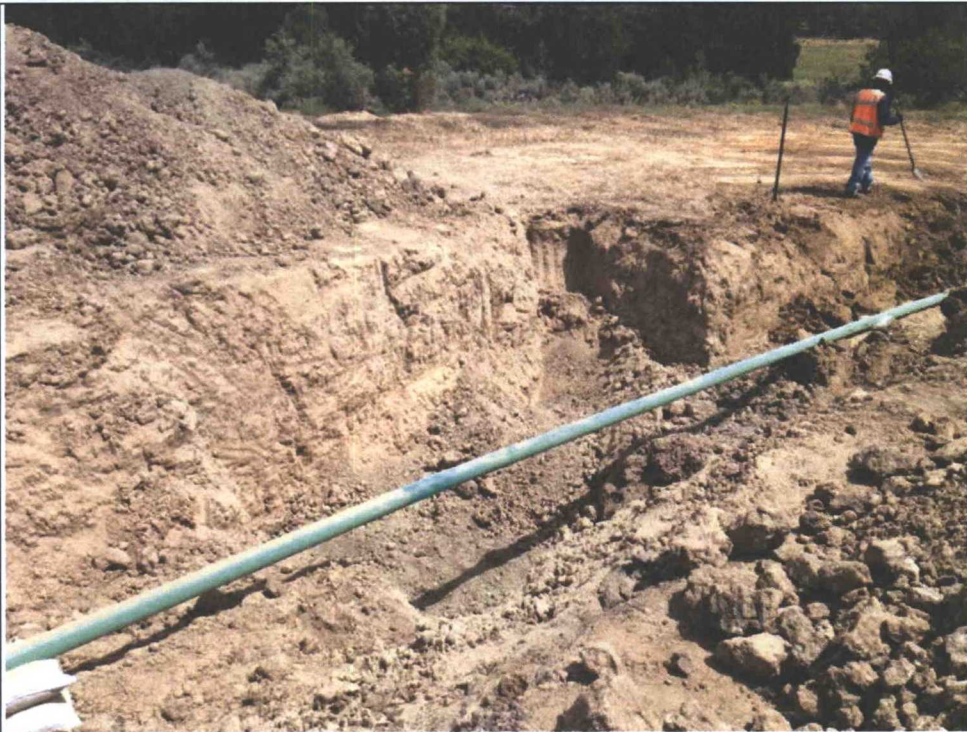
Photograph #3

Client: Enterprise	
Site Name: Jicarilla Apache H Tract 2 #2 Well Tie Pipeline Release	
Date Photo Taken: August 22, 2017	
Release Location: N36.24778, W107.04833 P-4-23N-2W Rio Arriba County, NM	
Photo Taken by: Heather Woods	
Description: Facing east, view of the expanded area of the final excavation.
