ENTERPRISE PRODUCTS OPERATING, LLC

Release Notification and Corrective Action

Name of Company Enterprise Field Services, LLC	Contact Thomas Long
Address 614 Reilly Ave, Farmington, NM 87401	Telephone No. 505-599-2286
Facility Name Lateral 2A-4	Facility Type Natural Gas Gathering Pipeline

Describe Area Affected and Cleanup Action Taken.*Repairs and remediation were completed on September 18, 2017. The final excavation measured approximately 25 feet long by 16 feet wide by 13 feet deep. Approximately 100 cubic yards of hydrocarbon impacted soil was excavated and transported to New Mexico Oil Conservation Division approved land farm facility. A third party corrective action report will be included with the "Final." C-141.

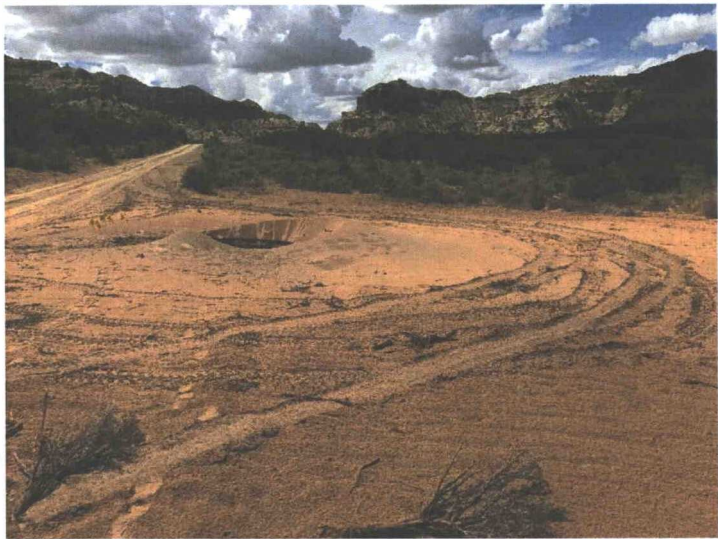
Photograph 1

View of the source area, facing south-west.

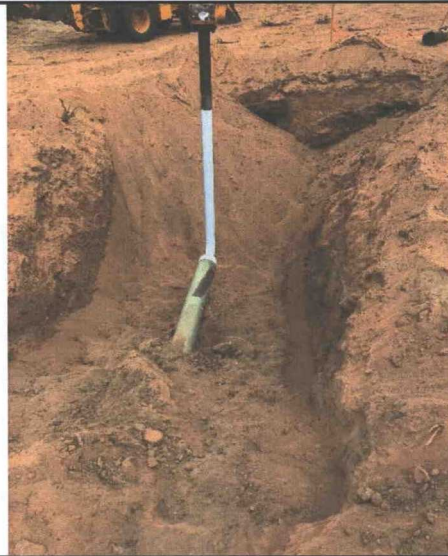
Photograph 2

View of the in-process corrective action activities, facing north.

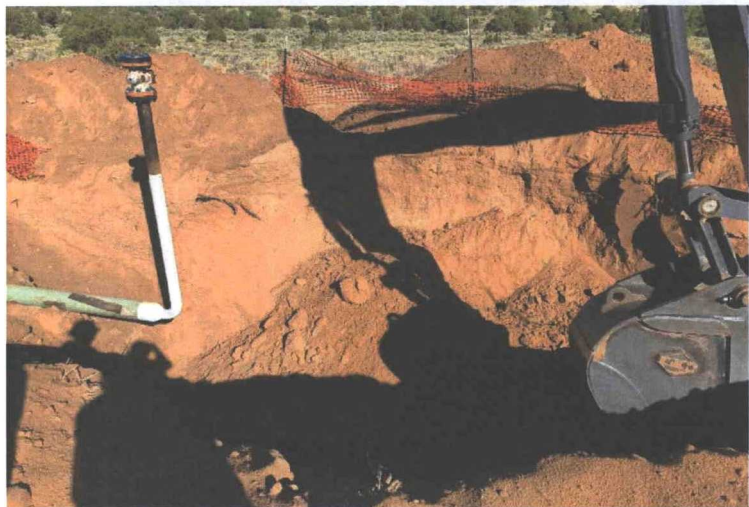
Photograph 3

View of the in-process corrective action activities, facing northwest.

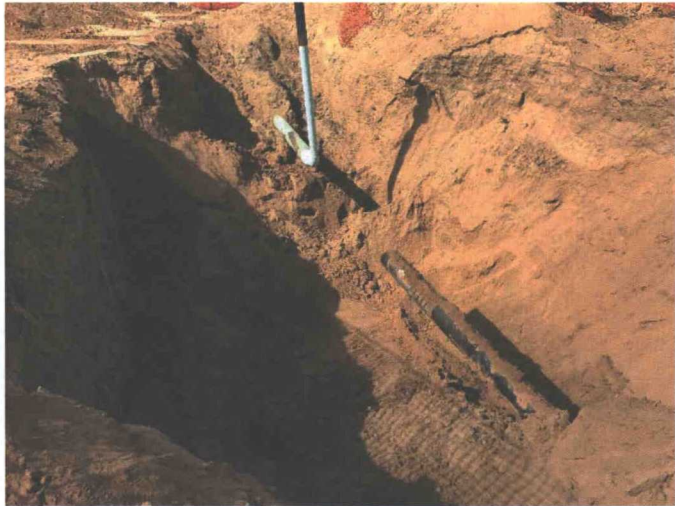
Photograph 4

View of the excavation, facing southwest.

The excavation measured approximately 25 feet long by 16 feet wide, with a total depth of approximately 13 feet bgs. The overspray affected approximately a 50-foot radius from the point of rupture.

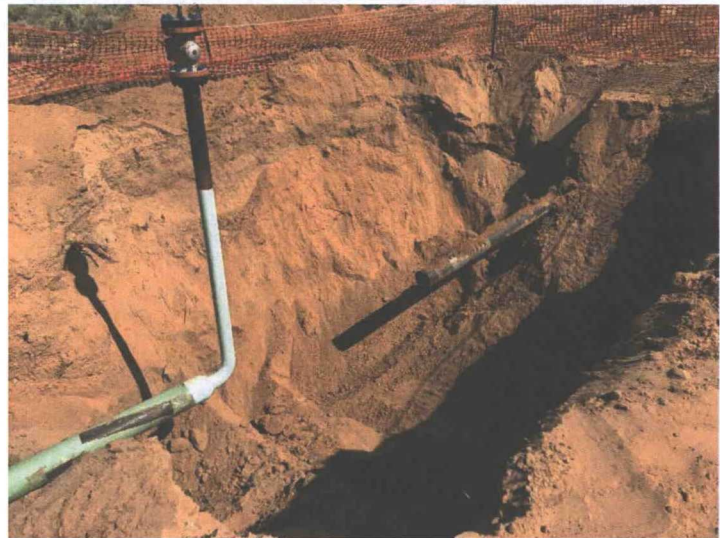
Photograph 5

View of the final excavation, facing north.

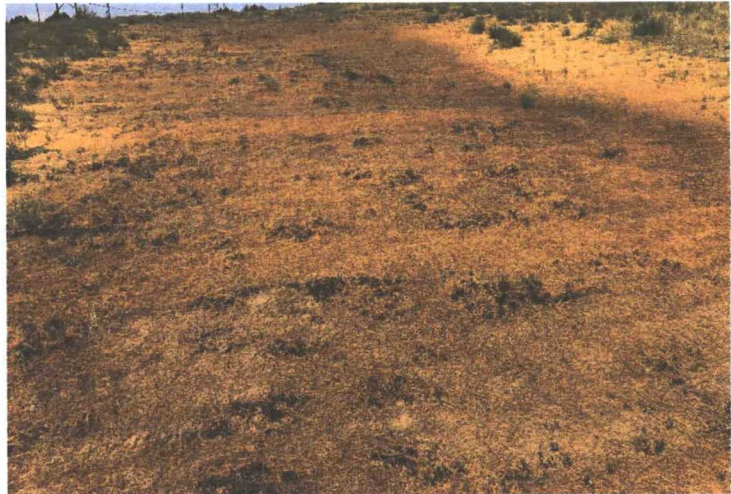
Photograph 1

View of the overspray area, facing west.

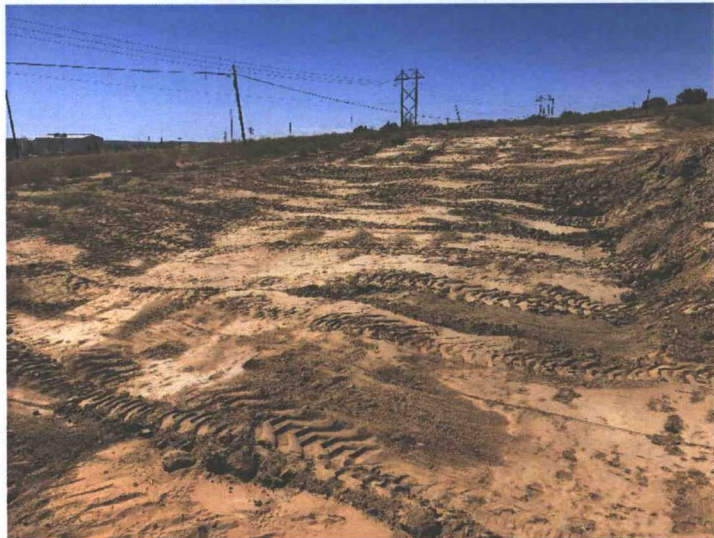
Photograph 2

View of the initial excavation.

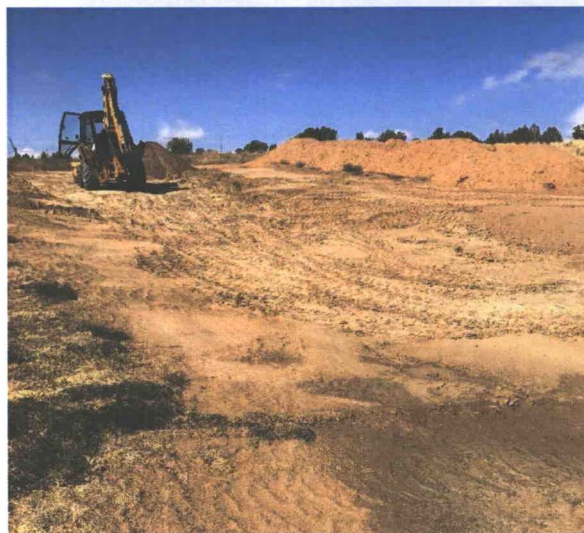
Photograph 3

View of in-process excavation activities.

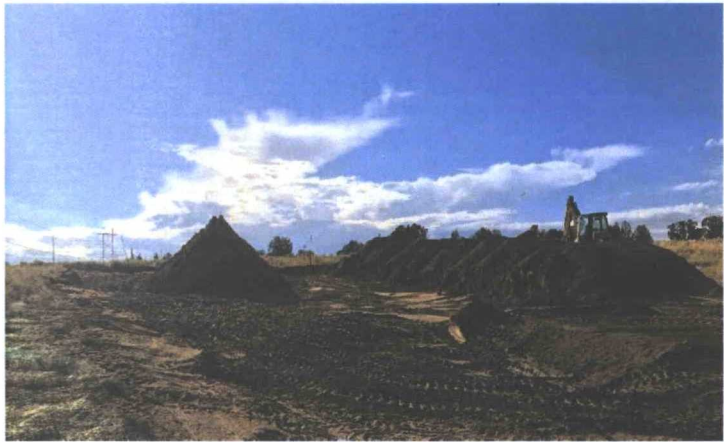
Photograph 4

View of the excavation.

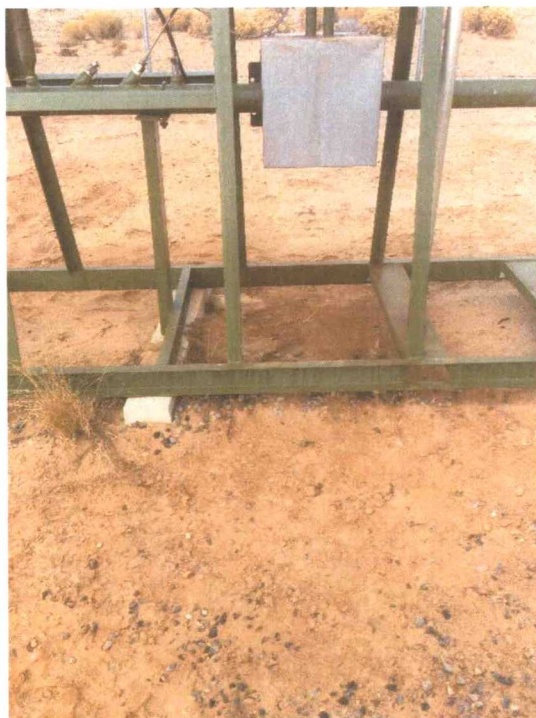
View of release point.

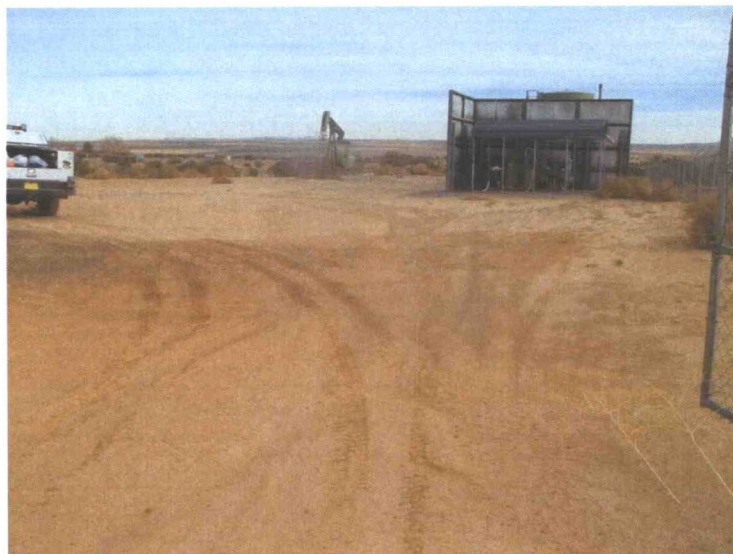
View west of flow path.

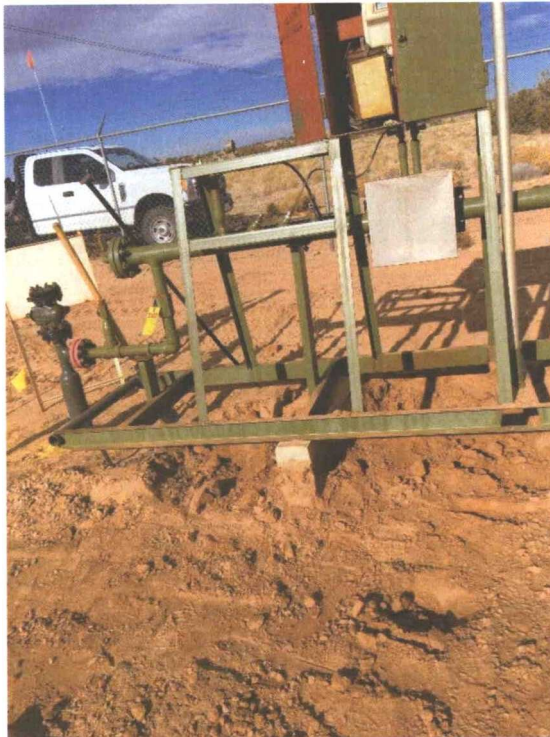
Excavated area at release point.

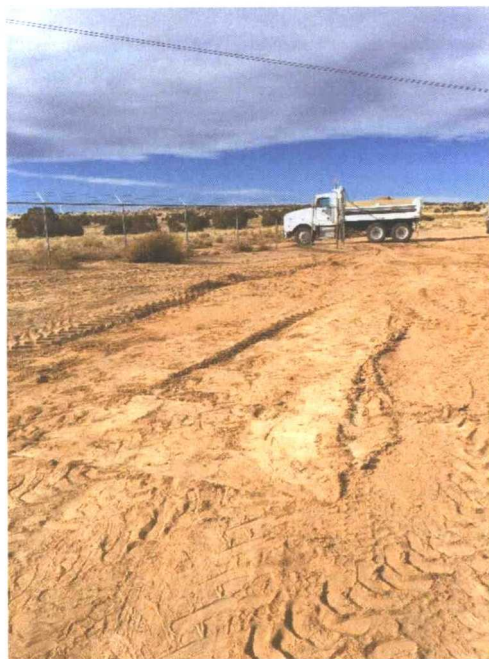
Surface scraped area along flow path.

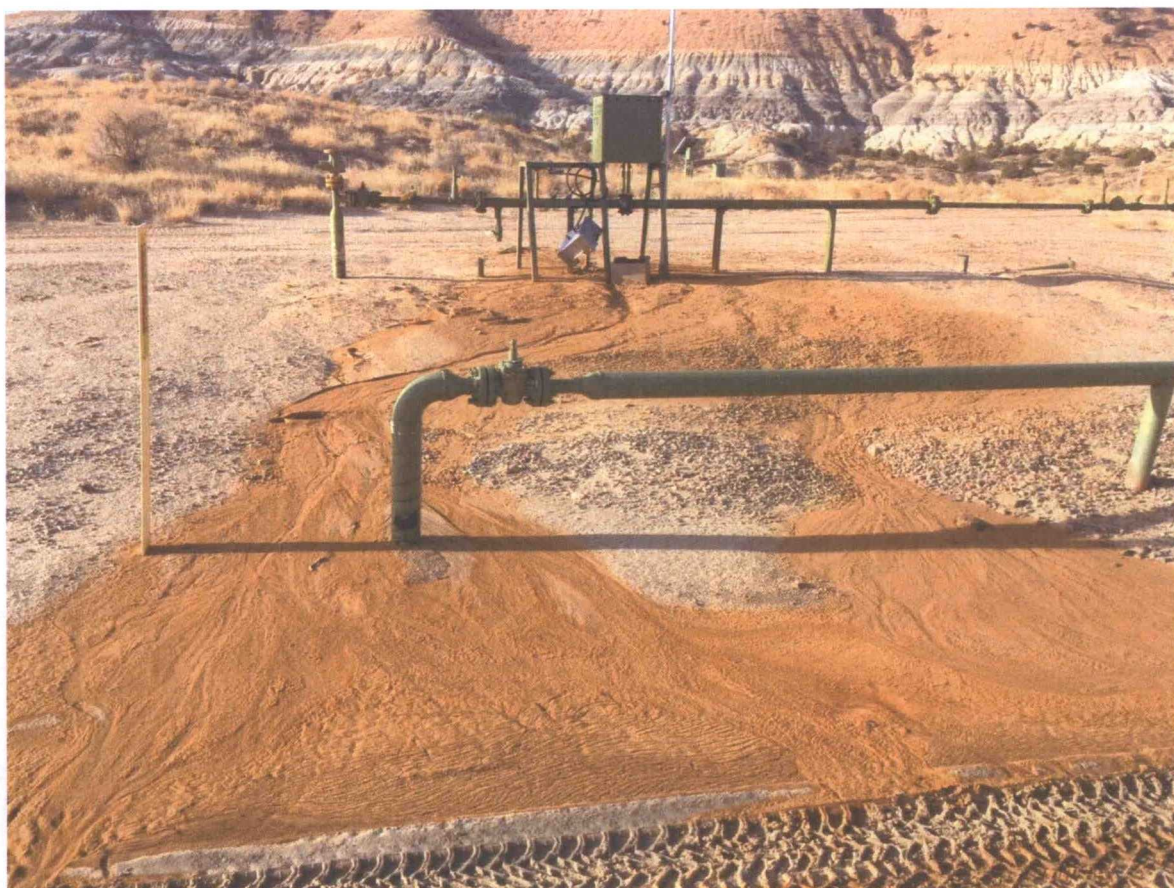
View South of release point and flow path.

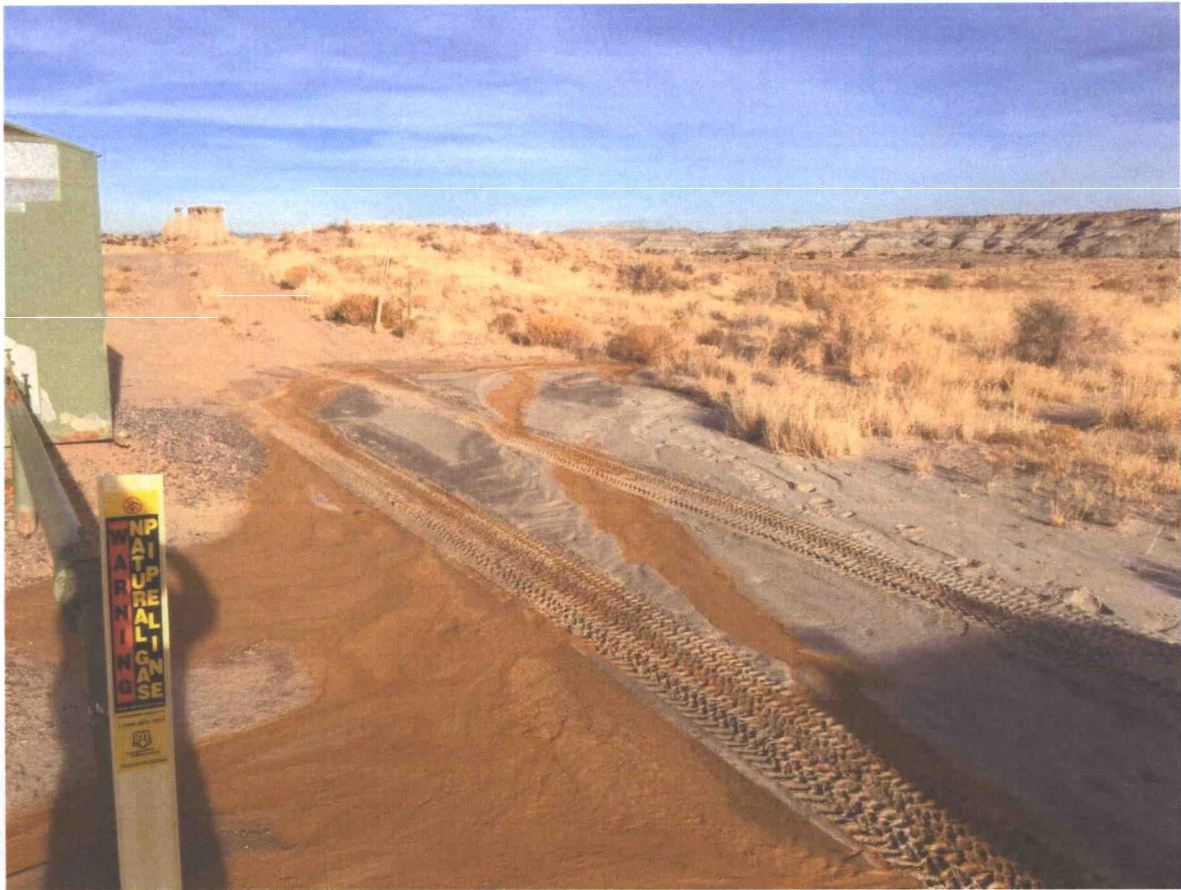
View North of flow path.

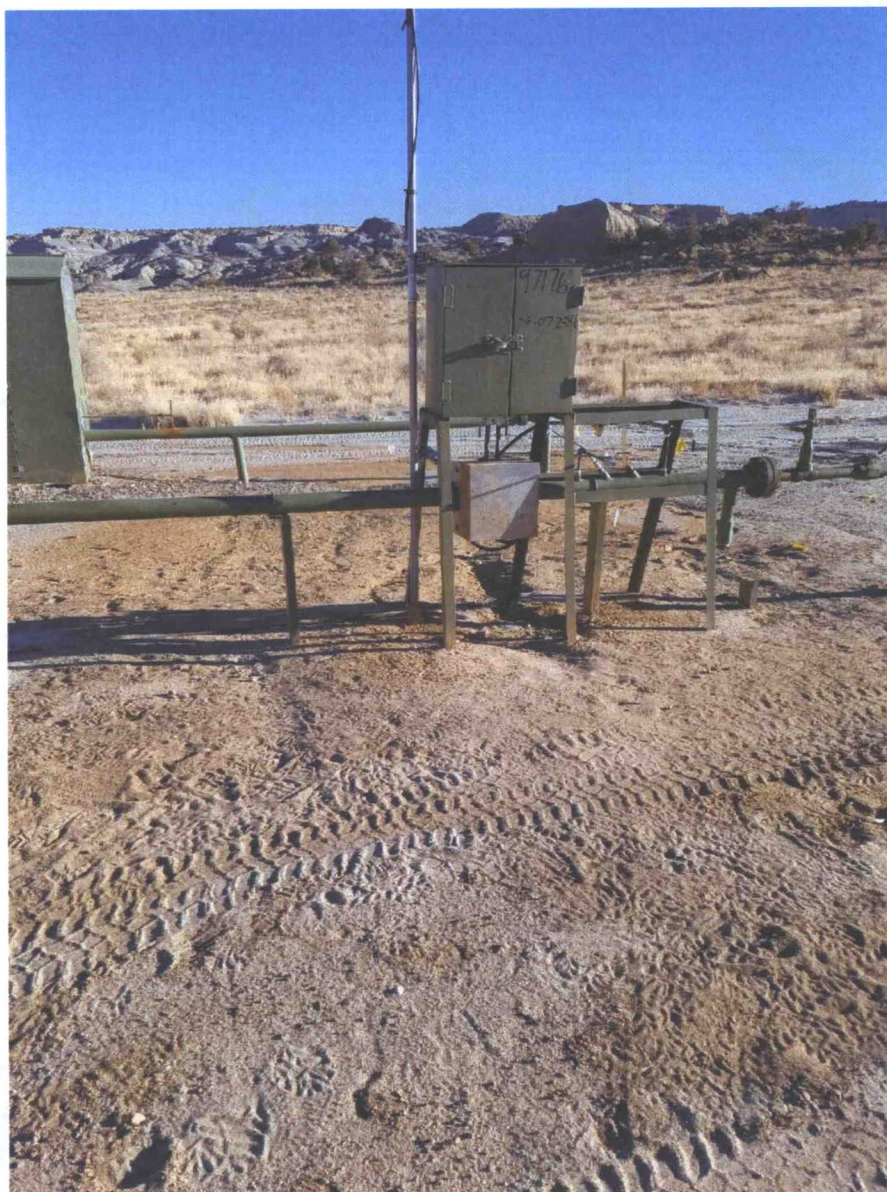
View of Meter tube release point.

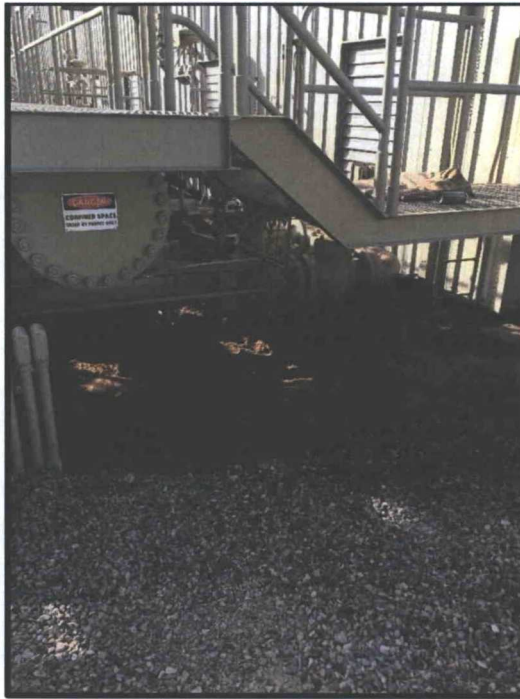
Figure 1. View of above ground piping in proposed sample area looking to the south.

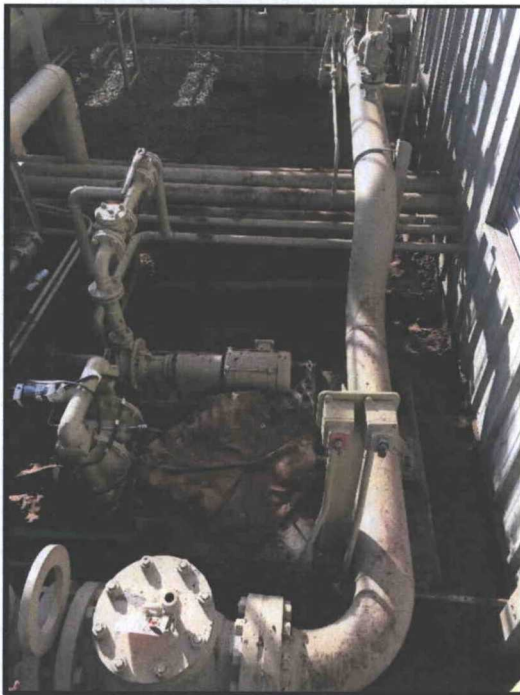
Figure 2. Aerial view extending north to south of above ground piping associated with proposed sample area.

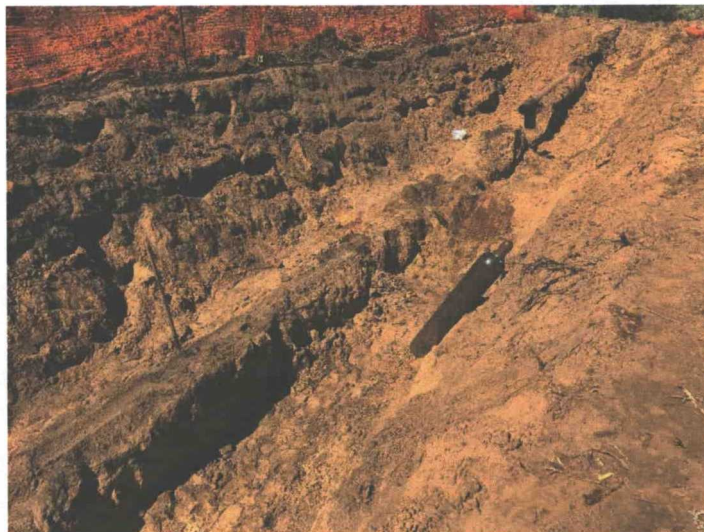
Photograph 1

View of the release area, facing north-west.

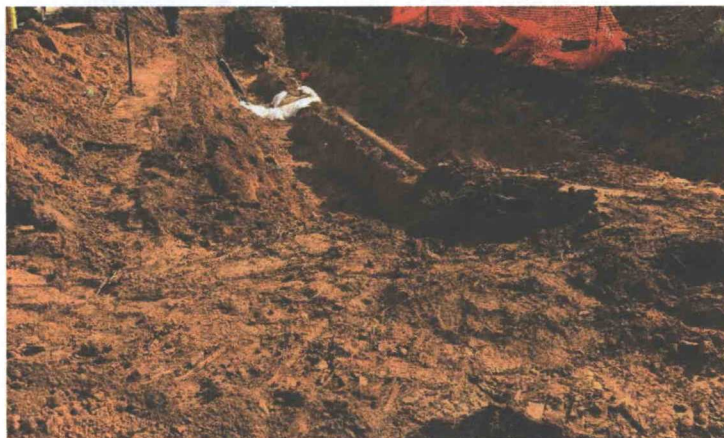
Photograph 2

View of the in-process corrective action activities, facing southwest.

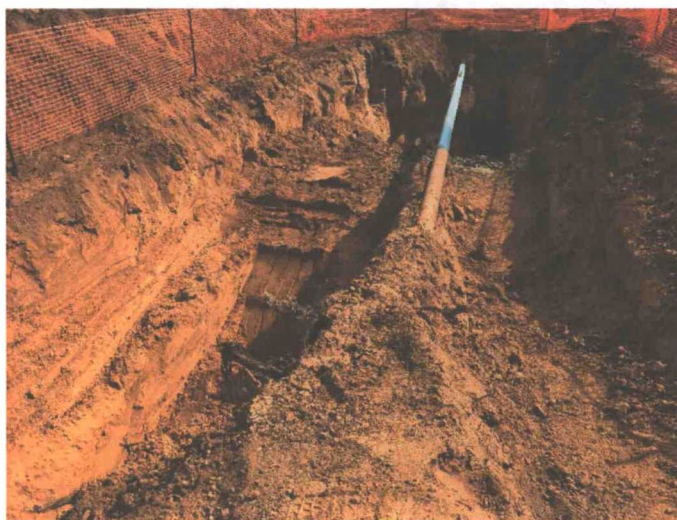
Photograph 3

View of the excavation, facing southeast.

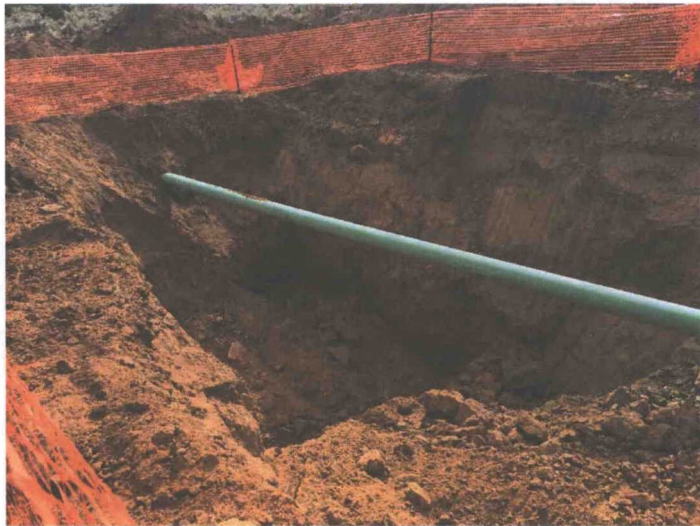
Photograph 4

View of the excavation, facing southwest.

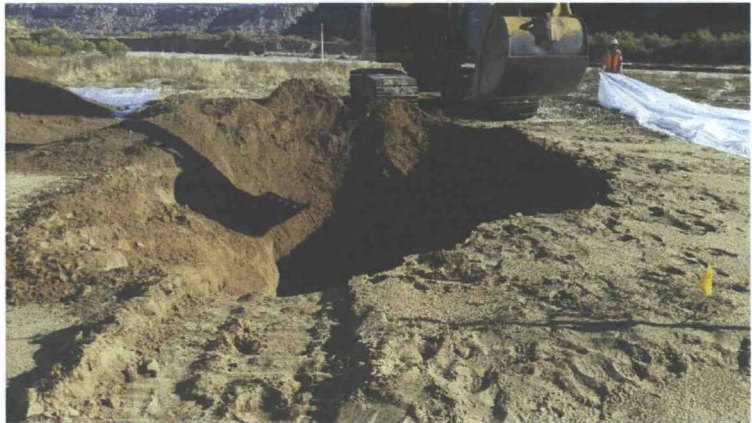
Photograph 1

View of excavation activities, facing northeast.

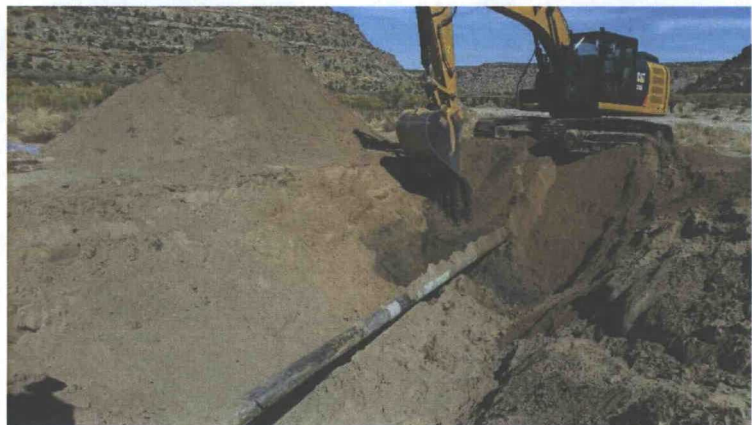
Photograph 2

View of excavation activities, facing north.

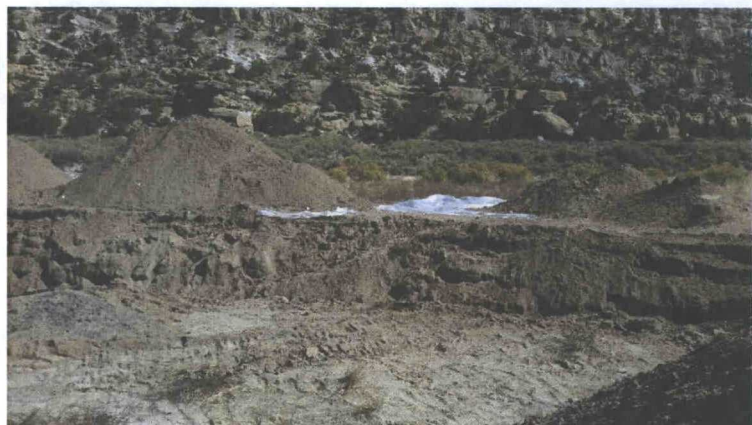
Photograph 3

View of stockpiled soils, facing east.

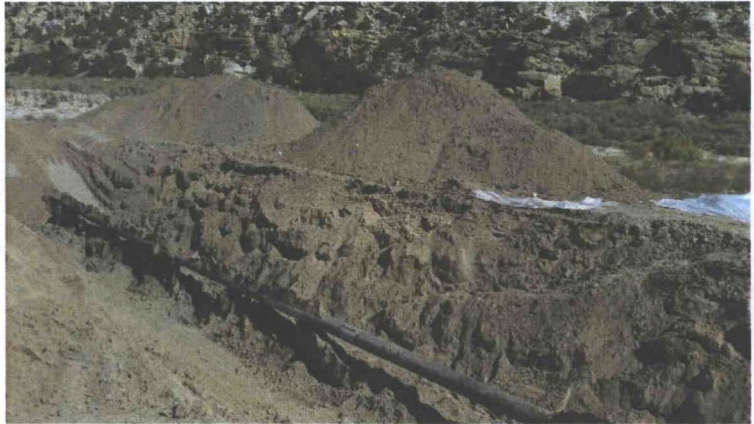
Photograph 4

View of the excavation, facing east.
