# AE Order Number Banner

**Williams Four Corners, LLC**

**Release Notification and Corrective Action**

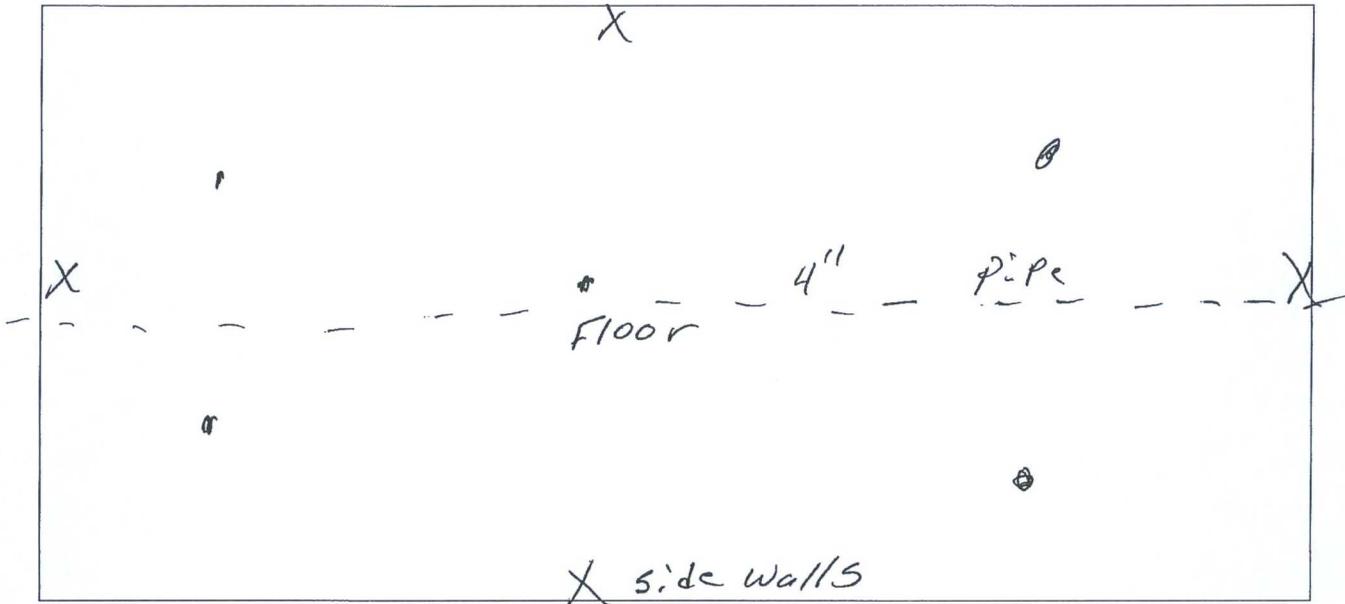
**Excavation Diagram and Sample Locations**

(Depict notable site features, excavation extents, visual observations, sample locations, north arrow, etc.)

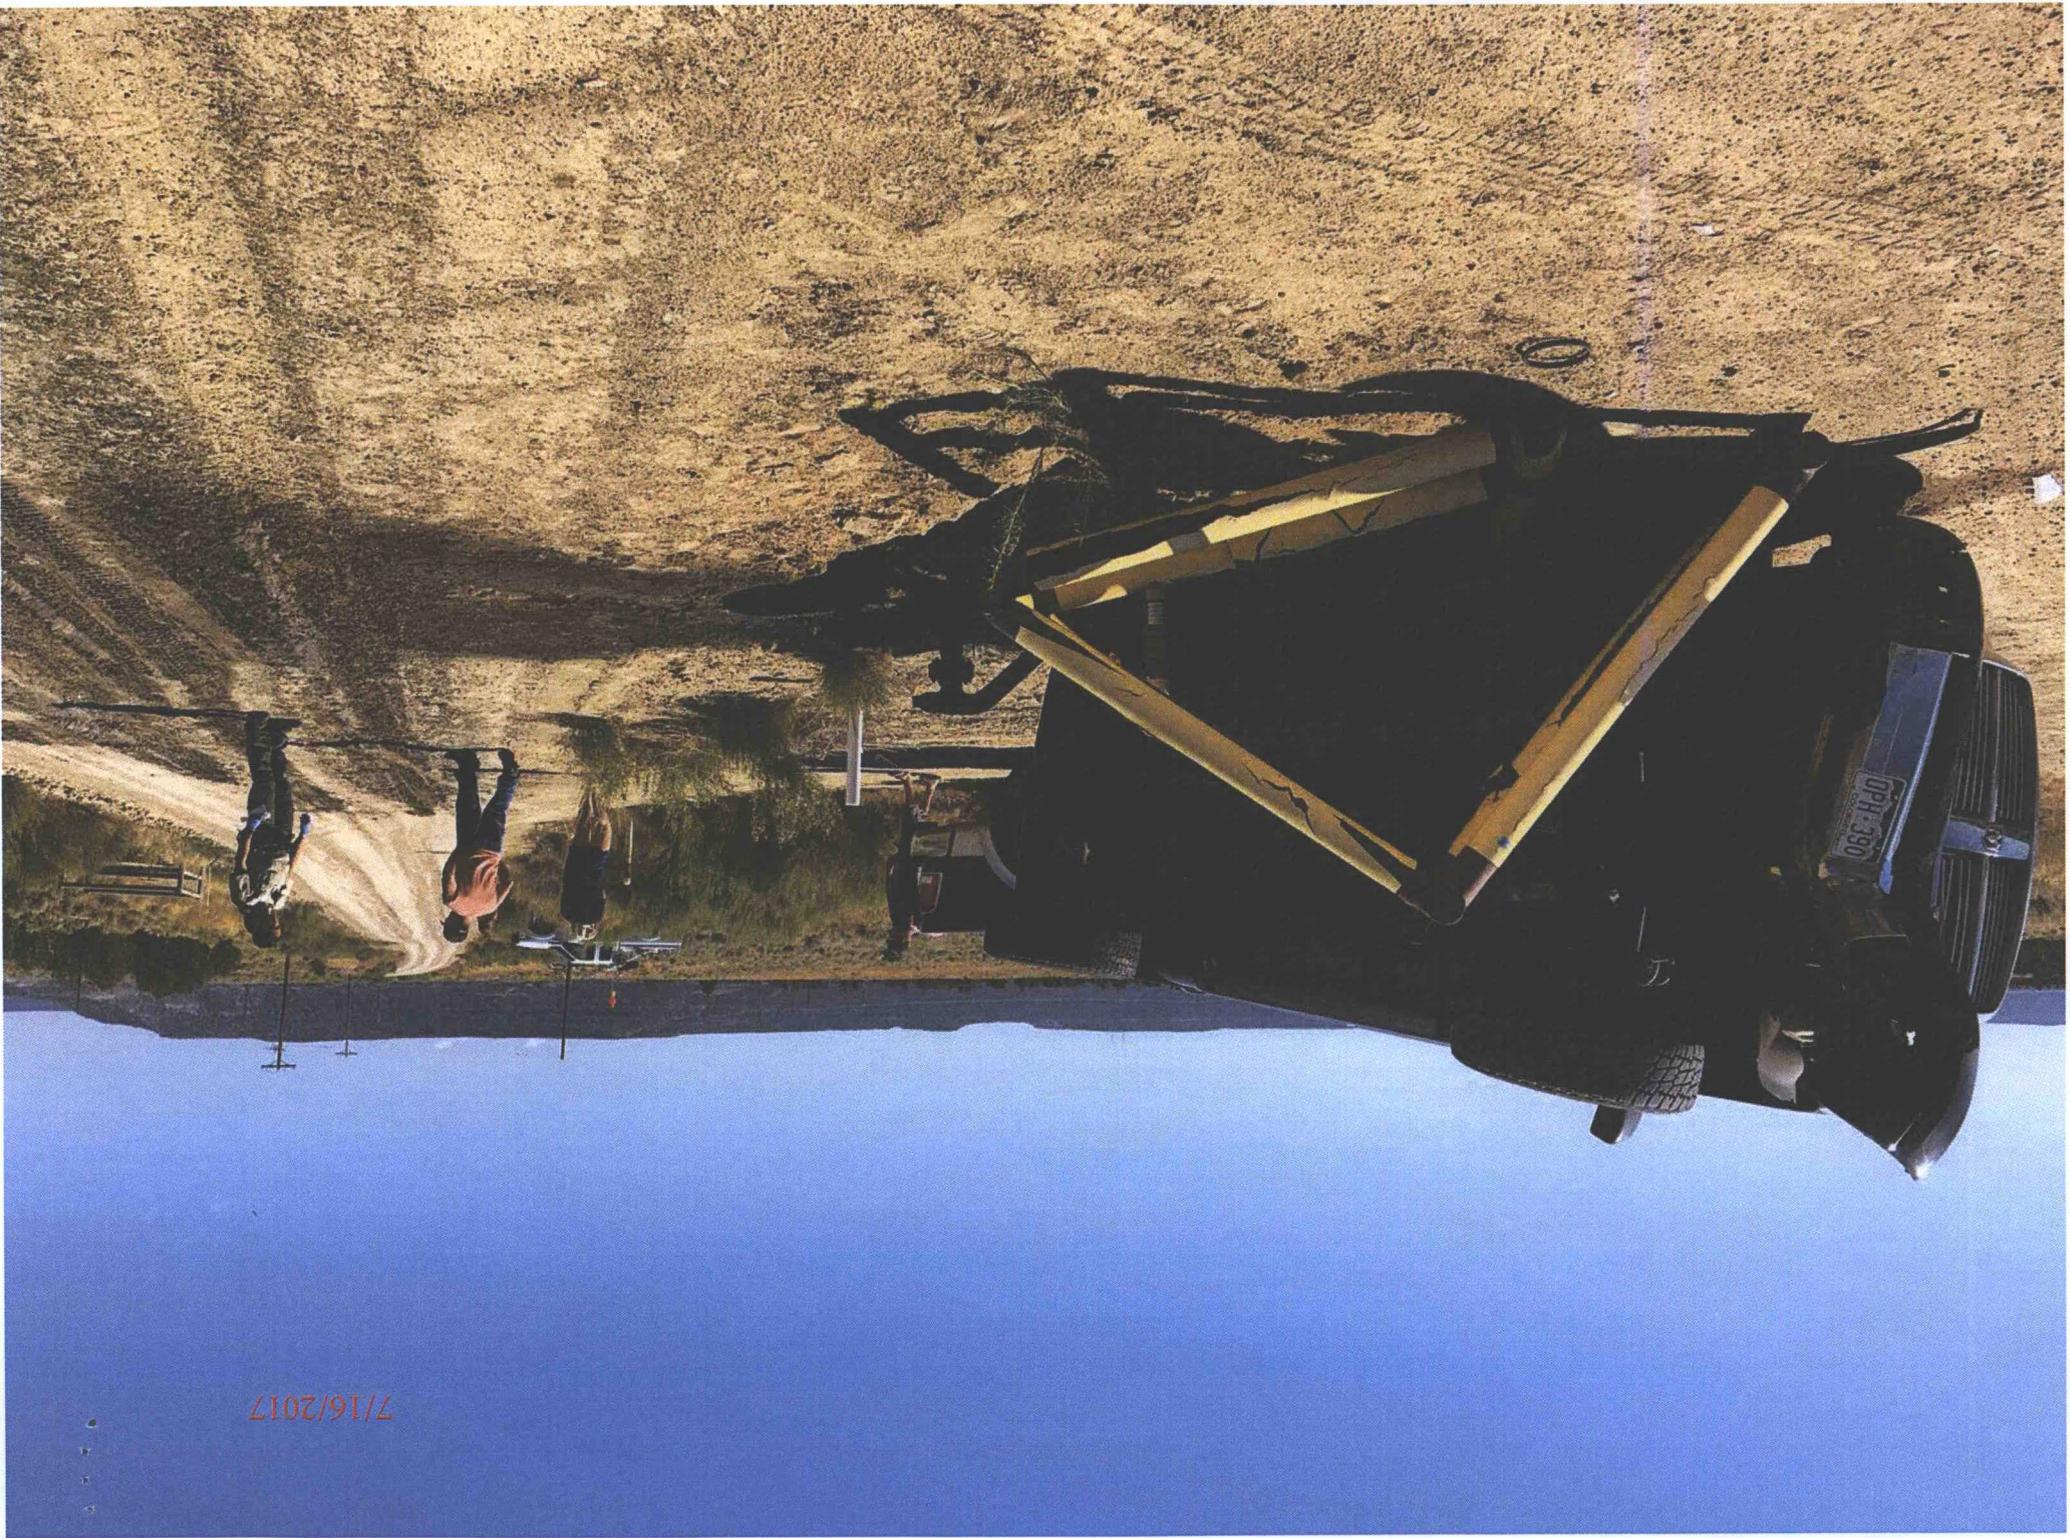
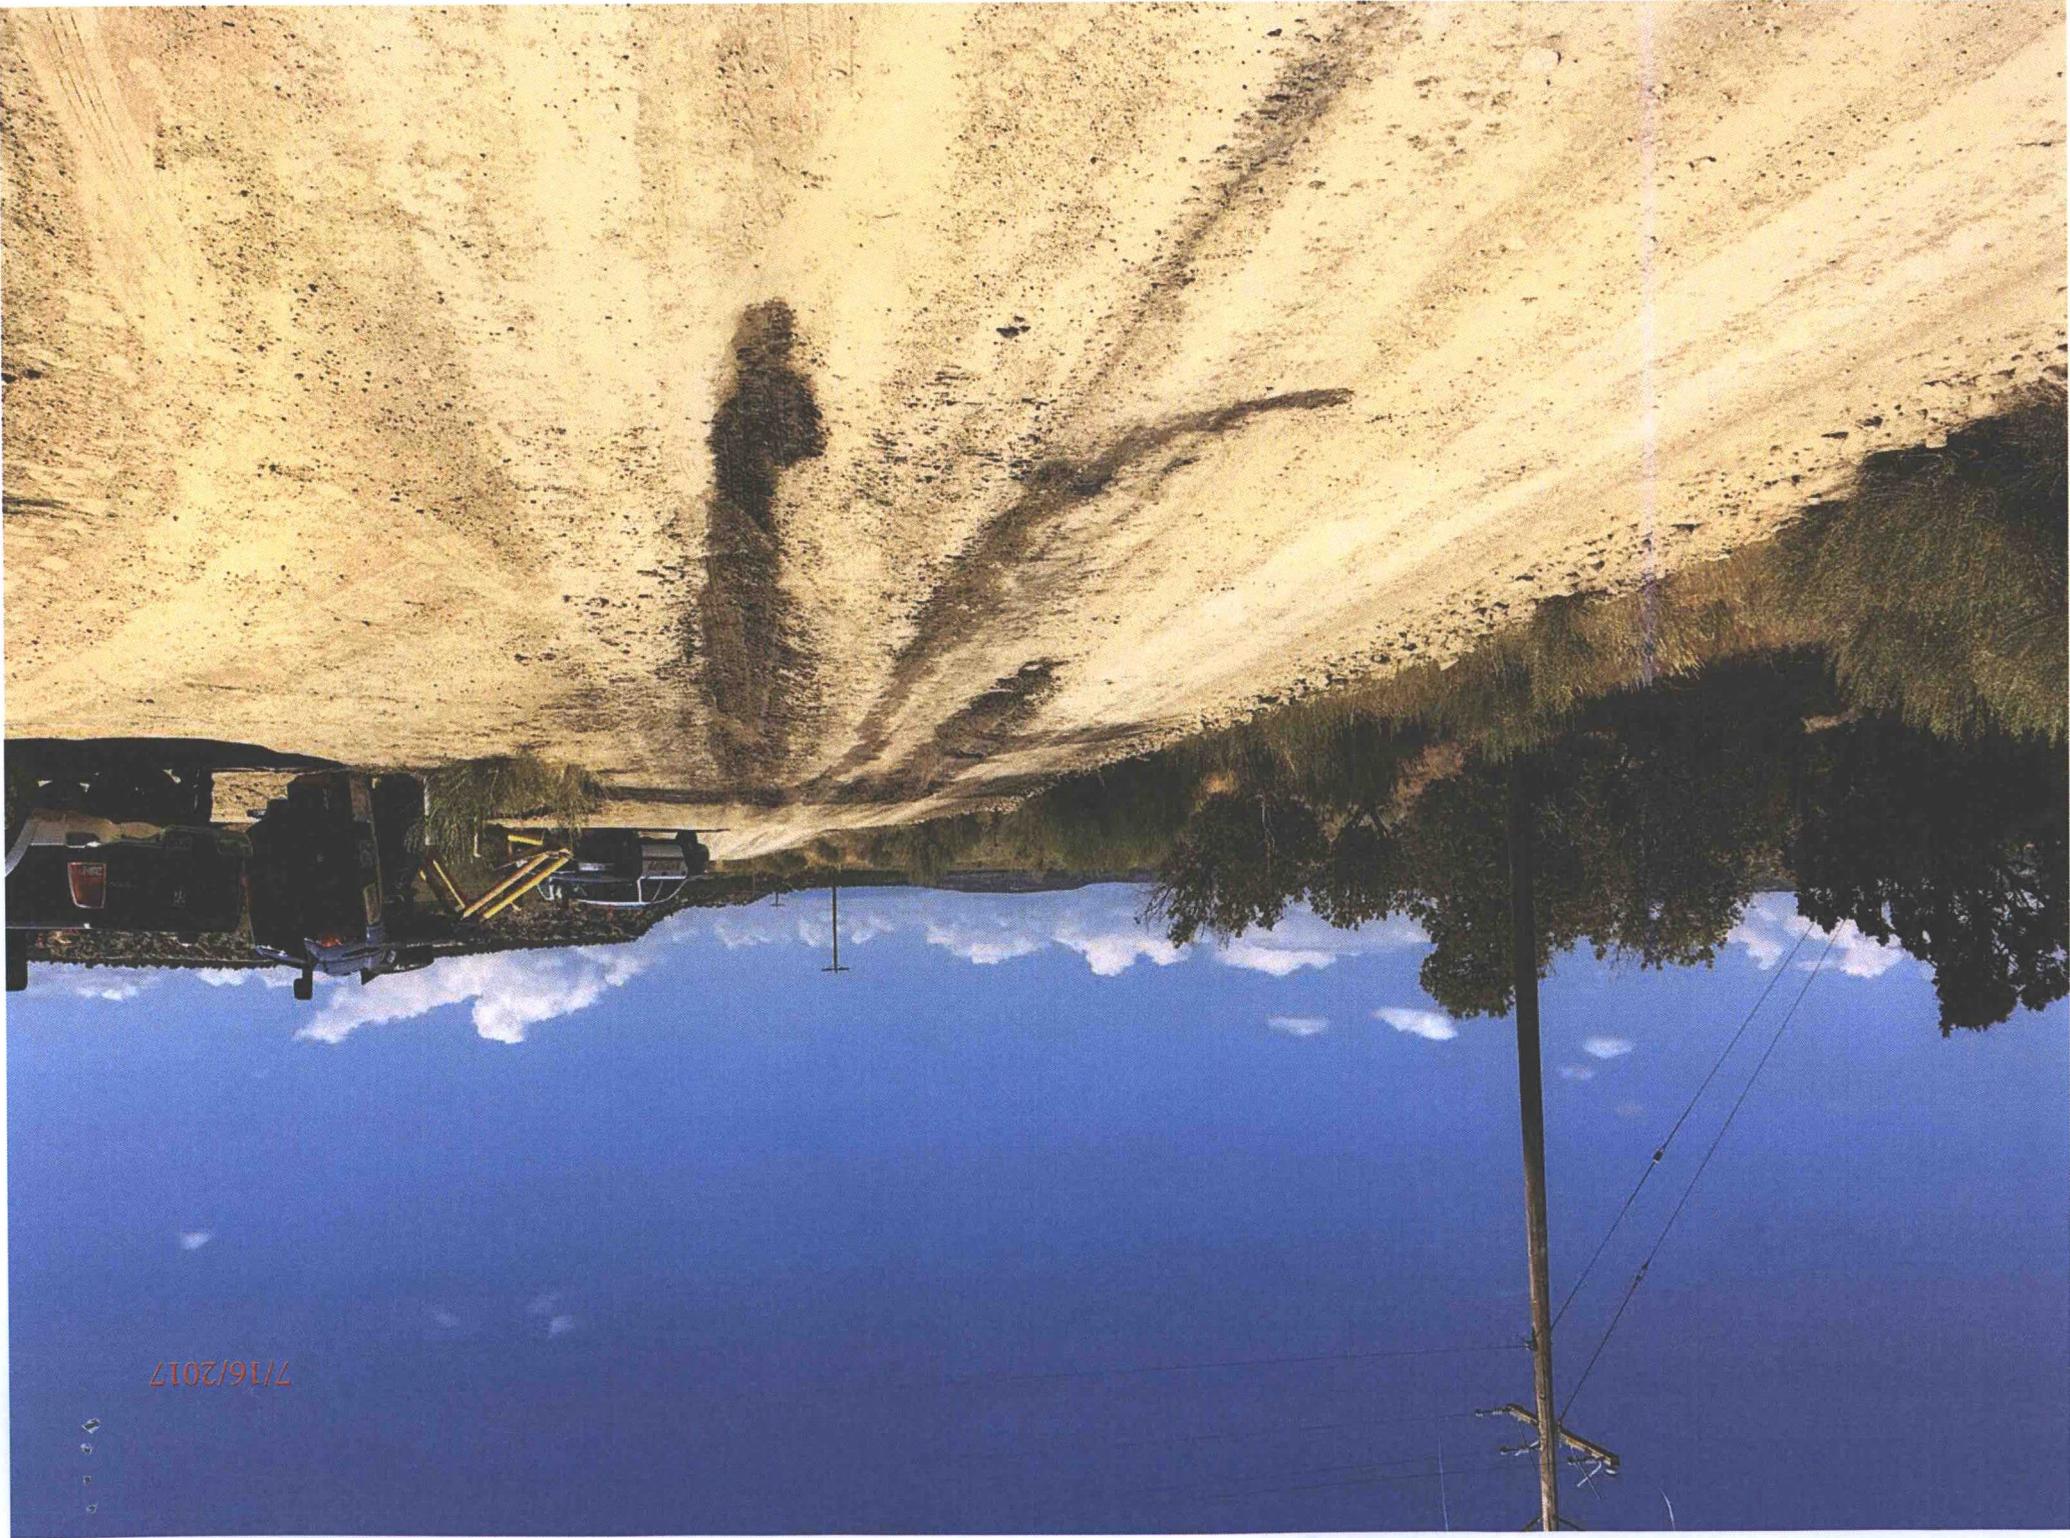
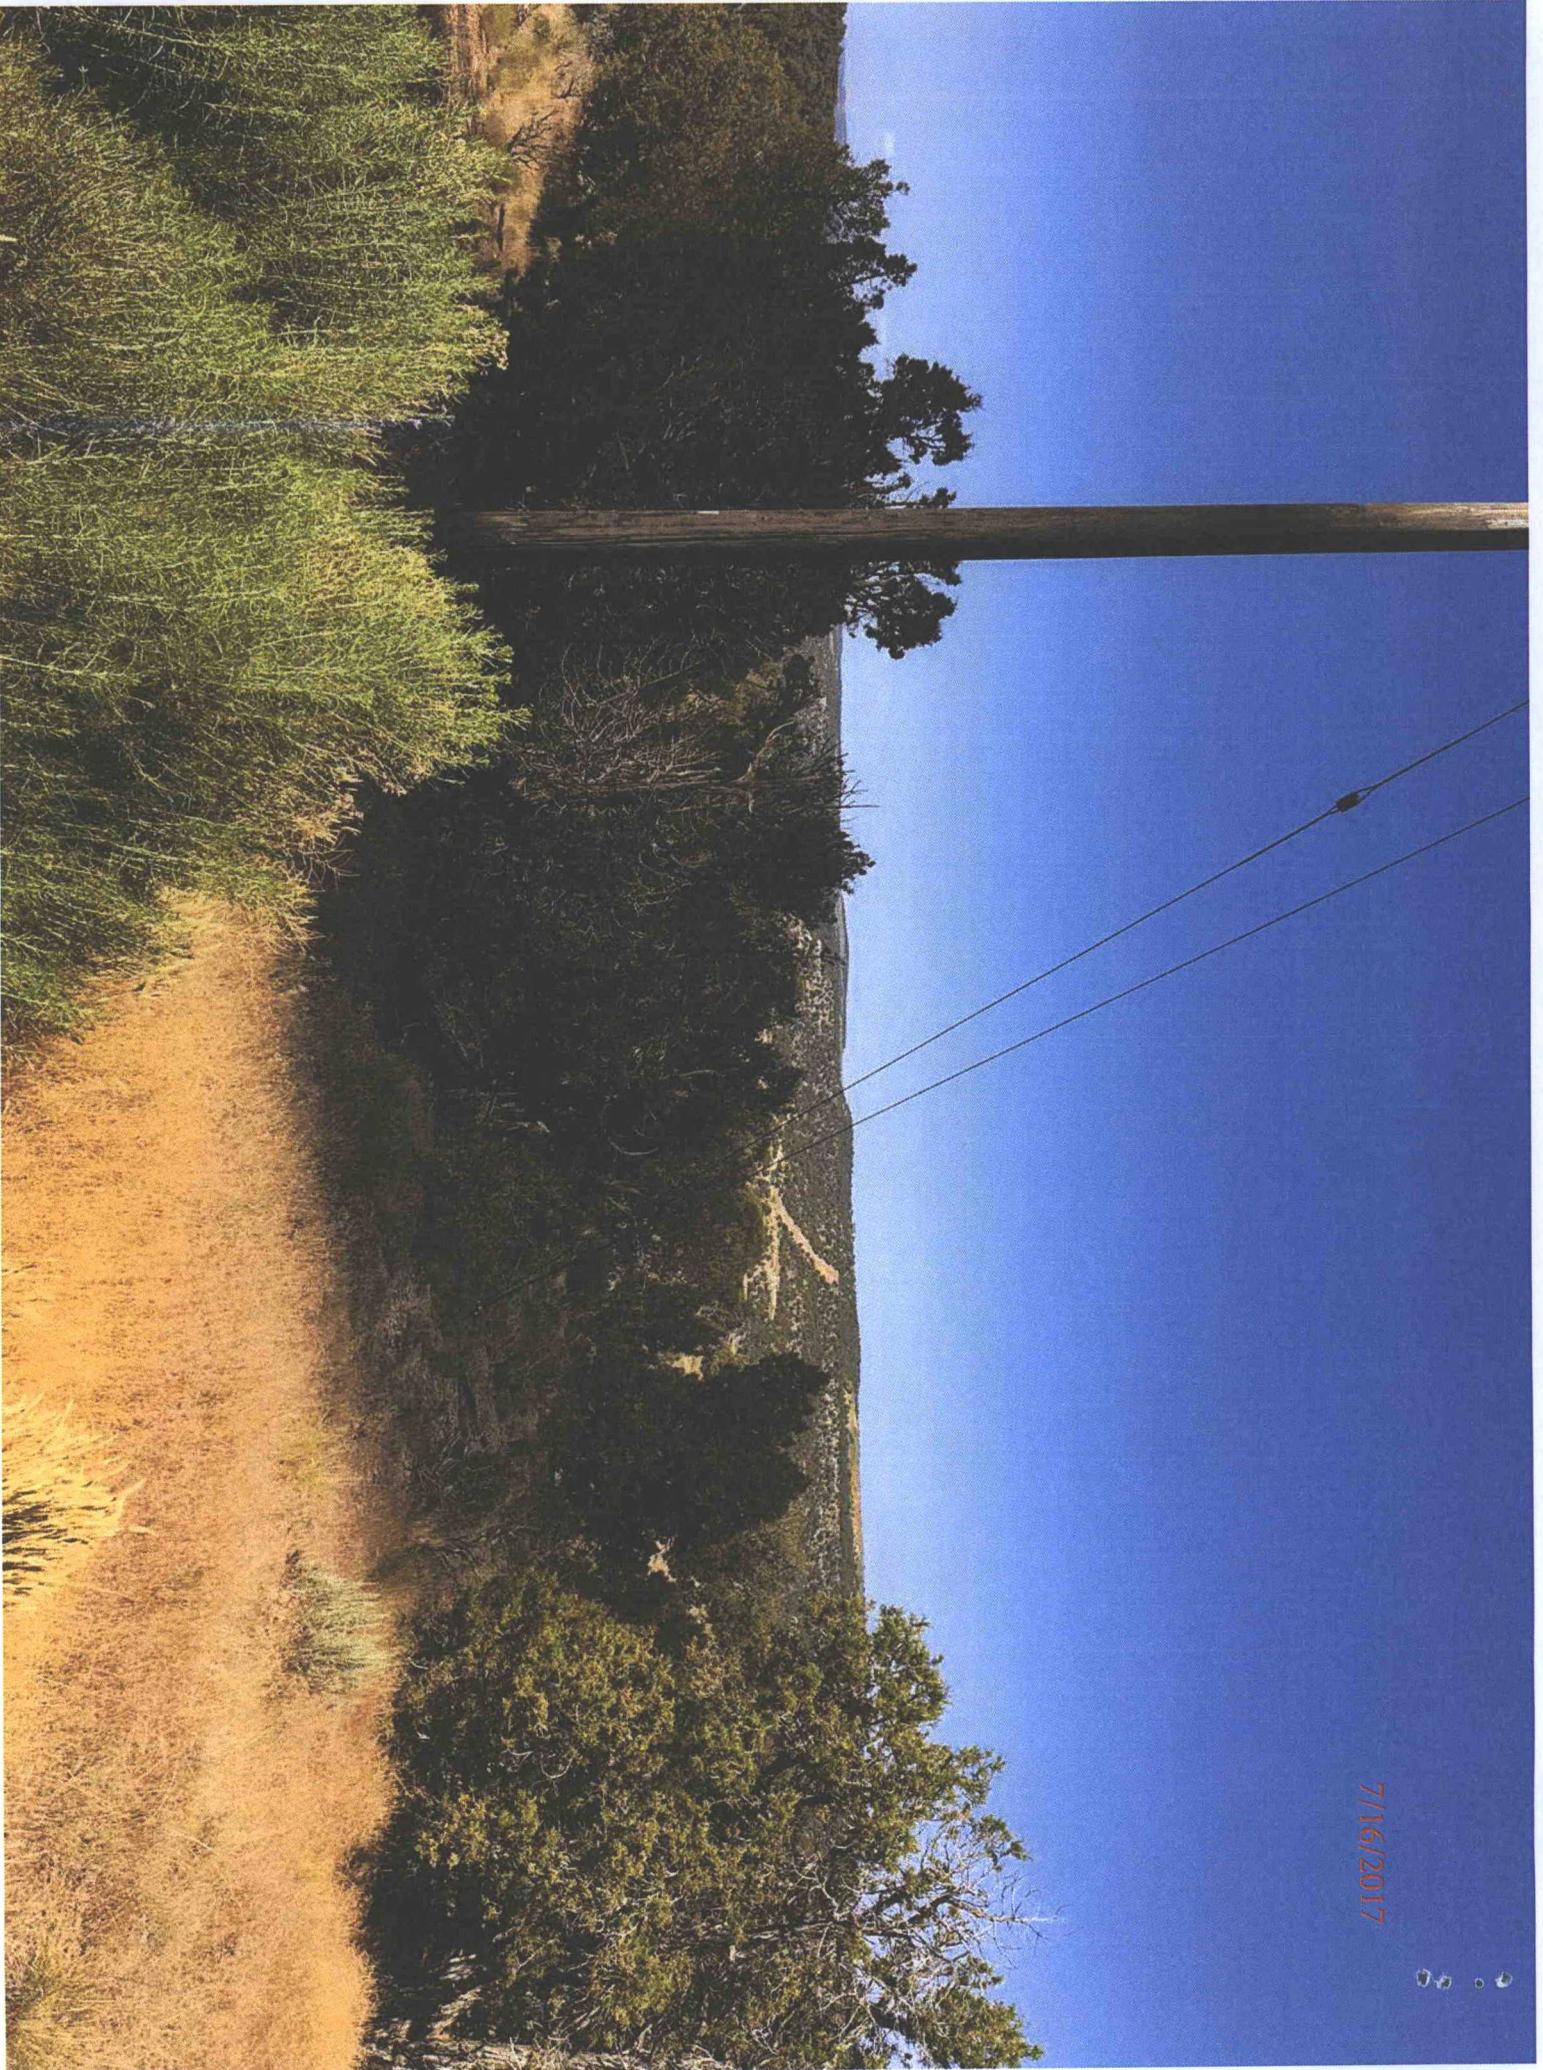
7/16/2017

The damaged dog leg and pipe was cut out and removed leaving only a valve above the ground. A new guard rail was placed to protect the valve on 7/17/2017.

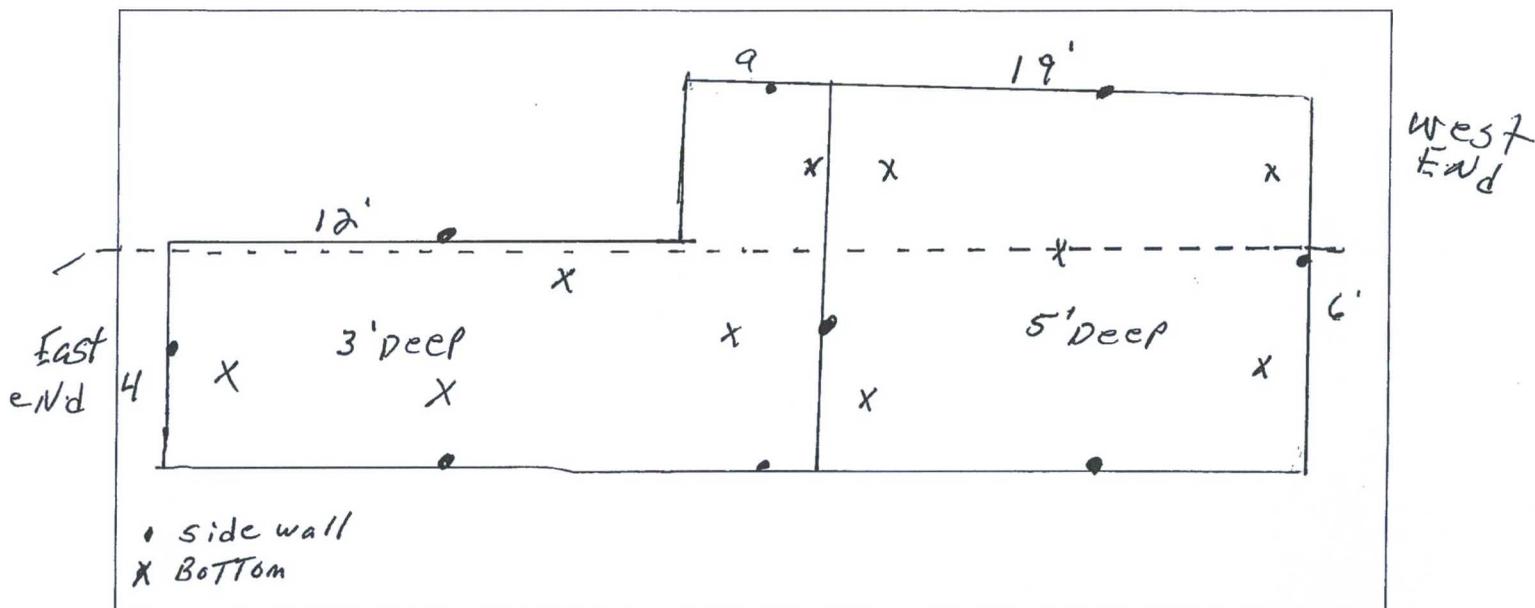
**Excavation Diagram and Sample Locations**

(Depict notable site features, excavation extents, visual observations, sample locations, north arrow, etc.)

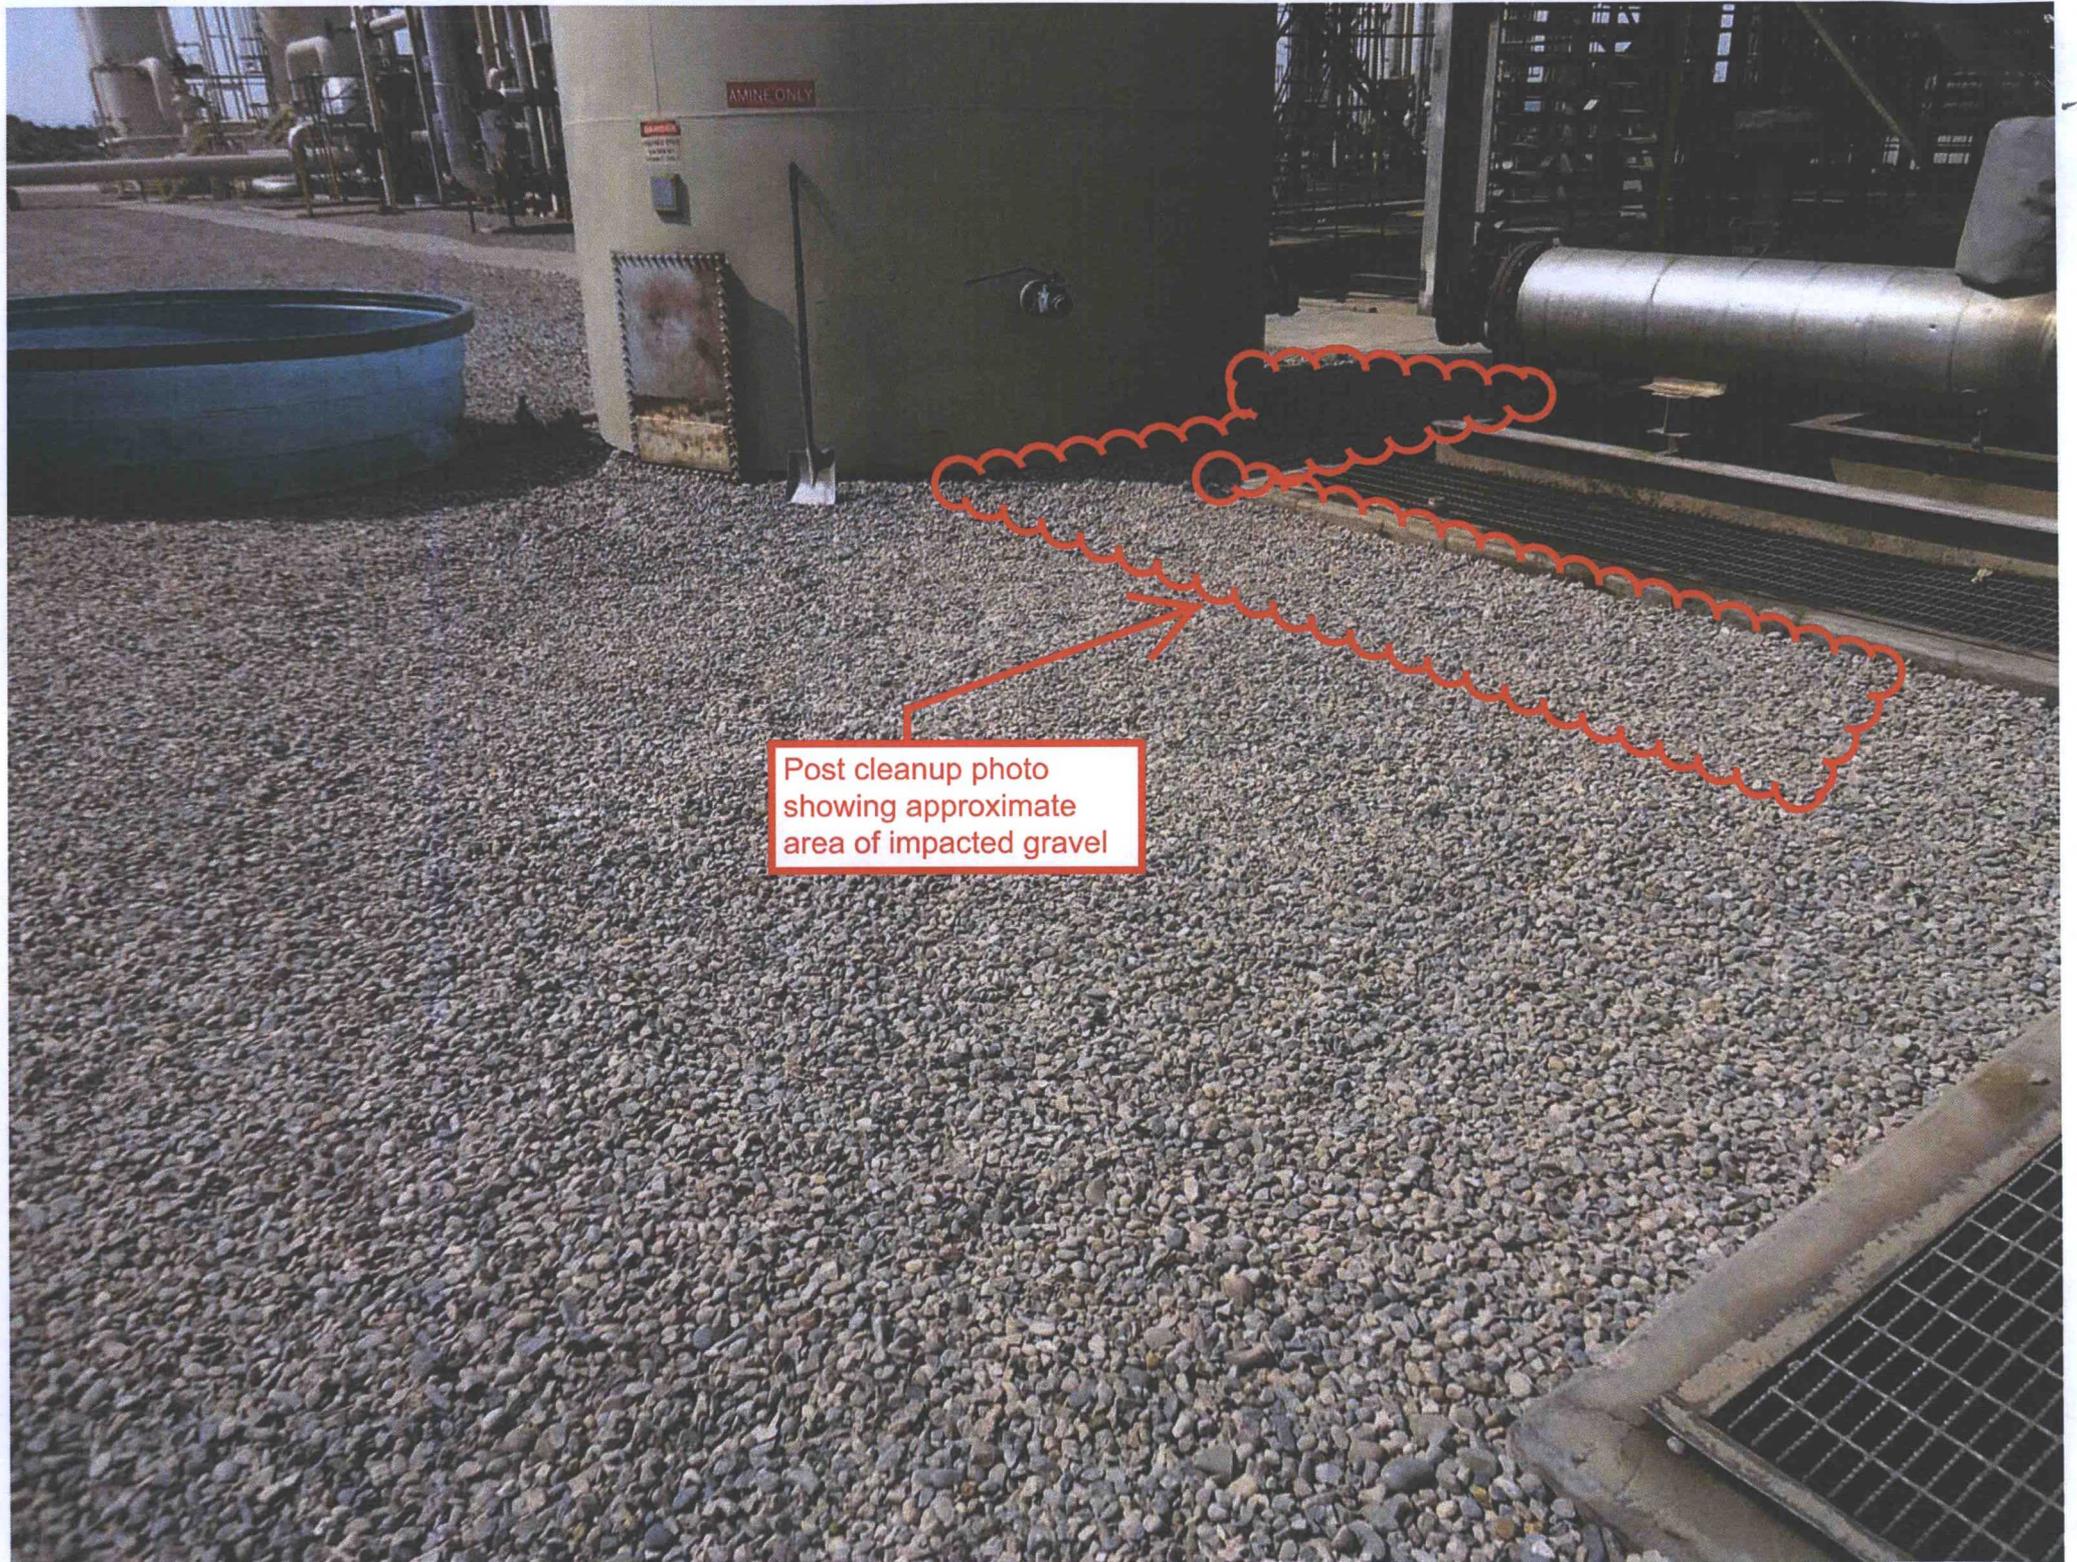
Post cleanup photo showing approximate area of impacted gravel

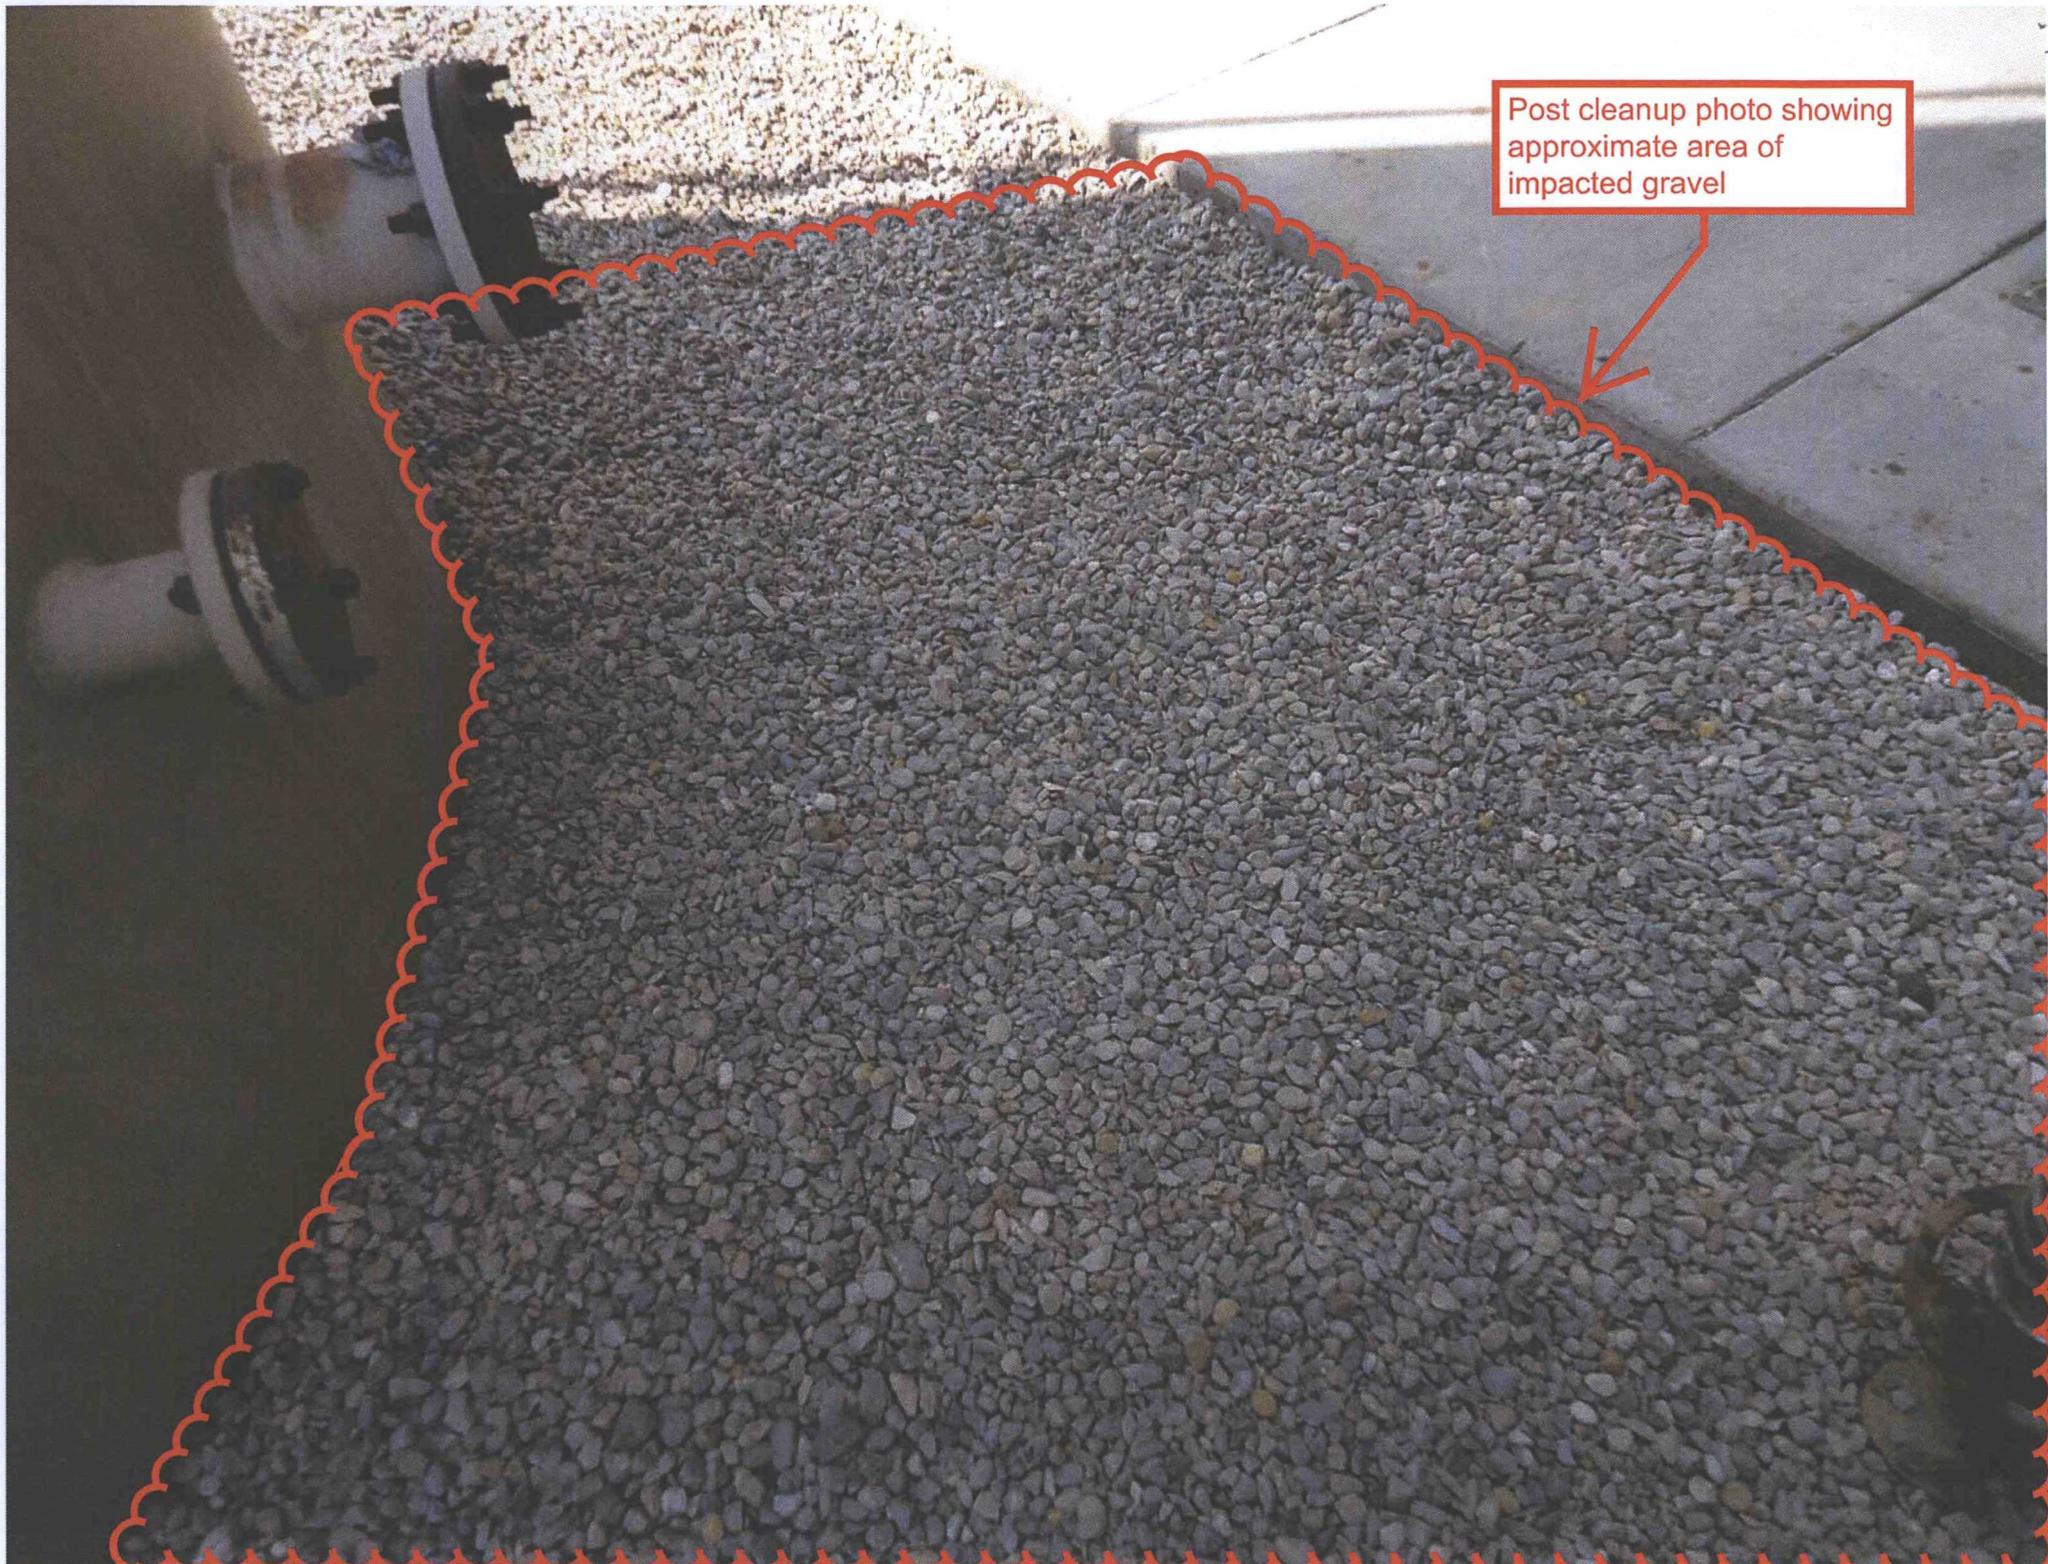
Post cleanup photo showing approximate area of impacted gravel

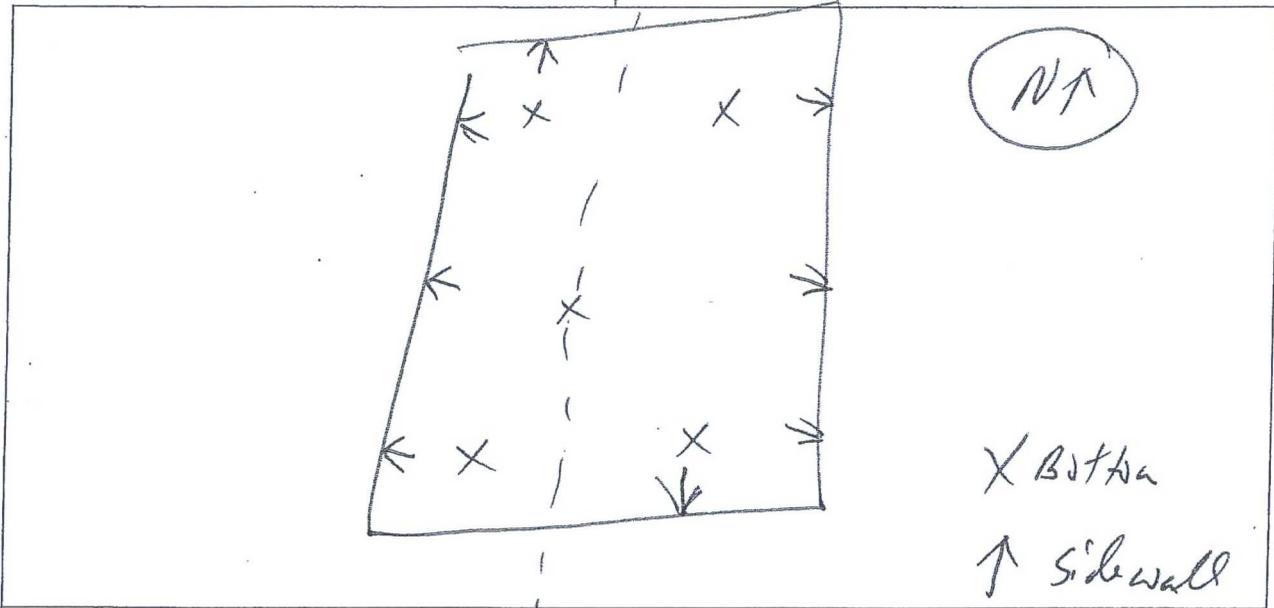
**Excavation Diagram and Sample Locations**

(Depict notable site features, excavation extents, visual observations, sample locations, north arrow, etc.)

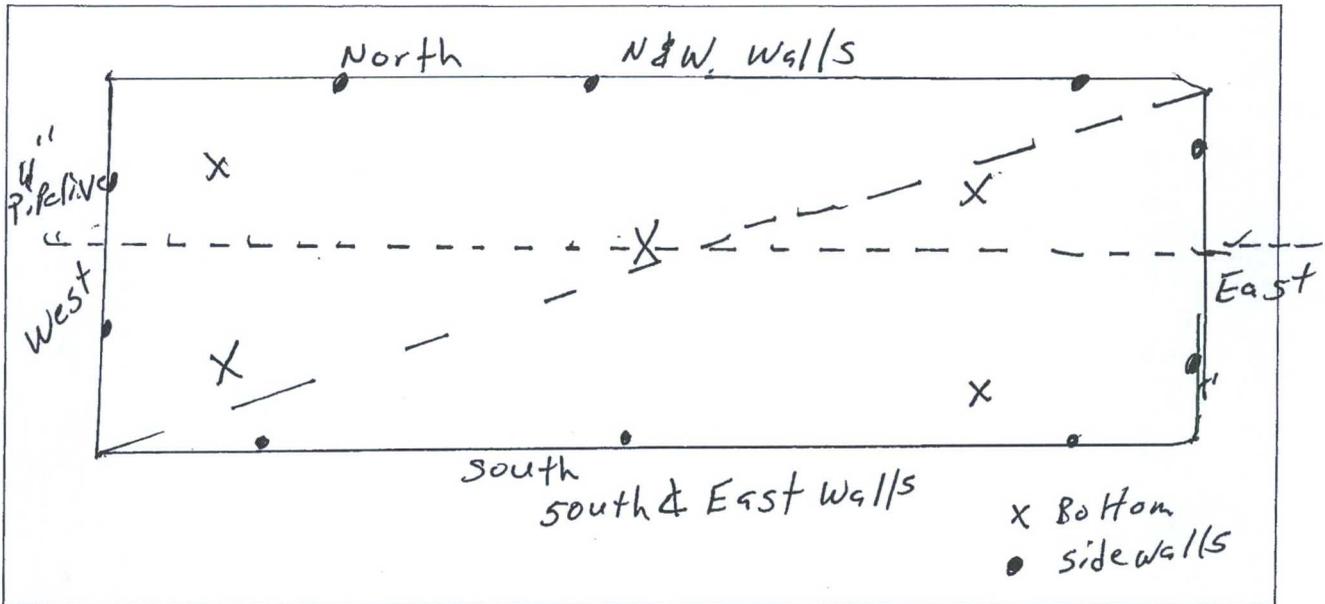
**Excavation Diagram and Sample Locations**

(Depict notable site features, excavation extents, visual observations, sample locations, north arrow, etc.)

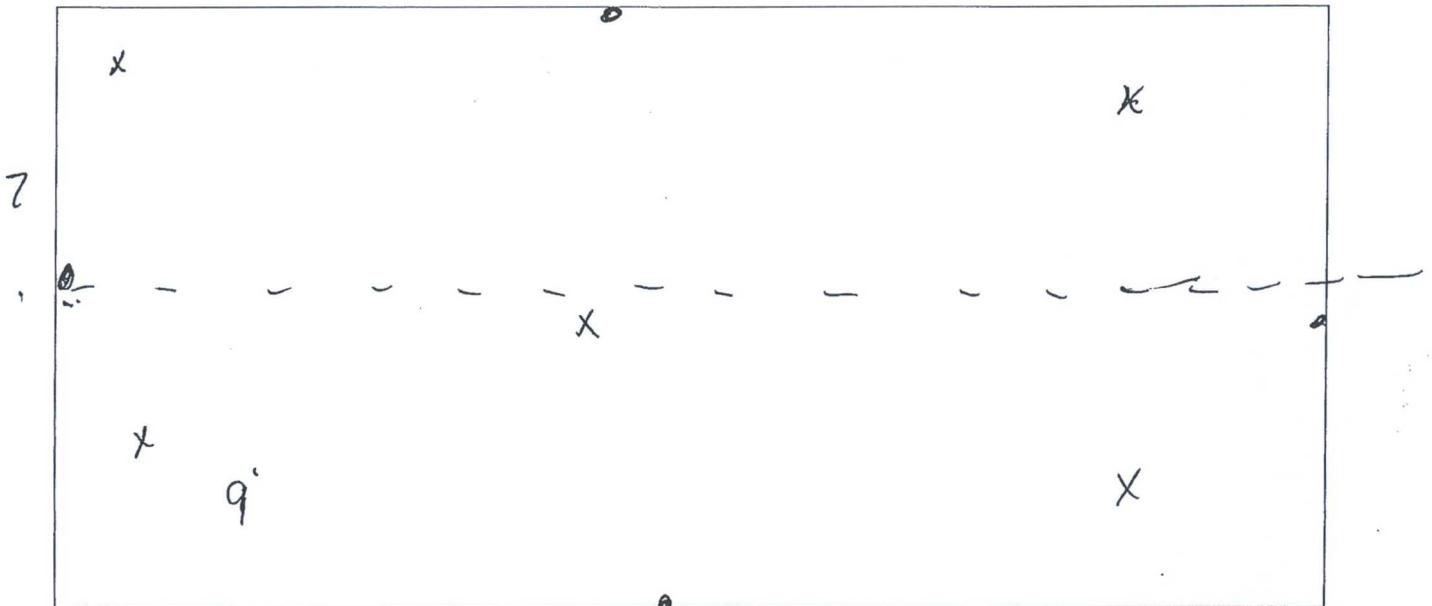
**Excavation Diagram and Sample Locations**

(Depict notable site features, excavation extents, visual observations, sample locations, north arrow, etc.)

X Floor samples  
● Walls
