3R-1012

**Release Report/ General
Correspondence**

Release Notification and Corrective Action

Enterprise Products
Lateral K-34 Pipeline Release
Latitude North 36.4225 1, Longitude West -107.58034
SE 1/4, SW 1/4 Section 4 T25N R7W
Rio Arriba County, New Mexico

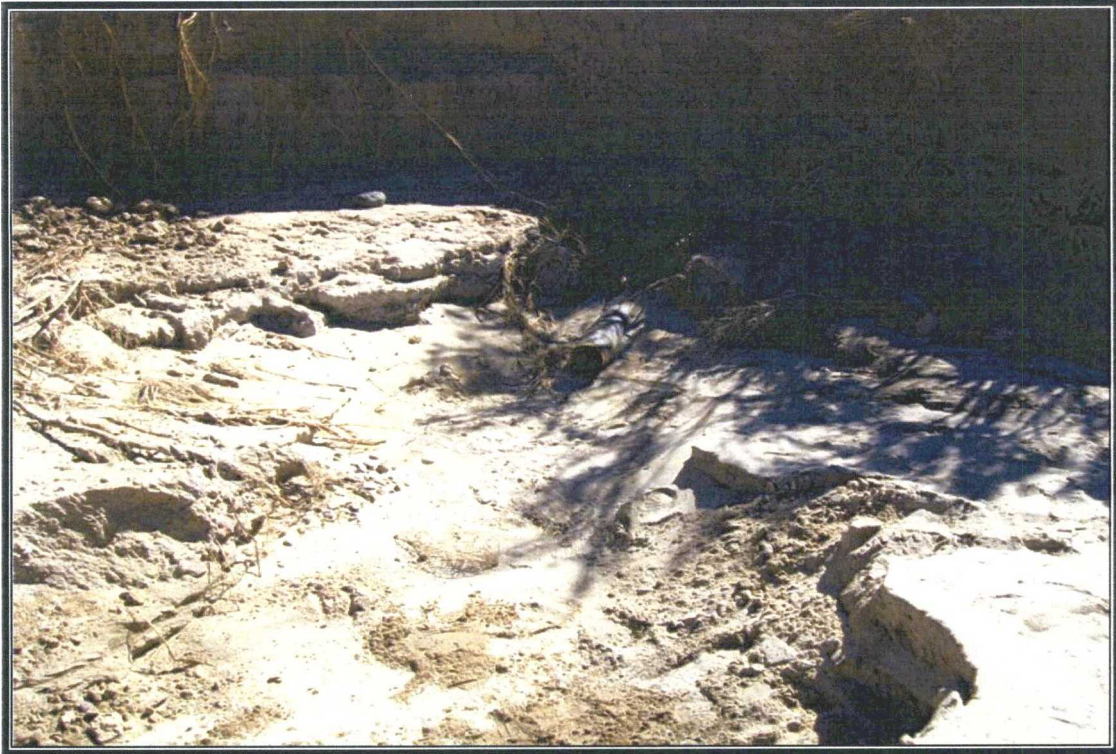
If a Watercourse was Impacted, Describe Fully.* A recent storm event caused approximately 30 feet of pipeline that spanned Palluche Wash to be completely severed. Palluche Wash is a tributary to Canyon Largo Wash. The release is location approximately 5 mile southwest of Canyon Largo Wash.		
Describe Cause of Problem and Remedial Action Taken.* A recent flash flood event caused approximately 30 feet of the pipeline to be completely severed. The line was isolated and LOTO applied during discovery. An environmental assessment was performed by 3 rd party environmental contractor (SMA) with soil borings in the area of the line break. The assessment showed there to be no environmental contamination present. A copy of SMA's report is included with this form.		
Describe Area Affected and Cleanup Action Taken.* A recent storm event caused an approximately 30 foot section of pipeline that spanned Palluche Wash to be completely severed. An environmental assessment performed on October 1 st by Souder, Miller & Associates showed there to be no contamination present at the site of the line break. Hence, cleanup is not needed. Enterprise will remove the broken section of pipe from the wash after obtaining regulatory approvals.

Photo 1: View of the severed pipeline and release area.

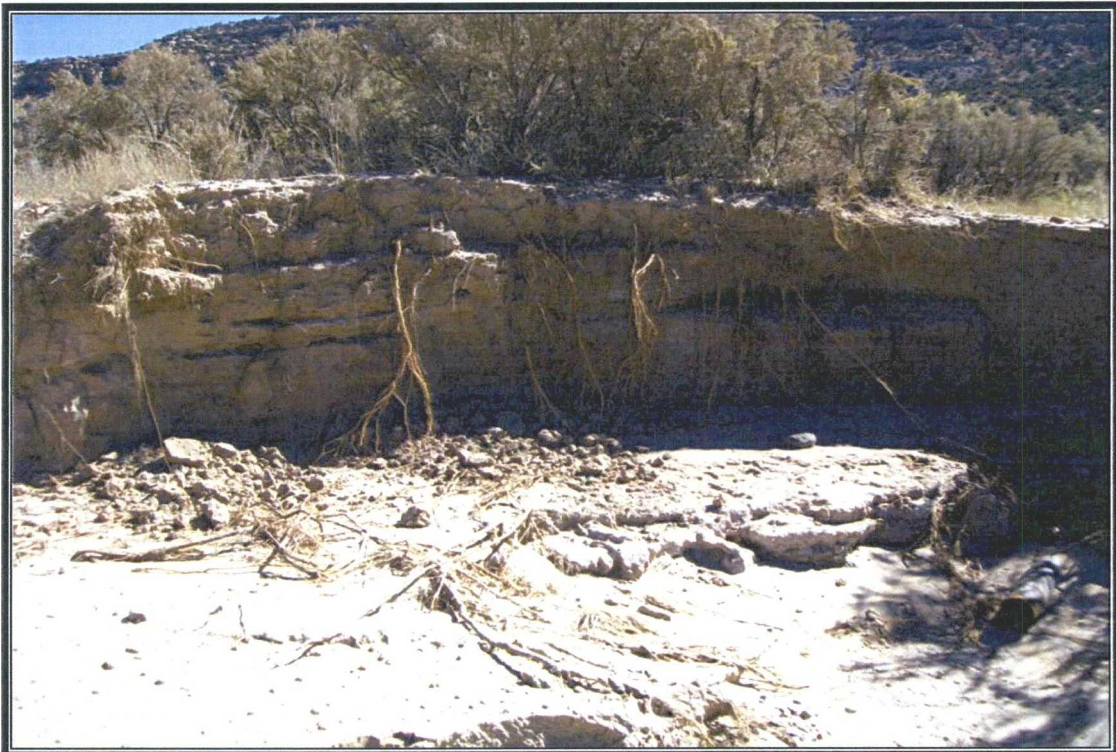
Photo 2: View of the release area.

SMA recommends no further action at this site.

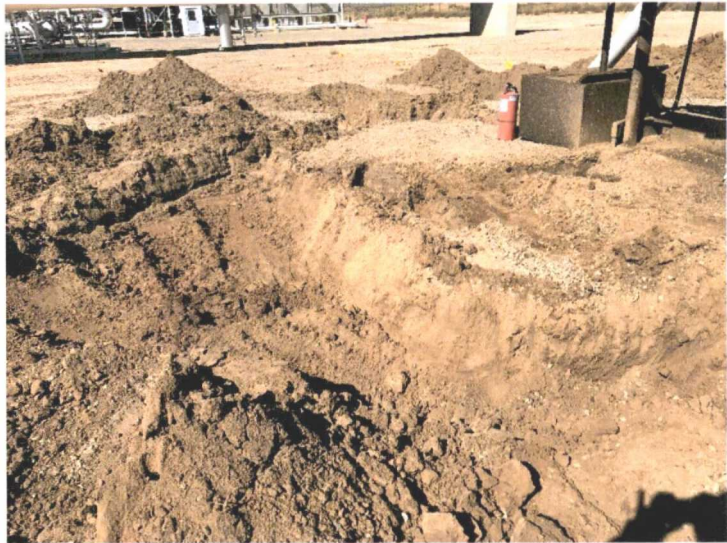
Photograph 1

View of in-process excavation activities, facing northwest.

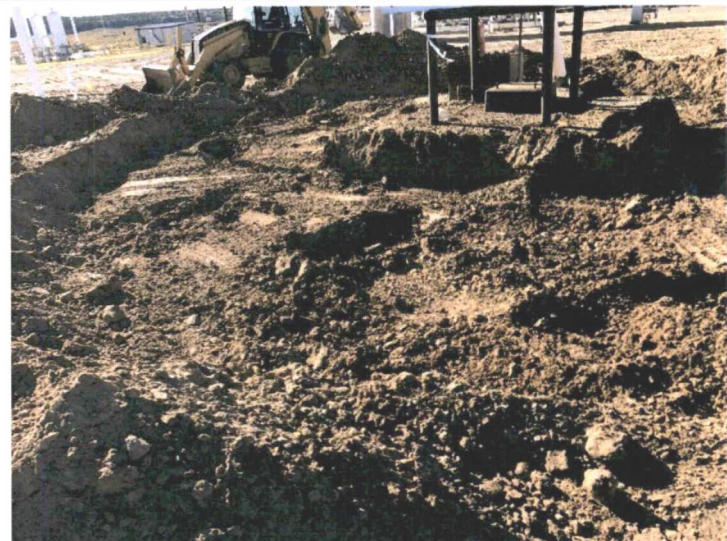
Photograph 2

View of in-process excavation activities, facing southwest.

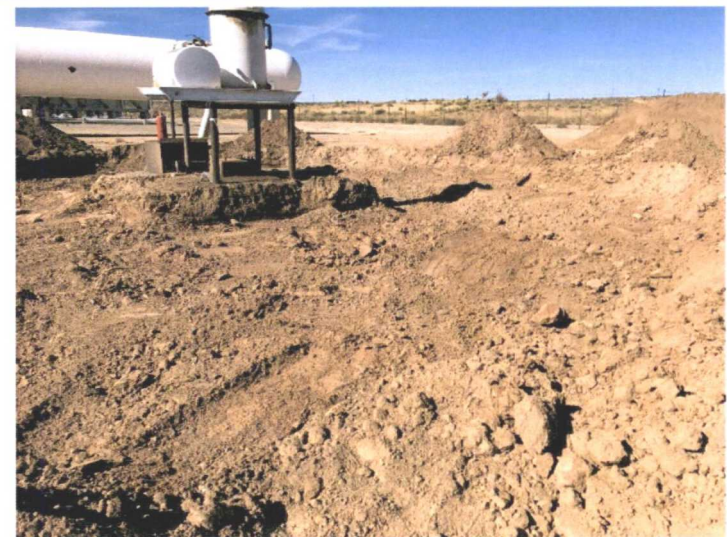
Photograph 3

View of in-process excavation activities, facing northwest.

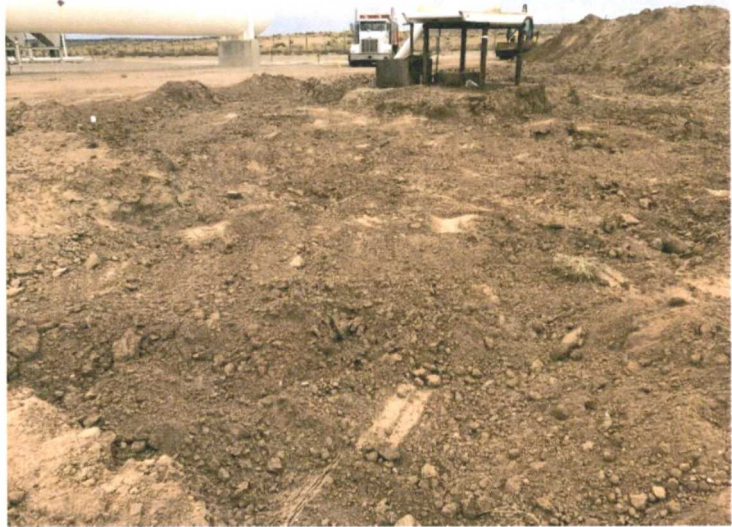
Photograph 4

View of the final excavation, facing northwest.

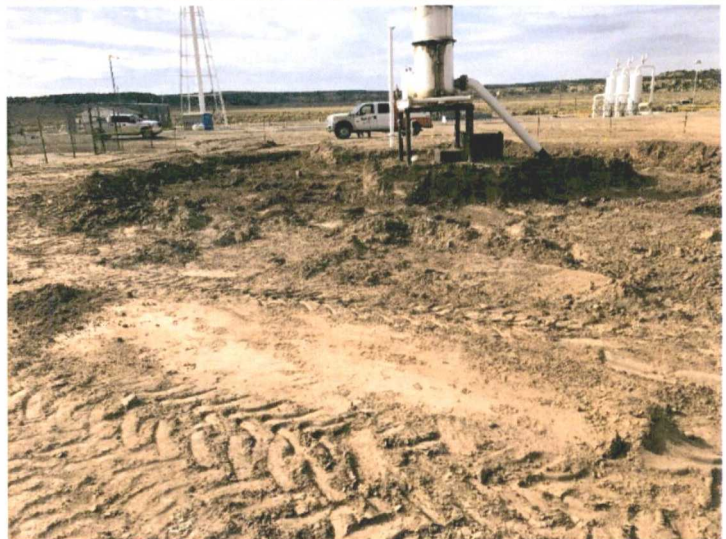
Photograph 5

View of the final excavation, facing south.

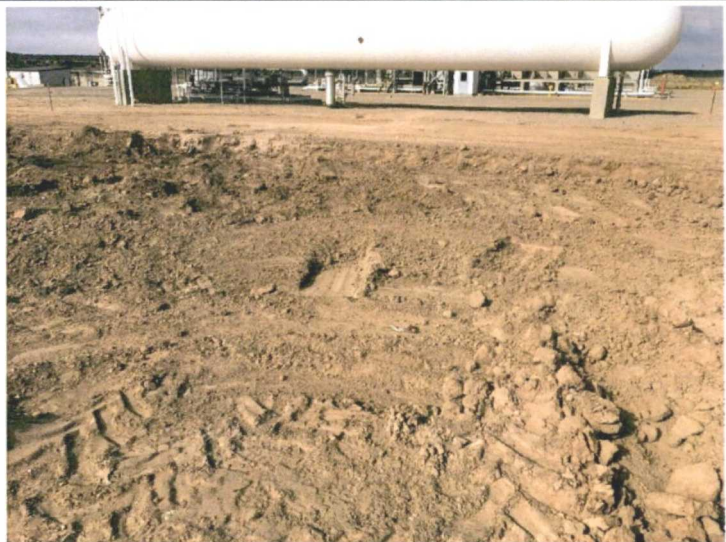
Photograph 6

View of the final excavation, facing west.

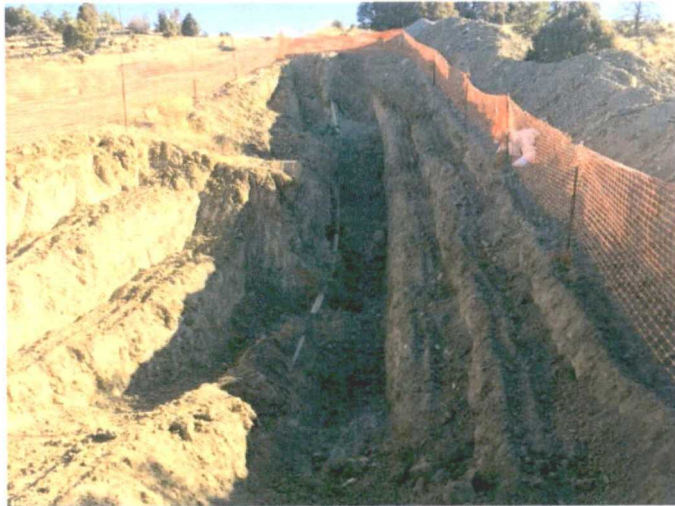
Photograph 1

View of the initial excavation, facing northeast.

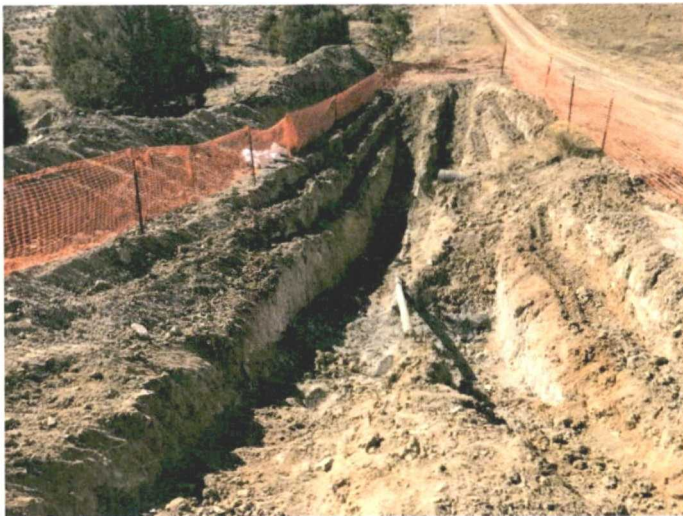
Photograph 2

View of the initial excavation, facing southwest.

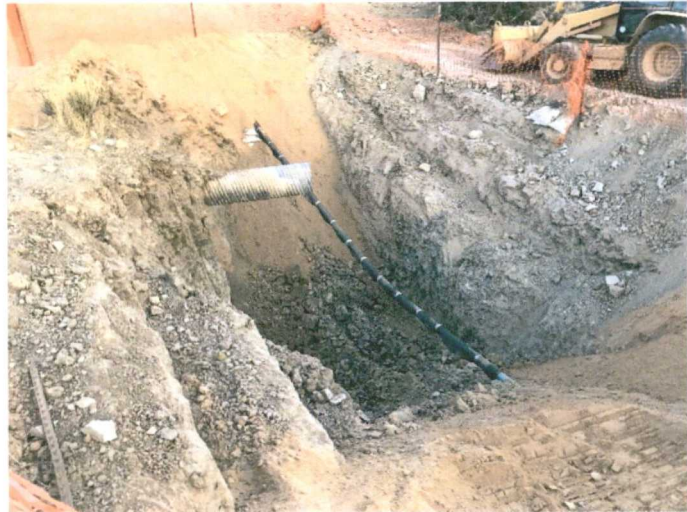
Photograph 4

View of the final excavation, facing southeast.

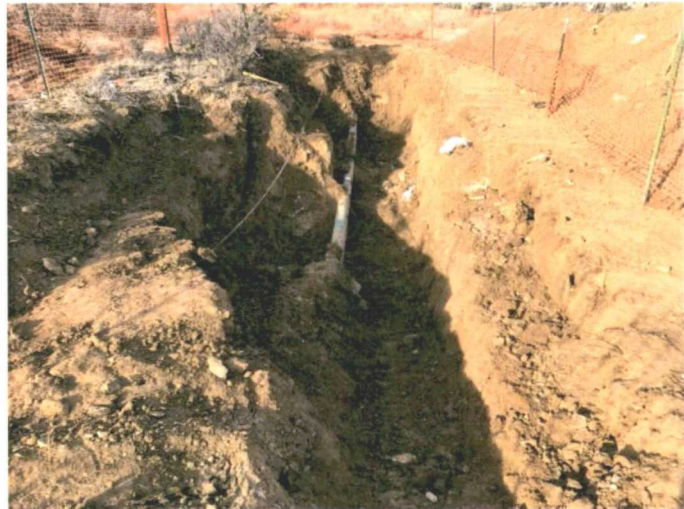
Photograph 1

View of the initial excavation, facing northwest.

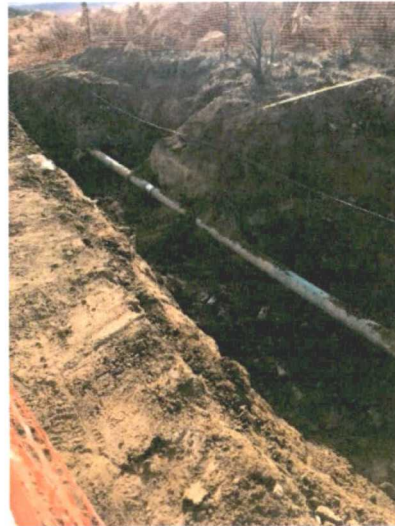
Photograph 2

View of the initial excavation, facing southeast.

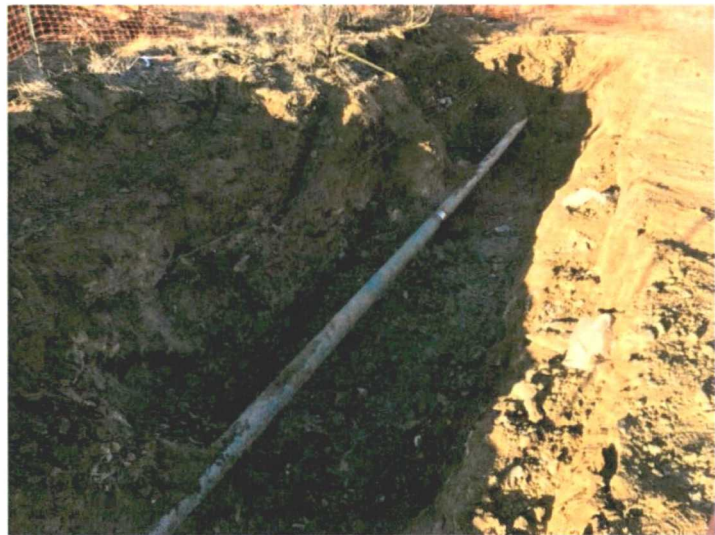
Photograph 3

View of the final excavation, facing southwest.
