Pit, Below-Grade Tank, or  
Proposed Alternative Method Permit or Closure Plan Application

1. Operator: DJR Operating, LLC OGRID #: 371838  
Address: PO BOX 156 Bloomfield, NM 87413  
Facility or well name: CBU Injection Plant BGT2  
API Number: N/A OCD Permit Number: N/A  
U/L or Qtr/Qtr O: SW/SE Section 5 Township 25N Range 12W County: San Juan  
Center of Proposed Design: Latitude 36.423597 Longitude -108.133581 NAD83  
Surface Owner: ☐ Federal ☐ State ☐ Private ☒ Tribal Trust or Indian Allotment

**RE: Below Grade Tanks Closure Report  
CBU Injection Plant  
San Juan County, New Mexico**

Animas Environmental Services, LLC (AES) is pleased to provide the final report associated with the closure of two below grade tanks (BGT) at the DJR Operating (DJR) CBU Injection Plant, located in San Juan County, New Mexico. Tank removal had been completed by DJR contractors after AES' arrival at the location.

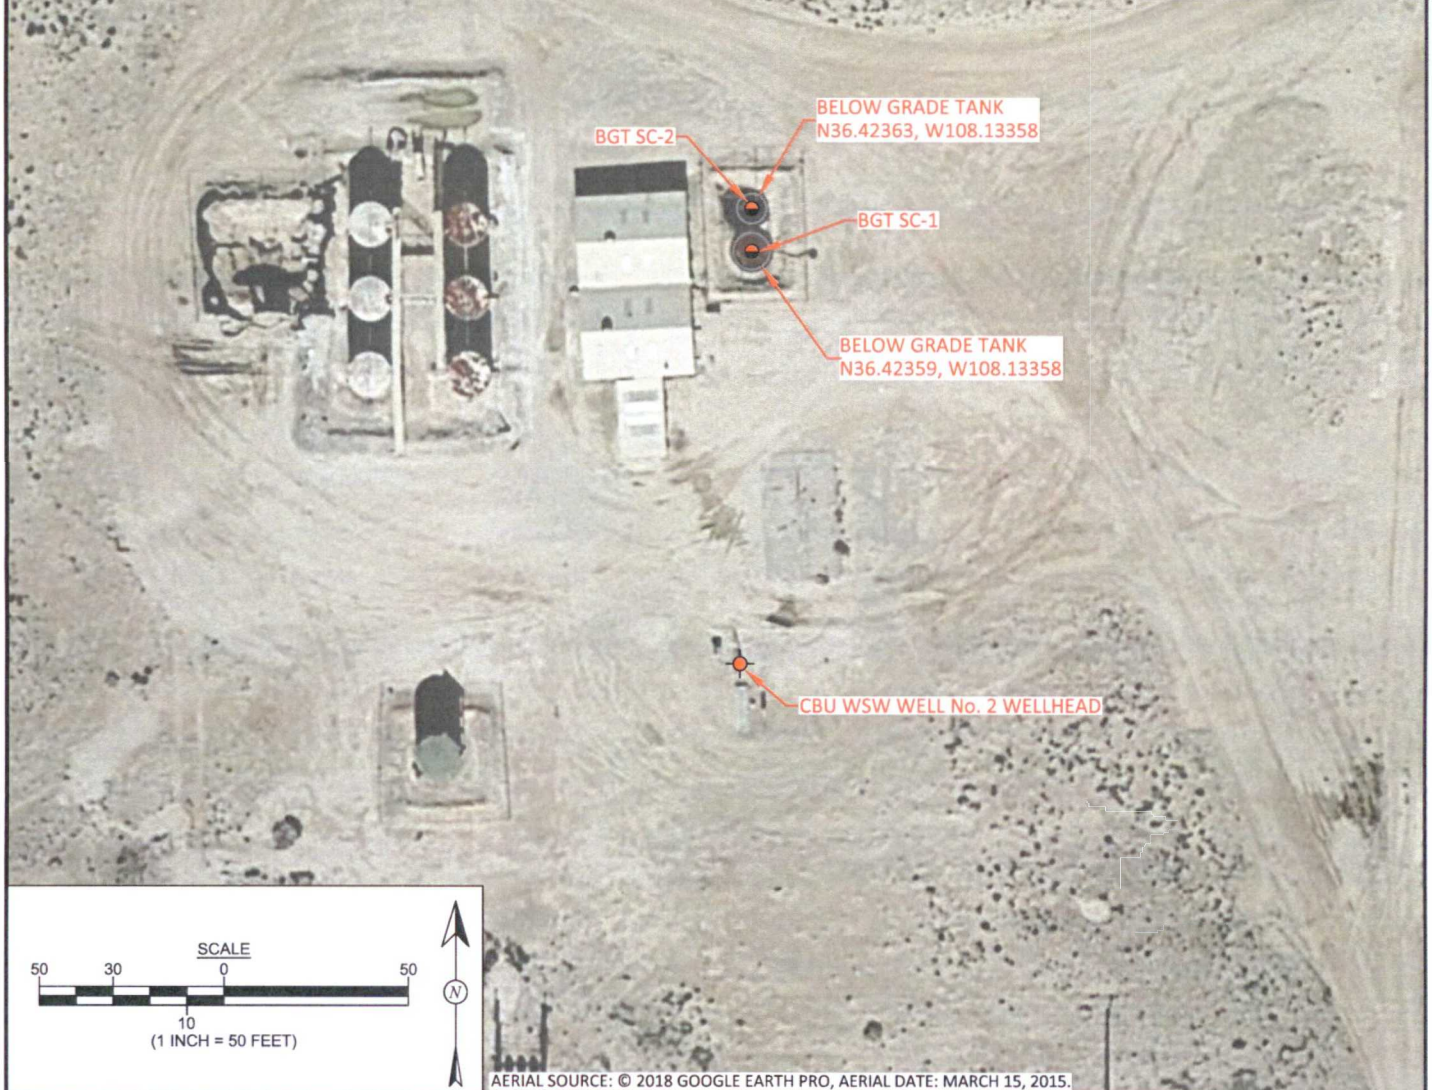
**FIGURE 2**

SAMPLE LOCATIONS

Laboratory Analytical Results								
Sample ID	Date	Depth (ft)	Benzene (mg/kg)	Total BTEX (mg/kg)	TPH-GRO (mg/kg)	TPH-DRO (mg/kg)	TPH-MRO (mg/kg)	Chlorides (mg/kg)
NMOCD ACTION LEVEL			10	50	1,000 GRO/DRO 2,500 GRO/DRO/MRO*			20,000
BGT SC-1	4/3/18	4	<0.025	<0.225	<5.0	61	370	270
BGT SC-2	4/3/18	6.5	<0.024	<0.220	<4.9	250	950	<30.0
ALL SAMPLES WERE ANALYZED PER USEPA METHOD 8260B, 8015D AND 300.0.								
*NOTE - USEPA METHOD 8015 (GRO, DRO, MRO) UTILIZED IN LIEU OF USEPA METHOD 418.1.

**AERIAL SITE LOCATION MAP  
BELOW GRADE TANK CLOSURE  
APRIL 2018**  
DJR OPERATING  
CBU INJECTION PLANT  
SW $\frac{1}{4}$  SE $\frac{1}{4}$ , SECTION 5, T25N, R12W  
SAN JUAN COUNTY, NEW MEXICO  
N36.42329, W108.13359
