Release Notification and Corrective Action PCS 1830931847

Name of Company Williams Four Corners LLC	Contact Aaron Galer
Address 1755 Arroyo Drive, Bloomfield, NM 87413	Telephone No. 801-584-6746
Facility Name Kutz Canyon Gas Plant	Facility Type Natural Gas Processing Plant

WILLIAMS FOUR CORNERS LLC	
KUTZ CANYON GAS PLANT SAN JUAN COUNTY, NEW MEXICO	
FIGURE NUMBER	SITE LOCATION
1-1	
  6380 South Fiddlers Green Circle Suite 310 Greenwood Village, CO 80111 www.APTIM.com

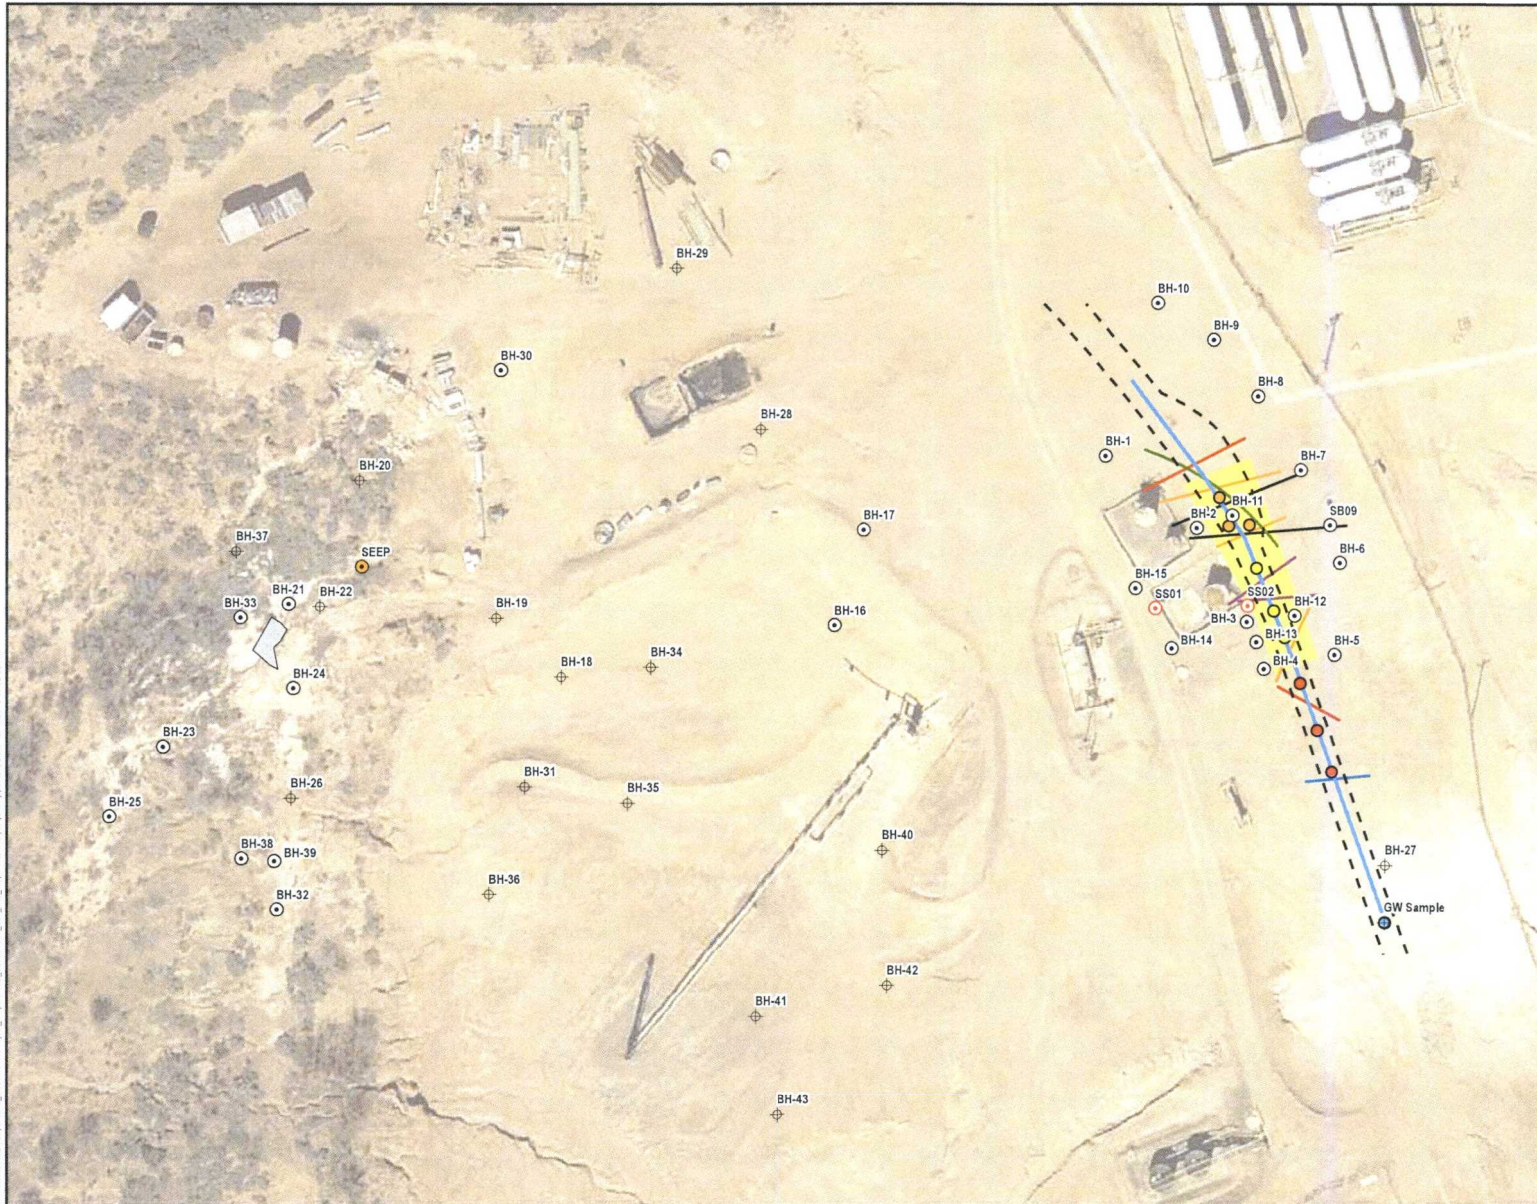
After observing a drop of 4-inches in the water column over a period of one hour, the piping close to the risers was exposed and wet soil was observed around a 4-inch pipe clamp and 4-inch elbow (see **Figure 1-2** for locations SS01 and SS02). The drain lines coming off the cooling tower and condensate tank were also tested and partially exposed to visually inspect the joints. No leaks were identified.

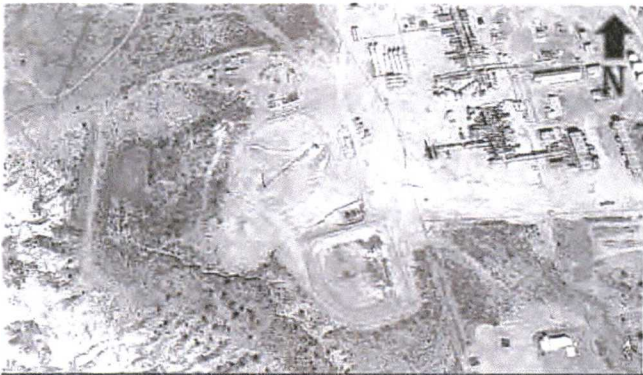
Boring/Well #	BH-9
Project:	Kutz Gas Plant
Project #	34017003.000
Date	12-1

Penetration Resistance	Moisture Content	Vapor (ppm)	Staining	Sample #	Depth (ft. bgs.)	Sample Run	Recovery	Soil/Rock Type	Lithology/Remarks	Well Completion
					15				SAA NO Stain/odor	
					16					
	moist	4.9	NO		17		100%			
					18					
					19					
					20					
					21					
					22					
					23					
					24					
					25				TD = 20'	
					26					
					27					
					28					
					29					
					30					
					31					
					32					
					33					
					34					
					35					
					36					
					37

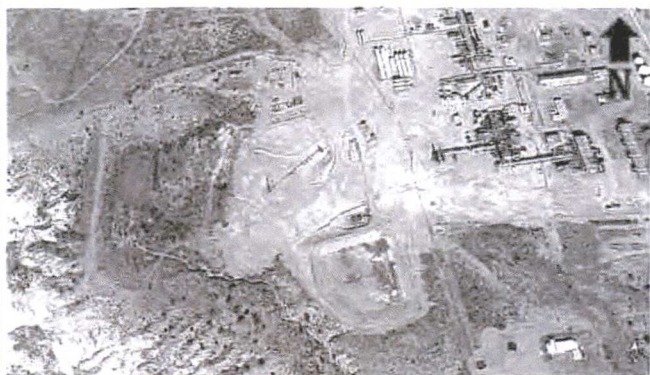
Boring/Well #	BH16
Project:	KUTZ Canyon GP
Project #	
Date	6/5/19

Penetration Resistance	Moisture Content	Vapor (ppm)	Staining	Sample #	Depth (ft. bgs.)	Sample Run	Recovery	Soil/Rock Type	Lithology/Remarks	Well Completion
	wet	364	YES	12-16'	15	12-16'		SP	Dark brown, loose coarse sand w/ black HC staining, slight odor	
					16					
					17					
					18					
	moist	123	YES		19			SP	Compact, yellow brown sand some silt/clay 30%, slight stain and odor	
					20					
					21			SP	SAA	
					22					
	dry	13.6	NO	20-24'	23			SP	SAA no stain/odor	
					24	20-24'		CL	Green/gray lean clay Refusal @ 24' backfilled w/ tight clay w/ bentonite no well install	
					25					
					26					
					27					
					28					
					29					
					30					
					31					
					32					
					33					
					34					
					35					
					36					
					37

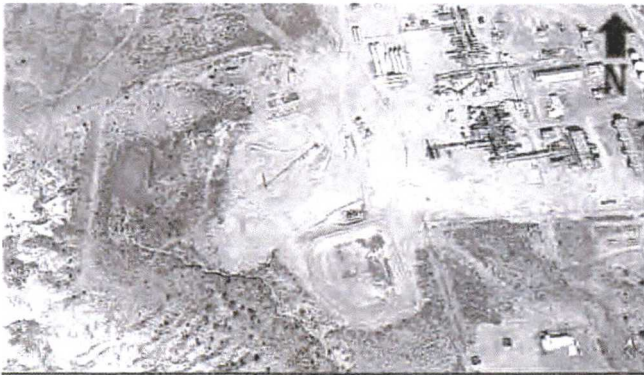
Boring/Well #	BH11
Project:	Kutz Canyon GP
Project #	
Date	6/6/15

Penetration Resistance	Moisture Content	Vapor (ppm)	Staining	Sample #	Depth (ft. bgs.)	Sample Run	Recovery	Soil/Rock Type	Lithology/Remarks	Well Completion
	moist	623	NO		15			CL	SAA NO stain swampy odor	
					16					
	Dry	164	NO	16-18'	17			CL	Very compact, green grey, lean clay some sand < 15 to	
					18				no stain swampy odor	
					19					
					20				Refusal @ 18.5' due to	
					21				tight clay no GW encountered	
					22					
					23					
					24					
					25					
					26					
					27					
					28					
					29					
					30					
					31					
					32					
					33					
					34					
					35					
					36					
					37

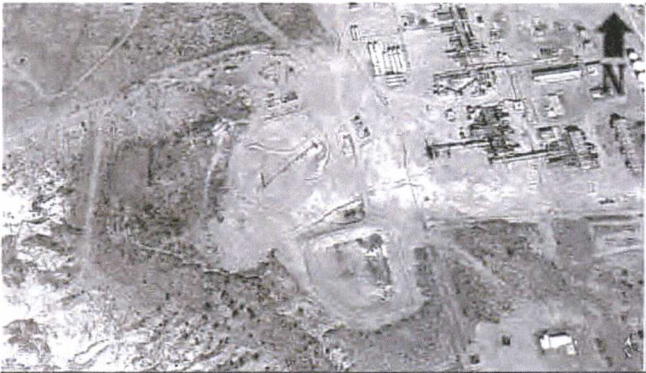
Boring/Well #	BH12
Project:	Kutz Canyon GP
Project #	
Date	6/6/19

Penetration Resistance	Moisture Content	Vapor (ppm)	Staining	Sample #	Depth (ft. bgs.)	Sample Run	Recovery	Soil/Rock Type	Lithology/Remarks	Well Completion
	moist	207 27.2	NO	12-10'	15			CL	SAA NO stain/odor	
					16					
					17					
					18				CL	
					19				Refusal @ 18' due to tight clay	
					20				no GW	
					21				encountered	
					22				NO well installed	
					23					
					24					
					25					
					26					
					27					
					28					
					29					
					30					
					31					
					32					
					33					
					34					
					35					
					36					
					37

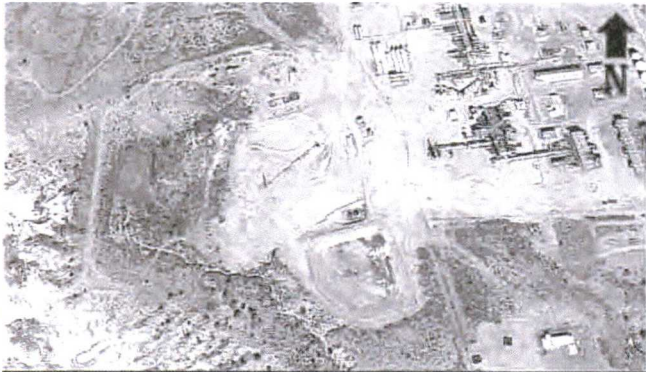
Boring/Well #	BH 13
Project:	Kutz Canyon GP
Project #	
Date	6/6/15

Penetration Resistance	Moisture Content	Vapor (ppm)	Staining	Sample #	Depth (ft. bgs.)	Sample Run	Recovery	Soil/Rock Type	Lithology/Remarks	Well Completion
	moist	32.6	NO	16-18'	15					
					16			CL	SAA No stain	
					17				sewage odor	
					18					
					19				Refusal @ 18' No groundwater	
					20				encountered tight clay	
					21				No well install	
					22					
					23					
					24					
					25					
					26					
					27					
					28					
					29					
					30					
					31					
					32					
					33					
					34					
					35					
					36					
					37

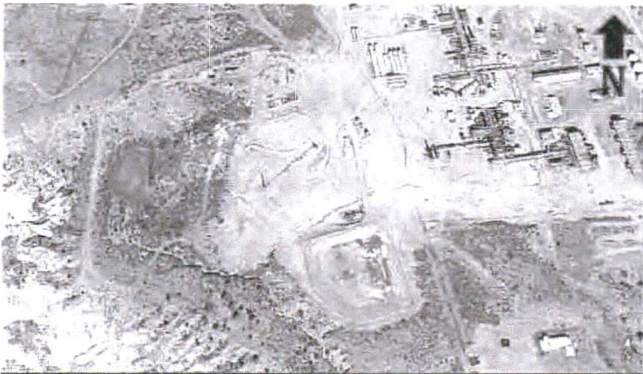
Boring/Well #	BH 17
Project:	Kutz Canyon GP
Project #	
Date	6/16/14

Penetration Resistance	Moisture Content	Vapor (ppm)	Staining	Sample #	Depth (ft. bgs.)	Sample Run	Recovery	Soil/Rock Type	Lithology/Remarks	Well Completion
	moist	137 437	YES	14-16	15			SP	loose, Black, coarse sand Slight odor, HC staining	
					16					
					17					
	moist	111	NO		18			CL	compact, Green Gray, lean clay x 15% sand, slight odor, no staining	
					19					
					20			CL	SAA	
	Dry	3.6	NO	20-23	21					
					22			CL	SAA No stain/odor	
					23					
					24				Refusal @ 23' no GW encountered Tight clay	
					25				No well set	
					26					
					27					
					28					
					29					
					30					
					31					
					32					
					33					
					34					
					35					
					36					
					37

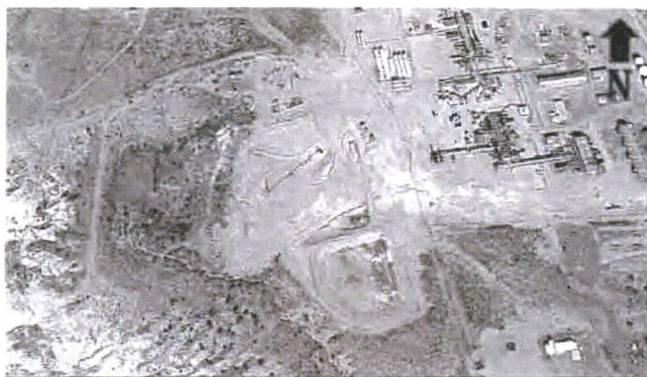
Penetration Resistance	Moisture Content	Vapor (ppm)	HC Staining?	Sample #	Depth (ft. bgs.)	Sample Run	Recovery	Soil/Rock Type	Lithology/Remarks	Well Completion
	dry	1.3	no		0			SP	loose, lt reddish brown, coarse sand, no stain loder	
	moist	2.3	no		1			SP	SAA NO S/O	
	moist	24.6	no		2					
	moist	160.7	yes		3					
	wet	183.4	yes		4					
		246.7	yes		5			SP	Black, loose, sand trace silt <15% slight odor, HC stain	
					6				GW encountered 7.5'-8'	
					7					
					8					
					9			SP	SAA	
					10					
					11			CL	Compact, Green grey, lean clay <15% sand	
	moist	124.3	no	10-12	12					
					13					
					14					
					15				Refusal @ 12' Tight clay Set well

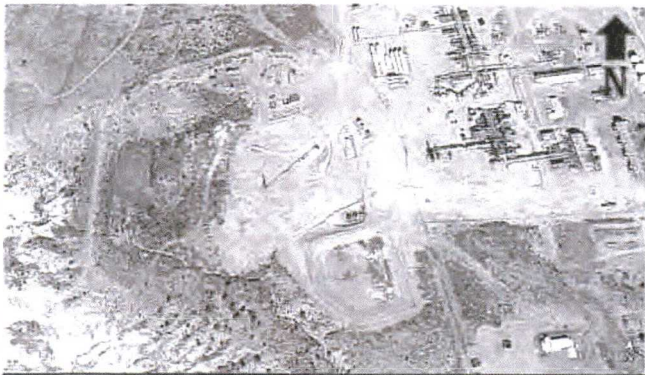
Boring/Well #	BH 19
Project:	Rutz Canyon GP
Project #	
Date	6/7/19

Penetration Resistance	Moisture Content	Vapor (ppm)	Staining	Sample #	Depth (ft. bgs.)	Sample Run	Recovery	Soil/Rock Type	Lithology/Remarks	Well Completion
	wet Sabor	386	Y	14-16	15			SAA	Strong odor HC stain	
	moist	63.0	N		16			CL	compact dark green lean clay <15% sand slight odor no stain	
	DRY	60.8	N		17			SAA		
					18					
					19					
					20					
	DRY	61.0	N	20-24	21			CL SAA		
					22					
					23					
					24				Refusal @ 24' Tight clay	
					25				@ 16' Set 1" temp well	
					26				backfill w. sand/	
					27					
					28					
					29					
					30					
					31					
					32					
					33					
					34					
					35					
					36					
					37

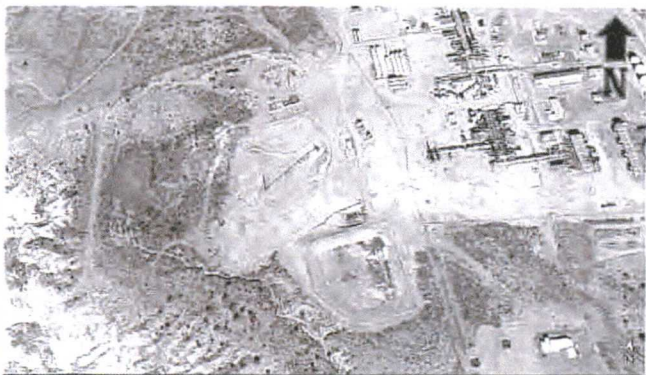
Penetration Resistance	Moisture Content	Vapor (ppm)	HC Staining?	Sample #	Depth (ft. bgs.)	Sample Run	Recovery	Soil/Rock Type	Lithology/Remarks	Well Completion
	moist	150.8	NO		0			SP	loose, lt reddish brown sand NO stain/odor	
	moist	1907	YES		1			SP	Bt loose, black sand, strong odor	
	moist	1154	YES	5'	2			CL	compact green grey sandy lean clay, slight odor	NO well installed backfill w/ sand
	Sat	1170	YES		3					
	moist	1095	NO		4			CL	compact, dark brown, lean clay < 30% sand NO stain slight odor	
					5					
					6					
					7					
					8					
					9					
					10					
					11					
					12				Stopped @ 6' due to presence of GW	
					13					
					14					
					15

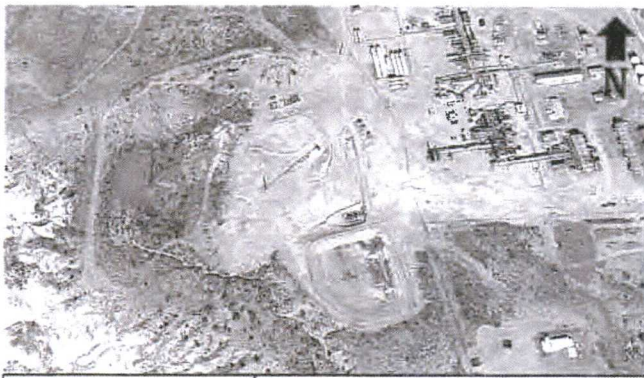
Penetration Resistance	Moisture Content	Vapor (ppm)	HC Staining?	Sample #	Depth (ft. bgs.)	Sample Run	Recovery	Soil/Rock Type	Lithology/Remarks	Well Completion
	moist	290.8	no		0			SP	Loose lt reddish brown sand No stain/odor	
	moist	341.6	yes		1			SP	Black sand strong odor, sulfur	
	Sat	1601	yes	<i>4'</i>	2			SP	SAA	
	Sat	1164	yes		3			SP	SAA	
	Sat	1452	yes		4			SP	SAA	
	Sat	1122	yes		5			SP	SAA	
					6			SP	SAA	
					7			SP	SAA	
					8			SP	SAA	
					9			SP	SAA	
					10			CL	compact grey clean clay trace black sand.	
					11			CL	SAA	
					12				Stopped @ 10' due to contaminated GW set well	
					13					
					14					
					15

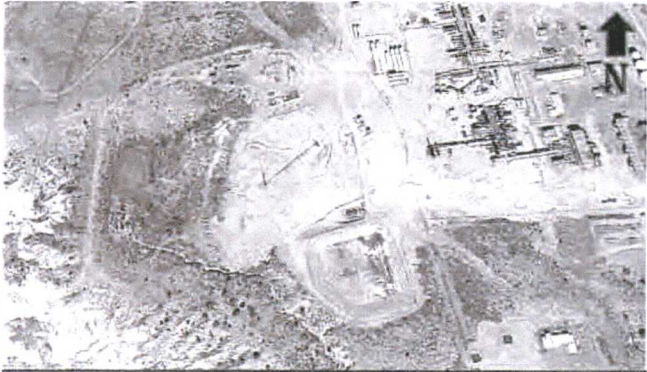
Penetration Resistance	Moisture Content	Vapor (ppm)	HC Staining?	Sample #	Depth (ft. bgs.)	Sample Run	Recovery	Soil/Rock Type	Lithology/Remarks	Well Completion
	DRY	23.0	NO		0			SP	loose, lt reddish brown sand	NO well installed backfill w/ some bentonite
	moist	1665	YES	2'	1			SP	no stain/odor	
	wet	310	YES		2			SP	black, loose, sand, strong odor	
					3					
					4			SP	SAA	
					5					
					6			CL	compact green grey lean clay	
					7					
	moist	27.6	NP		8			CL	SAA	
					9					
					10					
					11				Stopped @ 8' for clean	
					12				clay beneath GW, GW	
					13				contaminating soil/GW	
					14				beneath clay	
					15

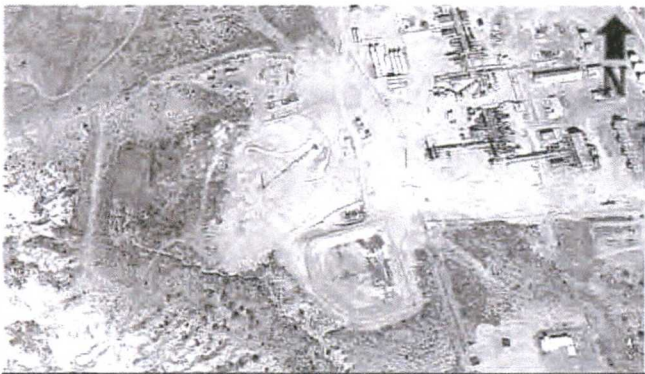
Penetration Resistance	Moisture Content	Vapor (ppm)	HC Staining?	Sample #	Depth (ft. bgs.)	Sample Run	Recovery	Soil/Rock Type	Lithology/Remarks	Well Completion
	Dry		NO		0			SP	loose, lt reddish brown, sand	NO well installed backfilled w/ bentonite
					1				NO stain/odor	
	moist	198.2	NO		2			SP	SAA	
					3					
	moist	180.4	YES		4			SP	Black loose sand strong odor	
					5					
	moist	176.0	YES		6					
					7			CL	Compact, green grey, lean clay staining and slight odor	
	Sat	884	YES	8'	8					
					9					
					10				Stopped @ 8' to limit vertical impact of contaminated H ₂ O	
					11					
					12					
					13					
					14					
					15

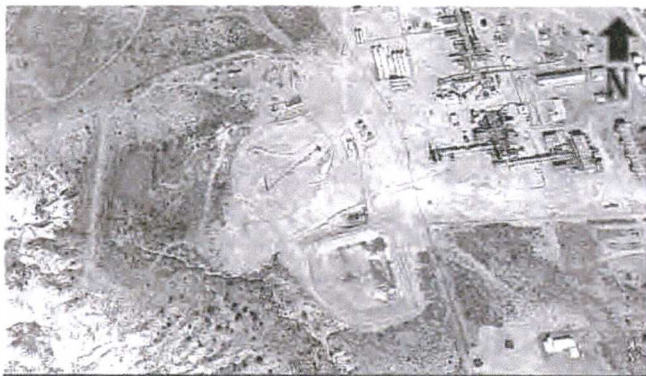
Penetration Resistance	Moisture Content	Vapor (ppm)	HC Staining?	Sample #	Depth (ft. bgs.)	Sample Run	Recovery	Soil/Rock Type	Lithology/Remarks	Well Completion
	Dry	1.2	NO		0				loose, lt reddish brown coarse sand NO stain/odor	NO well installed backfill w/ bentonite
					1			SP		
					2					
	Dry	1.4	NO		4			CL	compact, green grey, lean clay < 15% sand NO stain/odor	
					5					
					6			SAA		
	Dry	1.3	NO	-8'	7			SAA	NO S/O	
					8					
					9			CL	Residual @ 8' tight clay	
					10					
					11					
					12					
					13					
					14					
					15

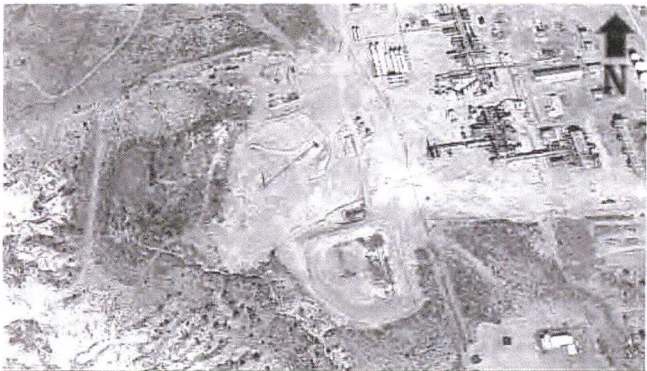
Penetration Resistance	Moisture Content	Vapor (ppm)	HC Staining?	Sample #	Depth (ft. bgs.)	Sample Run	Recovery	Soil/Rock Type	Lithology/Remarks	Well Completion
	Dry	1.2	NO		0			SP	Dry, loose, 1E red brown sand	
					1			SP	NA stain slight odor	
					2					
					3					
	moist	436	Yes	4-6'	4			CL	Compact, green grey lean clay < 15% sand some staining HC odor	
	wet	64.3	Yes		5					
					6					
					7			SP	Saturated, coarse sand, grey trace clay < 10% slight stain/odor	
					8					
	moist	141	NO	p-12	9			CL	Compact, green grey, lean clay < 15% sand NO stain/odor	
					10					
					11					
					12				Refusal @ 12' tight clay	
					13					
					14					
					15				GW @ 6' well get

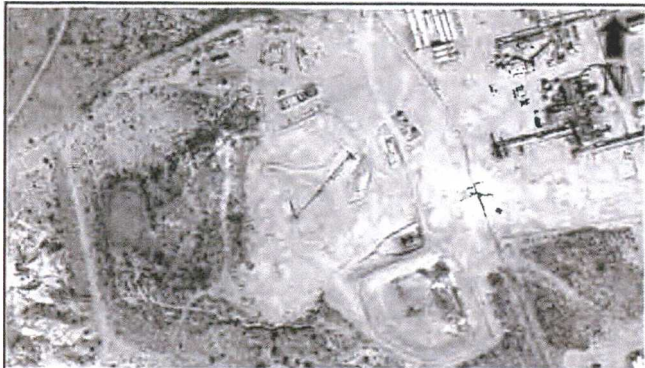
Screen Type: **Schedule 40 PVC** Slot: **0.010"** Diameter: **2" 1"** Length: **5'** Total Depth: **9.5'** Depth to Water: **8**

Penetration Resistance	Moisture Content	Vapor (ppm)	HC Staining?	Sample #	Depth (ft. bgs.)	Sample Run	Recovery	Soil/Rock Type	Lithology/Remarks	Well Completion
					0					
	Dry	1.7	No		1			SP -SC	-Fill material mixed w/ H. reddish brown med. sand w/ tr. clay No s/o	
	sl. moist	2.1	No		2			SP -SC	-olive H. gray fn. clayey sand No s/o	
	v. moist	3.8	No		3				olive brown clayey med. fn. sand. No s/o	
	sat.		No		4				-some moisture on auger	
			No		5				SAA. No stain/odor	
	Dry	2.7	No		6				saturated soil @ 8'	
					7				no sheen observed.	
					8				lean clay, dense, green/gray	
					9				refusal @ 9.5'	
					10					
					11					
					12					
					13					
					14					
					15

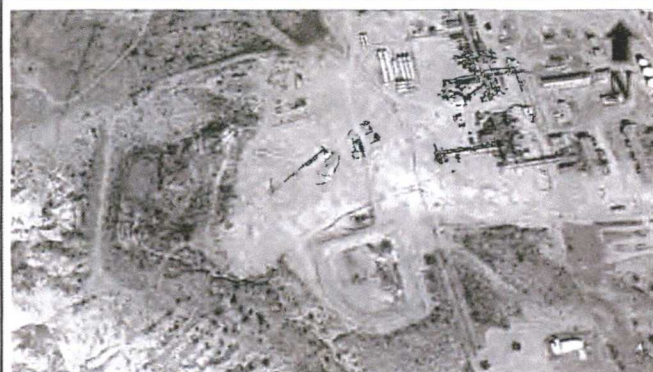
Penetration Resistance	Moisture Content	Vapor (ppm)	HC Staining?	Sample #	Depth (ft. bgs.)	Sample Run	Recovery	Soil/Rock Type	Lithology/Remarks	Well Completion
	Dry	0.0	NO		0				loose, lt reddish brown, coarse sand	
					1			SP	NO stain/odor	
	moist	0.2	NO		2				loose, lt reddish brown, coarse sand	
					3				NO stain/odor	
	moist	0.2	NO		4				SAA NO S/O	
					5					
	moist	0.4	NO		6			SP	SAA NO S/O	
				NA	7	NA				
	moist	0.9	NO		8				SAA NO S/O	
					9					
	moist	8.7	NO		10			SP	loose dark brown, sand trace silt	
					11				21% NO stain/odor	
	Sat	86.8	YES		12				loose, black, coarse sand	
					13				Strong odor, HC staining	
	Sat	80.3	YES		14				loose, grey, coarse sand	
					15				Strong odor HC staining

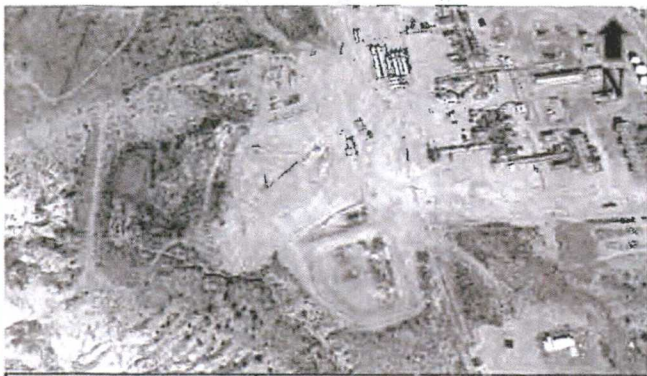
Boring/Well Number: *BH-30* Project: *Kutz Canyon GP*

Screen Type: *Schedule 40 PVC* Slot: *0.010"* Diameter: *1"* Length: Total Depth: *6'* Depth to Water:

Penetration Resistance	Moisture Content	Vapor (ppm)	HC Staining?	Sample #	Depth (ft. bgs.)	Sample Run	Recovery	Soil/Rock Type	Lithology/Remarks	Well Completion
	<i>Dry</i>	<i>0.0</i>	<i>NO</i>		<i>0</i>				<i>loose, lt reddish brown, coarse sand w/ gravel</i>	
					<i>1</i>			<i>SP</i>	<i>NO stain/odor</i>	
	<i>Dry</i>	<i>0.0</i>	<i>NO</i>		<i>2</i>			<i>SAA</i>		<i>NO well installed</i>
					<i>3</i>					
	<i>Dry</i>	<i>0.0</i>	<i>NO</i>		<i>4</i>			<i>SP</i>	<i>SAA</i>	
					<i>5</i>					
	<i>Dry</i>	<i>0.0</i>	<i>NO</i>		<i>6</i>			<i>SAA</i>		
					<i>7</i>				<i>refusal @ 6'</i>	
					<i>8</i>				<i>encountered debris, boulders that stopped hand auger</i>	
					<i>9</i>				<i>attempted several locations</i>	
					<i>10</i>					
					<i>11</i>					
					<i>12</i>					
					<i>13</i>					
					<i>14</i>					
					<i>15</i>

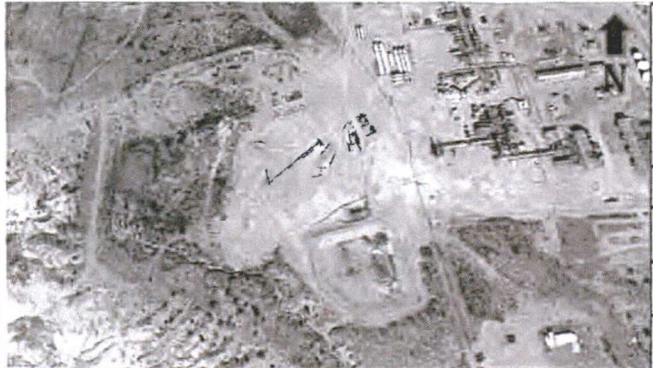
Boring/Well Number: BH-31	Project: Kutz Canyon GP
Date: 7/3/2018	Project Number:
Logged By: Eric Carroll	Drilled By: LTE
Elevation:	Drilling Method: Hand Auger
Detector: PID	Sampling Method: Hand Auger
Gravel Pack: 10-20 Silica Sand	Seal: NA
Casing Type: Schedule 40 PVC	Grout: NA
Screen Type: Schedule 40 PVC	Diameter: 1"
Slot: 0.010"	Length: 5'
	Hole Diameter: 2.5"
	Depth to Liquid: —
	Total Depth: 9'
	Depth to Water: 7'

Penetration Resistance	Moisture Content	Vapor (ppm)	HC Staining?	Sample #	Depth (ft. bgs.)	Sample Run	Recovery	Soil/Rock Type	Lithology/Remarks	Well Completion
	Dry	0.0	No		0				Very loose, lt reddish brown, coarse sand	
					1			SP	no steel ladder	
	Dry	0.0	No		2			SAA		
					3					
	moist	27.6	yes		4			SP	loose, black, coarse sand, slight odor	
				NA	5	NA				
	Sat	213.3	yes		6			SP	loose, lt grey, coarse sand, strong odor	
					7				Saturated sheen on water	
					8					
	moist	31.3	No		9			CH	Dense, green/grey, lean clay	
					10				< 15% sand	
					11					
					12					
					13					
					14					
					15

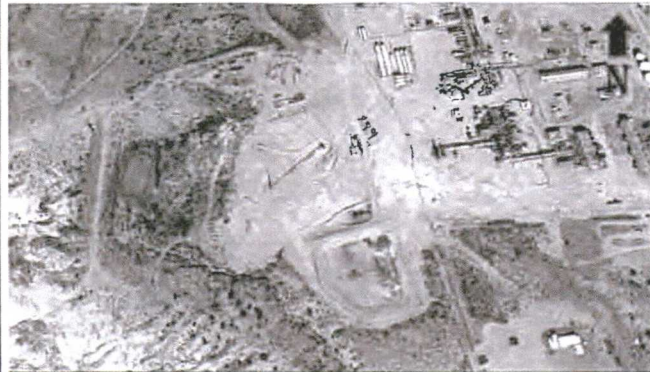
Boring/Well Number: BH-32	Project: Kutz Canyon GP					
Date: 7/3/2018	Project Number:					
Logged By: Eric Carroll	Drilled By: LTE					
Elevation:	Drilling Method: Hand Auger	Sampling Method: Hand Auger				
Detector: PID	Seal: N/A	Grout: NA				
Gravel Pack: 10-20 Silica Sand	Diameter: 1"	Length: —	Hole Diameter: 2.5"	Depth to Liquid: NA		
Casing Type: Schedule 40 PVC	Screen Type: Schedule 40 PVC	Slot: 0.010"	Diameter: 1"	Length: —	Total Depth: 10'	Depth to Water: NA

Penetration Resistance	Moisture Content	Vapor (ppm)	HC Staining?	Sample #	Depth (ft. bgs.)	Sample Run	Recovery	Soil/Rock Type	Lithology/Remarks	Well Completion
	DRY	0.0	NO		0				compact, reddish brown, sand	
					1			SP	no stain / odor	Dry
	DRY	0.0	NO		2				SAA	NO well installed
					3					
	DRY	0.0	NO		4				compact, yellow red, sand	
					5			SP	no stain / odor	
				NA	6	NA				
	DRY	0.0	NO		7			CL	compact, dark brown, lean clay	
					8				< 30% sand	
	DRY	0.0	NO		9				SAA NO S/O	
					10			CL	SAA NO S/O	
	DRY	0.0	NO		11					
					12					
					13					
					14					
					15

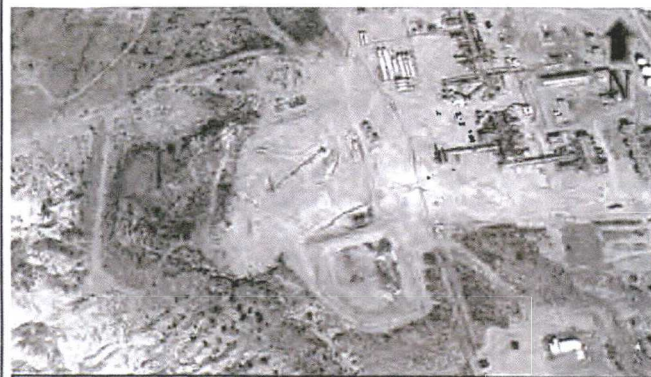
Boring/Well Number: <i>BH-33</i>	Project: Kutz Canyon GP				
Date: 7/3/2018	Project Number:				
Logged By: Eric Carroll	Drilled By: LTE				
Elevation:	Detector PID	Drilling Method: Hand Auger	Sampling Method: Hand Auger		
Gravel Pack: 10-20 Silica Sand	Seal:	Grout:			
Casing Type: Schedule 40 PVC	Diameter: 1"	Length: —	Hole Diameter: 2.5"	Depth to Liquid: —	
Screen Type: Schedule 40 PVC	Slot: 0.010"	Diameter: 1"	Length: —	Total Depth: 9'	Depth to Water: —

Penetration Resistance	Moisture Content	Vapor (ppm)	HC Staining?	Sample #	Depth (ft. bgs.)	Sample Run	Recovery	Soil/Rock Type	Lithology/Remarks	Well Completion
	DRY	0.0	NO		0				Compact, lt reddish brown, sand no stain/odor	Dry Well was installed!
					1			SP		
	DRY	0.0	NI		2			SAA	NO s/o	
					3					
	DRY	1.1	NO		4			CL	dense friable, dark brown lean clay ~70% sand	
				NA	5	NA			NO stain/odor.	
	DRY	0.6	NO		6			SAA		
					7					
	DRY	0.6	NO		8			CL	SAA NO s/o	
					9					
					10					
					11					
					12					
					13					
					14					
					15

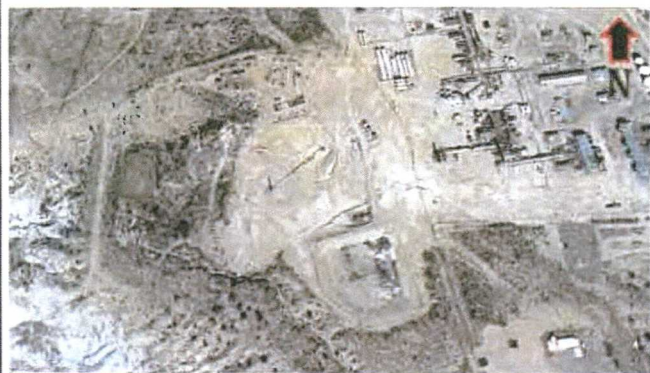
Boring/Well Number: <i>BH 34</i>	Project: Kutz Canyon GP				
Date: 7/23/2018	Project Number:				
Logged By: Eric Carroll	Drilled By: LTE				
Elevation: <i>5770</i>	Detector: PID	Drilling Method: Hand Auger	Sampling Method: Hand Auger		
Gravel Pack: 0-20 Silica Sand Pre Pac	Seal: NA	Grout: NA			
Casing Type: Schedule 40 PVC	Diameter: 1"	Length: 5'	Hole Diameter: 2.5"	Depth to Liquid: NA	
Screen Type: Schedule 40 PVC	Slot: 0.010"	Diameter: 1"	Length: 5'	Total Depth: 9'	Depth to Water: 7.5'

Penetration Resistance	Moisture Content	Vapor (ppm)	HC Staining?	Sample #	Depth (ft. bgs.)	Sample Run	Recovery	Soil/Rock Type	Lithology/Remarks	Well Completion
	Dry	1.3	NO		0			SP	Loose, reddish brown, coarse sand no stain/odor	
					1					
	moist	12.3	NO		2			SP	SAA NO stain/odor	
					3					
	moist	16.3	NO		4			SP	SAA NO stain/odor	
					5					
	moist	506	YES		6			SP	Loose, black grey, coarse sand trace silt <15% HC staining, strong odor	
					7					
	moist silt	231	YES		8			SPSM	SAA	
					9					
	moist silt	57	YES		10			CL	SAA	
					11					
					12			CL	compact green lean clay <15% sand	
					13				no stain, slight odor	
					14				refusal @ 9' due to tight clay	
					15

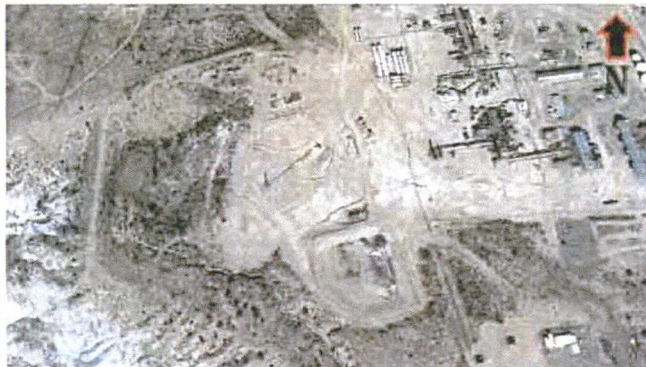
Boring/Well Number: BH 35		Project: Kutz Canyon GP	
Date: 7/23/2018		Project Number:	
Logged By: Eric Carroll		Drilled By: LTE	
Elevation: 5770	Detector: PID	Drilling Method: Hand Auger	Sampling Method: Hand Auger
Gravel Pack: 0-20 Silica Sand Pre Pac		Seal: NA	Grout: NA
Casing Type: Schedule 40 PVC		Diameter: 1"	Length: 5'
Screen Type: Schedule 40 PVC		Diameter: 1"	Length: 5'
Slot: 0.010"		Hole Diameter: 2.5"	Depth to Liquid: NA
		Total Depth: 8'	Depth to Water: 6.5'

Penetration Resistance	Moisture Content	Vapor (ppm)	HC Staining?	Sample #	Depth (ft. bgs.)	Sample Run	Recovery	Soil/Rock Type	Lithology/Remarks	Well Completion
	Dry	1.3	NO		0			SP	Loose, reddish brown, coarse sand NO stain/odor	
	moist	14.6	NO		1			SP	SAA NO stain/odor	
	moist	487	YES		2			SP	Loose, black, coarse sand HC staining, or strong odor	
	Sat	364	YES		3			SP	SAA	
	moist	43	NO		4			CL	Compact, green, lean clay < 15% sand, NO stain/odor	
					5					
					6					
					7					
					8					
					9					
					10					
					11					
					12					
					13					
					14					
					15

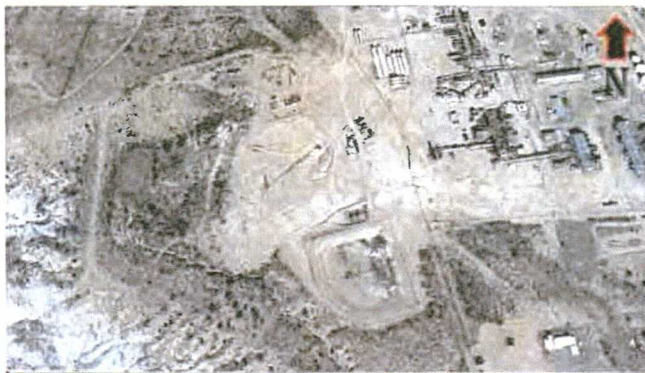
Boring/Well Number: BH 36		Project: Kutz Canyon GP	
Date: 7/23/2018		Project Number:	
Logged By: Eric Carroll		Drilled By: LTE	
Elevation: 5770		Detector: PID	
Drilling Method: Hand Auger		Sampling Method: Hand Auger	
Gravel Pack: 0-20 Silica Sand Pre Pac		Seal: NA	
Casing Type: Schedule 40 PVC		Grout: NA	
Screen Type: Schedule 40 PVC		Diameter: 1"	Length: 5'
Slot: 0.010"		Hole Diameter: 2.5"	Depth to Liquid: NA
Total Depth: 9'		Depth to Water: 6'

Penetration Resistance	Moisture Content	Vapor (ppm)	HC Staining?	Sample #	Depth (ft. bgs.)	Sample Run	Recovery	Soil/Rock Type	Lithology/Remarks	Well Completion
	Dry	0.3	NO		0			SP	Loose, lt reddish brown, coarse sand no stain/odor	
	moist	0.7	NO		1			SP	SAA NO stain/odor	
					2			SP	SAA NO stain/odor	
					3					
	moist	0.6	NO		4			SP	SAA NO stain/odor	
					5					
	moist	1.1	NO		6			SP	Loose, yellow brown, coarse sand no stain/odor	
					7					
	Sat	0.8	NO		8			SP	Loose, dark brown, coarse sand, some gravel no stain/odor	
					9					
	moist	0.4	NO		10			CL	compact, green, lean clay < 15% sand no stain/odor	
					11					
					12					
					13					
					14					
					15

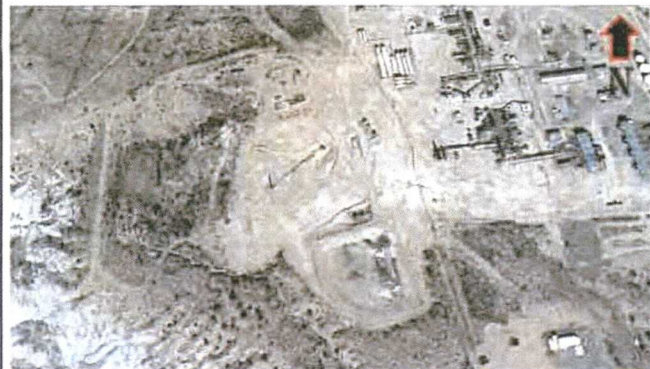
Diameter: **1"** Length: **5'** Total Depth: **6'** Depth to Water: **4'**

Penetration Resistance	Moisture Content	Vapor (ppm)	HC Staining?	Sample #	Depth (ft. bgs.)	Sample Run	Recovery	Soil/Rock Type	Lithology/Remarks	Well Completion
	dry	0.6	NS		0			SP	Loose, lt reddish brown, coarse sand no stain/odor	
	moist	1.6	NO		1			SP	SAA NO stain/odor	
					2					
					3					
	sat	14.6	NO		4			SP	loose, grey, coarse sand, saturated no stain/odor	
					5					
	moist	12.3	NA		6			CL	compact, green, lean clay < 15% sand no stain/odor	
					7					
					8					
					9					
					10					
					11					
					12					
					13					
					14					
					15

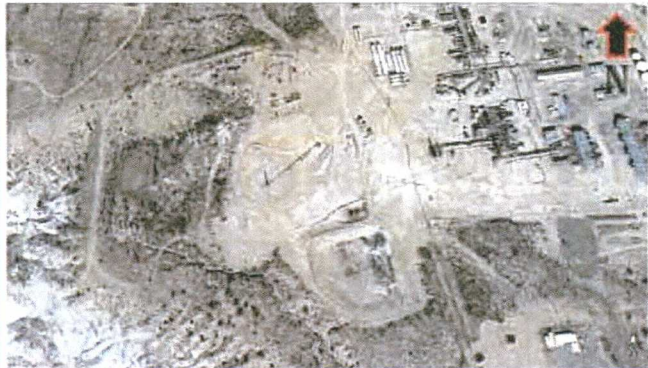
Boring/Well Number: <i>BH 38</i>	Project: Kutz Canyon GP				
Date: 7/23/2018	Project Number:				
Logged By: Eric Carroll	Drilled By: LTE				
Drilling Method: Hand Auger	Sampling Method: Hand Auger				
Elevation: <i>5770</i>	Detector: PID				
Gravel Pack: 0-20 Silica Sand Pre Pac	Seal: NA				
Casing Type: Schedule 40 PVC	Diameter: 1"	Length: <i>NA</i>	Hole Diameter: <i>2.5"</i>	Depth to Liquid: <i>NA</i>	
Screen Type: Schedule 40 PVC	Slot: 0.010"	Diameter: 1"	Length: <i>NA</i>	Total Depth: <i>8'</i>	Depth to Water: <i>NA</i>

Penetration Resistance	Moisture Content	Vapor (ppm)	HC Staining?	Sample #	Depth (ft. bgs.)	Sample Run	Recovery	Soil/Rock Type	Lithology/Remarks	Well Completion
	Dry	0.0	NO		0			CL	Loose, friable, green/gray, lean clay	N/A Well Installed
					1				<30% sand	
					2				NO Stain/odor	
	Dry	0.0	NP		3					
					4			CL	SAA NO Stain/odor	
					5					
	Dry	0.0	NP		6			CL	SAA NO Stain/odor	
					7					
	Dry	0.0	NP		8			CL	SAA NO Stain/odor	
					9					
					10				Stopped Auger @ 8'	
					11				NO GW encountered	
					12				NO well installed	
					13					
					14					
					15

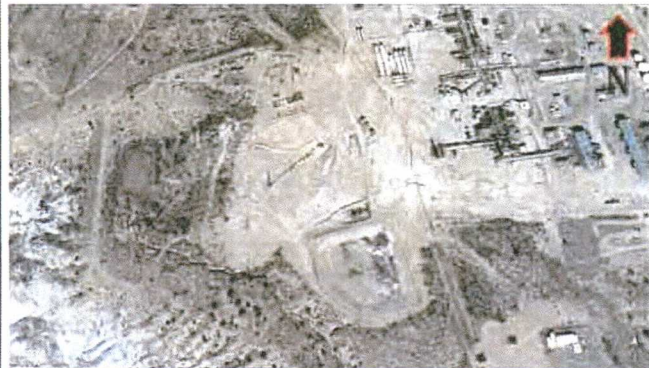
Diameter: 1" Length: *NA* Total Depth: *9'* Depth to Water: *NA*

Penetration Resistance	Moisture Content	Vapor (ppm)	HC Staining?	Sample #	Depth (ft. bgs.)	Sample Run	Recovery	Soil/Rock Type	Lithology/Remarks	Well Completion
	<i>Dry</i>	<i>0.0</i>	<i>NO</i>		0			<i>CL</i>	<i>Loose, sandy grey, sandy clay 40% sand/60% clay</i>	<i>NO Well installed</i>
					1					
	<i>moist</i>	<i>97.0</i>	<i>NO</i>		2			<i>CL</i>	<i>Loose, green grey, lean clay <15% sand NO stain, light odor</i>	
					3					
	<i>moist</i>	<i>54.4</i>	<i>NO</i>		4			<i>CL</i>	<i>SAA NO stain/odor</i>	
					5					
	<i>moist</i>	<i>48.6</i>	<i>NO</i>		6			<i>CL</i>	<i>SAA NO stain/odor</i>	
					7					
	<i>moist</i>	<i>12.1</i>	<i>NO</i>		8			<i>CL</i>	<i>compact hard, green, lean clay <15% sand NO stain/odor</i>	
					9					
					10					
					11				<i>Boring refusal @ 9' due to tight clay</i>	
					12				<i>NO GW encountered</i>	
					13				<i>no well installed</i>	
					14					
					15

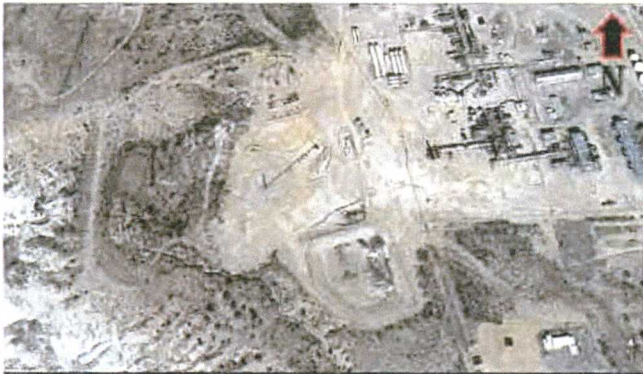
Boring/Well Number: <i>BH 40</i>	Project: Kutzs Canyon GP				
Date: 8/1/2018	Project Number:				
Logged By: Eric Carroll	Drilled By: LTE				
Elevation: 5770	Detector: PID	Drilling Method: Hand Auger	Sampling Method: Hand Auger		
Gravel Pack: 10-20 Silica Sand <i>Pie Pack</i>	Seal: <i>NA</i>	Grout: <i>NA</i>			
Casing Type: Schedule 40 PVC	Diameter: 1" 2"	Length: 5'	Hole Diameter: 2.5"	Depth to Liquid: <i>NA</i>	
Screen Type: Schedule 40 PVC	Slot: 0.010"	Diameter: 1" 2"	Length: 5'	Total Depth: 7.5'	Depth to Water: 5.5'

Penetration Resistance	Moisture Content	Vapor (ppm)	HC Staining?	Sample #	Depth (ft. bgs.)	Sample Run	Recovery	Soil/Rock Type	Lithology/Remarks	Well Completion
	Dry	0.0	NO		0			SP	Loose, lt reddish brown, coarse sand NO stain/odor	
	moist	0.2	NO		1			SP	SAA NO stain/odor	
	moist	12.1	NO		2					
					3					
	moist	12.1	NO		4			SP-SC	Loose, grey, sand trace clay <15% fines NO stain/odor	
	Sat	894	YES		5					
					6			SP	Loose, Black, coarse sand, HC staining and odor, Heavy sheen	
					7					
	moist	601	NO		8			CL	compact, green grey, lean clay <15% sand. NO stain, Slight odor	
					9					
					10					
					11					
					12					
					13					
					14					
					15

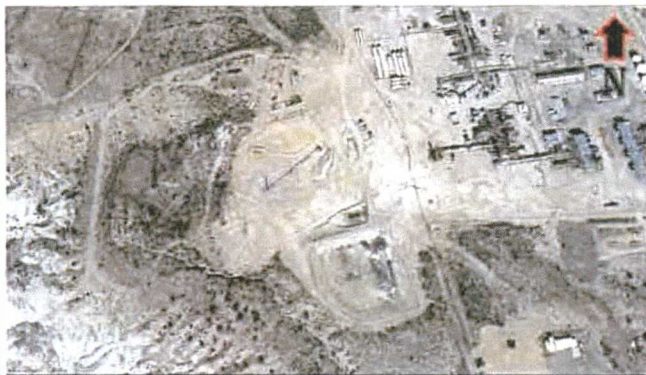
Penetration Resistance	Moisture Content	Vapor (ppm)	HC Staining?	Sample #	Depth (ft. bgs.)	Sample Run	Recovery	Soil/Rock Type	Lithology/Remarks	5.75" Well Completion
	Dry	0.0	NO		0			SP	Loose, lt reddish brown, coarse sand no stain/odor	
	moist	0.0	NO		1			SP	SAA NO stain/odor	
	moist	0.2	NO		2			SP	SAA NO stain/odor	
	moist	0.2	NO		3			SP	SAA NO stain/odor	
	moist	0.2	NO		4			SP	SAA NO stain/odor	
	moist	6.9	NO		5			SP	Loose, lt reddish brown, coarse sand grey mottles, no stain/odor	
	moist	6.9	NO		6			SP	Loose, lt reddish brown, coarse sand grey mottles, no stain/odor	
	moist	6.9	NO		7			SP	Loose, lt reddish brown, coarse sand grey mottles, no stain/odor	
	Sat	17.4	NO		8			SP	Loose, lt reddish brown, coarse sand trace clay <15% fines no stain no odor, saturated soil	
	moist	276.3	yes		9			SC	SAA NO	
	moist	276.3	yes		10			SP	Loose, Black, Sand, HC stain slight odor	
					11			SP	Loose, Black, Sand, HC stain slight odor

12			SP	Refusal @ ~11-12' due to gravel	
					13			SP	Refusal @ ~11-12' due to gravel	
					14			SP	Refusal @ ~11-12' due to gravel	
					15			SP	Refusal @ ~11-12' due to gravel

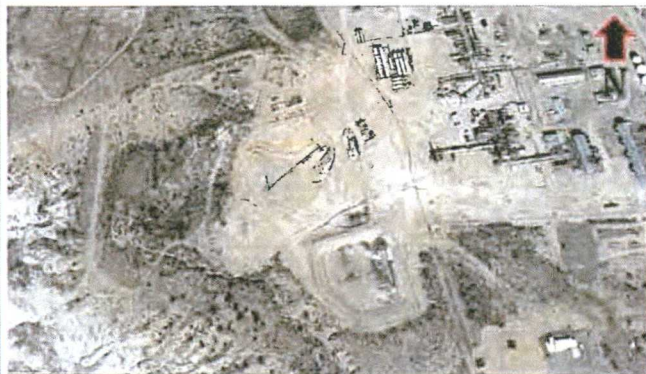
Boring/Well Number: <i>BH40</i>	Project: Kutzs Canyon GP				
Date: 8/3/2018	Project Number:				
Logged By: Eric Carroll	Drilled By: LTE				
Elevation: 5770	Detector: PID	Drilling Method: Hand Auger	Sampling Method: Hand Auger		
Gravel Pack: 10-20 Silica Sand	Pre-Pack	Seal: <i>NA</i>	Grout: <i>NA</i>		
Casing Type: Schedule 40 PVC	Diameter: 1"	Length: 5'	Hole Diameter: 2.5"	Depth to Liquid: <i>NA</i>	
Screen Type: Schedule 40 PVC	Slot: 0.010"	Diameter: 1"	Length: 5'	Total Depth: <i>109.5'</i>	Depth to Water: <i>8'</i>

Penetration Resistance	Moisture Content	Vapor (ppm)	HC Staining?	Sample #	Depth (ft. bgs.)	Sample Run	Recovery	Soil/Rock Type	Lithology/Remarks	Well Completion
	<i>Dry</i>	<i>0.0</i>	<i>NO</i>		0			<i>SP</i>	<i>Loose, lt reddish brown coarse sand w/ gravel < 20% NO stain/odor</i>	
					1					
	<i>moist</i>	<i>0.0</i>	<i>NO</i>		2			<i>SP</i>	<i>SAA NO stain/odor</i>	
					3					
	<i>moist</i>	<i>1.3</i>	<i>NO</i>		4			<i>SP</i>	<i>Loose, dark reddish brown, coarse sand NO stain/odor</i>	
					5					
	<i>moist</i>	<i>1.4</i>	<i>NO</i>		6				<i>SAA NO stain/odor</i>	
					7			<i>SP</i>		
	<i>Sat moist</i>	<i>24.3</i>	<i>NO</i>		8				<i>Loose, Saturated, grey, coarse sand NO stain slight odor</i>	
					9					
	<i>moist</i>	<i>41.1</i>	<i>NO</i>		10			<i>CL</i>	<i>Compact, friable, green, lean clay < 30% sand, NO stain slight odor</i>	
					11					
					12					
					13					
					14					
					15

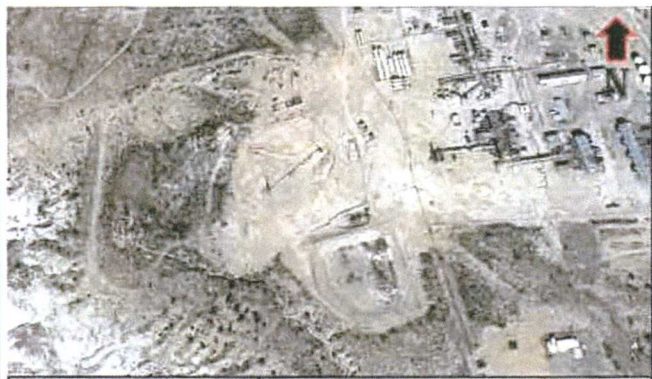
Penetration Resistance	Moisture Content	Vapor (ppm)	HC Staining?	Sample #	Depth (ft. bgs.)	Sample Run	Recovery	Soil/Rock Type	Lithology/Remarks	Well Completion
	Dry	0.0	NO		0				Loose, lt reddish brown, coarse sand	
					1			SP	NO stain/odor	
	Dry	0.0	NO		2				SAA NO stain/odor	
					3					
	moist	0.1	NO		4			SP	SAA NO stain/odor	
					5					
	moist	0.0	NO		6				SAA NO stain/odor	
					7					
	moist	0.7	NO		8				SAA NO stain/odor	
					9					
	sat moist	10.4	NO		10			SP	Loose, grey, coarse sand	
					11				NO stain/odor	
	moist sat	9.8	NO		12			EL	compact, green, lean clay, <15% sand	
					13				NO stain/odor	
					14					
					15
