Release Notification and Corrective Action

Name of Company Whiptail Midstream	Contact Ernie Johnson
Address 504 S. Bloomfield Blvd, Bloomfield, NM 87413	Telephone No. 918-289-2147
Facility Name 7-1 CDP	Facility Type Central Depository

SUBJECT: Final Closure Report for Incident Number: nVF1816448793 (Whiptail Midstream 7-1 CDP)

7-1 CDP

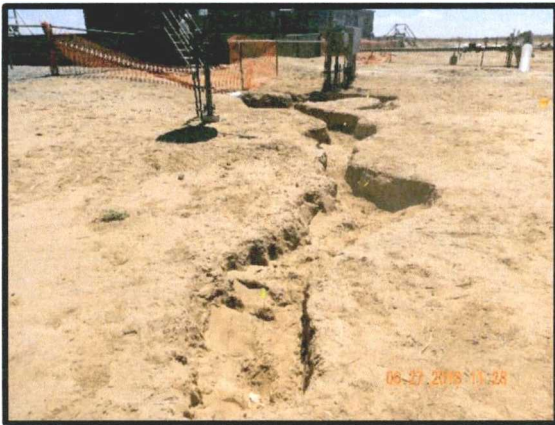
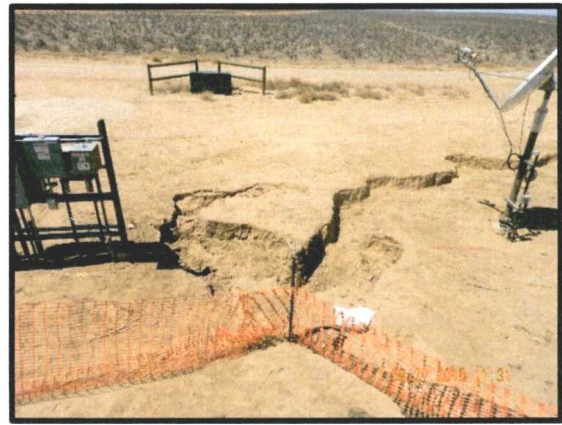
Area 1

Soils impacted along the southern edge of the pad/adjacent to the secondary containment were observed to be sandy loam, composed primarily of fine-course sands with little clay content. A vacuum truck and hand crews utilizing hand shovels removed free standing liquids and saturated soils from the impacted area along the southern edge of the pad and from underneath the containment liner to the furthest extent deemed to be safe. Remediation activities outside and underneath the containment took place between 6/5/18 and 6/15/18. In total, two vacuum trucks and two pickup truck loads of soil (placed in secured sand bags) were delivered to Envirotech Landfarm for disposal. An initial Form C-141 was submitted to the NMOCD District III Office in hard copy format on 6/19/2018.
