Release Notification and Corrective Action

Name of Company	BP America Production Company	Contact	Erin Garifalos
Address	200 Energy Court, Farmington, NM 87401	Telephone No.	(832) 609-7048
Facility Name	PUMP CANYON WATER TRANSFER	Facility Type	Natural Gas Well
Surface Owner	Federal	Mineral Owner	Federal
		API No.	PLA02123109

FIELD REPORT: (circle one): <input checked="" type="checkbox"/> BGT CONFIRMATION / <input type="checkbox"/> RELEASE INVESTIGATION / <input type="checkbox"/> OTHER:	PAGE #: 1 of 1
--	------------------------------

SITE INFORMATION:	SITE NAME: PUMP CANYON WATER TRANSFER	DATE STARTED: 04/05/18
QUAD/UNIT: O SEC: 12 TWP: 30N RNG: 9W PM: NM CNTY: SJ ST: NM		DATE FINISHED: _____
1/4 - 1/4 FOOTAGE: SW/SE LEASE TYPE: <input checked="" type="checkbox"/> FEDERAL / <input type="checkbox"/> STATE / <input type="checkbox"/> INDIAN		ENVIRONMENTAL SPECIALIST(S): NJV
LEASE #: - PROD. FORMATION: NA CONTRACTOR: BP - J. GONZALES

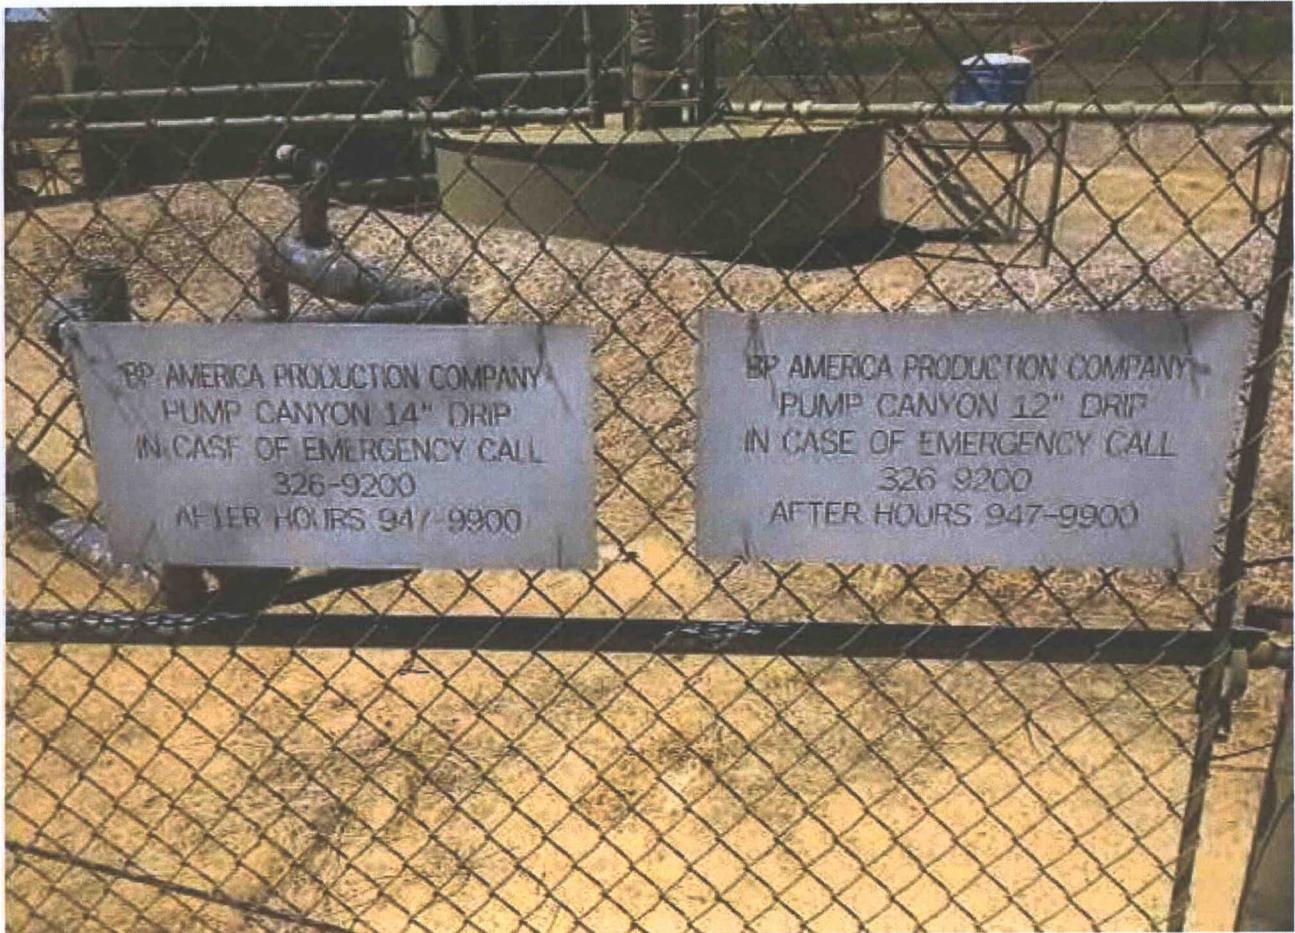
BP AMERICA PRODUCTION COMPANY
PUMP CANYON 14" DRIP
IN CASE OF EMERGENCY CALL
326-9200
AFTER HOURS 947-9900

BP AMERICA PRODUCTION COMPANY
PUMP CANYON 12" DRIP
IN CASE OF EMERGENCY CALL
326-9200
AFTER HOURS 947-9900

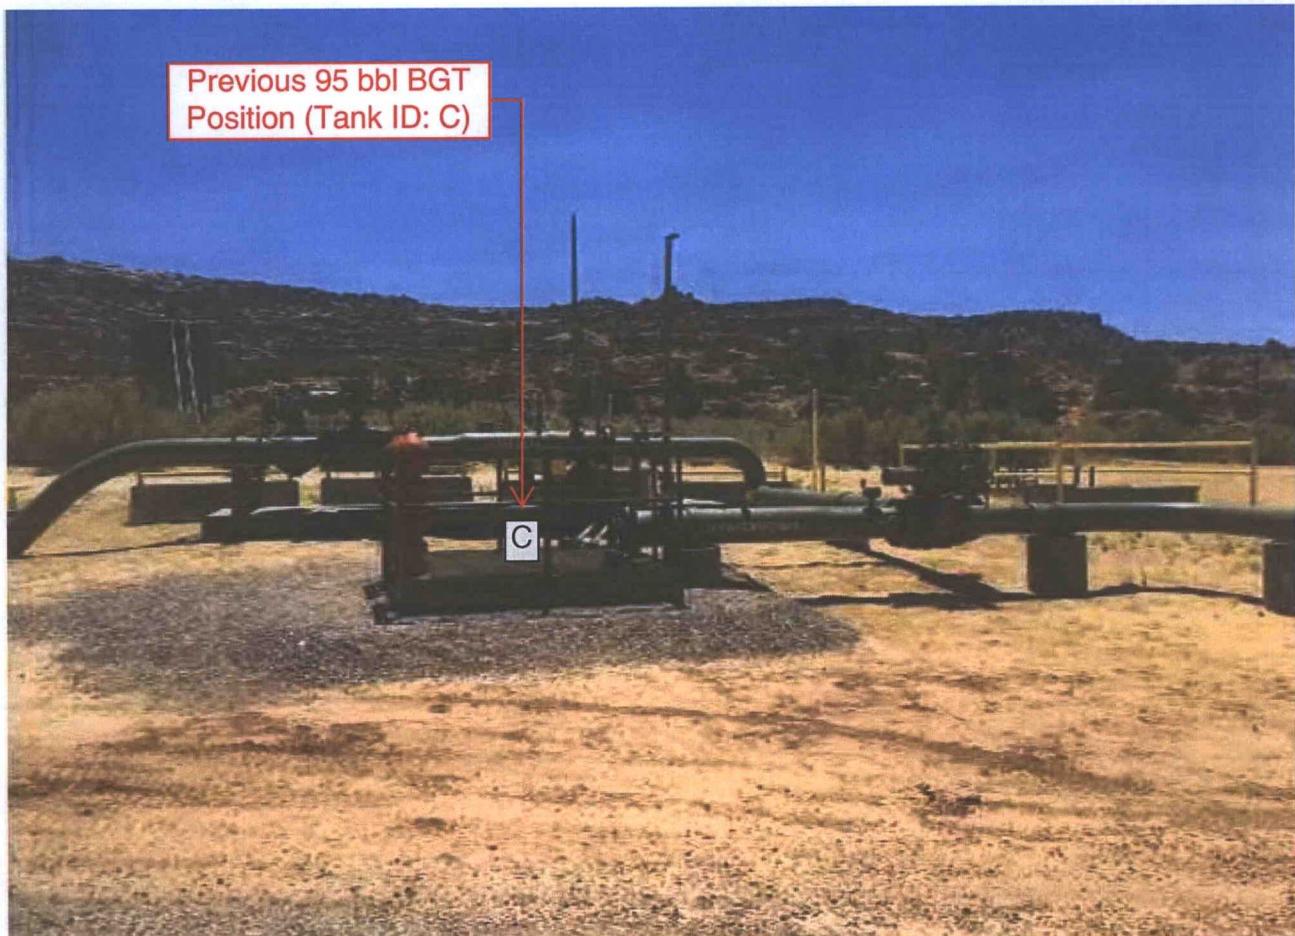
Previous 95 bbl BGT
Position (Tank ID: C)
