Release Notification and Corrective Action

Name of Company: Williams Four Corners LLC	Contact: Kijun Hong	
Address: 1755 Arroyo Dr., Farmington, NM 87413	Telephone No.: (505) 632-4475	
Facility Name: Sims Mesa Compressor Station	Facility Type: Glycol Dehydration Unit	
Surface Owner: BLM	Mineral Owner	BLM Project No. NMNM81378

Remediation Excavation and Sampling Form

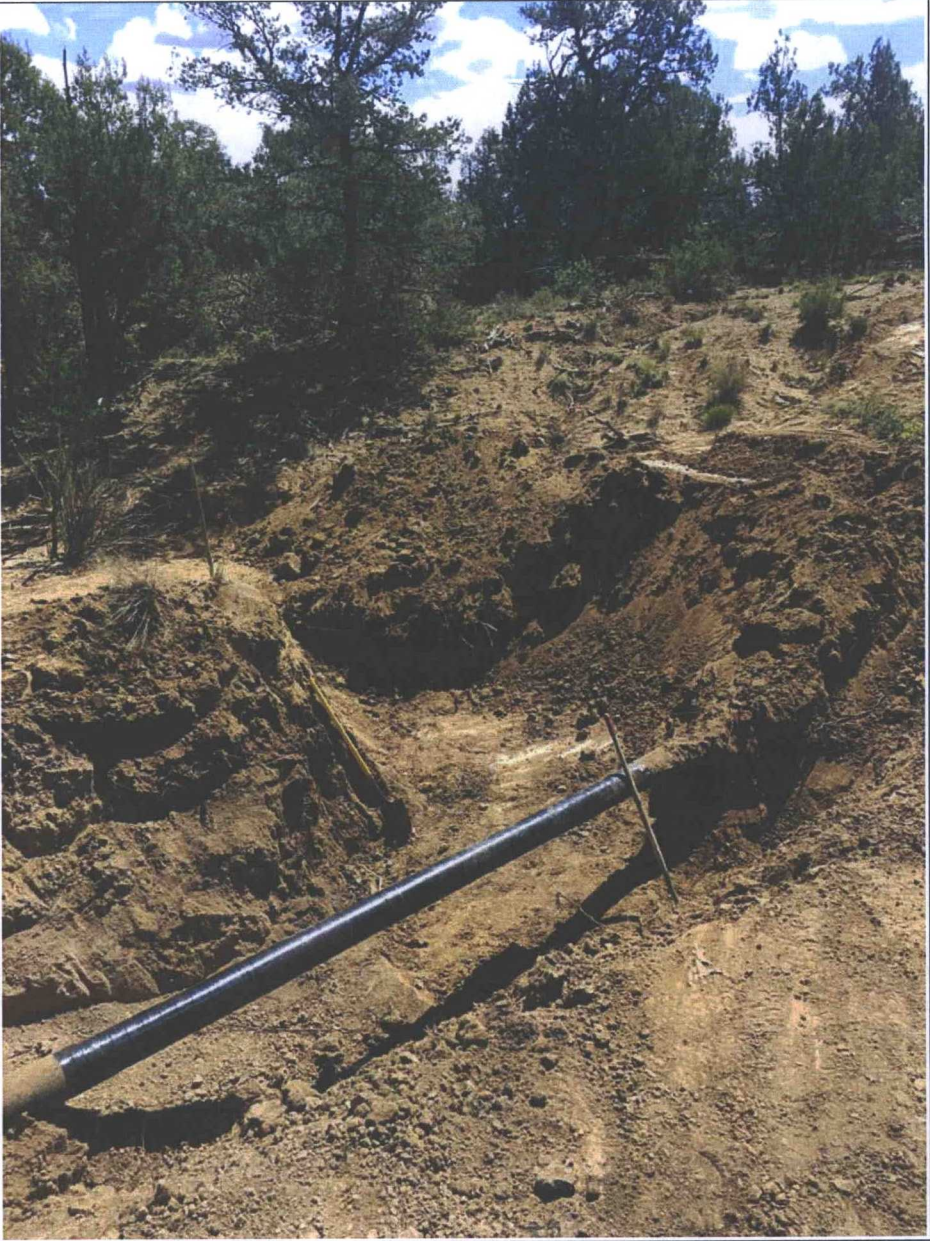
Photograph #1

Client: Harvest Four Corners, LLC	
Site Name: Lateral D-2 Pipeline Release	
Date Photo Taken: September 10, 2018	
Release Location: N36.504125, W107.303735 H-12-26N-5W Rio Arriba County, NM	Description: Facing east, view of remedial excavation and pipeline.

The excavation was backfilled with clean, imported soil following the receipt of laboratory analytical results.
