**Lateral 2C-116**  
**Release Closure Report**

Unit Letter L, Section 12, Township 24 North, Range 7 West  
Rio Arriba County, New Mexico

March 28, 2019

# **Enterprise Field Services, LLC Lateral 2C-116 Pipeline Release Closure Report**

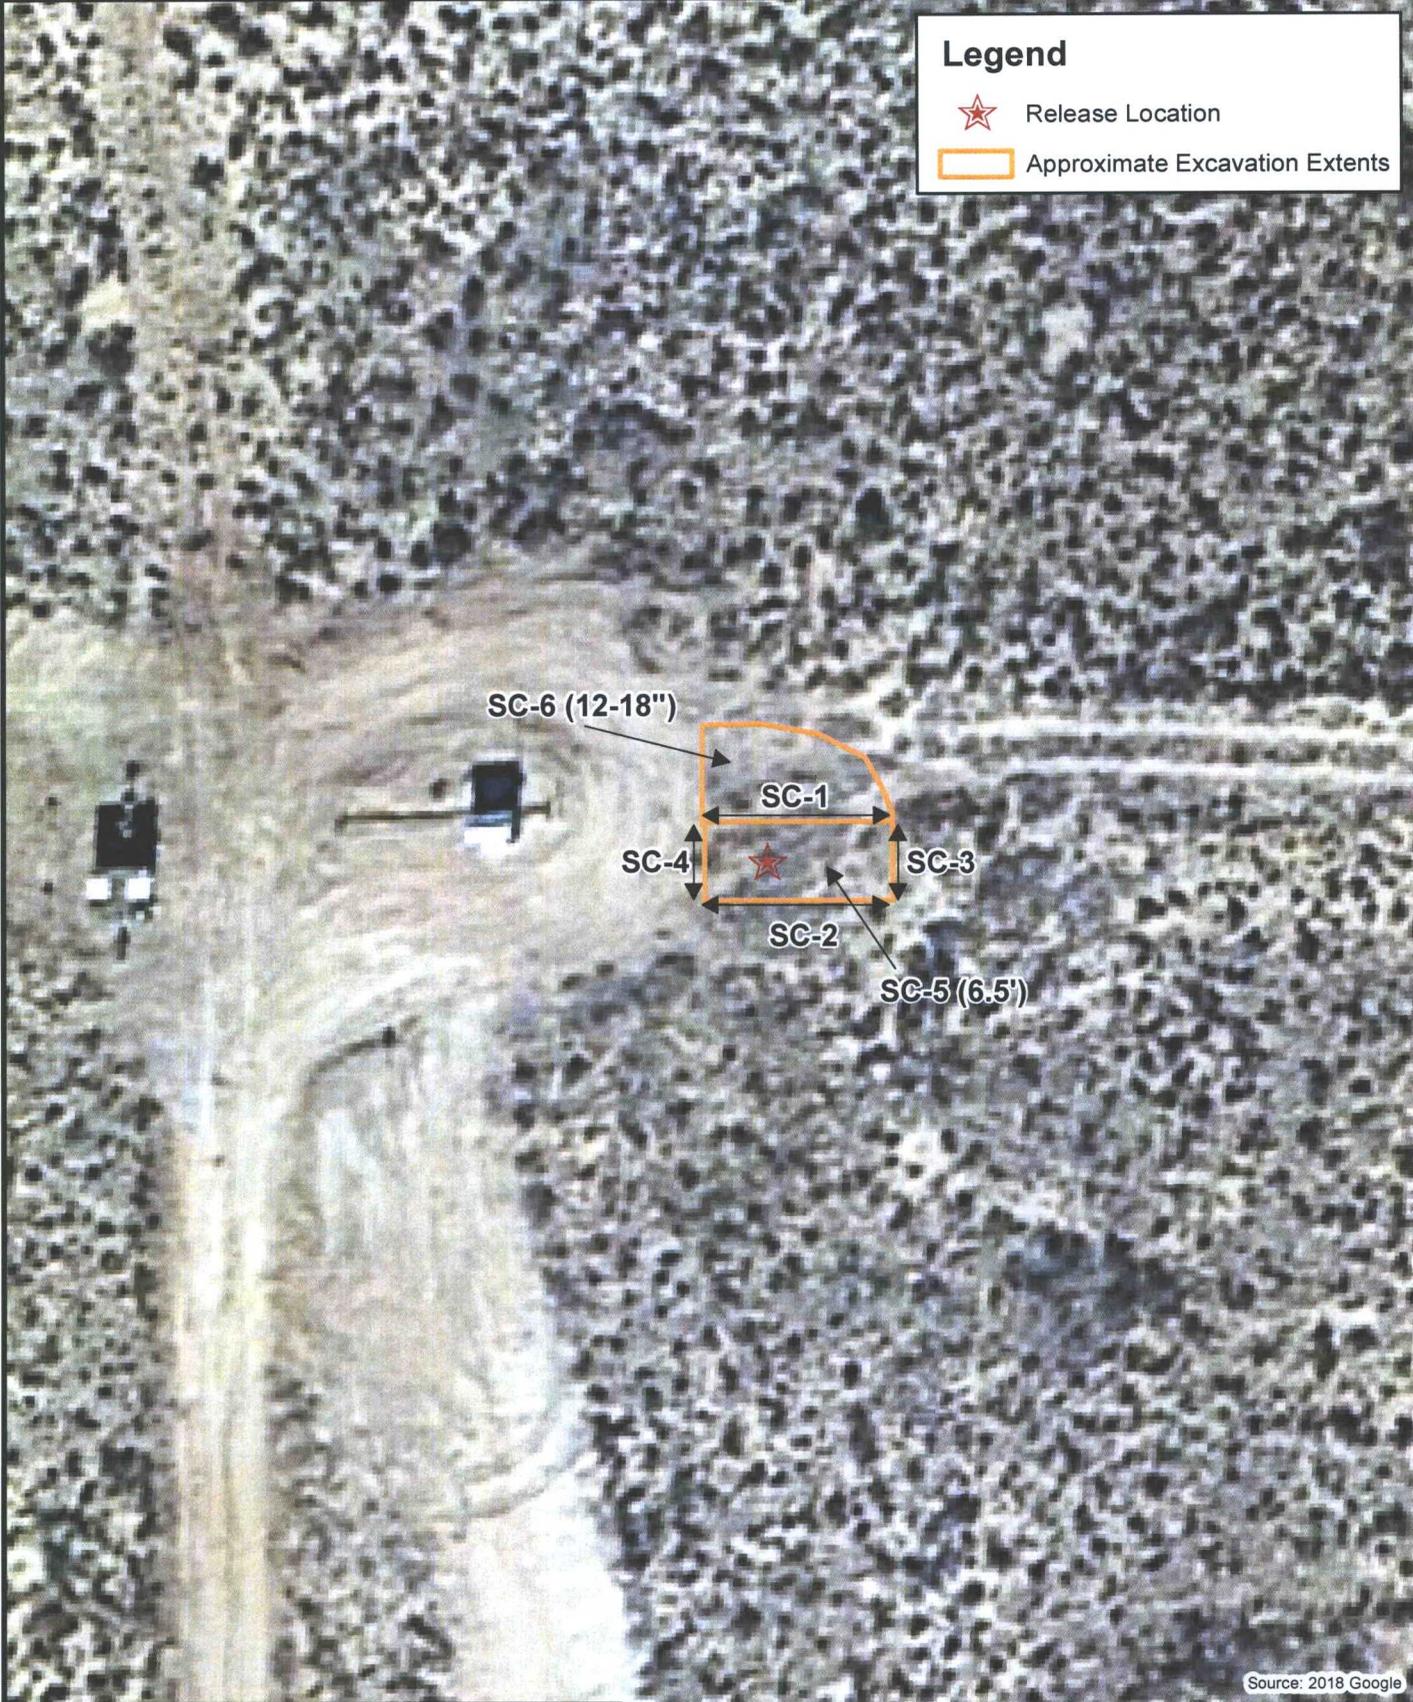
**Figure 2**  
**Aerial Site Map**  
Enterprise Lateral  
2C-116

A depiction of the excavation with sample locations is included as Figure 2. A copy of the executed C-138 Solid Waste Acceptance Form is included in Appendix C.

A depiction of the excavation extents with sample locations is included as Figure 2. A copy of the NMOCD correspondence containing the approval for shortened sampling

Laboratory analytical results are summarized in Table 1, confirmation sample locations are illustrated on Figure 2, and the analytical laboratory reports are included in Appendix E.

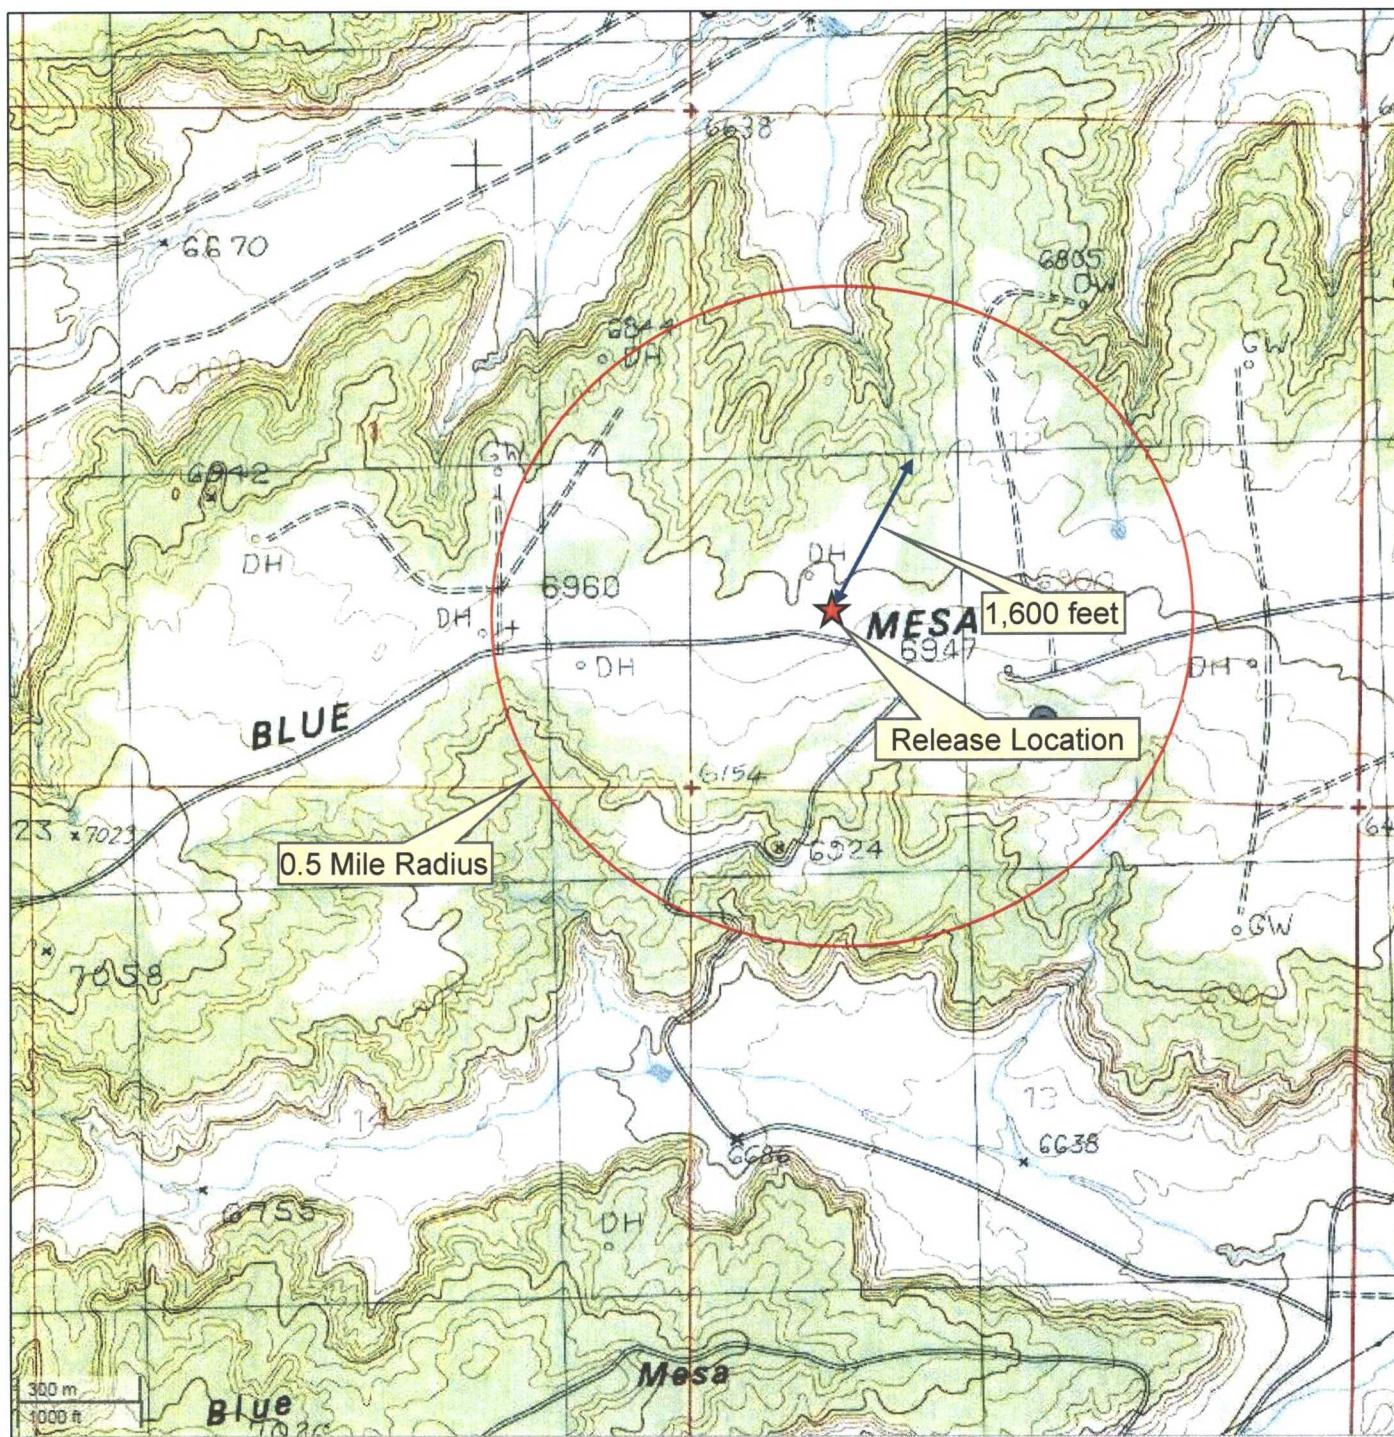
Hydrology Figure 1. Topographic Map

Depth to groundwater is anticipated to be greater than 100 feet below ground surface. The site is located on top of a sandstone mesa at an elevation of 6930 amsl. The shale bottom valleys surrounding the mesa are about 6700 amsl immediately adjacent to the cliff faces, therefore groundwater is anticipated to be at least 200 feet deep at the site.

There are no springs indicated on the topographic map and no increased vegetation cover on the aerial photo to suggest the presence of a spring within 0.5 mile of the site.

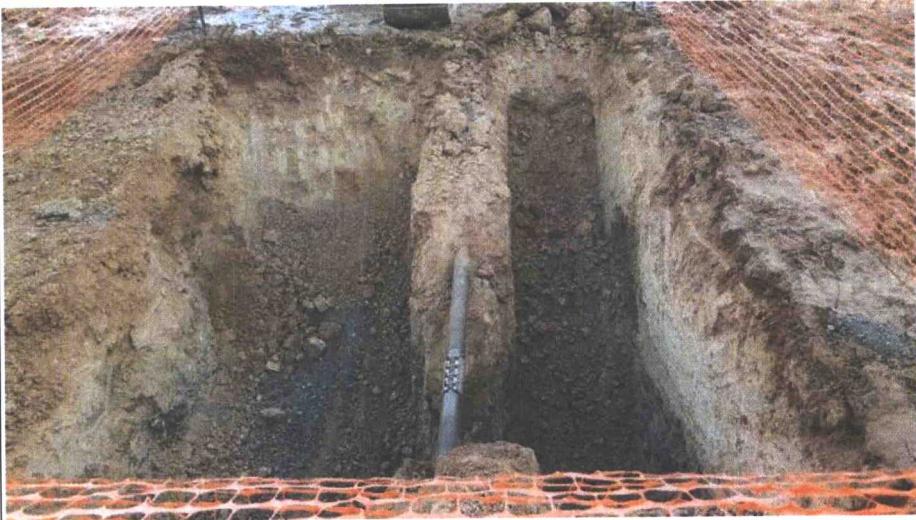
Photograph #1

Client: Enterprise	
Site Name:  Lateral 2C-116 Pipeline Release	
Date Photo Taken: January 17, 2019	
Release Location: N36.32380, W107.53279  L-12-24N-7W Rio Arriba County, NM	
Photo Taken by: Heather Woods	
Description: Facing east, view of the final excavation extents.

On January 17, 2019, Enterprise completed repair activities at the location. OFT provided heavy equipment operation and repair support. Rule Engineering, LLC (Rule) personnel provided excavation guidance and collected confirmation samples from the resultant excavation. Approximately 74 cubic yards of hydrocarbon impacted soils were removed from the remedial portion of the excavation measuring approximately 22 feet by 11 feet by 6.5 feet in depth. A shallow, irregularly shaped excavation immediately north of the repair excavation measured approximately 22 feet by 11 feet by 12 to 18 inches in depth.

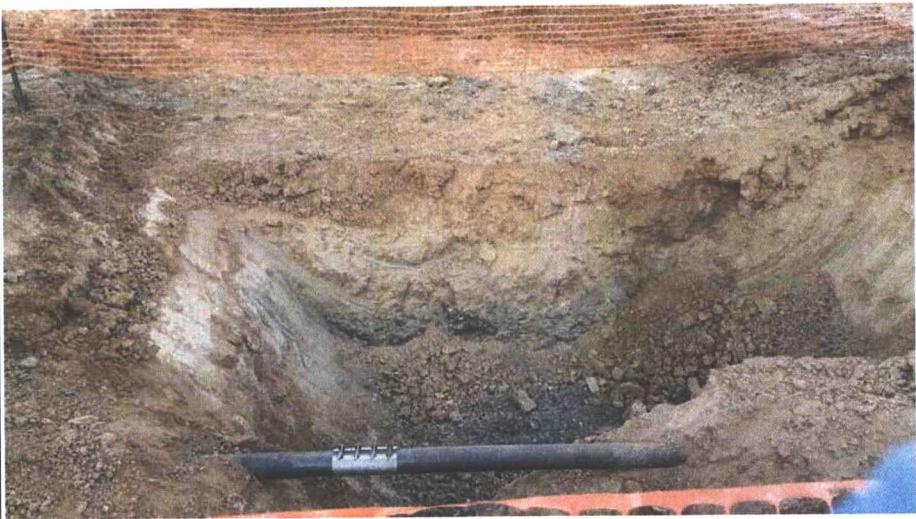
Photograph #2

Client: Enterprise	
Site Name:  Lateral 2C-116 Pipeline Release	
Date Photo Taken: January 17, 2019	
Release Location: N36.32380, W107.53279  L-12-24N-7W Rio Arriba County, NM	
Photo Taken by: Heather Woods	
Description: Facing north, view of the final excavation extents, including shallow excavation to the north of main excavation.
