## Release Notification

Site Name	<b>Lateral H-21</b>	Site Type	<b>Pipeline</b>
Date Release Discovered	<b>3/12/2019</b>	API# (if applicable)

Harvest Four Corners, LLC (Harvest) presents the following report summarizing remediation and soil sampling activities at the Lateral M-3 Launcher (Site) located in Unit P, Section 6, Township 30 North, Range 4 West, in Rio Arriba County, New Mexico (Attachment 1). On January 2, 2019, Harvest damaged an unmarked polyethylene pipeline containing produced water during excavation while conducting maintenance on a pig launcher. The polyethylene pipeline is owned by Southland Royalty Company and was not marked appropriately prior to the excavation. Approximately 8 barrels (bbl) of produced water were released and all 8 bbl were recovered with a vacuum truck. Harvest submitted a Release Notification and Corrective Action Form C-141 to the New Mexico Oil Conservation Division (NMOCD) on January 17, 2019. The NMOCD assigned the release incident number NVF1902432312.

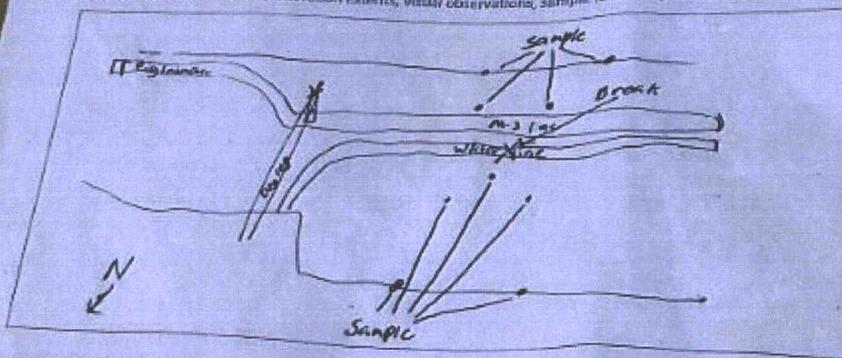
Excavation Diagram and Sample Locations

(Depict notable site features, excavation extents, visual observations, sample locations, north arrow, etc.)

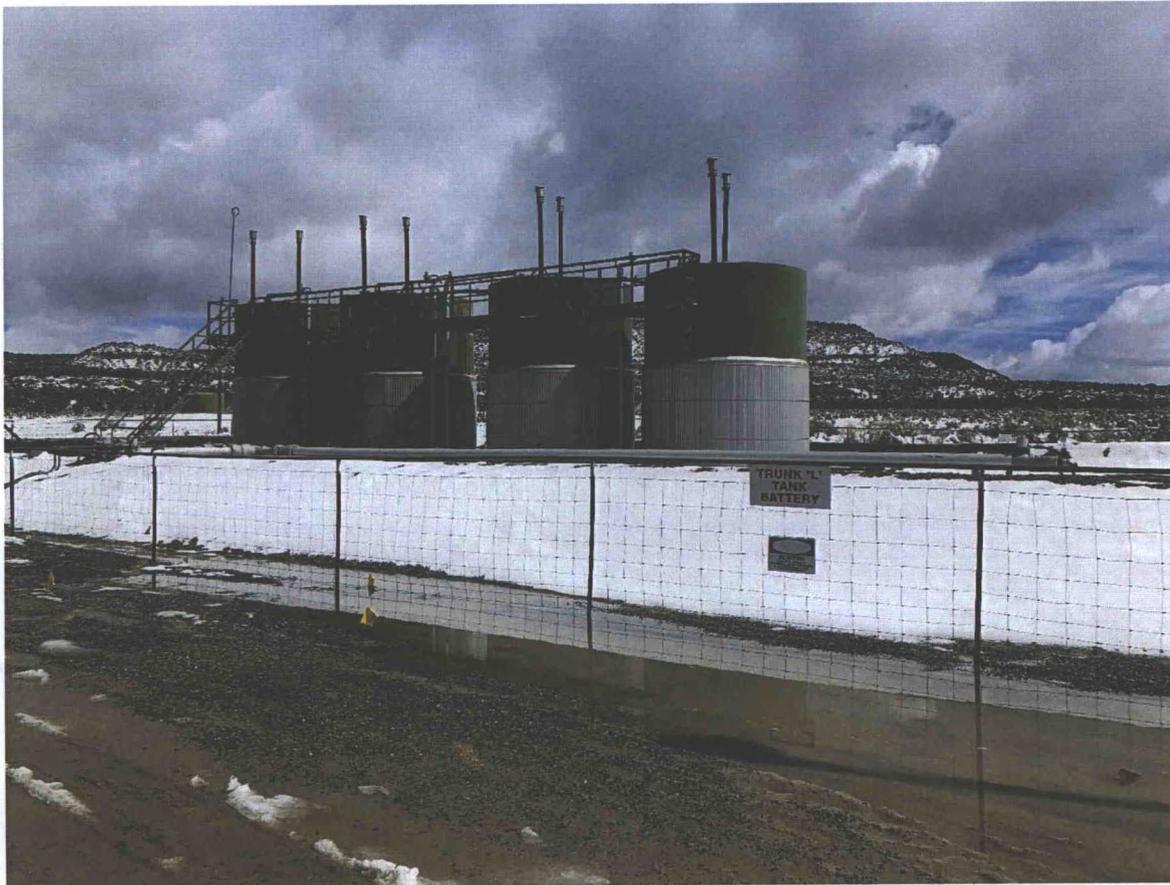
Project: 090319022	Trunk L Tank Battery – View looking east at tank battery

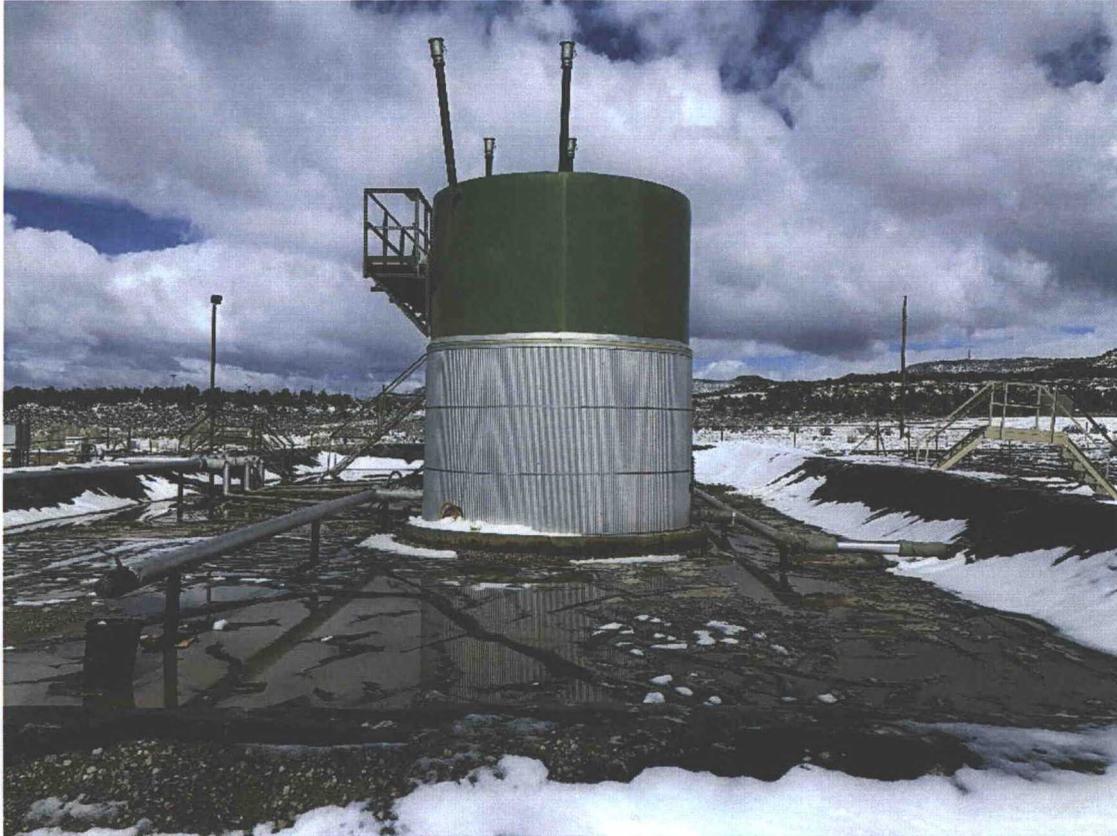
Project: 090319022	Trunk L Tank Battery – View looking northeast at tanks inside lined berm

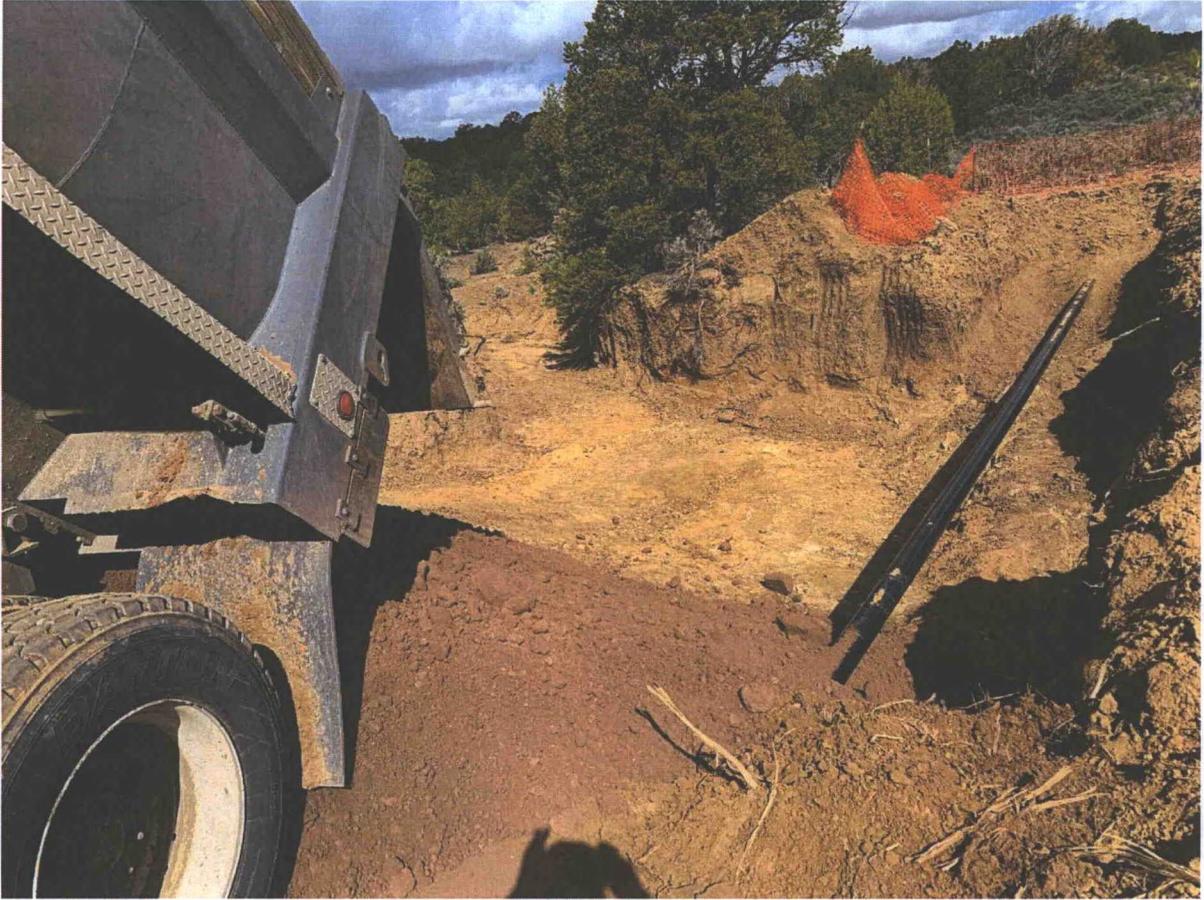
View of excavation during pipeline repair.
