# CLOSURE REPORT

## STATE C-20 BATTERY RELEASE SITE

**REF: 150006**

**LEA COUNTY, NEW MEXICO**

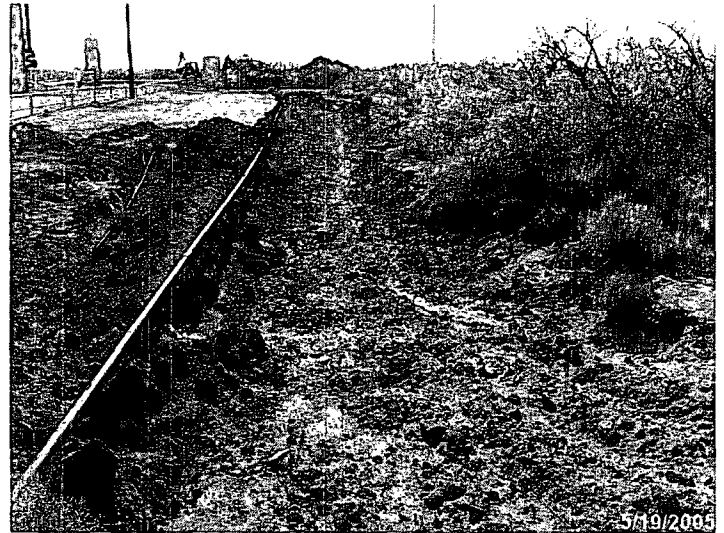
Photo #4: Excavation, looking easterly.
