SITE CHARACTERIZATION

JULIO STATE #1 RELEASE SITE

EPI REF: #160052

LEA COUNTY, NEW MEXICO

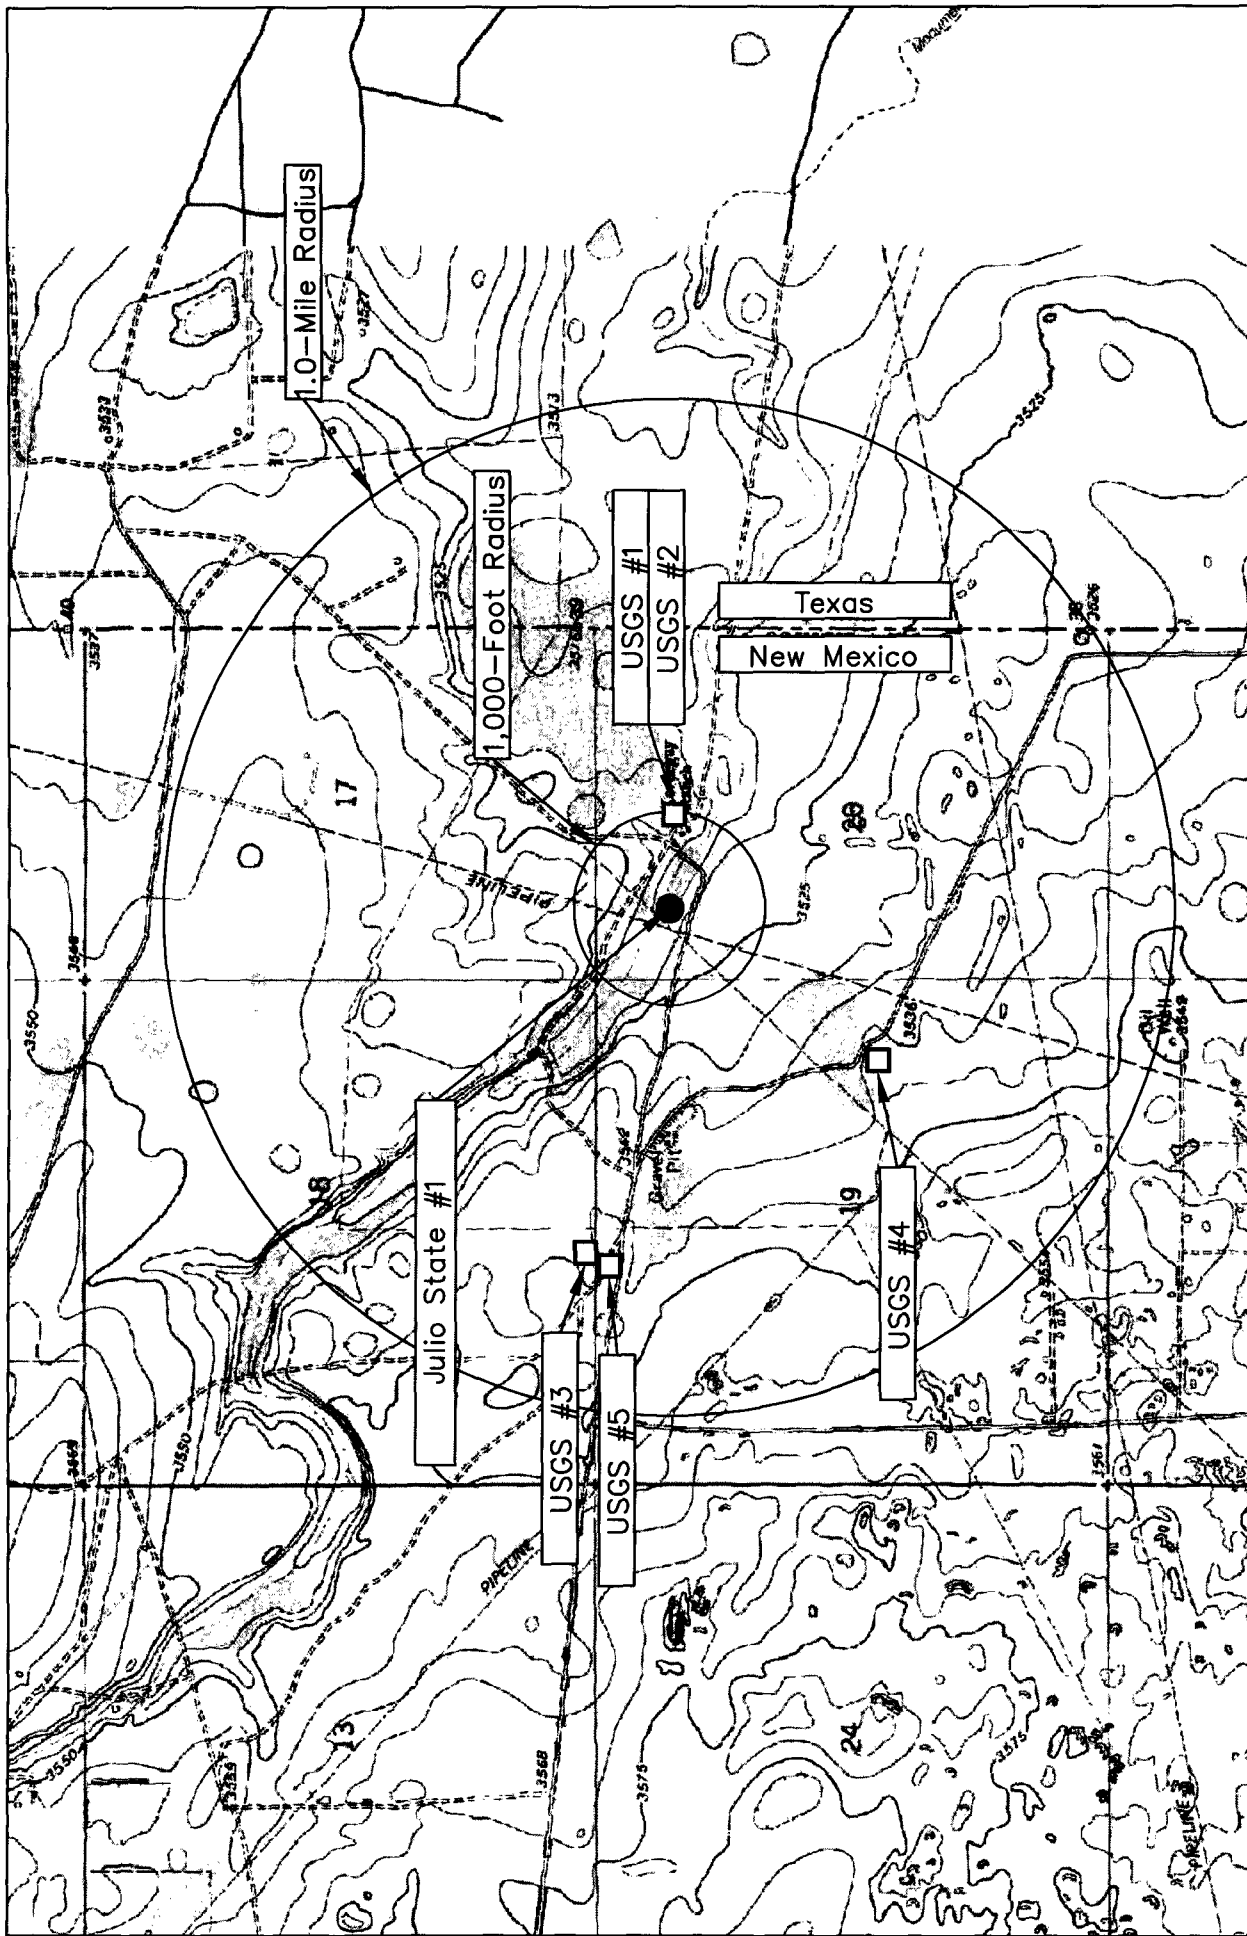
<p>Figure 2 Site Location Map Chesapeake Energy Julio State #1</p>	<p>Lea County, New Mexico NW 1/4 of the NW 1/4, Sec. 20, T20S, R39E N 32° 33' 49.44" W 103° 04' 26.54" Elevation: 3,515 feet amsl</p>	<p>DWG By: Daniel Dominguez March 2006</p>	<p>REVISED:</p>	<p>4,000 2,000 0</p> <p>Feet</p> <p>SHEET 1 of 1</p>

- 2.9** *Area Water Wells*
There are two water supply wells located within a 1,000-foot radius of the release site as indicated by USGS water well data. However, there are no private, domestic fresh water wells or springs used by less than five households for domestic or stock watering purposes located within a 200-foot radius of the release site (reference *Figure 2*).

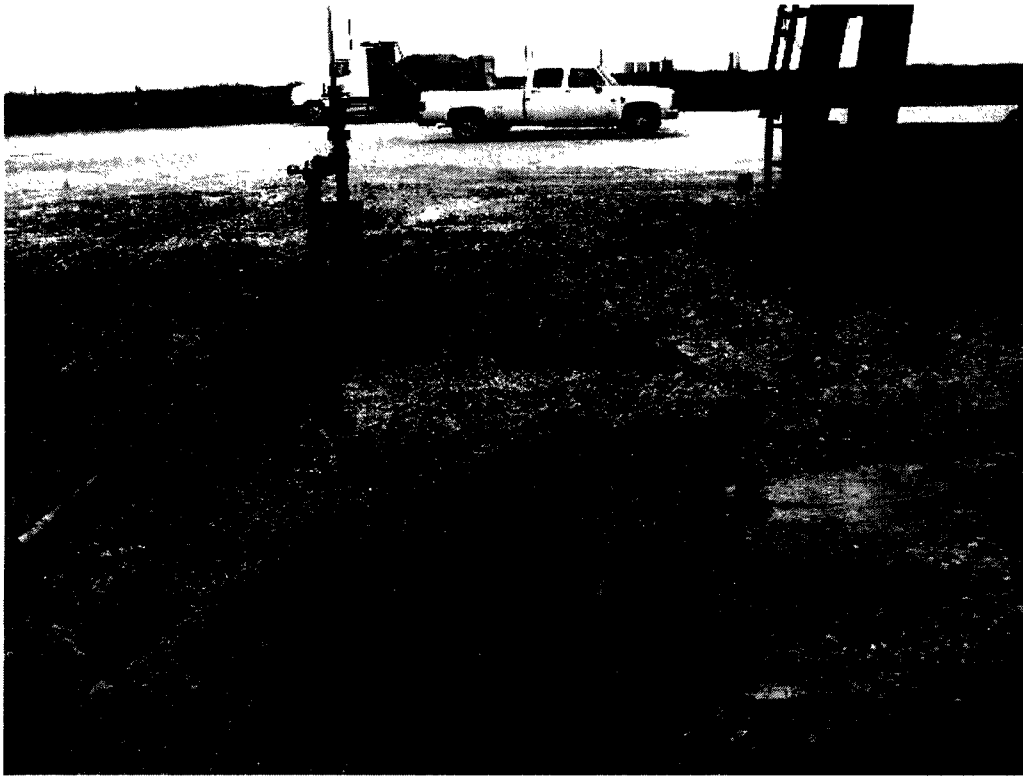
Photograph #5 – Excavation area looking westerly.

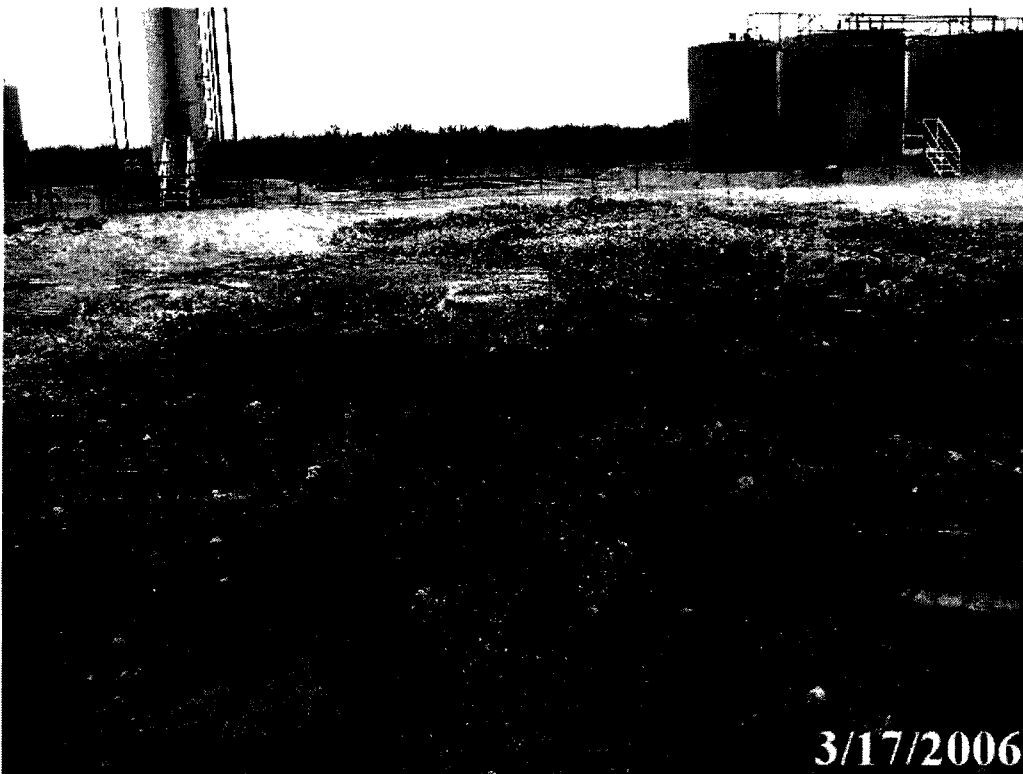
Photograph #6 – Excavation area looking southerly.
