Closure Report

2 RP-1035

Saber Resources
F M Hollyway S W D # 1

Incident - n PAC0628637724
Application - p PAC0628637817

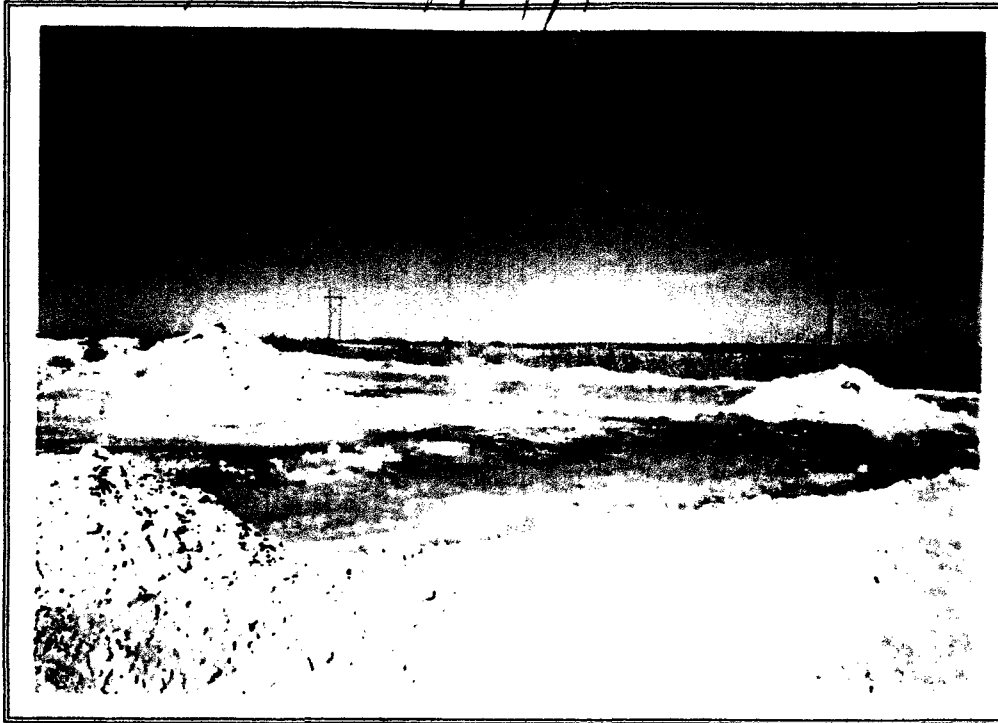
39. F.M. Holloway #1 SWD Facility - diked spill area, east of facility.

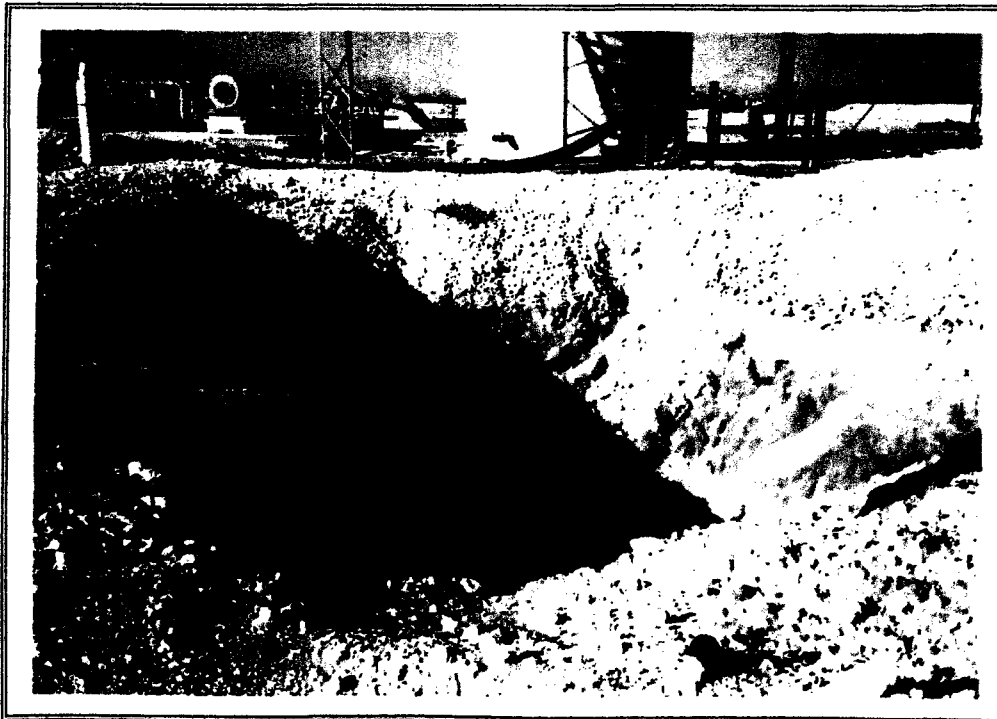
40. F.M. Holloway #1 SWD Facility - trench open hole at southwest corner of diked spill area.

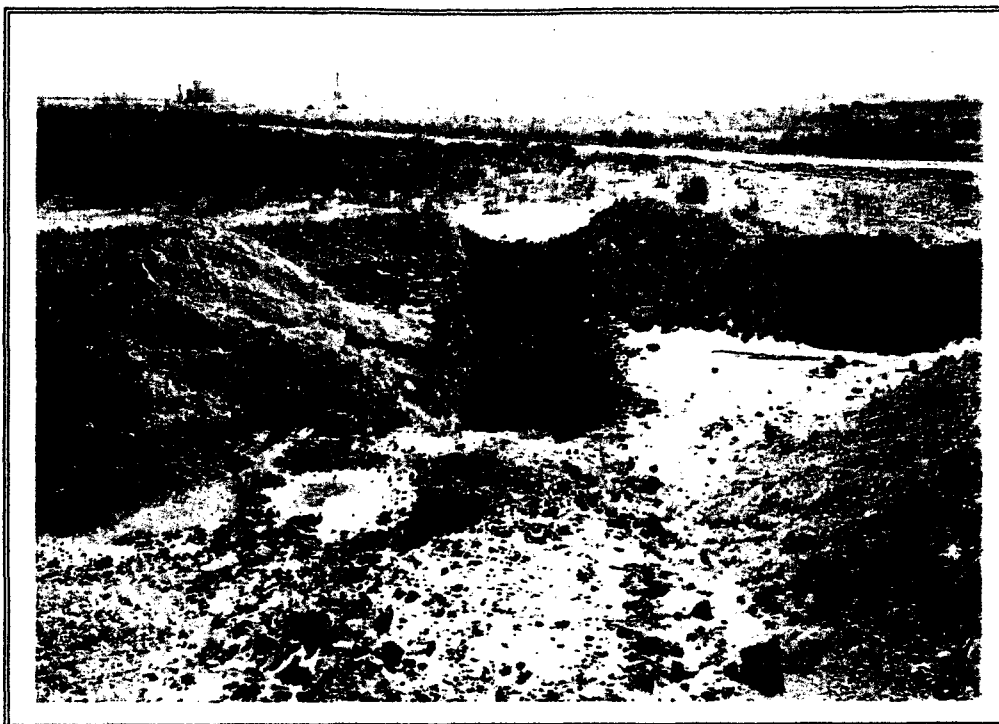
41. F.M. Holloway #1 SWD Facility - trench hole,
at southeast corner of diked spill area.

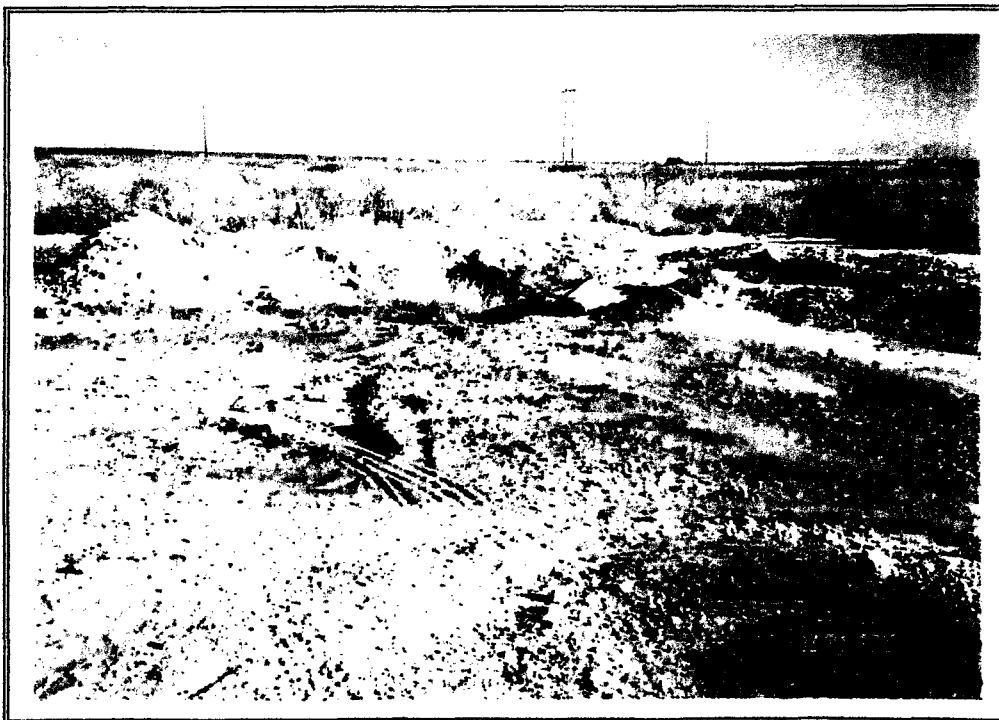
42. F.M. Holloway #1 SWD Facility - trench hole,
at northeast corner of diked spill area.

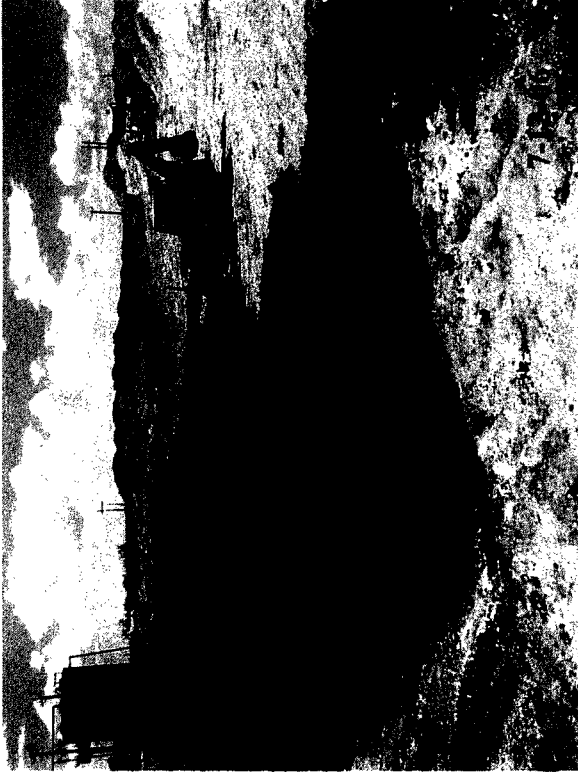
Mixing Clay for Liner

Joe backfilling to put in liner, Then started blending. Javier putting in liner.

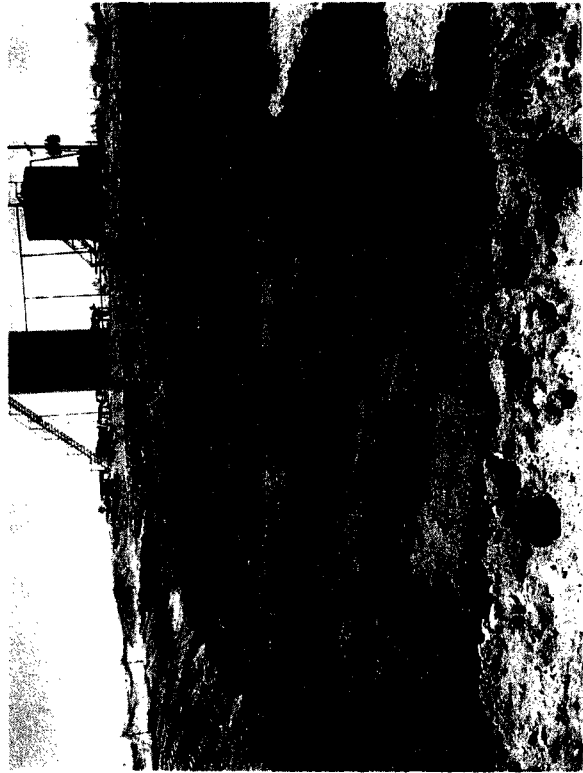
Putting in Liner

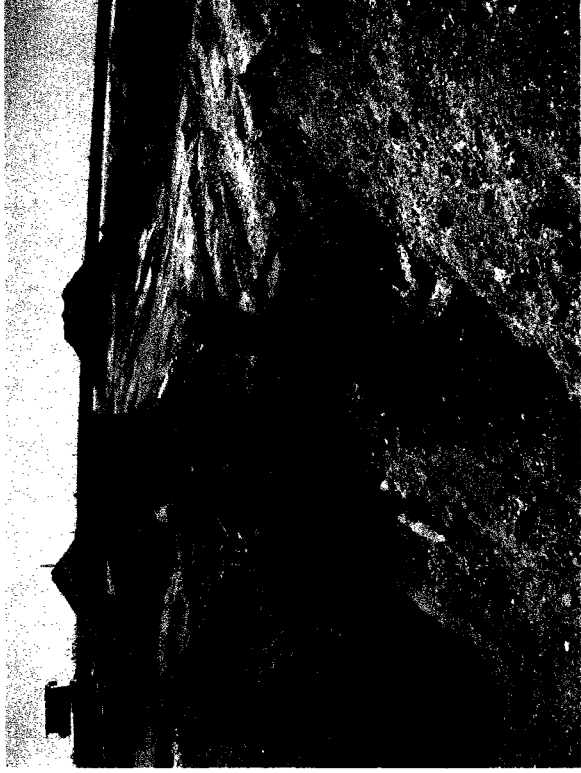
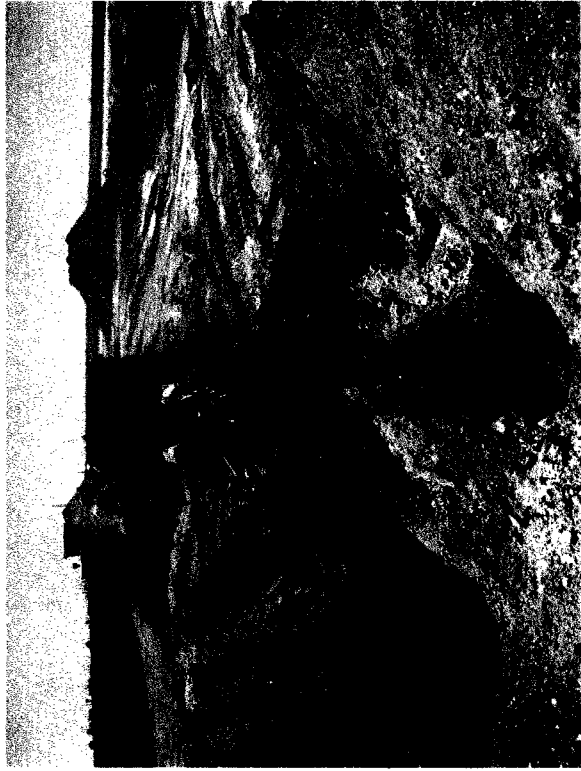
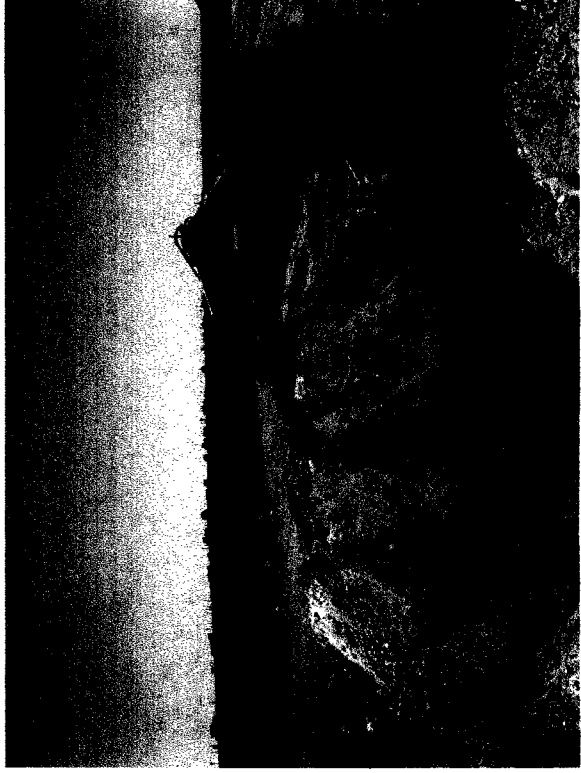
Excavating Clean to Blend with Contaminated Soil
