# **CLOSURE REPORT**

## **TT-1 PIPELINE**

**1RP # 1138**  
**COMPANY NO. 36785**  
**EPI REF: 130047**

**LEA COUNTY, NEW MEXICO**

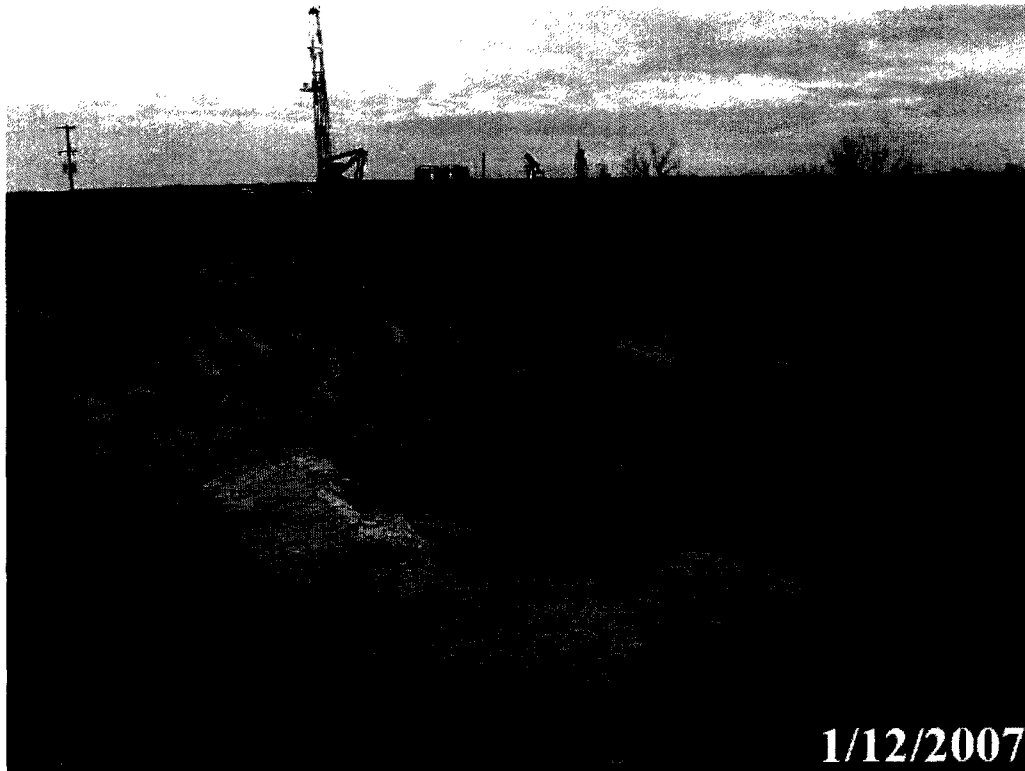
*Photo #3:* Looking southerly across western excavation area.
