**GW - 022**

**Re: Sulfur Plant Demolition and Sampling Report, Frontier Field Services, LLC,  
Empire Abo Gas Plant, (GW-022), Unit I (NE/4, SE/4), Section 3, Township  
18 South, Range 37 East, Eddy County, New Mexico**

Frontier Field Services - Empire ABO  
Sulfur Recovery Area Soil Analytical Data Summary

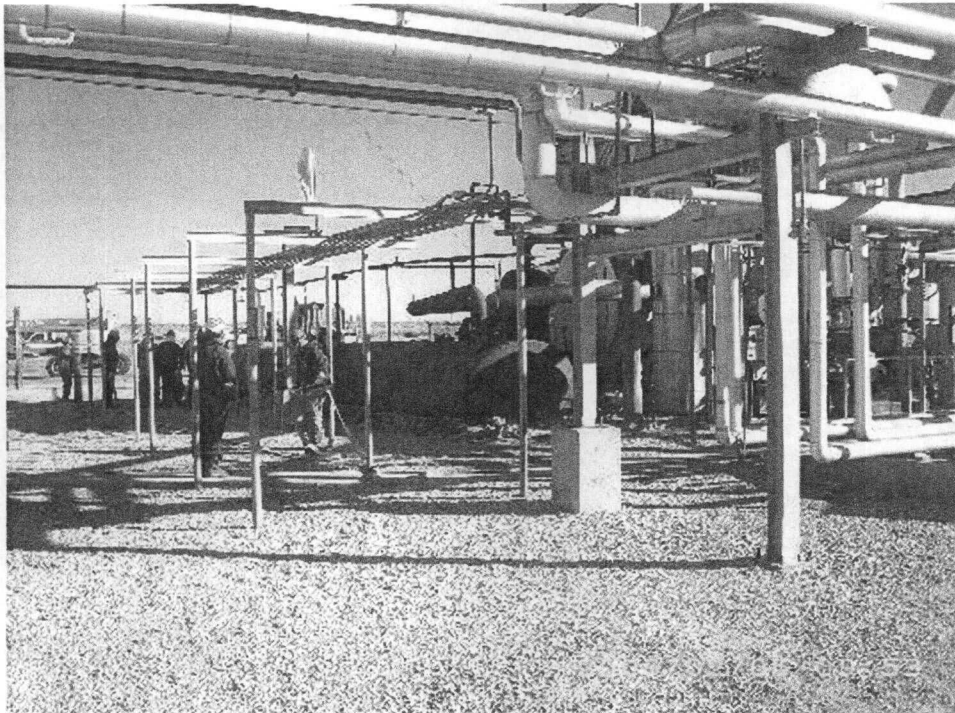
**Sulfur Tank (Prior to Removal) Looking North**

On February 5, 2009, Watson Construction Company (Watson) was contracted by Frontier to remove the tank and equipment. Once removed, LAI personnel collected soil samples from beneath the tank and equipment. A 3-part composite sample was collected beneath the tank (SS-A, 0-1'), and a 5-part composite sample (SS-B, 0-1') was collected beneath the equipment. A background sample (SS-C, 0-1') was also collected from an undisturbed area north of the Facility. The samples were placed in glass laboratory containers, sealed, chilled in an ice chest and delivered under chain of custody control to DHL Analytical (DHL) located in Round Rock, Texas. DHL analyzed the samples for pH, moisture percent, and total petroleum hydrocarbons (TPH) including gasoline range organics (GRO) and diesel range organics (DRO). The laboratory method included SW-846-9045C (pH), D-2216 (moisture percent), SW-846-8015V (GRO) and SW-846-8015D (DRO). The background sample was analyzed for pH only. A stainless steel trowel was used to collect the samples and was thoroughly cleaned between uses with a solution of potable water and laboratory-grade detergent and rinsed with distilled water. The tank and out-of-service equipment was placed in a temporary salvage area near the southeast corner of the Facility pending transport to a metal recycler. Table 1 presents a summary of the laboratory results. Appendix B presents the laboratory report. Appendix C presents photographs.

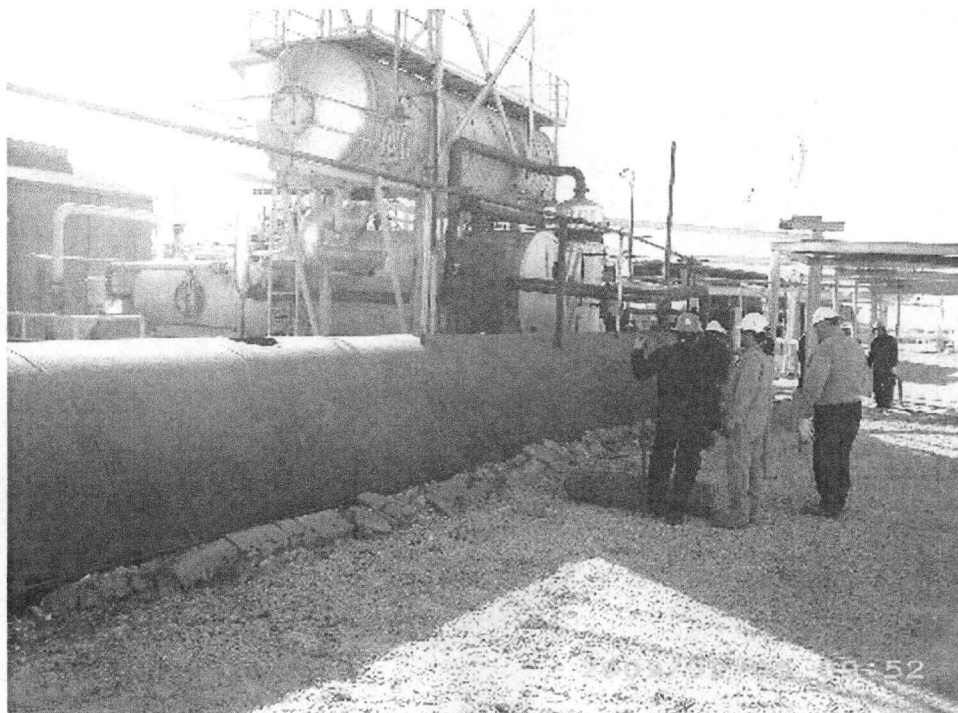
**Sulfur Tank (Prior to Removal) Looking South**

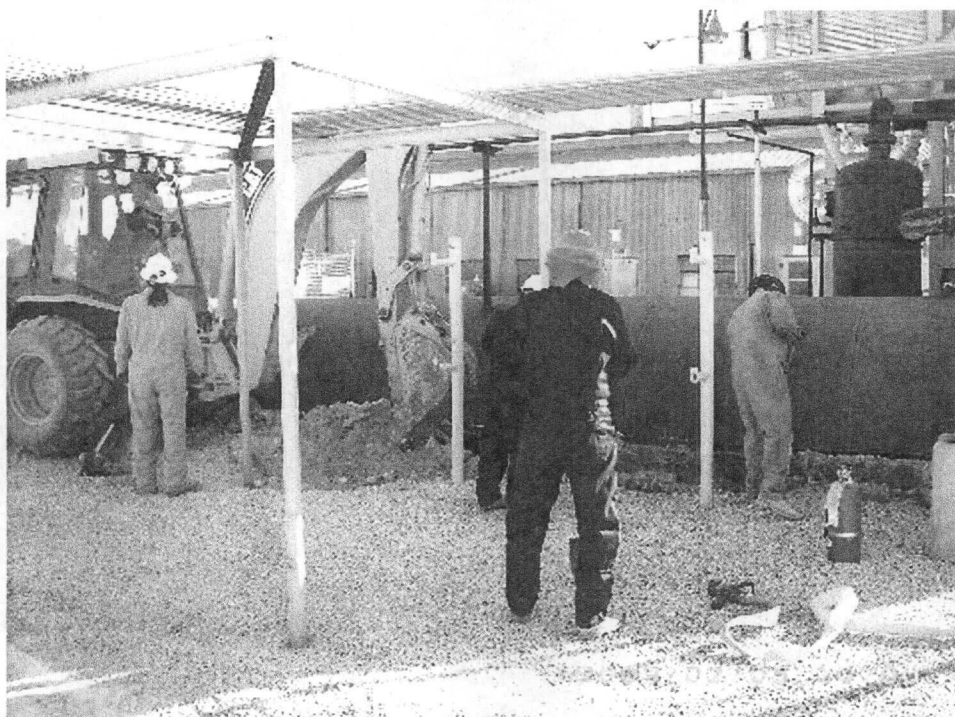
Trenching at Base of Sulfur Tank Looking North

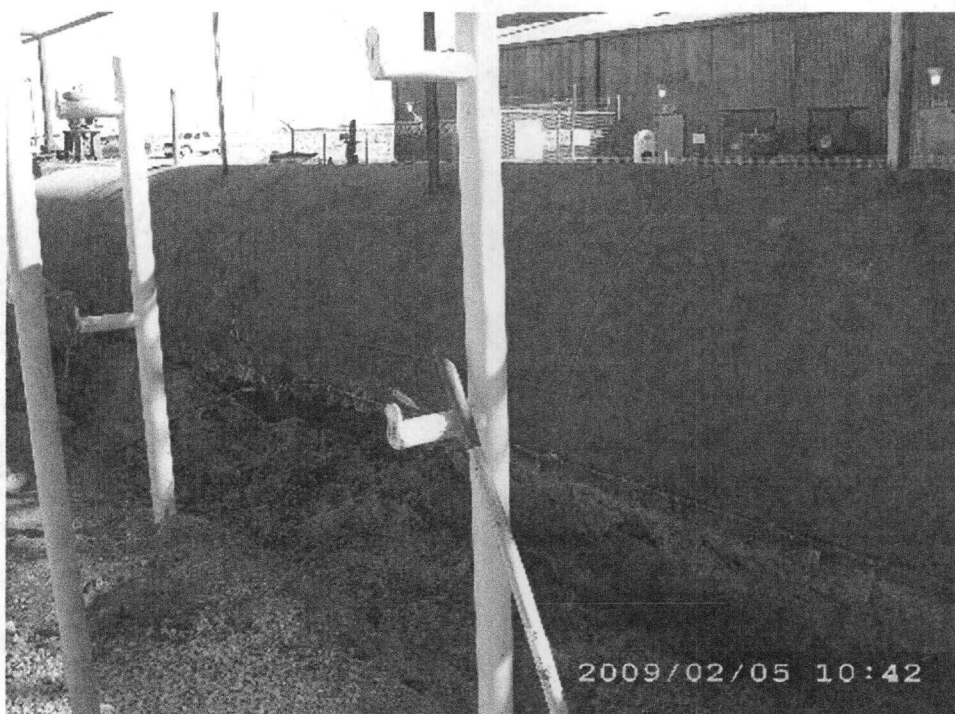
Exposed Sulfur Tank Looking North

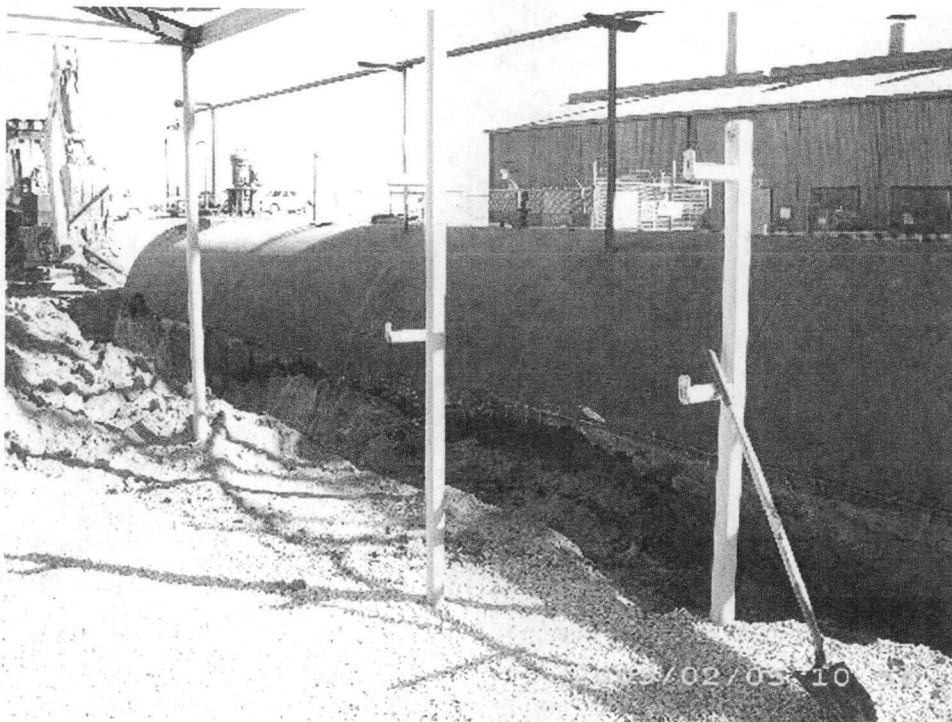
Exposed Sulfur Tank Looking North

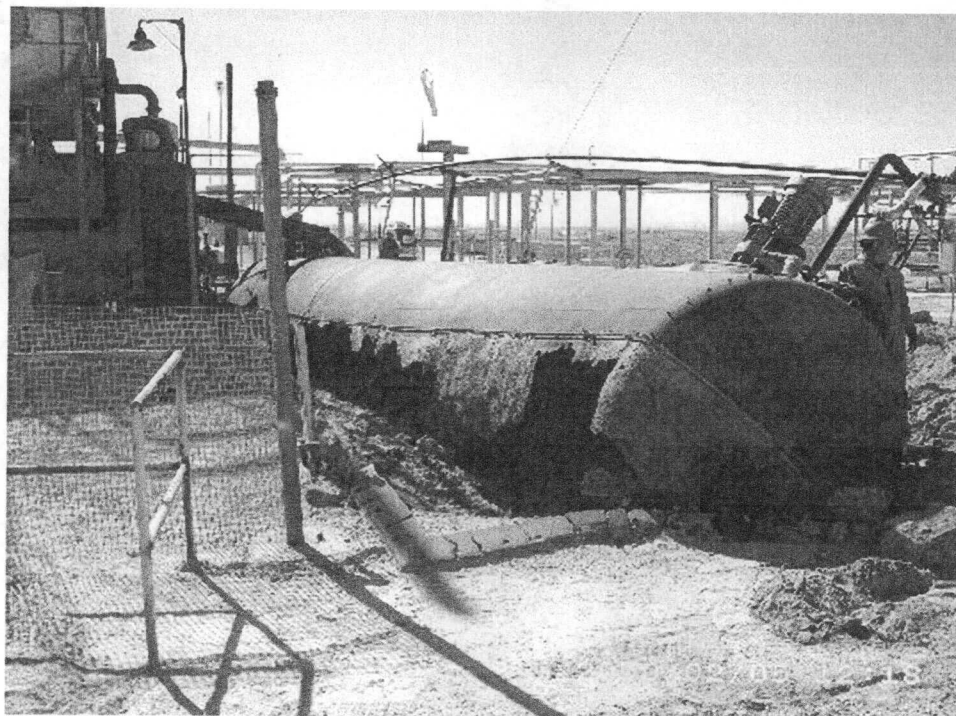
Sulfur Tank Removal Looking Southwest

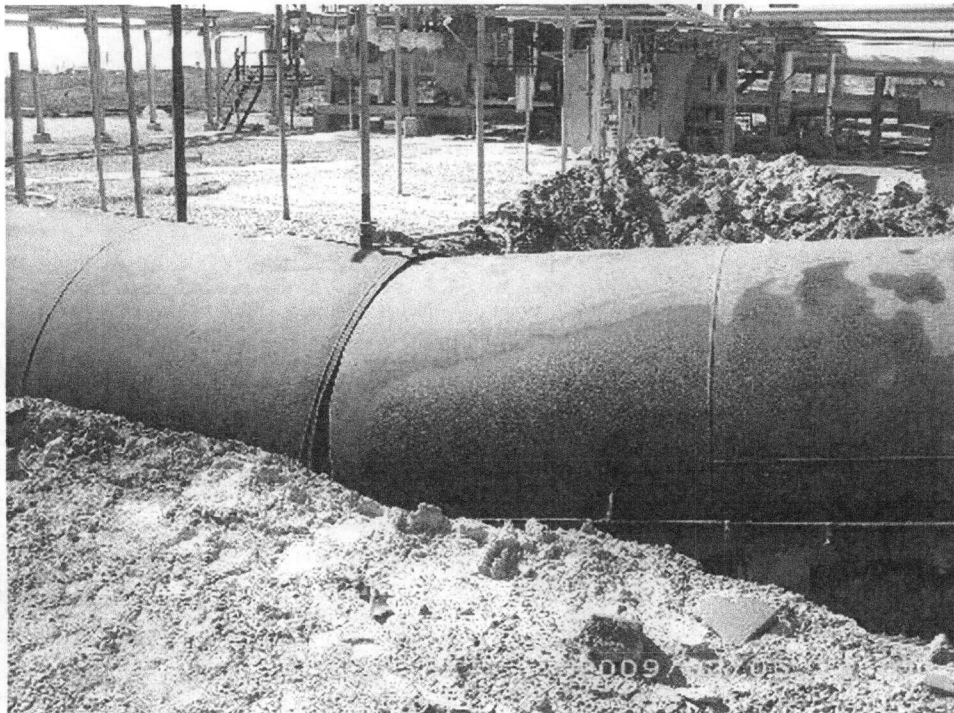
Sulfur Tank Removal Looking Southwest

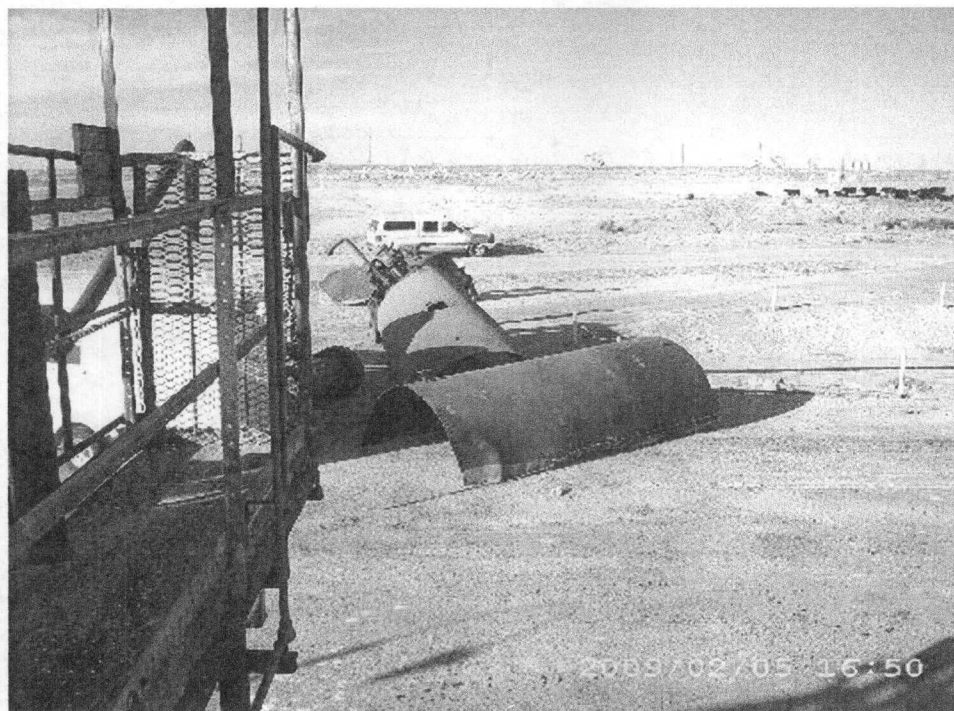
Removed Sulfur Tank Looking North

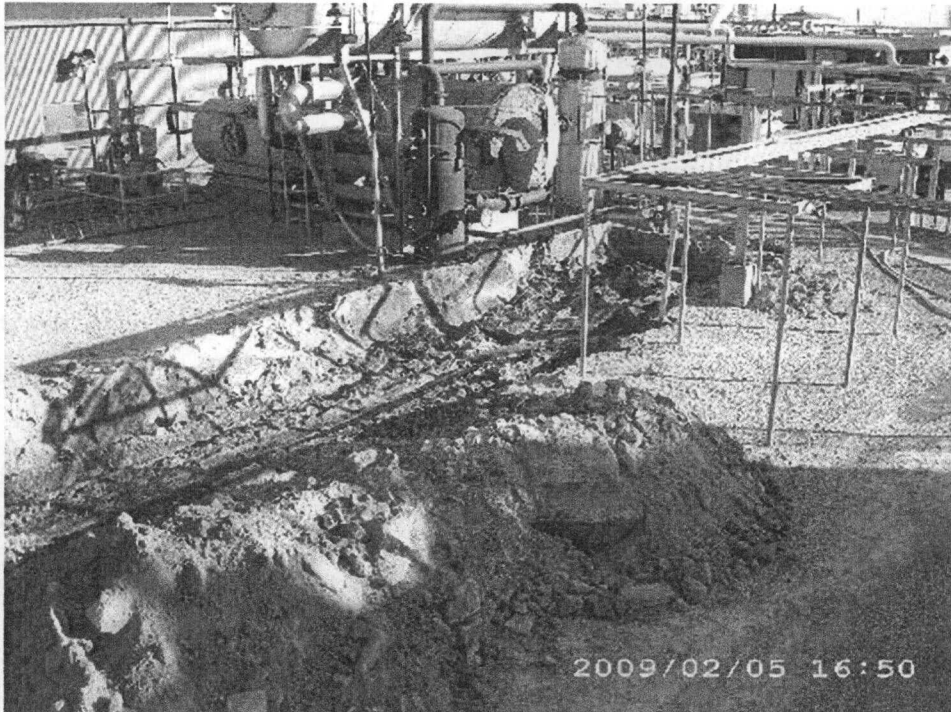
**Sulfur Tank Excavation Looking Southeast**

Referring to Table 1, the pH balance of samples SS-A and SS-B was 6.8 and 7.15 standard units (S.U.), respectively. The pH of the background sample was 7.54 S.U. The TPH in sample SS-A was 164 milligrams per kilogram (mg/Kg) and 256 mg/Kg in sample SS-B. The tank excavation was filled with crushed caliche.

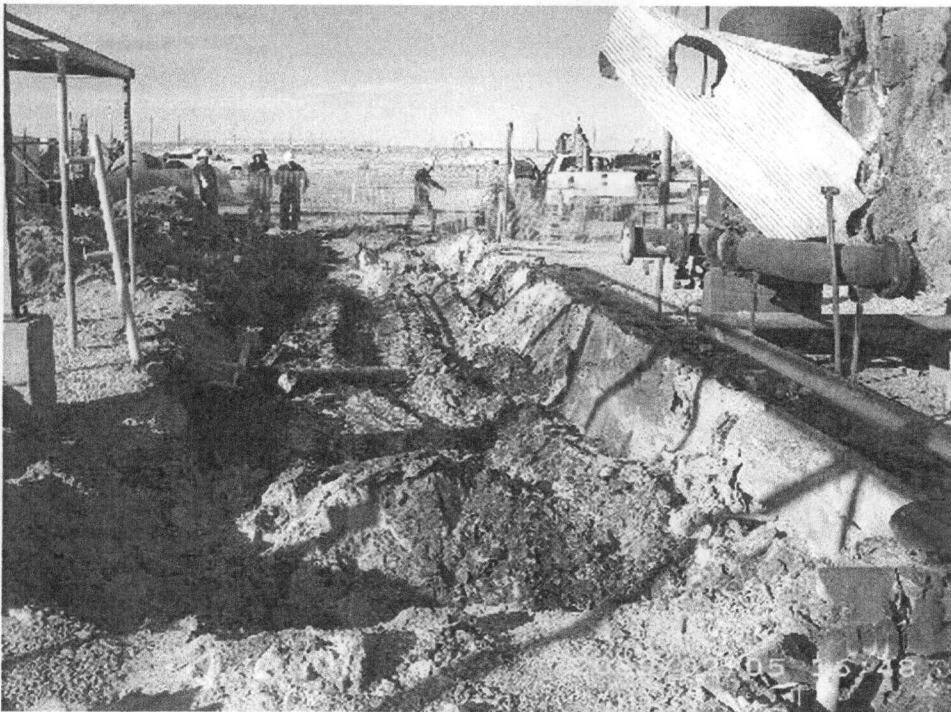
**Sulfur Tank Excavation Looking North**

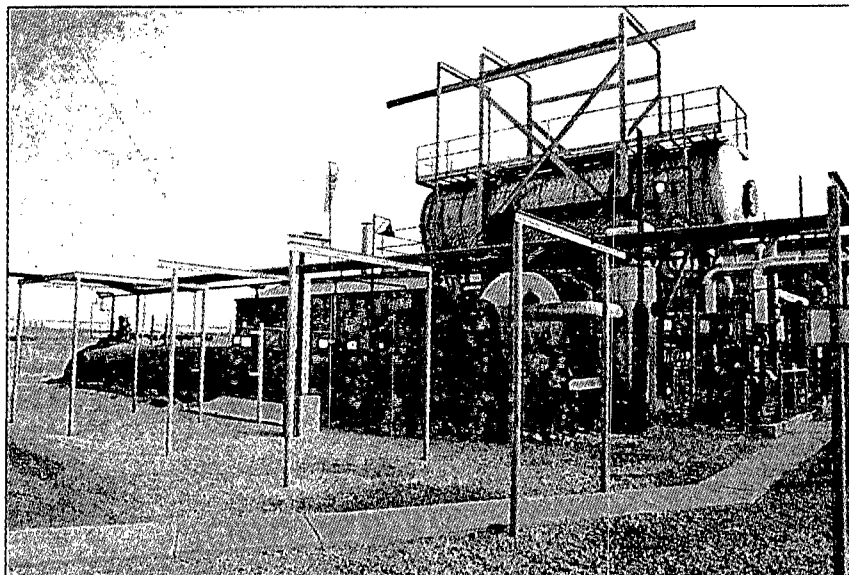
Sulfur Recovery Equipment , Frontier Field Services,  
Empire Abo Gas Plant, Looking Northeast, January 23,  
2009

The sulfur recovery equipment is located near the northwest corner of the Facility and has been out of service for about 20 years. The process includes a boiler, sulfur recovery equipment and storage tank. The storage tank was partially buried and was used to store molten sulfur. The tank is constructed of single walled steel about 6 feet in diameter and about 25 feet in length. The lower portion of the tank is buried beneath the surface. There is no leak detection or secondary containment equipment. Placards on the equipment state that no asbestos containing material (ACM) is present. Appendix A presents photographs.

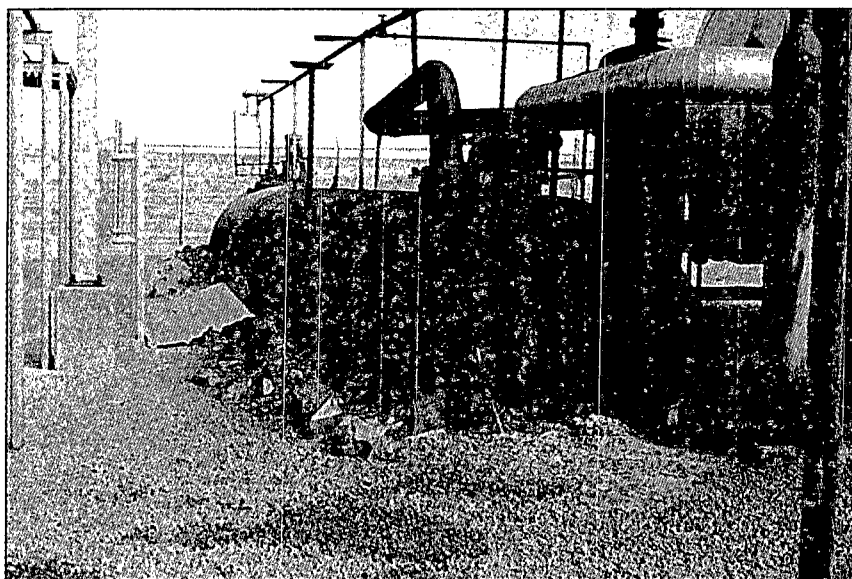
Sulfur Recovery Tank, Frontier Field Services, Empire  
Abo Gas Plant, Looking North, January 23, 2009
