**RE: Investigation and Characterization Plan
Rice Operating Company – Vacuum SWD
State P EOL T 17S R 35E Section 26 Unit A**

Appendix A – Junction Box Disclosure Report

Appendix B – Photo chronology.

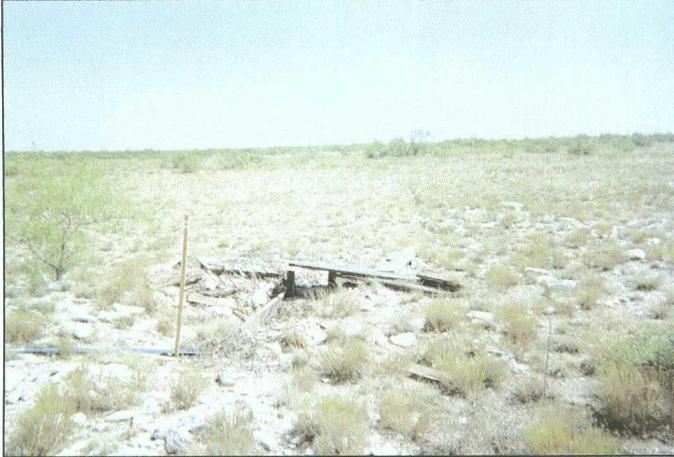
Junction box prior to excavation: 7/11/2005

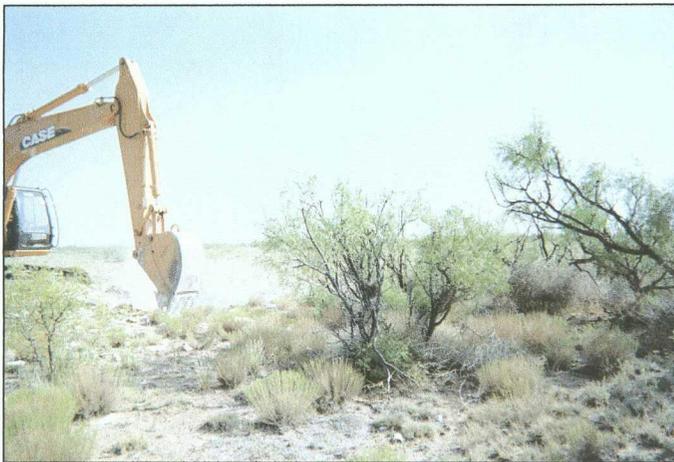
Beginning delineation with trackhoe: 8/2/2005

General Description of Remedial Action: This junction box was addressed as part of the abandonment of the Vacuum SWD system. After the box lumber was removed, the site was delineated using a trackhoe to collect soil samples at regular intervals, producing a 30 x 20 x 12-ft-deep excavation. Chloride and organic vapors were measured in the field for each sample. All PID readings yielded very low concentrations (<10 ppm), however, chloride concentrations increased with depth. The excavated soil was blended on site and then returned to the hole up to 6 ft BGS where a 1-ft-thick clay barrier was installed. The remaining fill was placed on top of the clay. Additional fill was needed so clean, imported fill was used to backfill the remainder of the excavation. An identification plate was placed on the surface of the site to mark the location of the former junction for future environmental consideration and the presence of the clay below. The disturbed surface was seeded with a blend of native vegetation on 4/24/2006 and is expected to return to productive capacity at a normal rate. On 4/3/2006, OCD was notified of potential groundwater impact at this site. ROC has retained the consultant, L. Peter Galusky Jr., Ph.D. to address environmental concerns at this site.

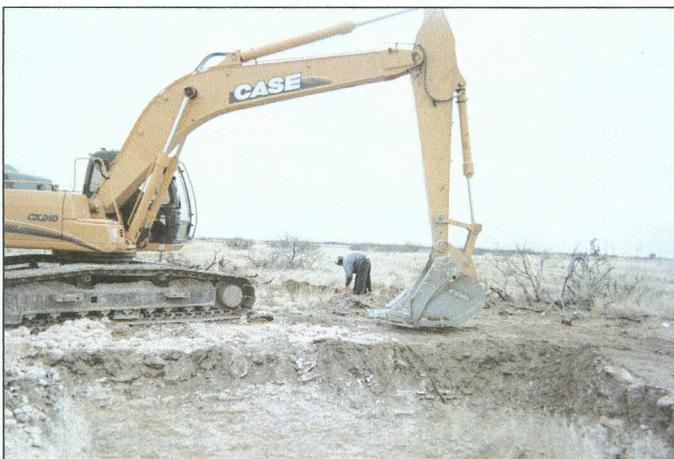
Collecting soil samples from excavation: 3/23/2006

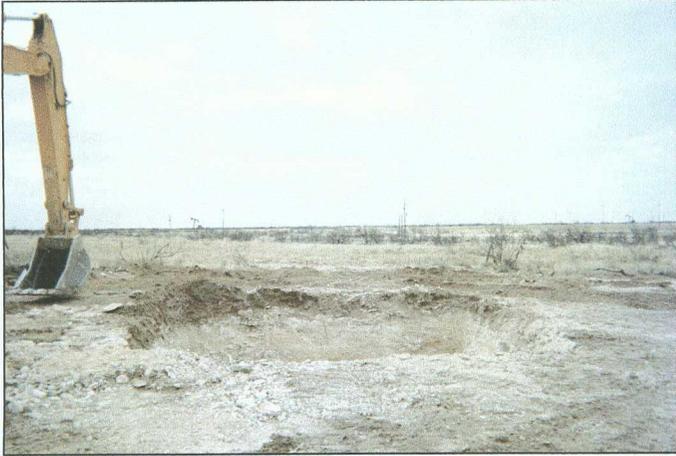
Final 30 x 20 x 12 ft deep excavation

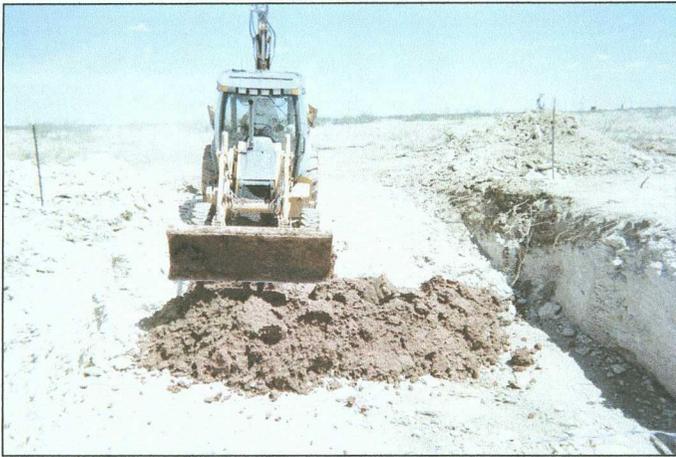
Installing clay barrier at 6 ft: 4/13/2006

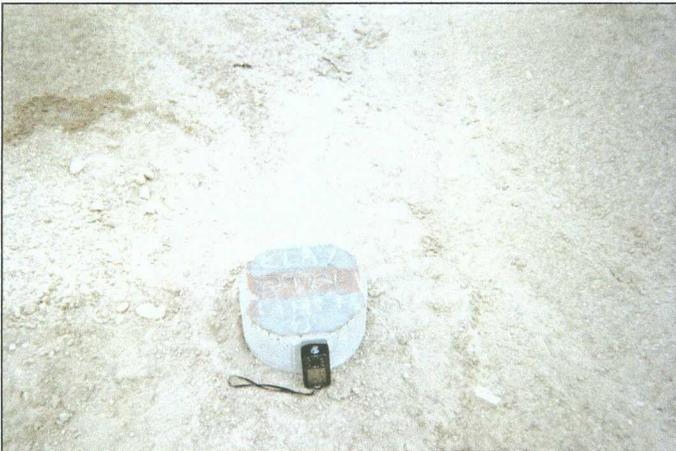
Identification plate to mark former junction site and clay barrier below.

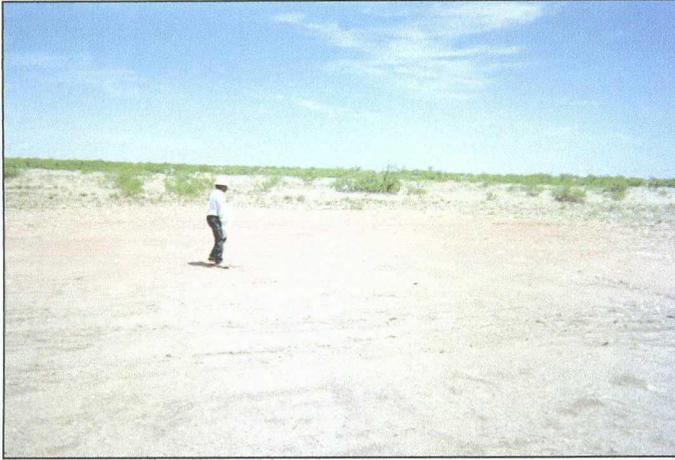
Seeding disturbed area at backfilled site: 4/24/2006

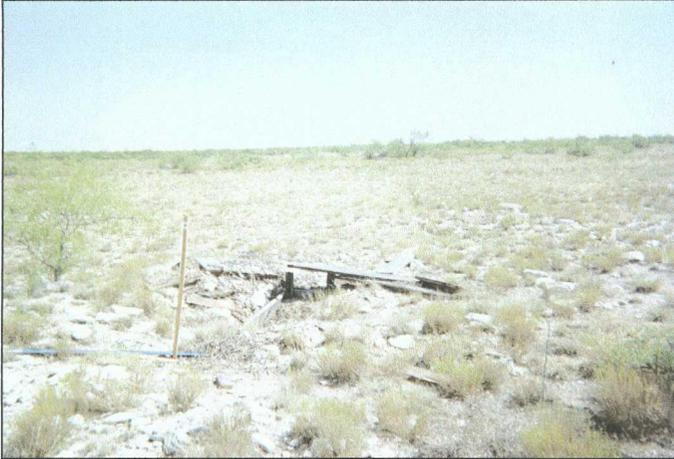
Junction box prior to excavation: 7/11/2005

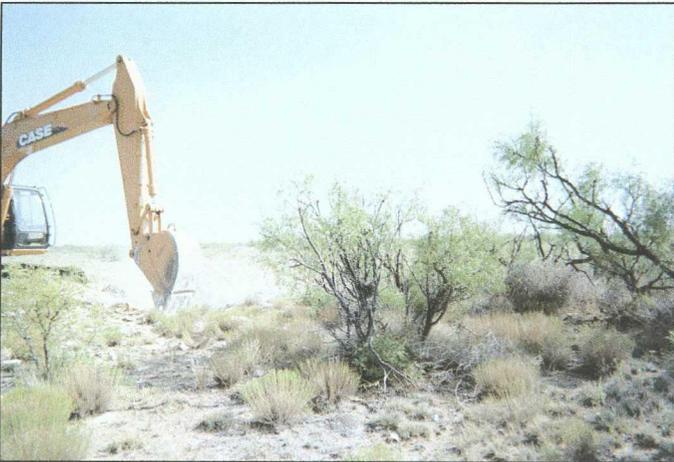
Beginning delineation with trackhoe: 8/2/2005

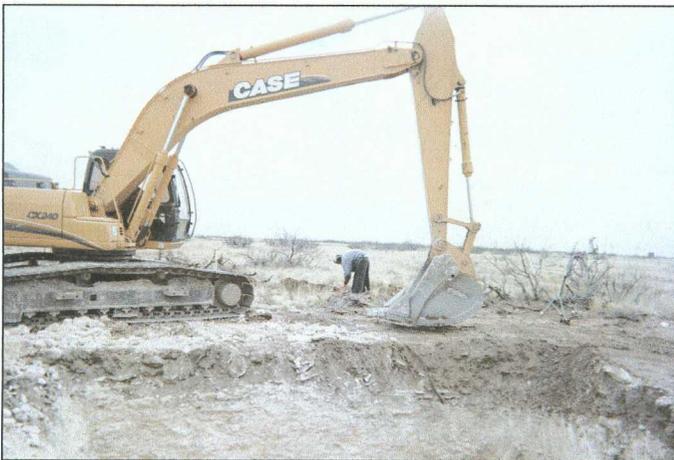
Collecting soil samples from excavation: 3/23/2006

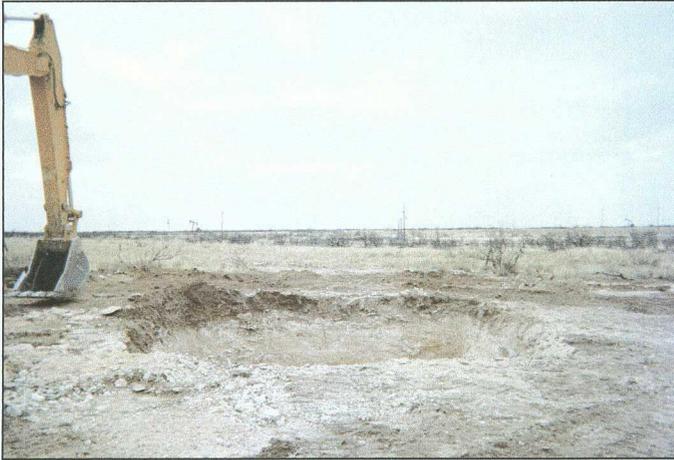
Final 30 x 20 x 12 ft deep excavation

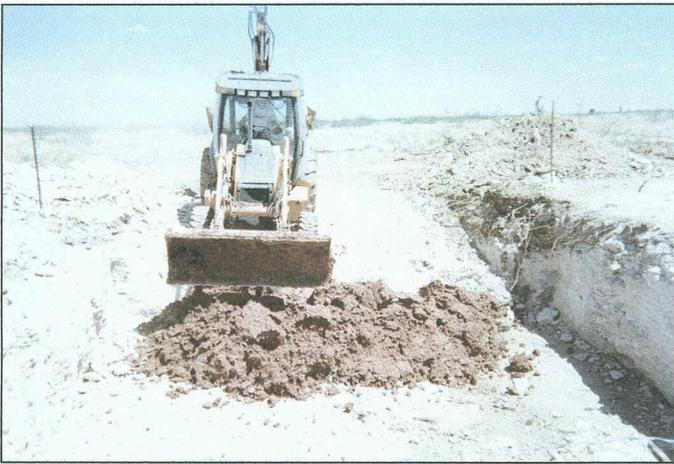
Installing clay barrier at 6 ft: 4/13/2006

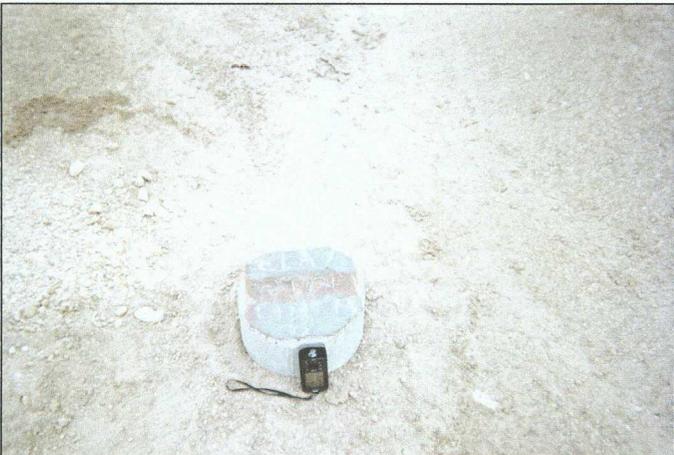
Identification plate to mark former junction site and clay barrier below.

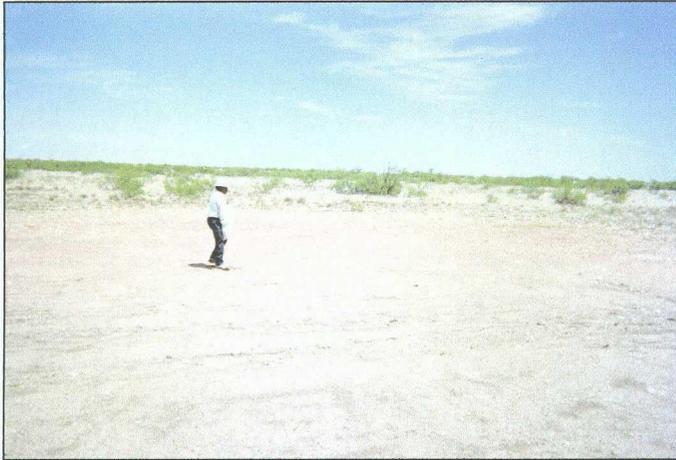
Seeding disturbed area at backfilled site: 4/24/2006
