Vacuum Mobil "P" EOL

RICE OPERATING COMPANY  
JUNCTION BOX DISCLOSURE\* REPORT

Unit 'A', Section 26, T17S, R35E

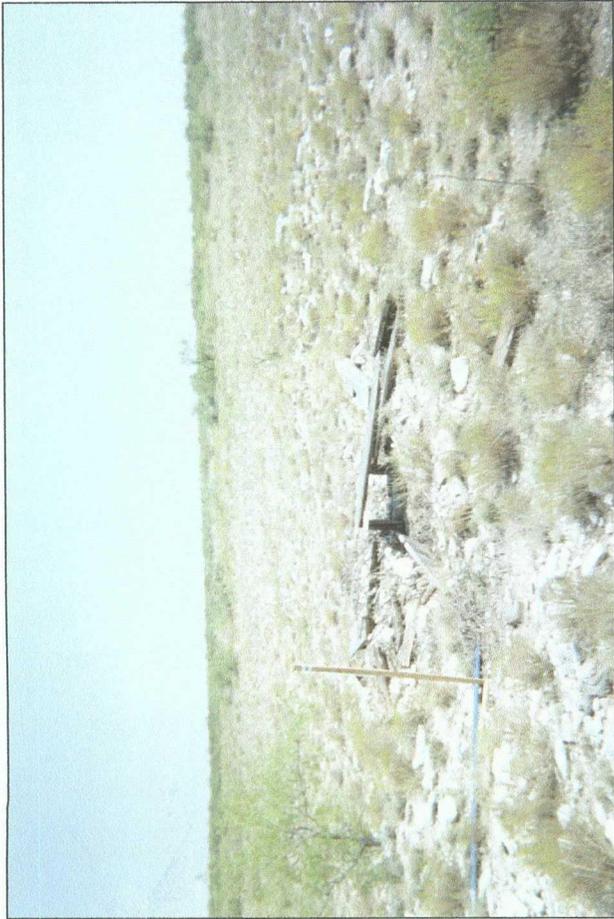
7/11/2005

junction box prior to excavation

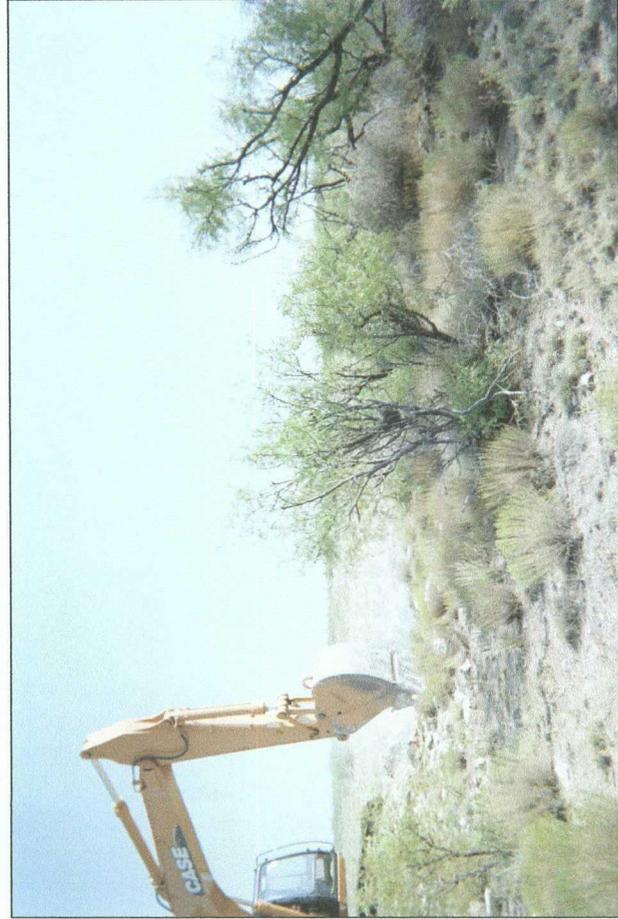
8/2/2005

beginning delineation with trackhoe

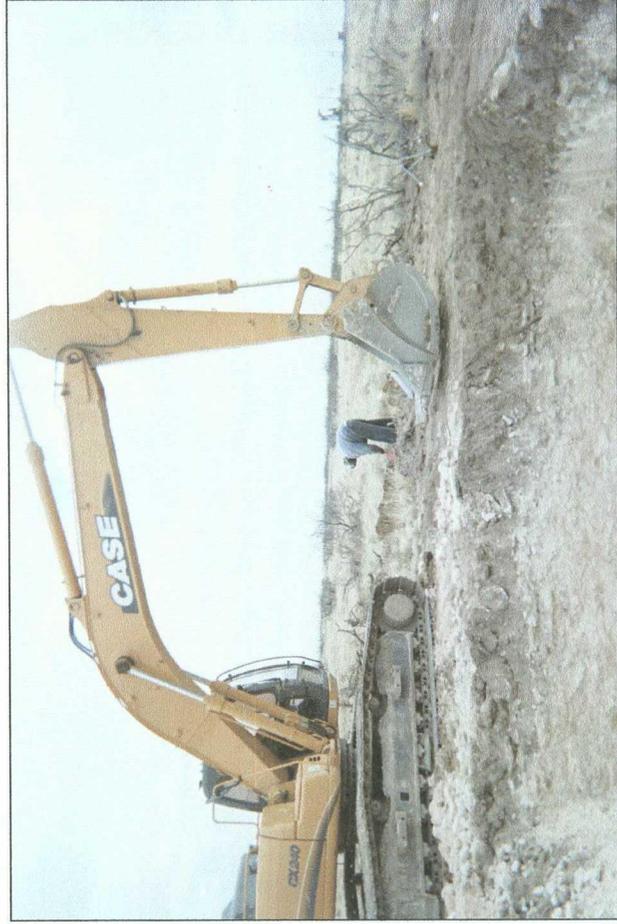
3/23/2006

collecting soil samples from excavation

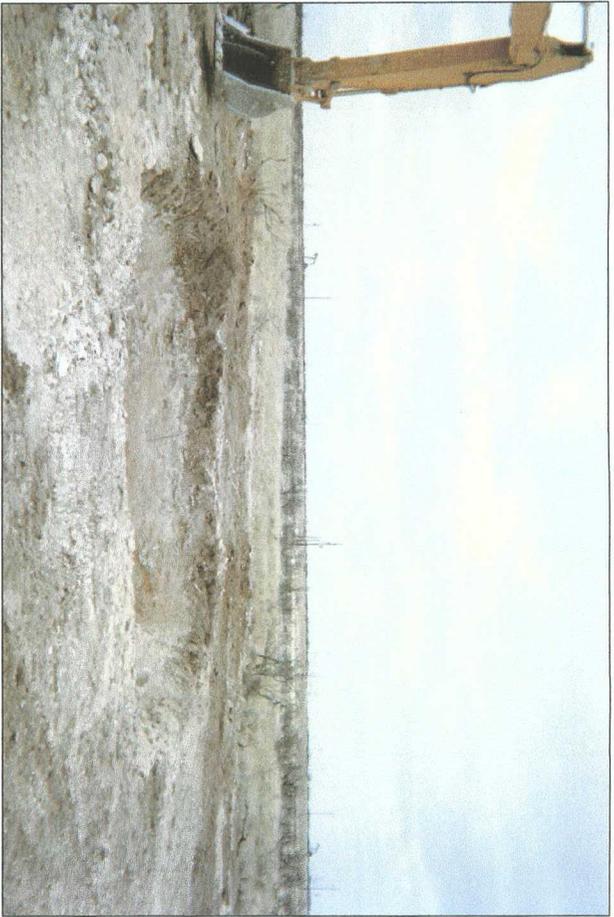
final 30 x 20 x 12 ft deep excavation

General Description of Remedial Action: This junction box was addressed as part of the abandonment of the Vacuum SWD system. After the box lumber was removed, the site was delineated using a trackhoe to collect soil samples at regular intervals, producing a 30 x 20 x 12-ft-deep excavation. Chloride and organic vapors were measured in the field for each sample. All PID readings yielded very low concentrations (<10 ppm), however, chloride concentrations increased with depth. The excavated soil was blended on site and then returned to the hole up to 6 ft BGS where a 1-ft-thick clay barrier was installed. The remaining fill was placed on top of the clay. Additional fill was needed so clean, imported fill was used to backfill the remainder of the excavation. An identification plate was placed on the surface of the site to mark the location of the former junction for future environmental consideration and the presence of the clay below. The disturbed surface was seeded with a blend of native vegetation on 4/24/2006 and is expected to return to productive capacity at a normal rate. On 4/3/2006, OCD was notified of potential groundwater impact at this site. ROC has retained the consultant, L. Peter Galusky Jr., Ph.D. to address environmental concerns at this site.

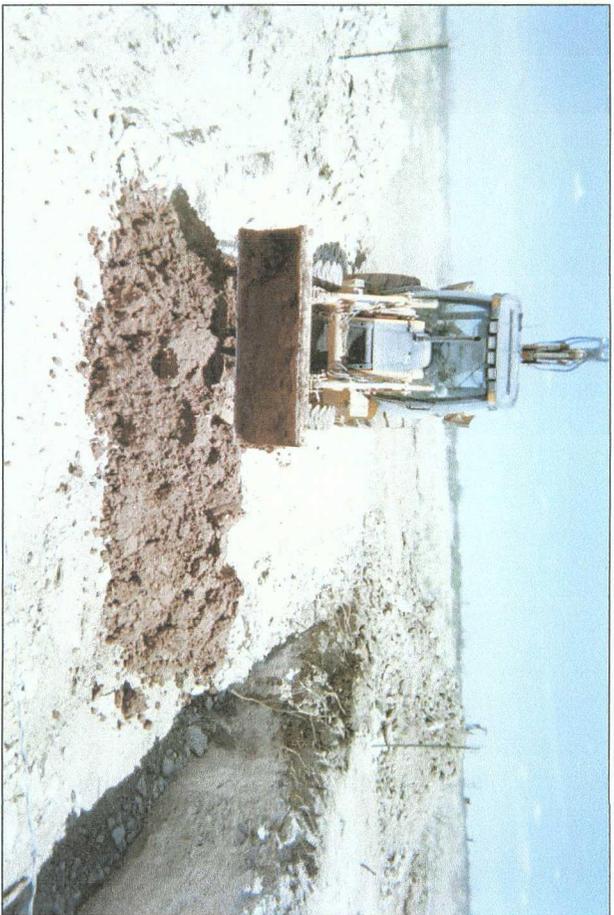
4/13/2006

installing clay barrier at 6 ft

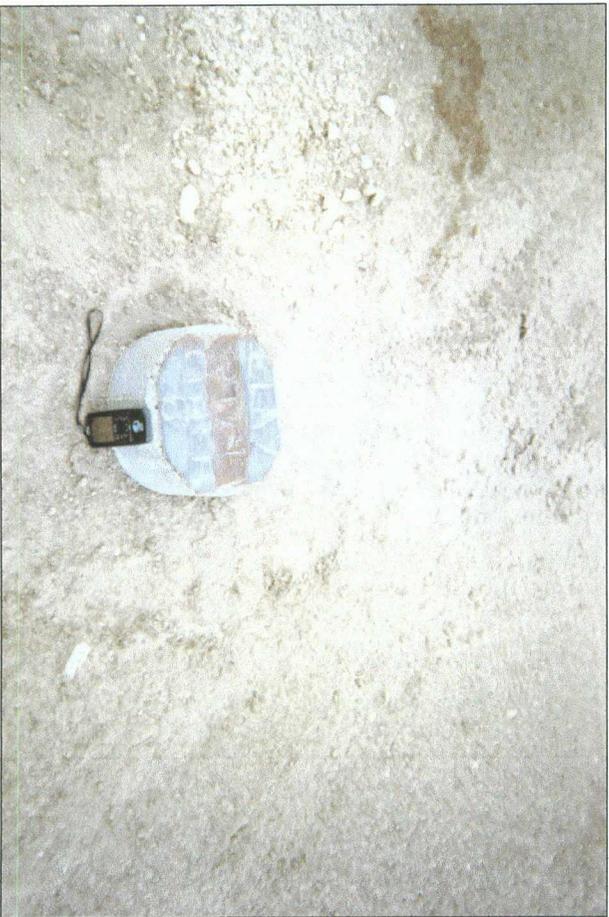
identification plate to mark former junction site and clay barrier below

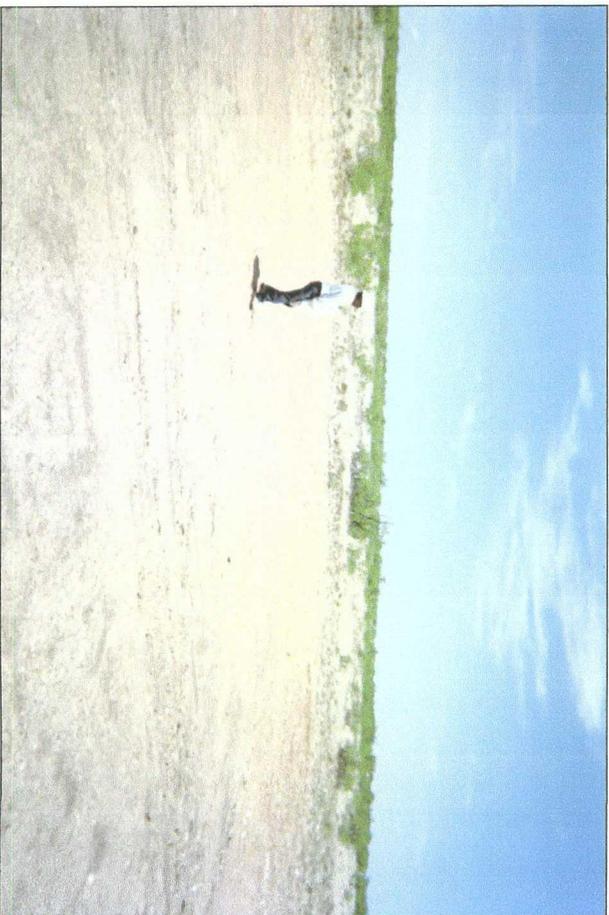
4/24/2006

seeding disturbed area at backfilled site

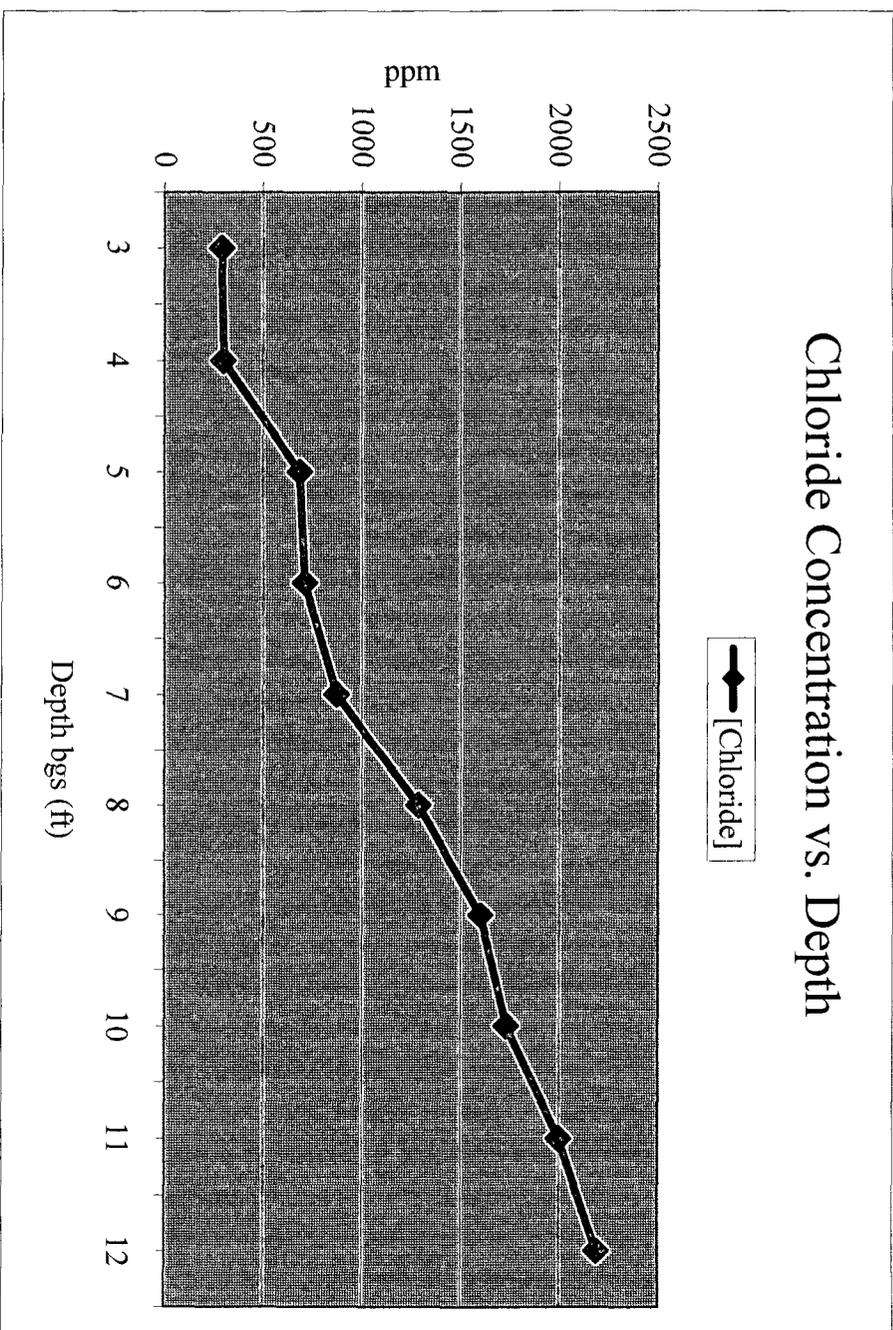
Vertical Delineation at Source

Depth bgs (ft)	[Cl] ppm
3	290
4	299
5	686
6	709
7	872
8	1286
9	1601
10	1733
11	1999
12	2189

Groundwater = 50 ft

LOCATION	DEPTH (ft)	ppm
delineation trench at junction	3	290
	4	299
	5	686
	6	709
	7	872
	8	1286
	9	1601
	10	1733
	11	1999
	12	2189
4-wall comp.	n/a	1050
bottom comp.	12	1554
backfill comp.	n/a	1404

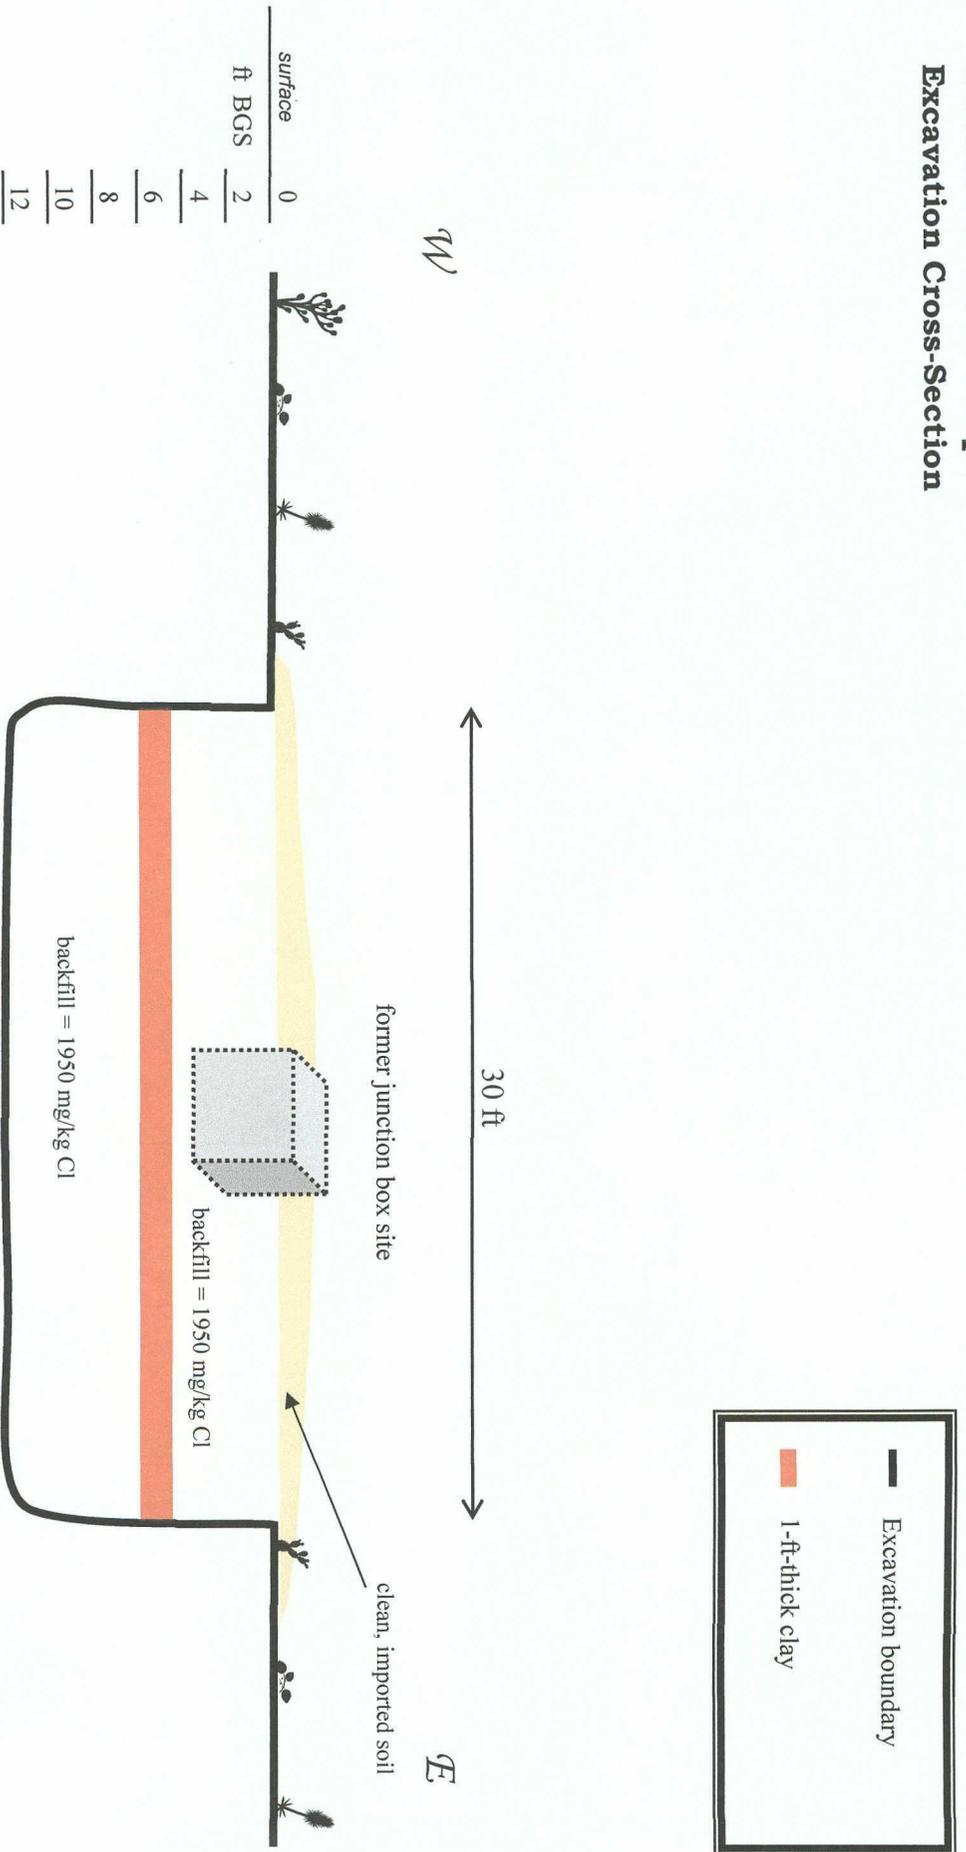
Excavation Cross-Section

30 x 20 x 12-ft-deep

Soil Excavated 267 cubic yards Excavation Length 30 Width 20 Depth 12 feet
