EME Jct O-32

Closure

**RICE OPERATING COMPANY
JUNCTION BOX FINAL REPORT**

**NORTH MONUMENT GRAYBURG SAN ANDRES UNIT
ABANDONED BATTERY SITE NO. 67
(CHEVRON MAY LOVE)**

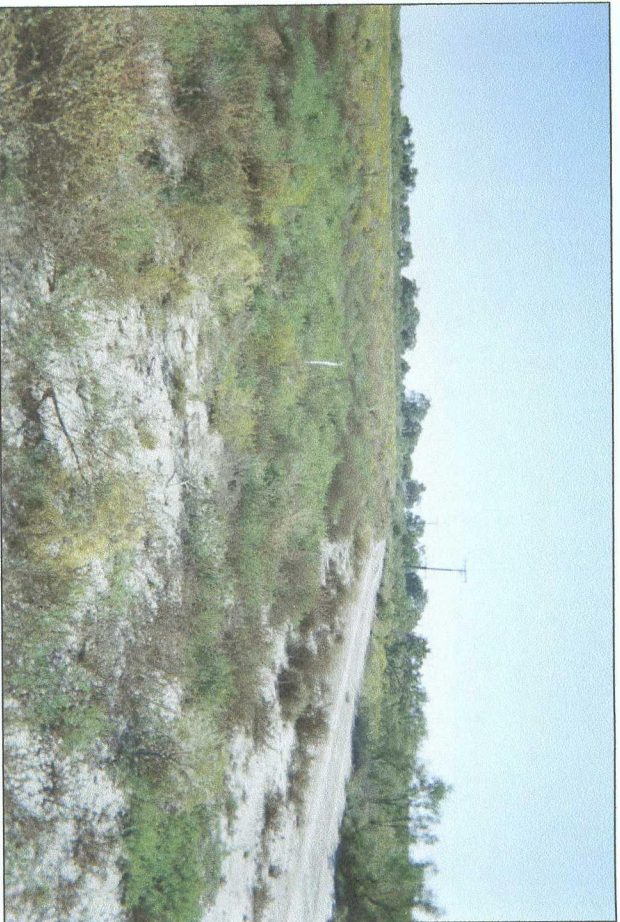
flagged stake marking former junction box site 10/12/2005

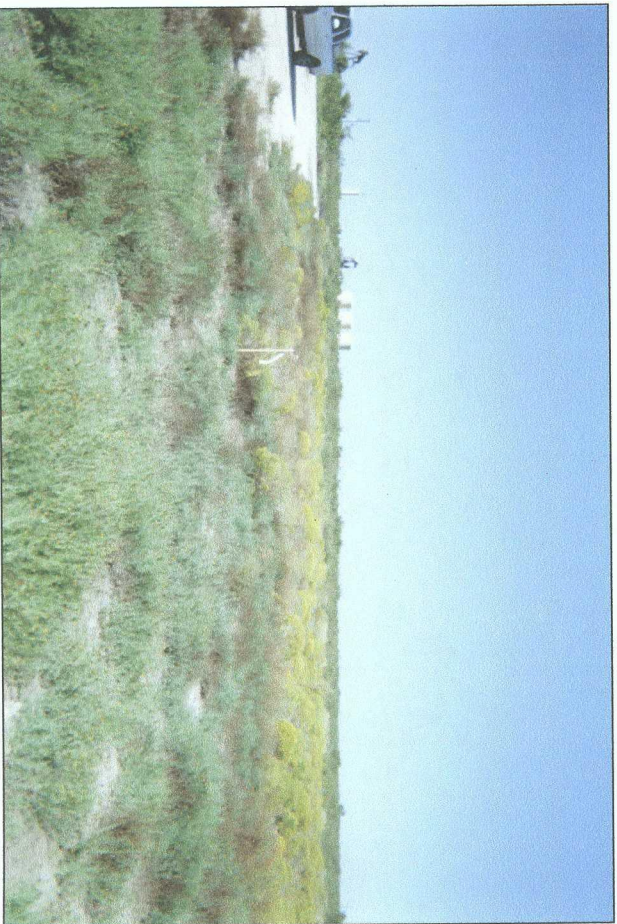
flagged stake marking former junction box site 10/12/2005

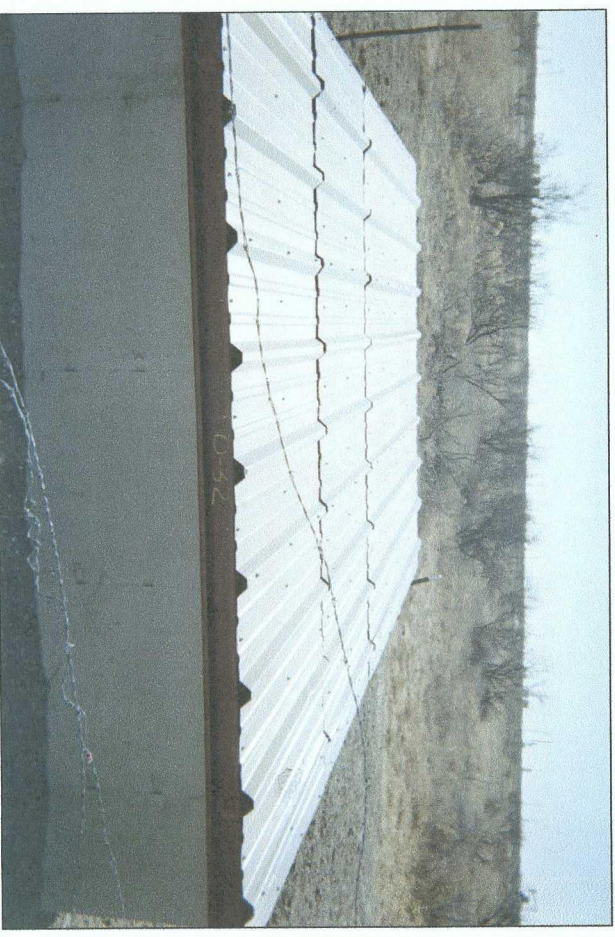
new junction box 50 ft south of former site 11/10/2005
