**RICE OPERATING COMPANY  
JUNCTION BOX FINAL REPORT**

SWD SYSTEM	JUNCTION	UNIT	SECTION	TOWNSHIP	RANGE	COUNTY	BOX DIMENSIONS - FEET		
EME	L-20 vent	L	20	19S	37E	Lea	Length	Width	Depth
							14	10	6

# EMIE L-20 vent

Unit 'L', Sec. 20, T19S, R37E

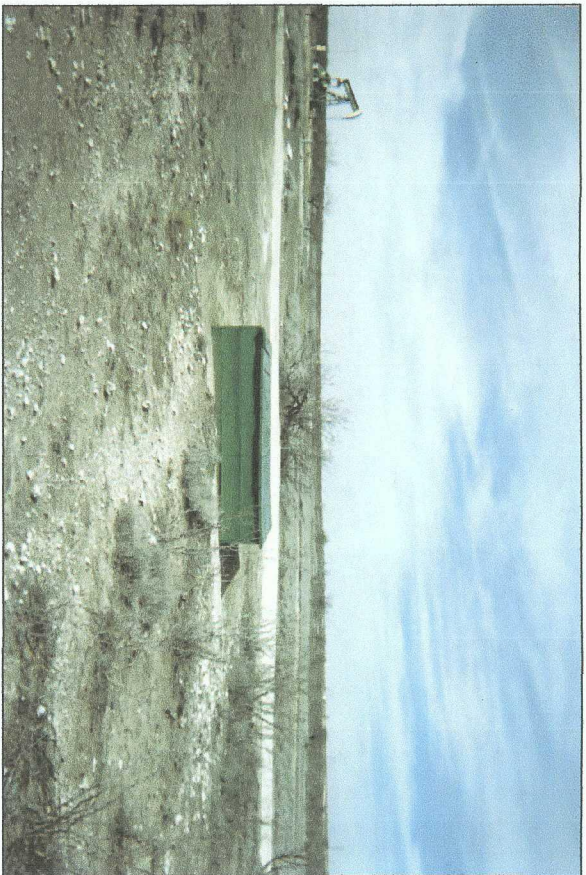
1/7/2004

undisturbed junction box

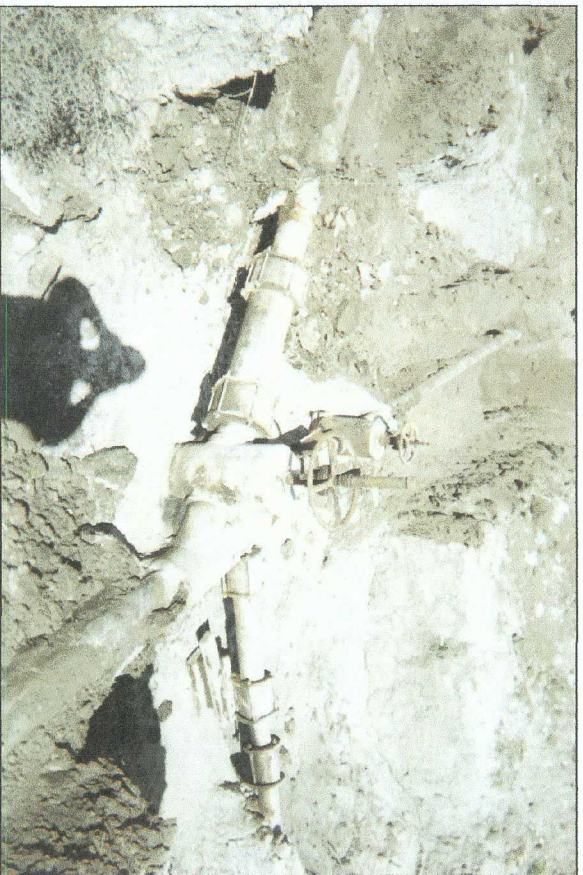
11/10/2004

box removed; old plumbing

General Description of Remedial Action: This junction was upgraded with the pipeline replacement program. When the old box was removed, the site was delineated using a backhoe while PID screenings and chloride field tests were performed on soil samples every vertical foot. A 30 x 25 x 12-ft-deep excavation was made and composite samples from the 12-ft bottom, 4-walls, and backfill were sent to a laboratory for analysis. All samples yielded non-detect TPH concentrations (<10.0 ppm), meeting NMOCD guidelines. Chloride samples were all less than 250 ppm. The excavated soil was blended on site and then backfilled into the excavation and contoured to the surrounding surface. The disturbed surface was seeded with a blend of native vegetation and is expected to return to productive capacity at a normal rate. A new watertight junction box has been built as a replacement over this location.

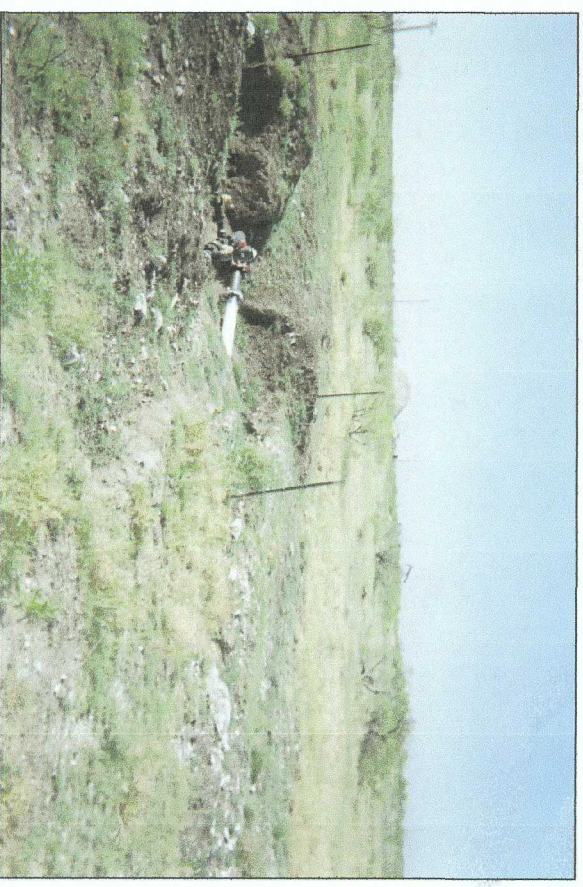
11/10/2004

new plumbing

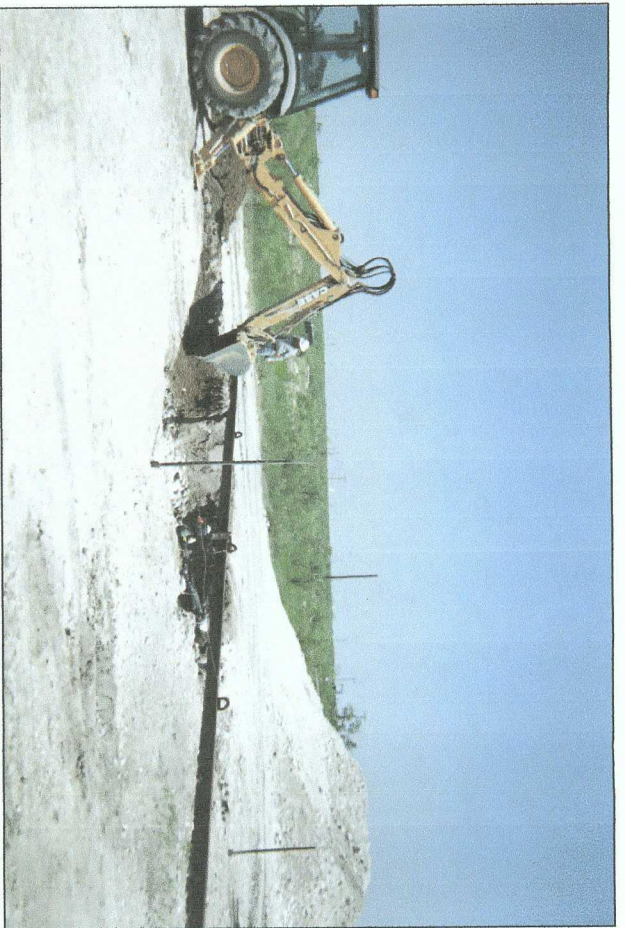
6/27/2005

delineation & excavation

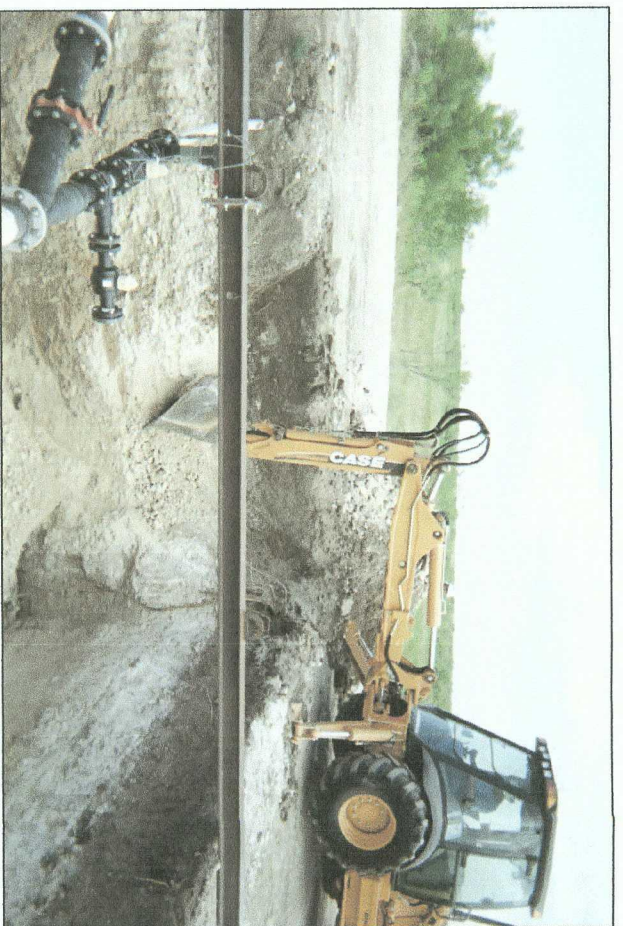
7/5/2005

delineation & excavation

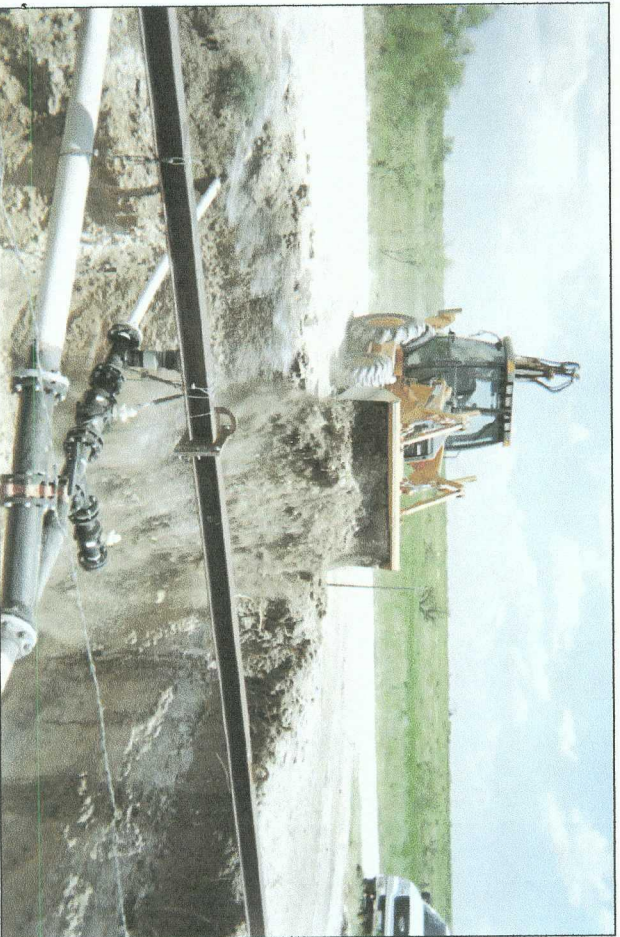
7/14/2005

backfilling excavation

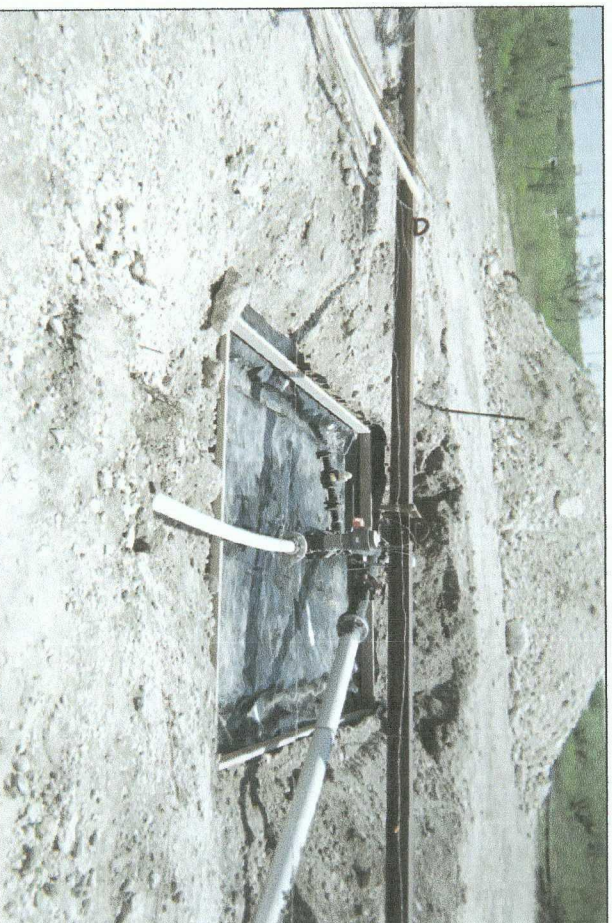
8/19/2005

floor of new junction box with poly liner
