Vac M-26 Vent

RICE OPERATING COMPANY JUNCTION BOX DISCLOSURE* REPORT

Vacuum M-26 vent

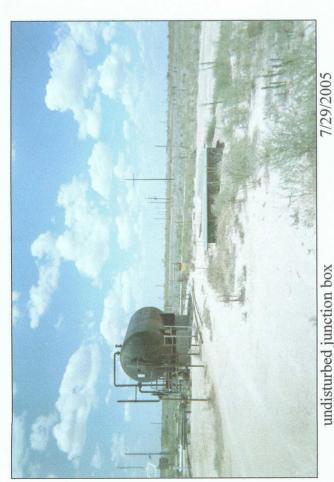
undisturbed junction box

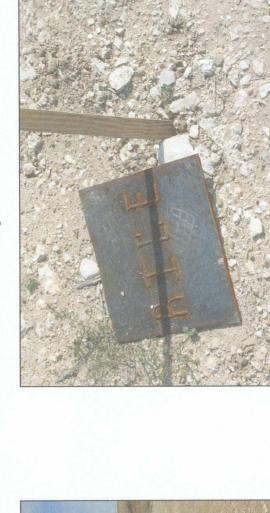
6/15/2006

identification plate at former jct. site

seeded with a blend of native vegetation and will be monitored for growth. An identification plate was placed on the surface to mark the former location of this junction box for future environmental considerations. OCD was notified of potential groundwater impact at this site on 10 1965 11 2303 10/5/2006. I HEREBY CERTIFY THAT THE INFORMATION ABOVE IS TRUE AND COMPLETE TO THE BEST OF MY KNOWLEDGE AND BELIEF. SITE SUPERVISOR Roy Rascon SIGNATURE AND COMPLETE TO THE BEST OF MY RICE Operating Company REPORT ASSEMBLED BY Kristin Farris Pope SIGNATURE AND COMPANY RICE Operating Company					·			_				
plate was placed on the surface to mark the former location of this junction box for future environmental considerations. OCD was notified of potential groundwater impact at this site on 11 2303 10/5/2006. 12 2999 I HEREBY CERTIFY THAT THE INFORMATION ABOVE IS TRUE AND COMPLETE TO THE BEST OF MY KNOWLEDGE AND BELIEF. SITE SUPERVISOR Roy Rascon SIGNATURE AND COMPANY RICE Operating Company REPORT ASSEMBLED BY Kristin Farris Pope SIGNATURE MILLIAM AND COMPANY RICE Operating Company				······································	******					9		1455

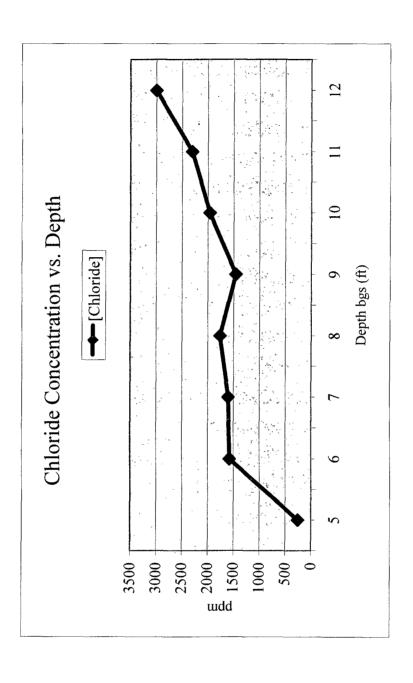
Vertical Delineation at Source

Depth bgs (ft)[CIT] ppm525661577716048176391455101965112303
12 2999

Groundwater = 70 ft

This junction box was addressed CHLORIDE FIELD TESTS as part of the Vacuum System abandonment. After the box was removed, a delineation trench was made at the jct, using a trackhoe to collect soil samples to 12 ft BGS. Chloride and VOC field tests were performed on each sample and both constituents increased with depth. A grab sample from the bottom of the trench (12 ft) was collected for laboratory analysis which confirmed that OCD TPH or BTEX guidelines were not met. The excavated soil was blended on site and then backfilled into the trench and contoured to the surrounding terrain. The disturbed area was seeded with a blend of native vegetation and will be monitored for growth. An identification plate was placed on the surface to mark the former location of this junction box for future environmental considerations. OCD was notified of potential groundwater impact at this site on I HEREBY CERTIFY THAT THE INFORMATION ABOVE IS TRUE AND COMPLETE TO THE BEST OF MY KNOWLEDGE AND BELIEF. SITE SUPERVISOR Roy Rascon SIGNATURE AND COMPANY RICE Operating Company REPORT ASSEMBLED BY Kristin Farris Pope SIGNATURE AND COMPANY RICE Operating Company	GRAB @ 12 ft BGS	3.39	4.	48	21.90		41.70	1	690	4520		 1480

field tests were performed on each sample and both constituents increased with depth. A grab sample from the bottom of the trench (12 ft) was collected for laboratory analysis which confirmed that OCD TPH or BTEX guidelines were not met. The excavated soil was blended on site and then backfilled into the trench and contoured to the surrounding terrain. The disturbed area was seeded with a blend of native vegetation and will be monitored for growth. An identification plate was placed on the surface to mark the former location of this junction box for future environmental considerations. OCD was notified of potential groundwater impact at this site on 10/5/2006. I HEREBY CERTIFY THAT THE INFORMATION ABOVE IS TRUE AND COMPLETE TO THE BEST OF MY KNOWLEDGE AND BELIEF. SITE SUPERVISOR Roy Rascon SIGNATURE ASSUM COMPANY RICE Operating Company REPORT ASSEMBLED BY Kristin Farris Pope SIGNATURE AND TO ADMINISTRATE ADMINISTRATE AND TO ADMINISTRATE ADM				box was r	removed, a de	lineation	trench	<u> </u>
