RICE OPERATING COMPANY
JUNCTION BOX DISCLOSURE* REPORT

SWD SYSTEM	JUNCTION	UNIT	SECTION	TOWNSHIP	RANGE	COUNTY	BOX DIMENSIONS - FEET		
							Length	Width	Depth
Vaccum	jct. F-31-1	F	31	17S	35E	Lea			
							box eliminated--System Abandonment

Vacuum jct. F-31-1

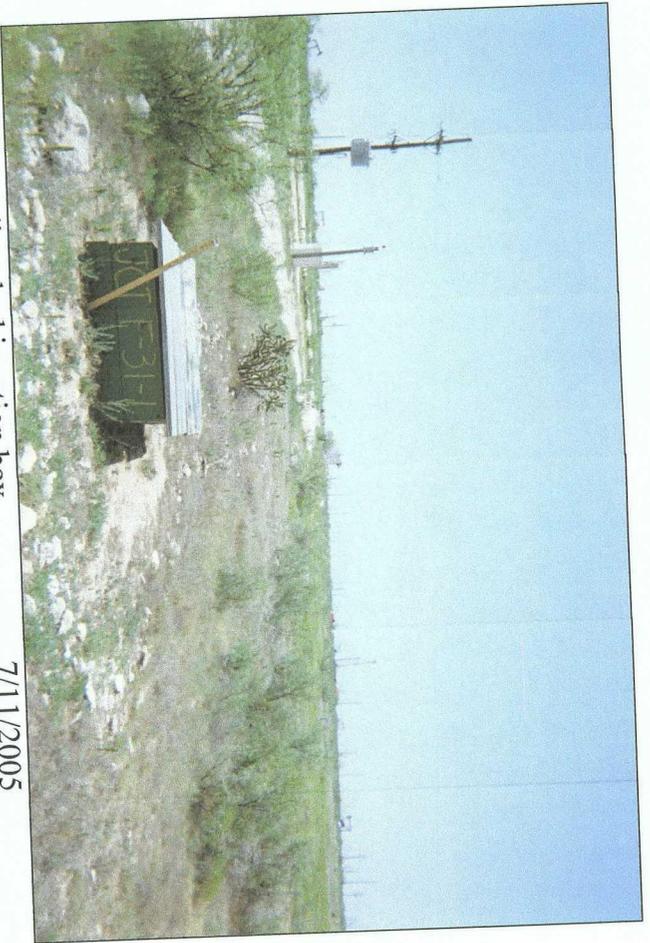
7/11/2005

undisturbed junction box

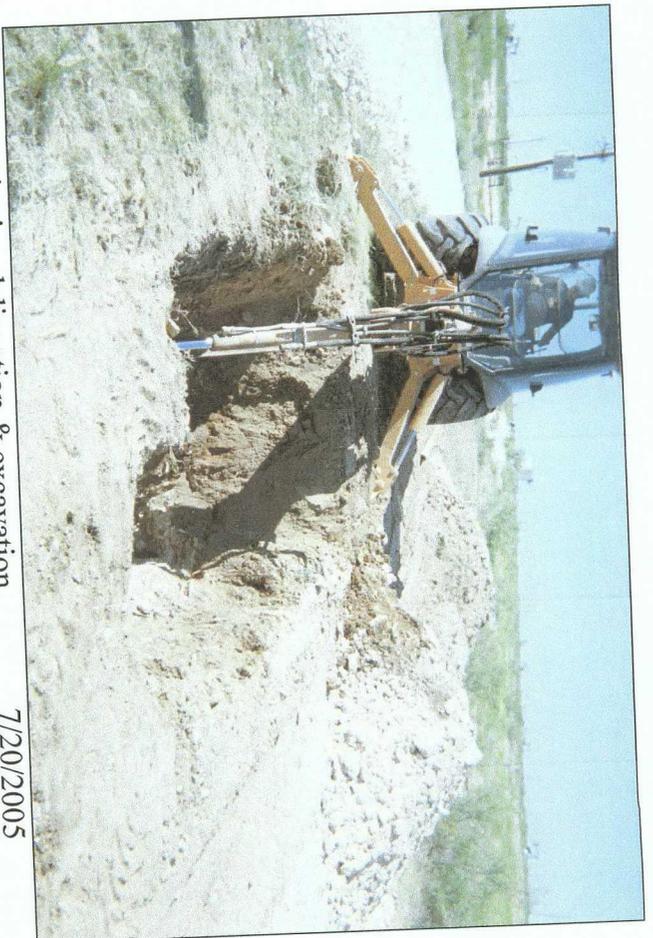
7/20/2005

beginning delineation & excavation

This junction box was addressed as part of the Vacuum SWD System abandonment. After removing the box materials, delineation trenches were excavated at the site using a trackhoe while soil samples were collected at regular intervals. Chloride field tests and PID screenings were conducted on each sample. Chloride concentrations were high at 12 ft while PID concentrations were relatively low throughout. After composite samples from the 10 x 10 x 12-ft excavation were collected for laboratory analysis, the excavation was backfilled with the excavated soil to 6 ft BGS.

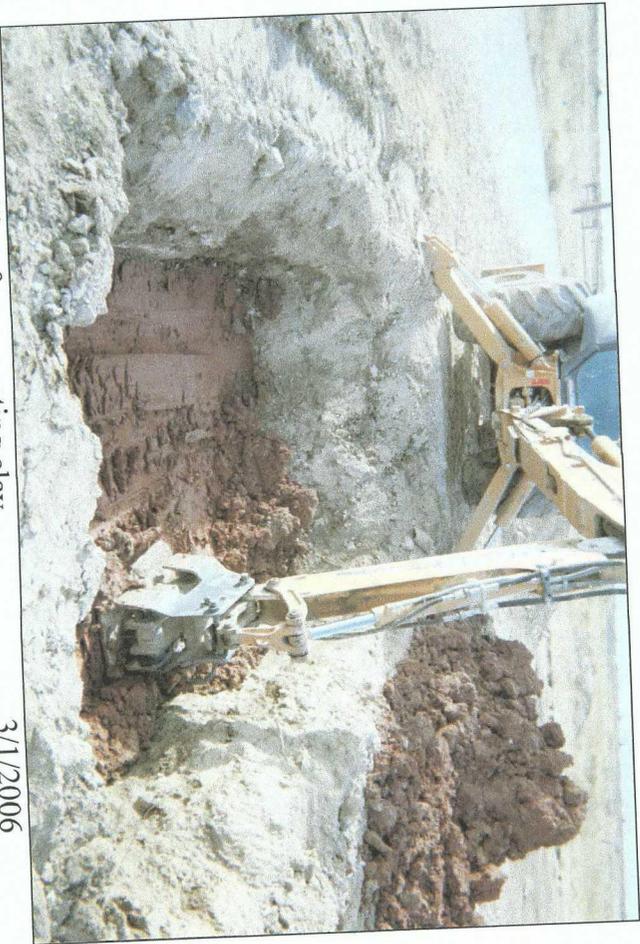
3/1/2006

installing & compacting clay

At 6 ft BGS, a 1-ft-thick compacted clay barrier was installed in the excavation. The remaining excavated soil was backfilled on top of the clay. Additional topsoil was imported and backfilled on top of the area. The disturbed surface has been seeding with a blend of native vegetation and will be monitored for growth. An identification plate was placed on the surface of this site to mark the former junction box location for future environmental considerations. NMOCD has been notified of potential groundwater impact at this site. A replacement junction box is not required because the Vacuum SWD System has been abandoned.

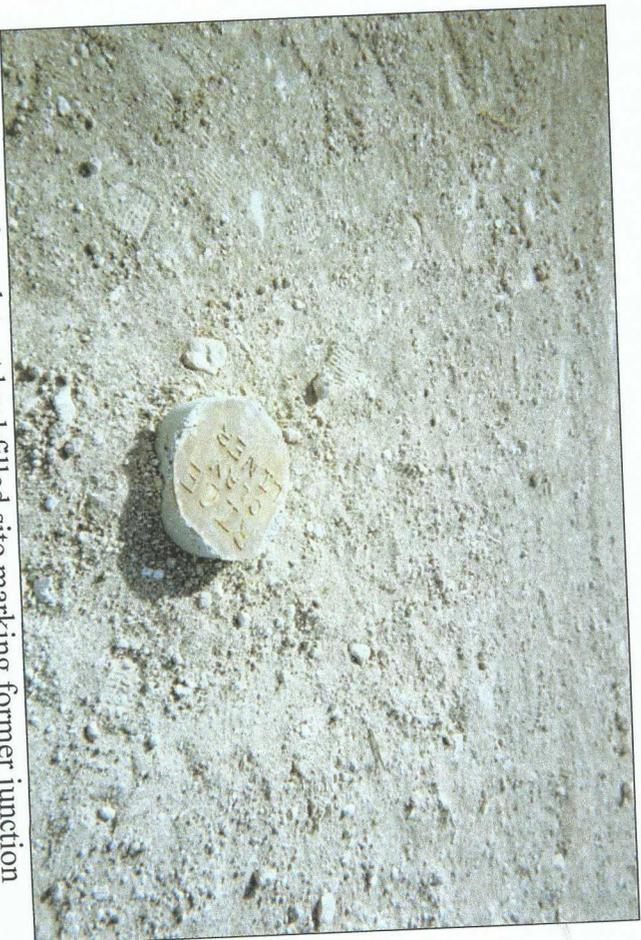
identification plate at backfilled site marking former junction

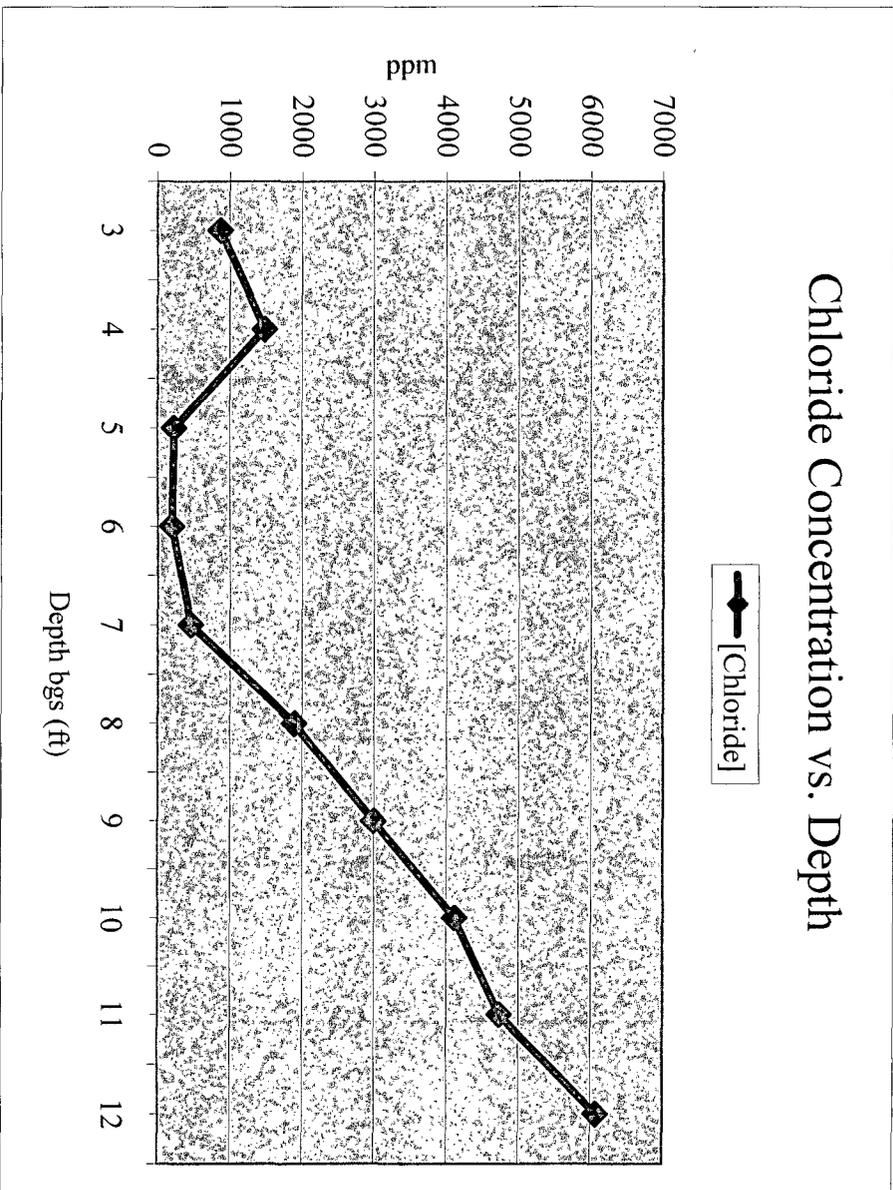
Vertical Delineation at Junction

Depth bgs. (ft)	[Cl] ppm
3	873
4	1481
5	231
6	198
7	458
8	1891
9	2993
10	4112
11	4731
12	6073

Groundwater = 117 ft

LOCATION	DEPTH (ft)	ppm	
vertical delineation trench at junction	3	873	
	4	1481	
	5	231	
	6	198	
	7	458	
	8	1891	
	9	2993	
	10	4112	
	11	4731	
	12	6073	
	4-wall comp.	n/a	4867
	bottom comp.	12	7947
backfill comp.	n/a	3467

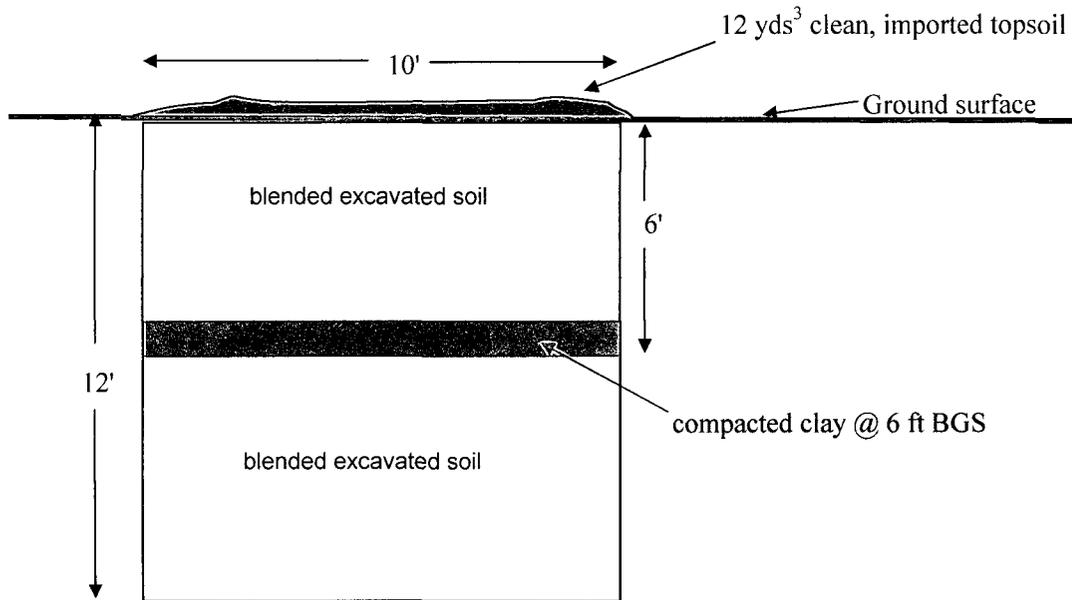
Clay Barrier Configuration

Location: Vacuum Jct. F-31-1
Legal Description: Unit 'F', Section 31, T17S, R35E
Dimensions of excavation: 10' L x 10' W x 12' D
