GENERAL CORRESPONDENCE

Investigation and Characterization Plan
Eunice Monument Eumont (EME) SWD Gaither Boot
T19S, R36E, Section 34, Unit I, Eunice, Lea County, New Mexico

RICE OPERATING COMPANY JUNCTION BOX DISCLOSURE* REPORT

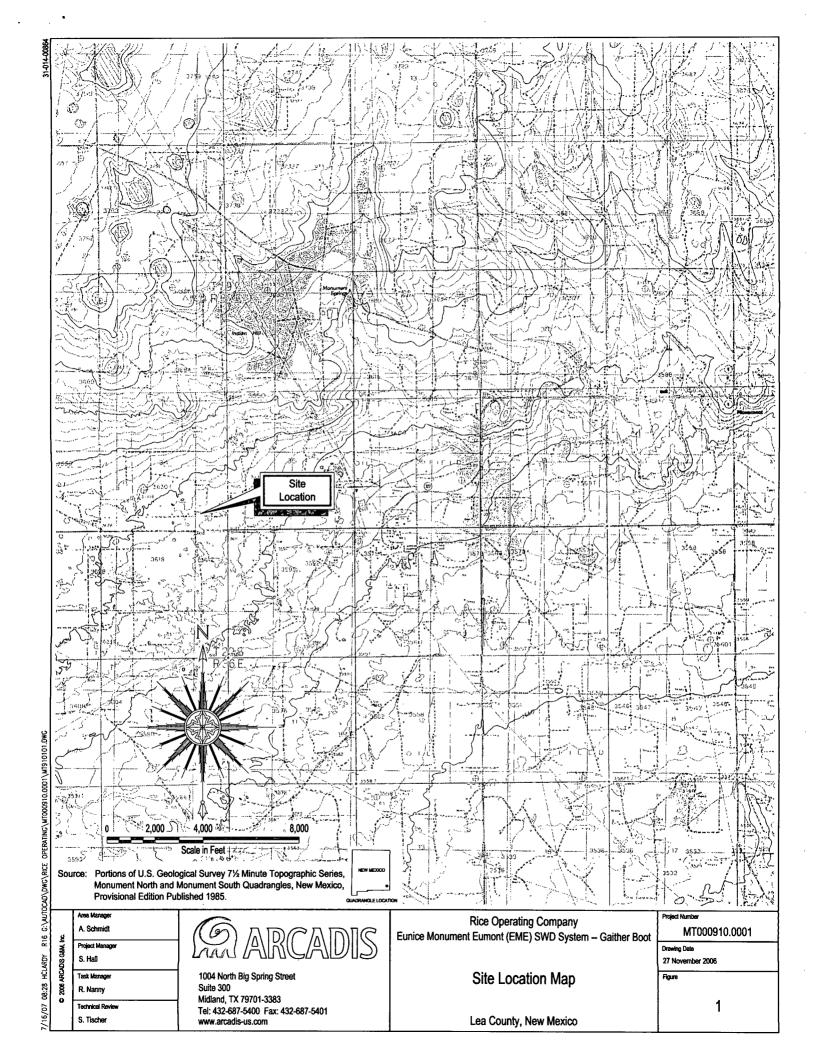
The site is located near the towns of Eunice and Monument, New Mexico (Figure 1). The expected depth to groundwater at this site is approximately 50 feet below ground surface.

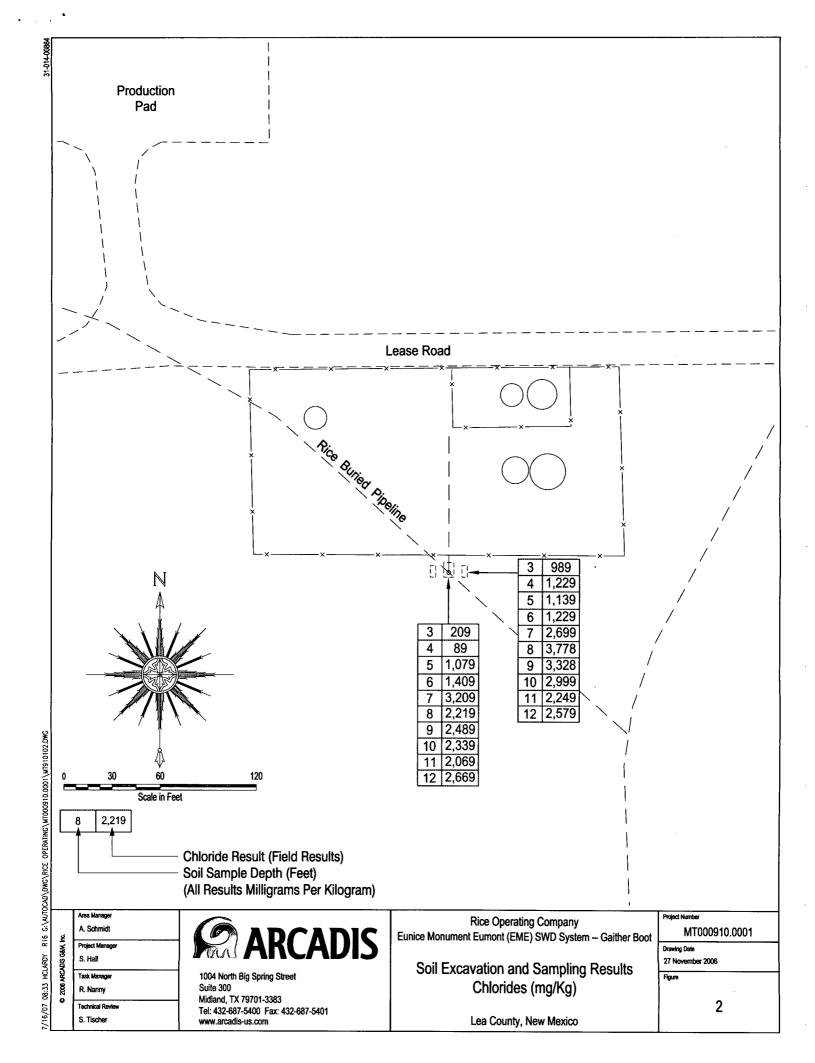
Based on the results of the soil sampling analytical results, elevated chloride and hydrocarbon concentrations are present at the subject site (Figure 2).
