1R - 427-15

**RE: Investigation and Characterization Plan
Rice Operating Company – EME SWD
State H EOL: Unit E Sec 17 T 20S R 37E**

Appendix B – Photo chronology.

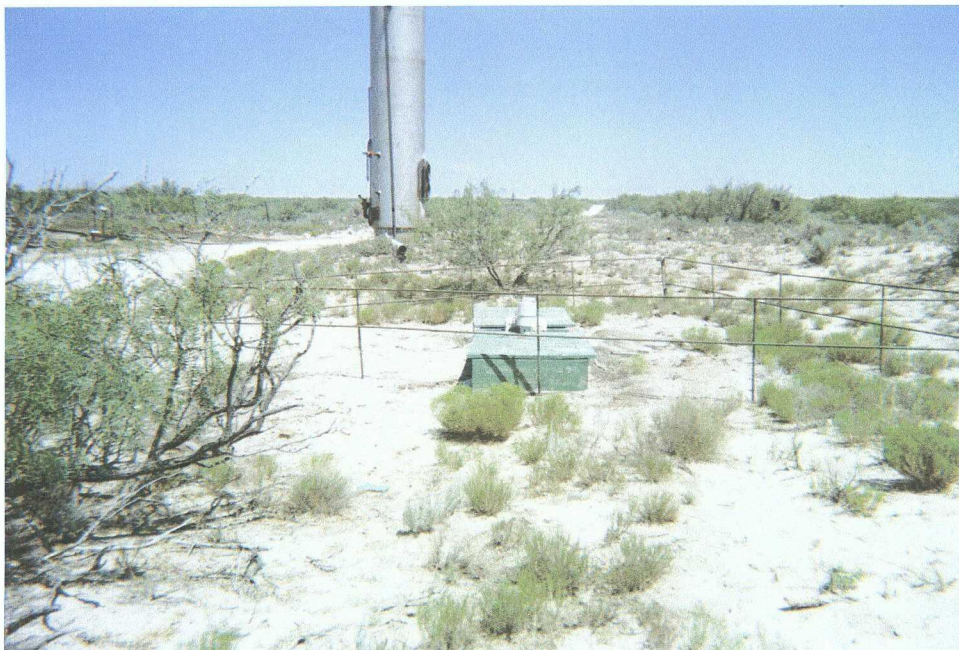
Figure 1 - Undisturbed north and south boxes: 08-06-2003.

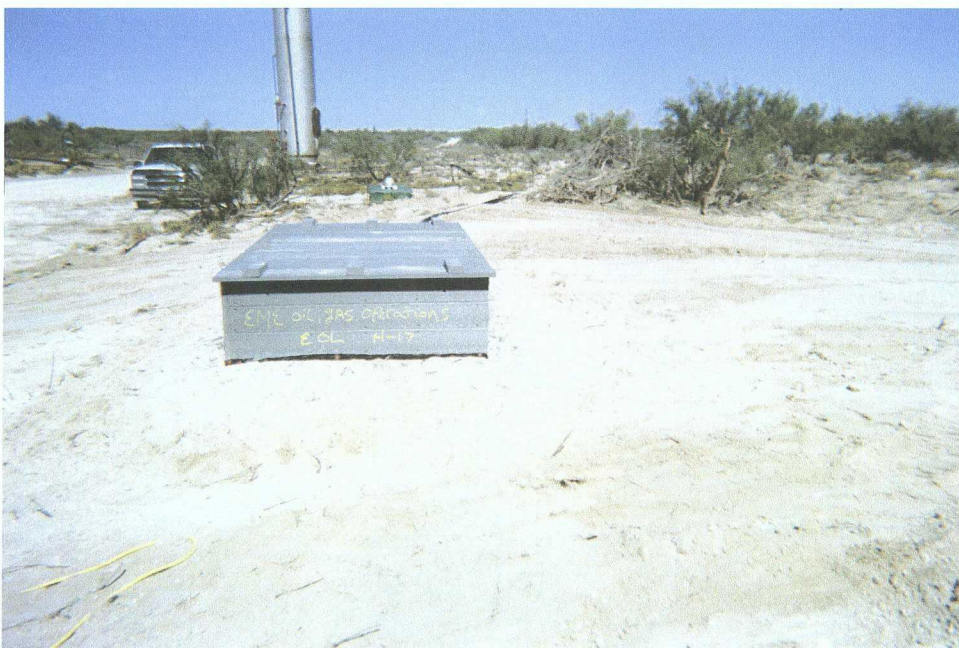
Figure 2 - Completed new box 50 ft south of old boxes in background: 10-15-2003.

General Description of Remedial Action: This site was composed of two boxes that were approximately 5 ft apart. Vertical delineation at each box did not result in a conclusive decline of chloride impact (see graph). All PID readings were 0.0 ppm and TPH concentrations were well below NMOCD guidelines. A 20 x 20 x 4-ft deep excavation was made around the boxes and at 4 ft bgs, a 1.5 ft compacted clay barrier was installed to inhibit further chloride migration. The excavated soil was landfarmed on site and then backfilled on top of the clay and the surface was contoured to the surrounding terrain. The disturbed surface has been seeded with a blend of native vegetation. A new EOL box has been built approximately 50 ft south of this location.

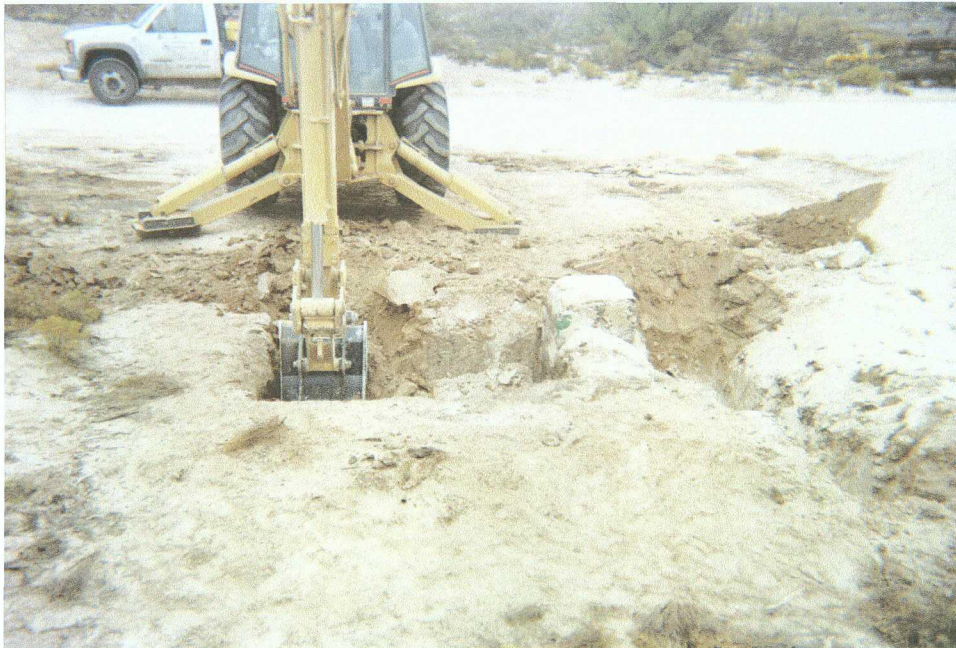
Figure 3 - Beginning excavation and delineation: 11-06-2003,

Rice removed soils from beneath the two former junction boxes in a 20 ft by 20 ft by 14 ft deep excavation. A 1.5 ft thick clay barrier was then installed to preclude potential for further downward chloride migration. The excavated soil was backfilled into the excavation and contoured to the surrounding terrain. The disturbed area was then seeded with a blend of native vegetation. A photographic chronology of these activities is provided in Appendix B.

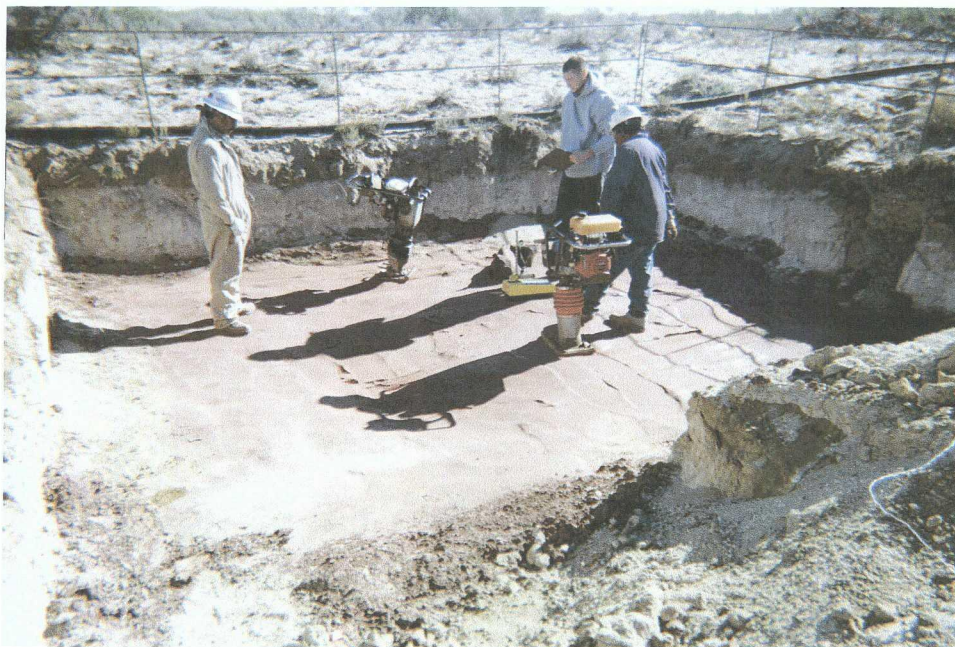
Figure 4 - Testing compacted clay: 11-20-2003.

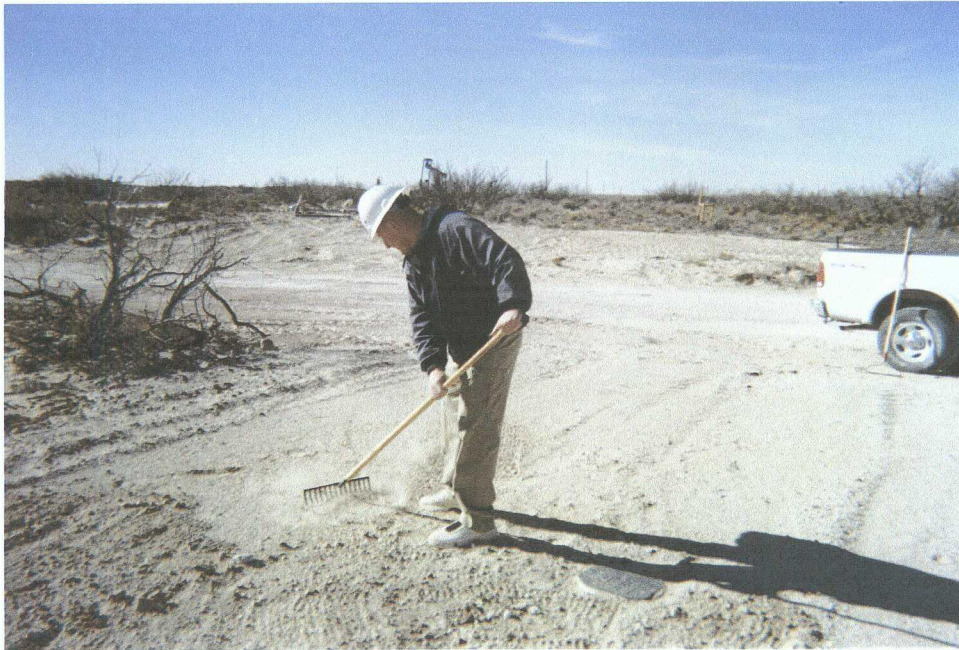
Figure 5 - Seeding disturbed surface.

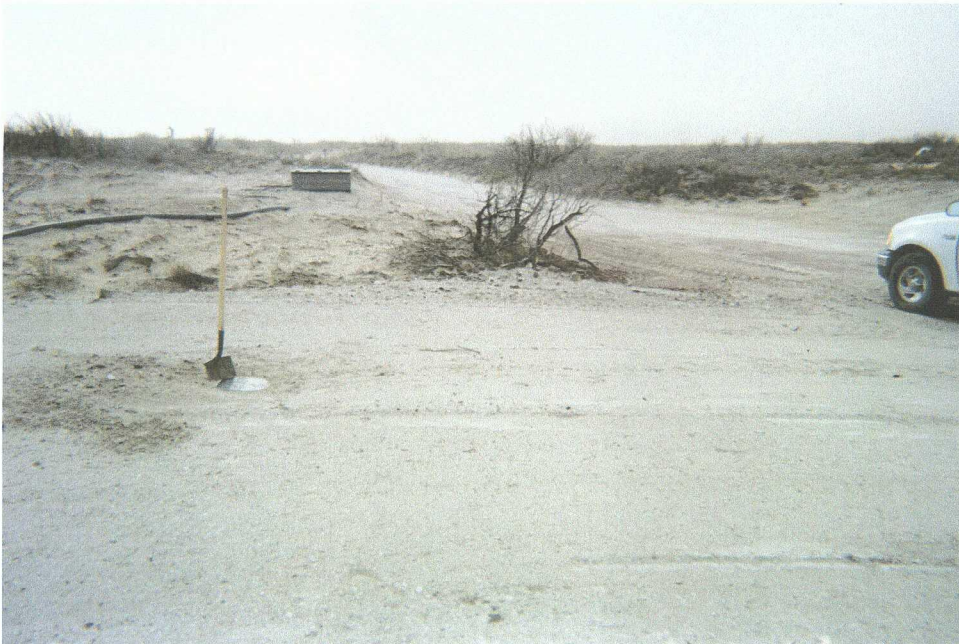
Figure 6 - Identification plate marking clay liner.
