**STAGE 1 & 2
ABATEMENT PLAN**

RE: BD Santa Rita EOL leak (AP-58)
PUBLIC NOTIFICATION

Stage 1 & 2 Abatement Plan (AP-58)

BD SANTA RITA EOL RELEASE SITE **T22S, R37E, SECTION 27, UNIT LETTER A** **LEA COUNTY, NEW MEXICO**

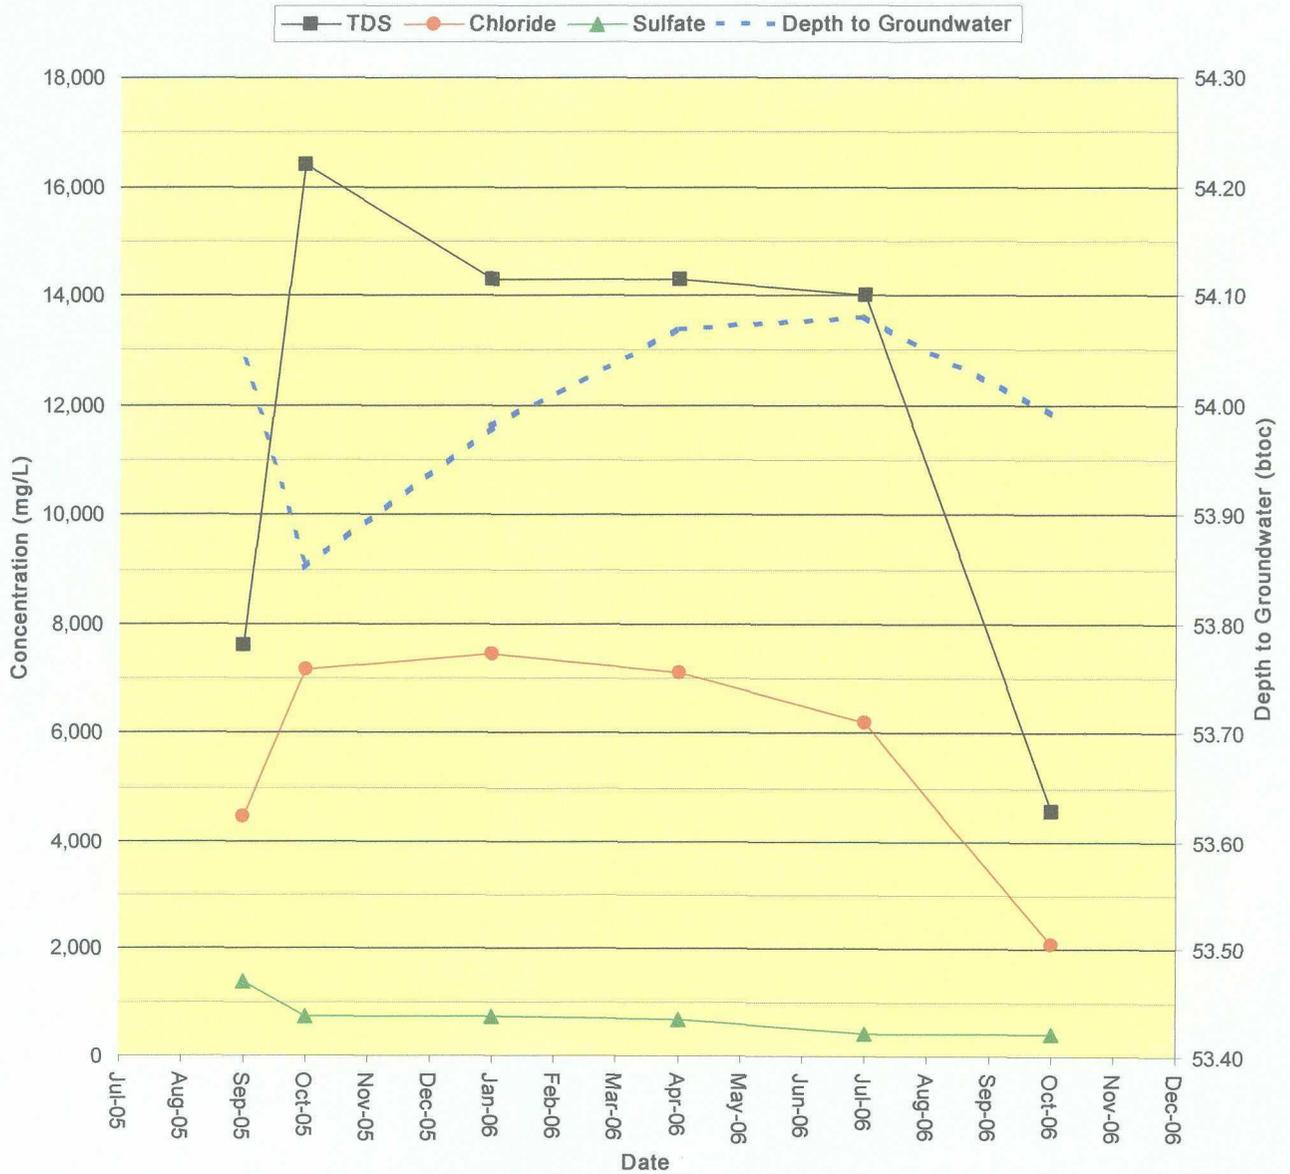
MW-1
 Chloride, Sulfate, TDS Concentrations, and Water Table Elevation Versus Time Graph
 Santa Rita EOL Site

Background and ambient concentrations of these compounds have not been established at this time. Chloride and TDS concentrations in MW-1 have consistently decreased since the initial sampling event. No correlations between chloride/TDS concentrations and changes in ground water levels are evident.

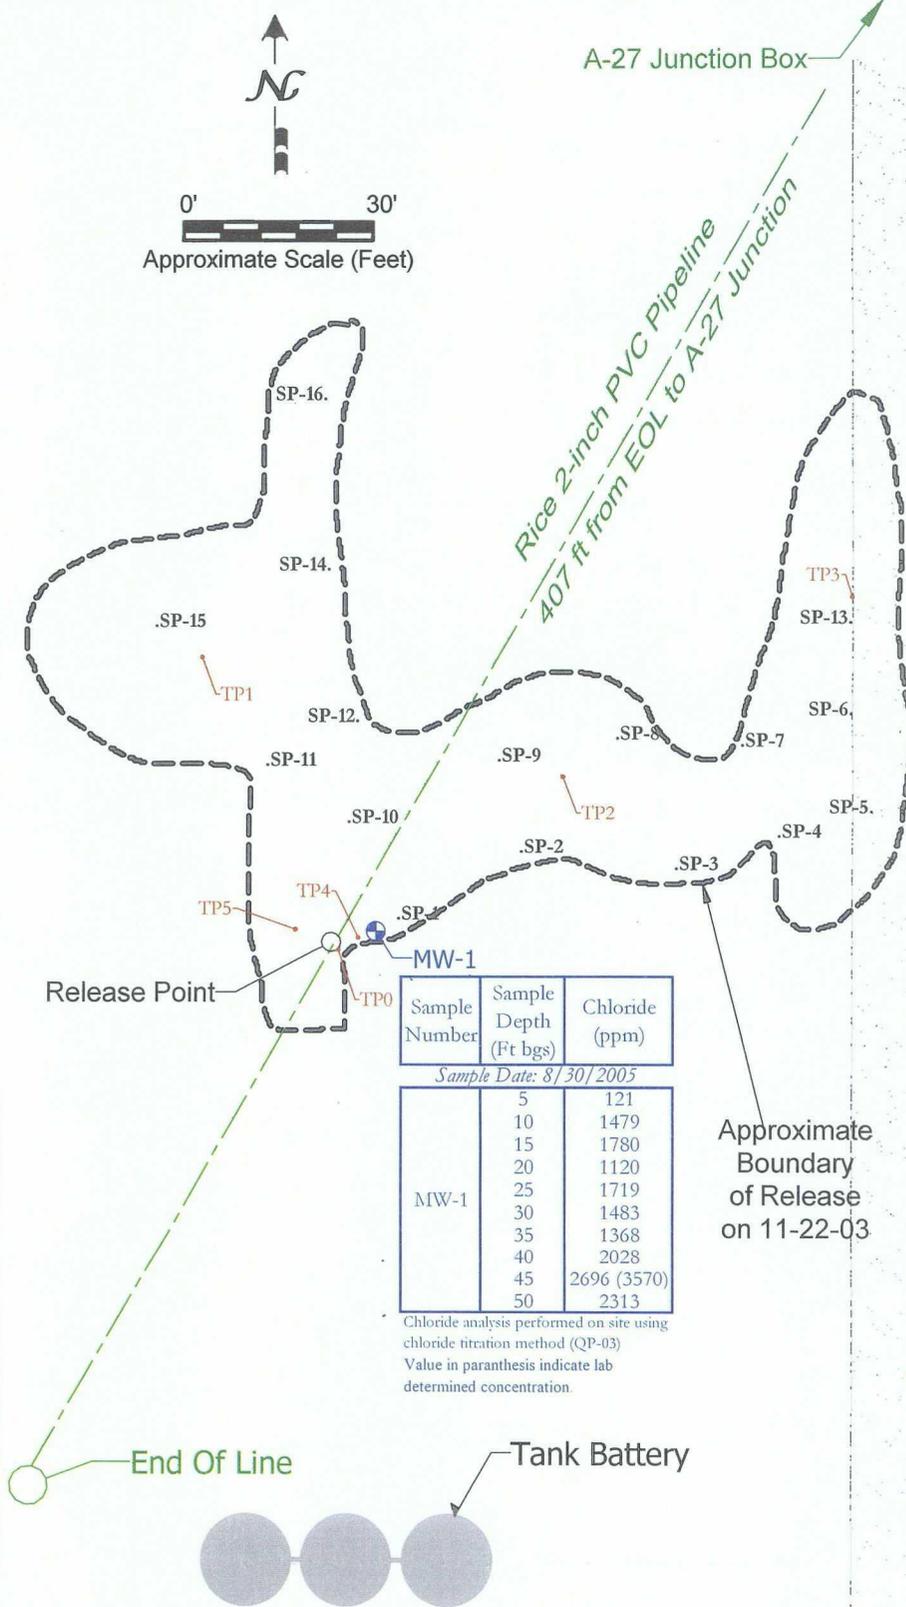
PLATE 3
PRELIMINARY SOIL
SAMPLE RESULTS

Chloride titration performed on site using chloride titration method (QP-03)
Value in paranthesis indicate lab determined concentration.

ROC conducted initial upper vadose zone delineation field activities on November 26 and December 19, 2003. Investigation activities were conducted with a backhoe by trenching to 12-feet below ground surface (bgs) at 6 locations immediately adjacent to the source of the leak and in areas where pooling was observed (Plate 3). Soil samples were analyzed in the field for chlorides using field-adapted Method 9253 (QP-03). Field chlorides ranged from a concentration of 1128 parts per million (ppm) at sample point TP-2 located 50 feet northwest of the release point and 2 feet deep to 5,530 ppm at the surface of sample point TP-1 located 45 feet northeast of the release point (Plate 3).

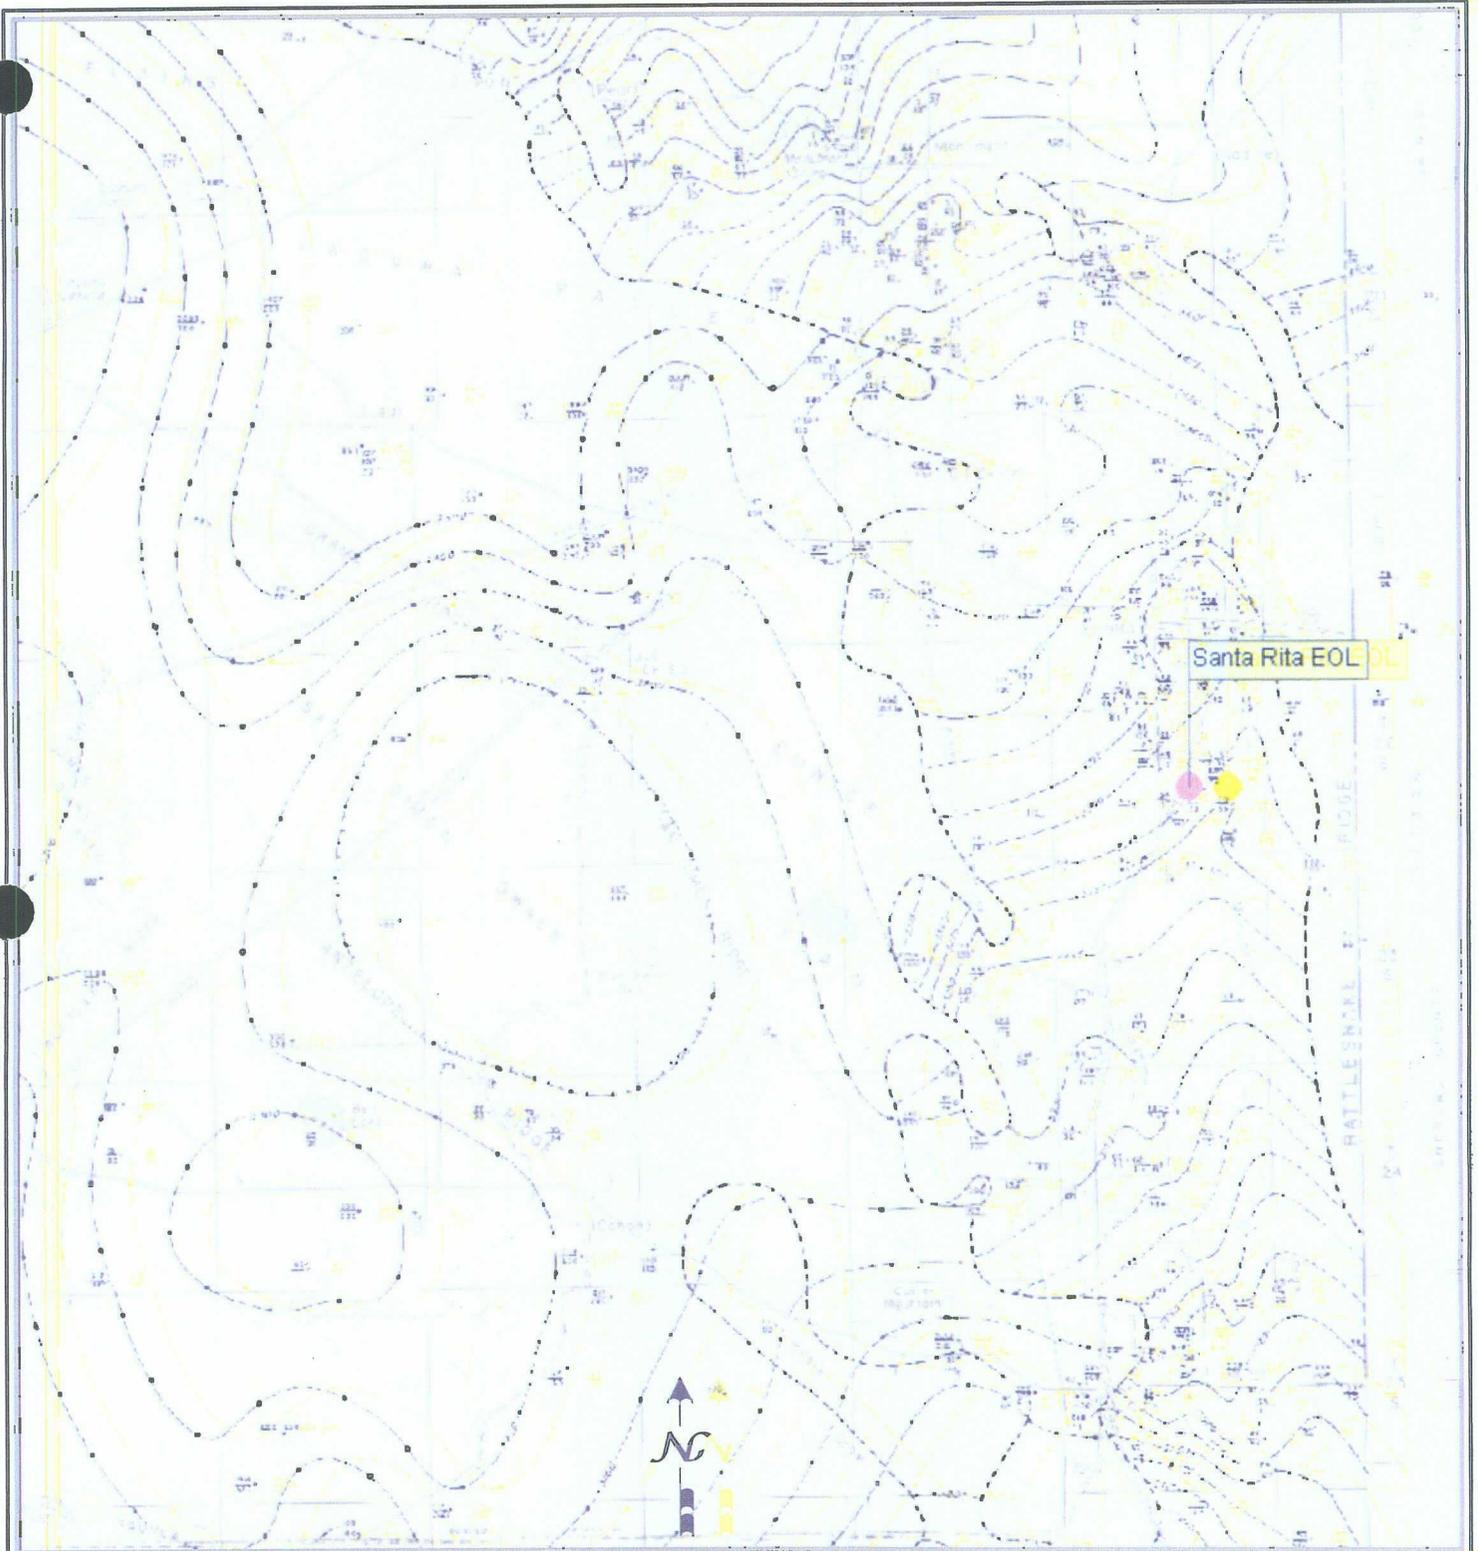
PLATE 5
 GROUND WATER MAP

Source: Nicholson & Clebsch (1961)

Nicholsen and Clebsch (1961) found that the regional gradient of the Ogallala and interconnected colluvial aquifer in the site area generally flows toward the southeast and the hydraulic gradient varies from approximately 0.001 to 0.01 feet/feet. Recent data from ROC sites within two miles from the Santa Rita EOL site (E-15 junction box, Zachary Hinton EOL O-12) confirm a similar potentiometric surface.

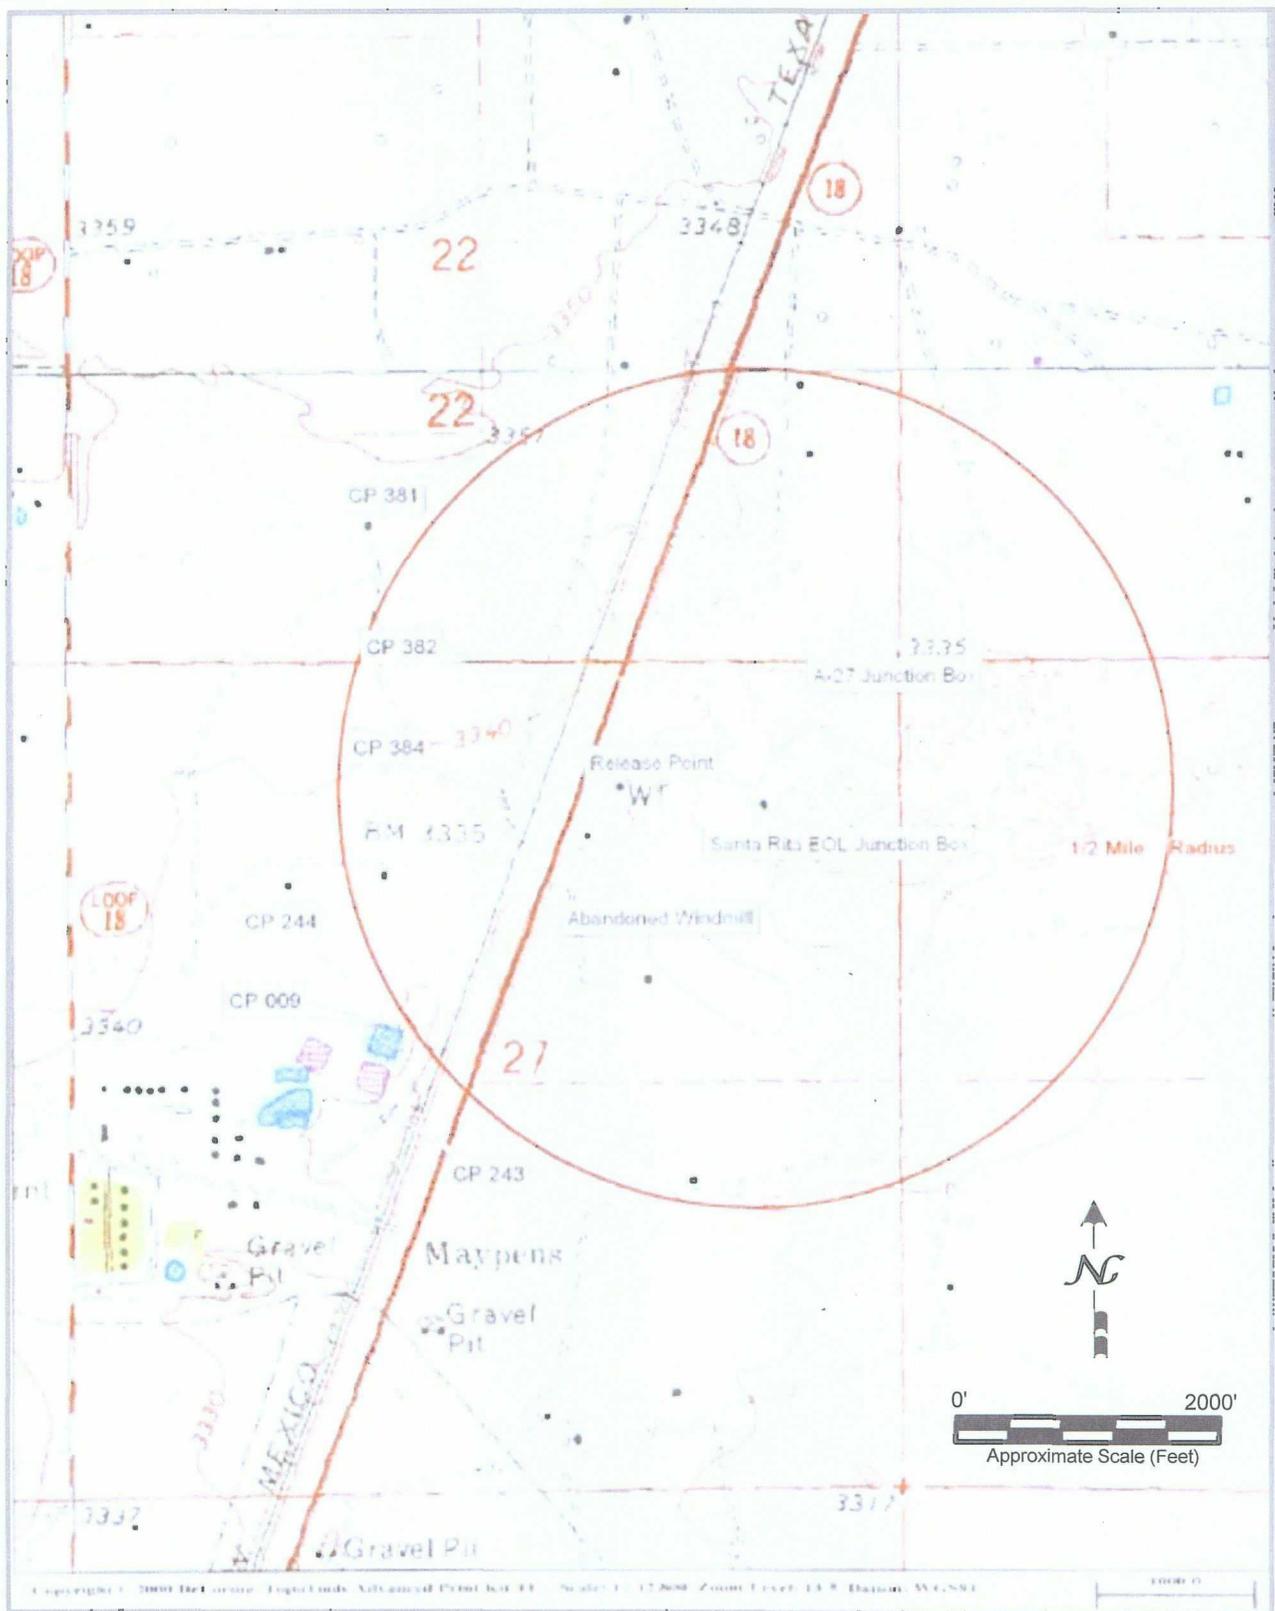
PLATE 6
 WATER WELL MAP

Plate 6: Water Well Map (NMSEO & USGS)

We plan to examine records at the OCD, NMED, Office of the State Engineer (OSE) and the US Geological Survey (USGS) for water quality and water level data. This file search will provide a better understanding of ground water flow and ambient (and possibly background) water chemistry. Plate 6 shows the locations of nearby water supply and monitoring wells obtained from ROC, OCD, NMED, OSE, and USGS databases. Further examination of data for these wells will assist us in understanding the contribution of the Santa Rita EOL site to the observed regional chemistry. Our characterization of ground water will include evaluation of monitoring data from other ground water investigation sites in the area, including the South Eunice gas plant. The water well inventory will also assist in identifying the location of potential water supply receptors (domestic, irrigation, or livestock wells).

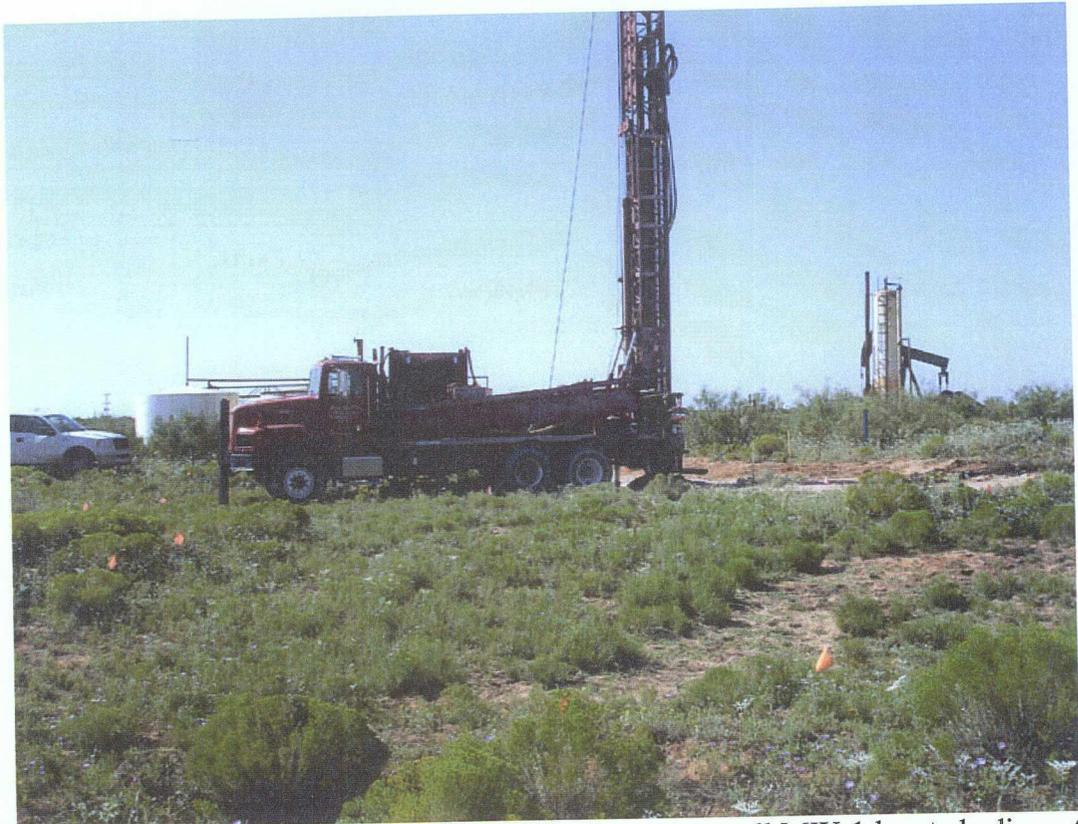
View facing southwest showing drilling of monitoring well MW-1 located adjacent to release point at the Santa Rita EOL Site. (08-30-05)

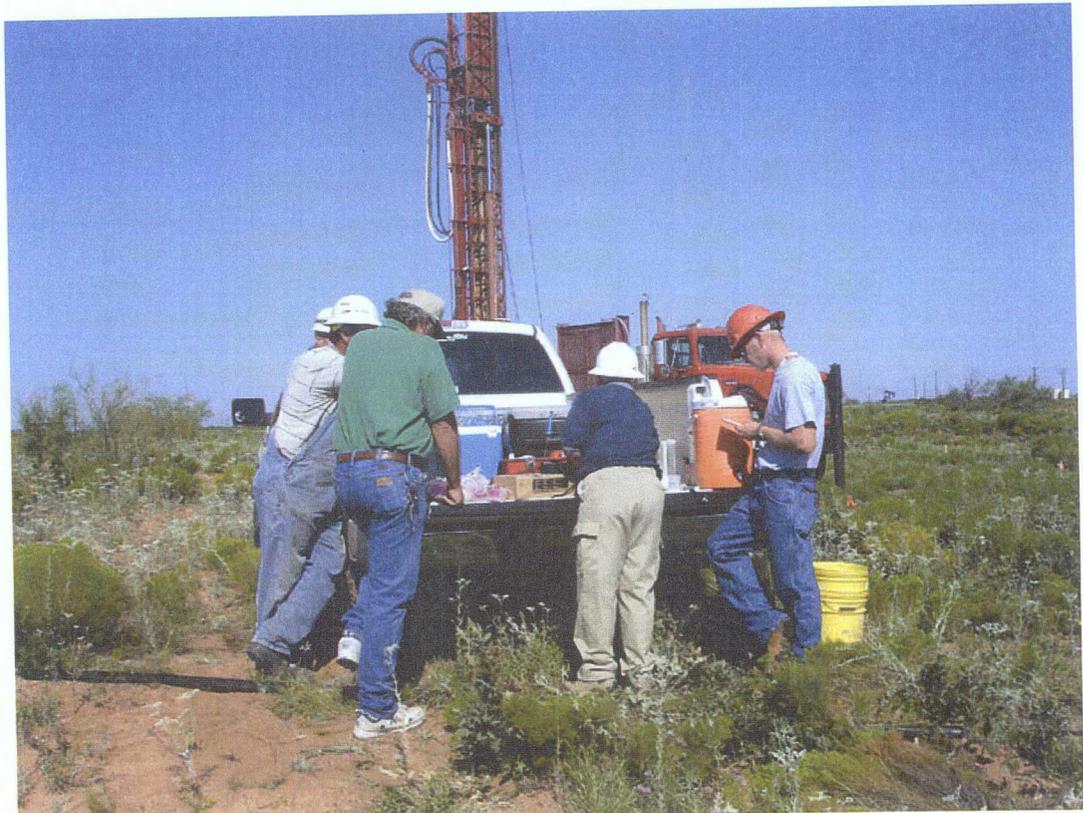
View facing west showing chloride screening activities for soil samples obtained from monitoring well MW-1 at the Santa Rita EOL site (08-30-05)
