RE: NOTIFICATION OF GROUNDWATER IMPACT
BD jct. P-26-2, #1R0426-107
Unit P, Sec. 26, T21S, R37E

SOIL BORING LITHOLOGIC LOG

LITHOLOGIC LOG AND MONITORING WELL CONSTRUCTION DIAGRAM

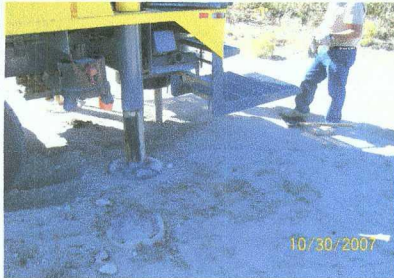
BOREHOLE NO.: B-1

COMMENTS: Boring located 8 feet west of former junction box (plate marker).

Photo at left shows drilling of B-1 (facing west) with marker plate in foreground.

1422	Split Spoon	2658	0		
	25					SM/CAL	Very fine-grained sand with calcium carbonate in matrix and intermittent hard (indurated) caliche, very pale orange (10YR 8/2). Sand grains are medium-sorted, subrounded, unconsolidated, dry. Sample submitted for laboratory analysis with results as follows: Chloride = 4670 mg/kg.
		1435	Split Spoon	5025	0		
	30						Very fine-grained sand with calcium carbonate in matrix and intermittent hard (indurated) caliche, very pale orange (10YR 8/2). Sand grains are medium-sorted, subrounded, unconsolidated, dry.
		1445	Split Spoon	2555	0		
	35						Very fine-grained sand with calcium carbonate in matrix and intermittent hard (indurated) caliche, very pale orange (10YR 8/2). Sand grains are medium-sorted, subrounded, unconsolidated, dry.
		1449	Split Spoon	2309	0		
	40	1505	Cuttings	2100			Very fine and fine-grained sand with calcium carbonate in matrix and intermittent hard (indurated) caliche, pale yellowish brown (10YR 6/2). Sand grains are medium-sorted, subrounded, unconsolidated, dry.

Bottom of boring at 40 feet below ground surface.
	45						
	50

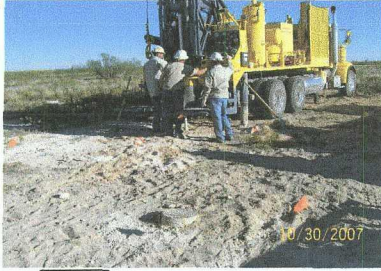
MONITORING WELL NO.: MW-1

COMMENTS: Located approximately 15 feet southeast of former junction box (plate marker).

Photo at left shows MW-1 drilling activities (facing southeast). Orange pin flagging identifies active brine water lines and marker plate is shown in foreground.

Sample		Chloride	PID	USCS	LITHOLOGIC DESCRIPTION:
		Depth	Time	Type	(ppm)	(ppm)	LITHOLOGY, COLOR, GRAIN SIZE, SORTING, ROUNDING, CONSOLIDATION, DISTINGUISHING FEATURES
Cement	3/8" Bentonite Hole Plug			Surface			SW
		5					Fine-grained dune sand, light brown (5YR 6/4), well sorted, well-rounded, unconsolidated, dry.
Cement	3/8" Bentonite Hole Plug		1540	Split Spoon	516	0	SM/CAL
		10	1542	Split Spoon	359	0	Fine-and medium-grained sand, pale yellowish brown (10YR 6/2) and grayish orange (10YR 7/4), moderately well-sorted, subrounded, unconsolidated, dry.
20/40 Brady Silica Sand Pack	2" Sched 40 PVC Blank Casing		1543	Split Spoon	564	0	SW
		15					Fine-and medium-grained sand, pale yellowish brown (10YR 6/2) and grayish orange (10YR 7/4), moderately well-sorted, subrounded, unconsolidated, dry. Sample submitted for laboratory analysis with results as follows: Chloride = 162 mg/kg.
20/40 Brady Silica Sand Pack	2" Diameter Screen with 0.010" Slots		1545	Split Spoon	457	0	SW

65					Fine-and med-grained sand, pale yellowish brown (10YR 6/2), well-sorted, sub to well-rounded, moist. Bottom of boring at 60 ft below ground surface.

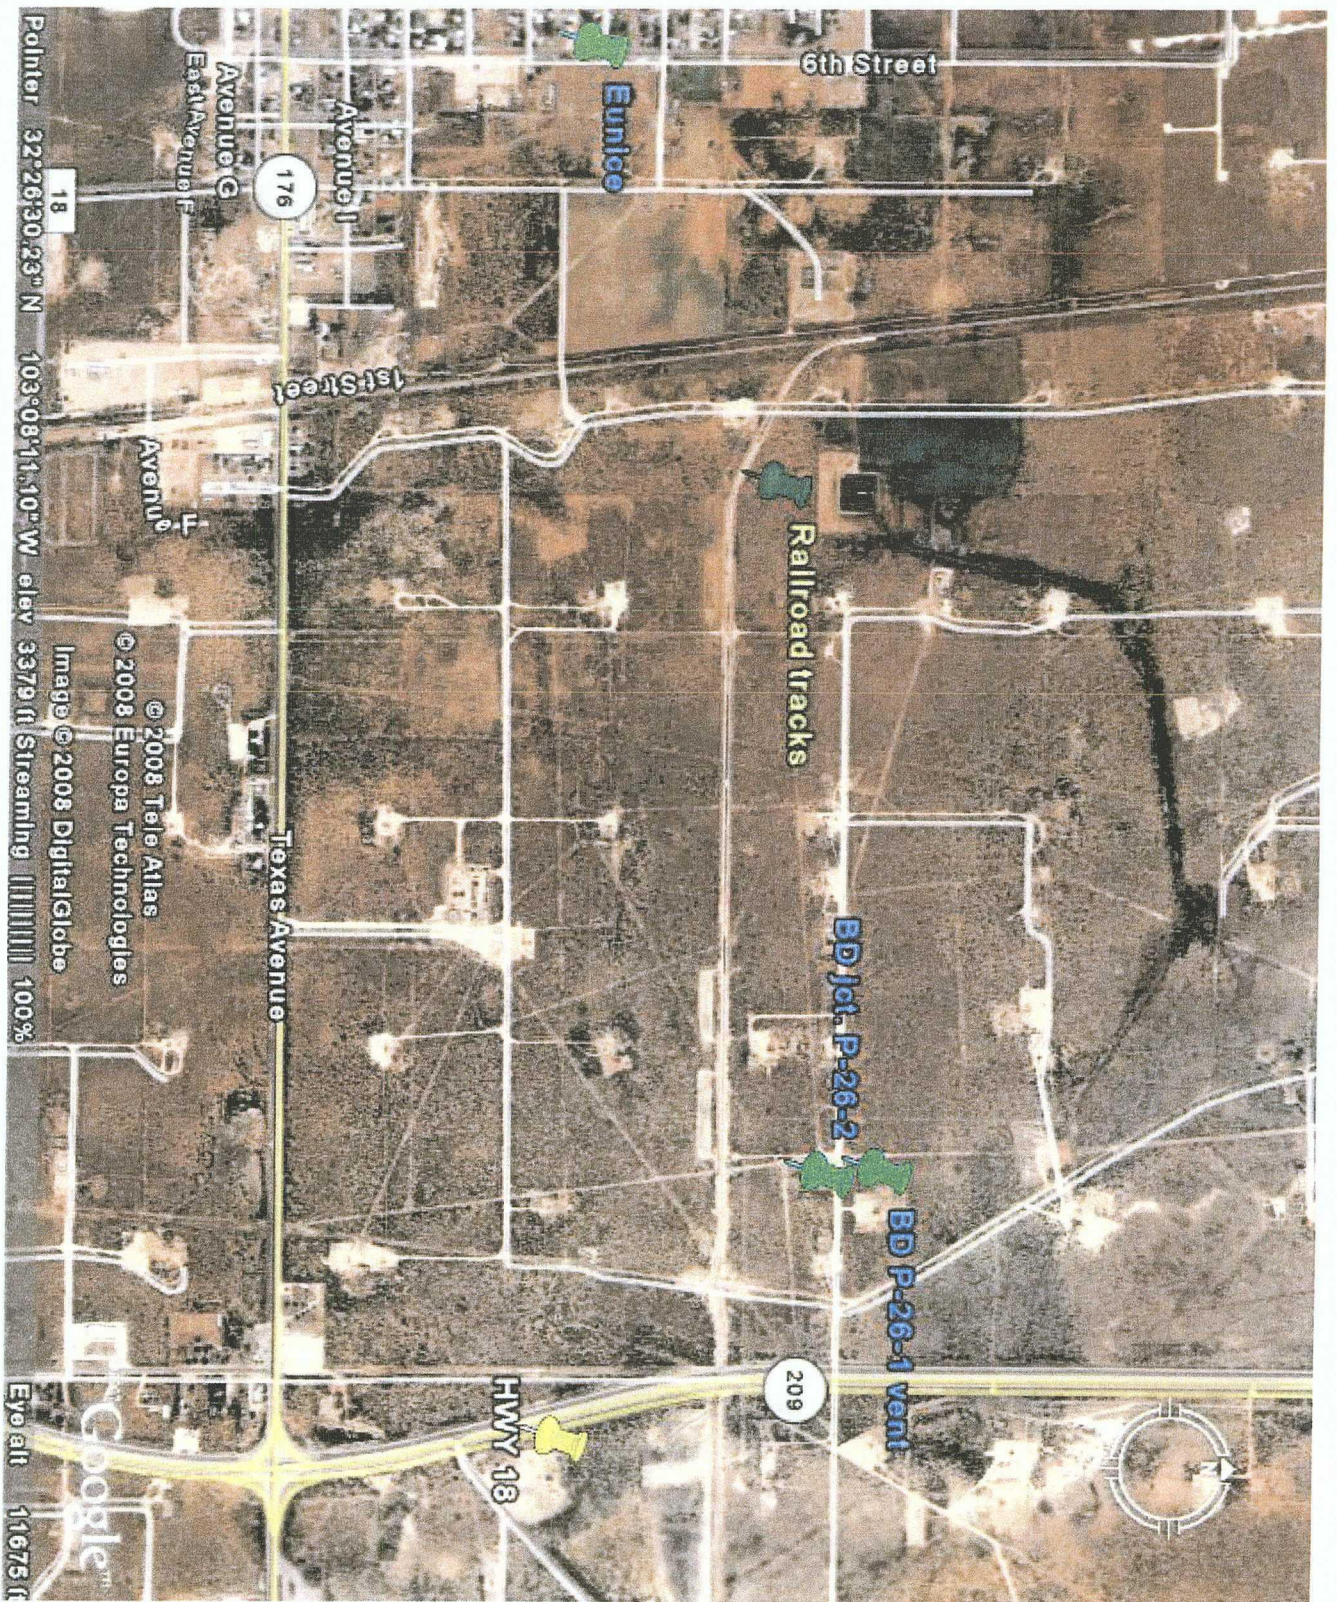
Point P-20-1 Vent
B-1
MX-1
