Release Notification and Corrective Action**OPERATOR** Initial Report Final Report

Name of Company: DCP Midstream, LLC	Contact: Steve Weathers
Address: 370 17 th St., Ste. 2500, Denver, CO 80202	Telephone No.: (303) 605-1718
Facility Name: A-19-19-3-1	Facility Type: 6" steel pipeline

**RE: Closure Report
DCP Midstream – A-19-19-3-1
NMOCD 1RP# 1151; EPI Ref. #130025
UL-M (SW $\frac{1}{4}$ of the SW $\frac{1}{4}$) of Section 21 T18S R33E
Latitude N 32° 43'33.8" and Longitude W 103° 40' 28.6"**

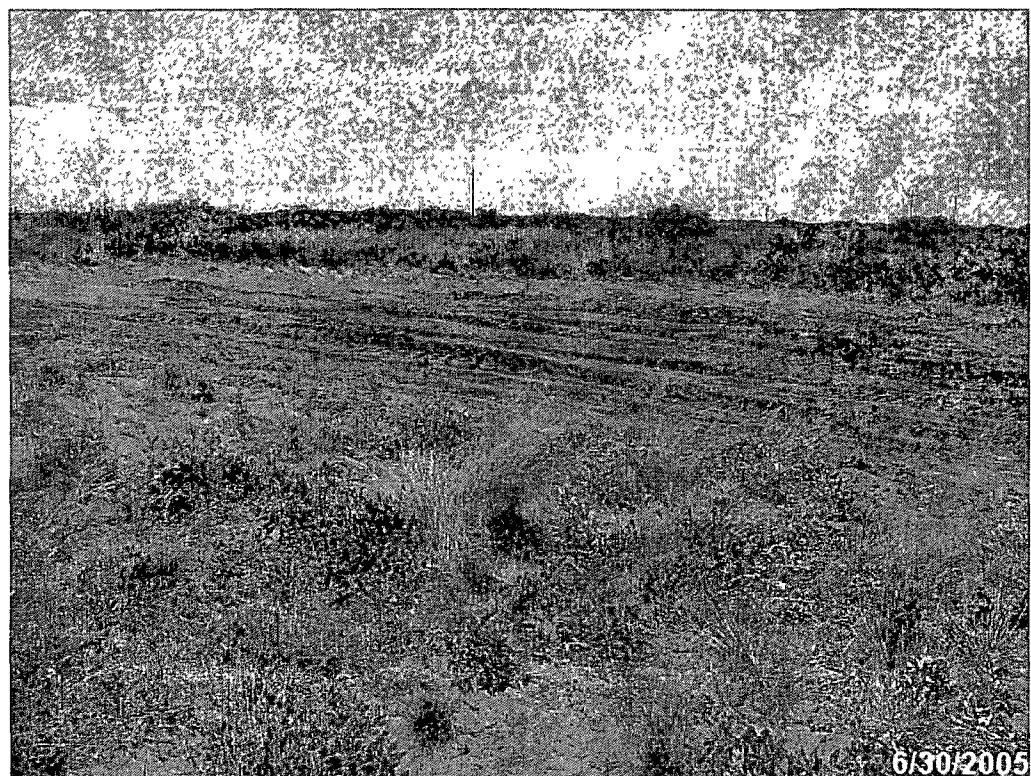
Photograph #1: Looking northwesterly across release area.

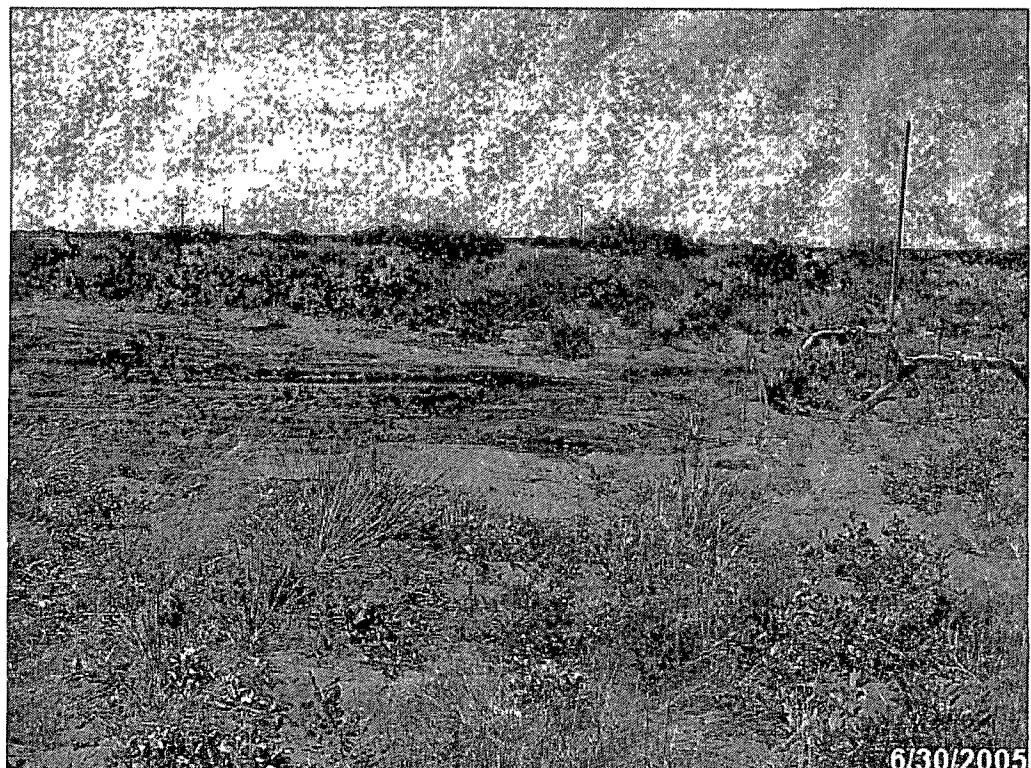
Photograph #2: Looking northerly across release and overspray areas.

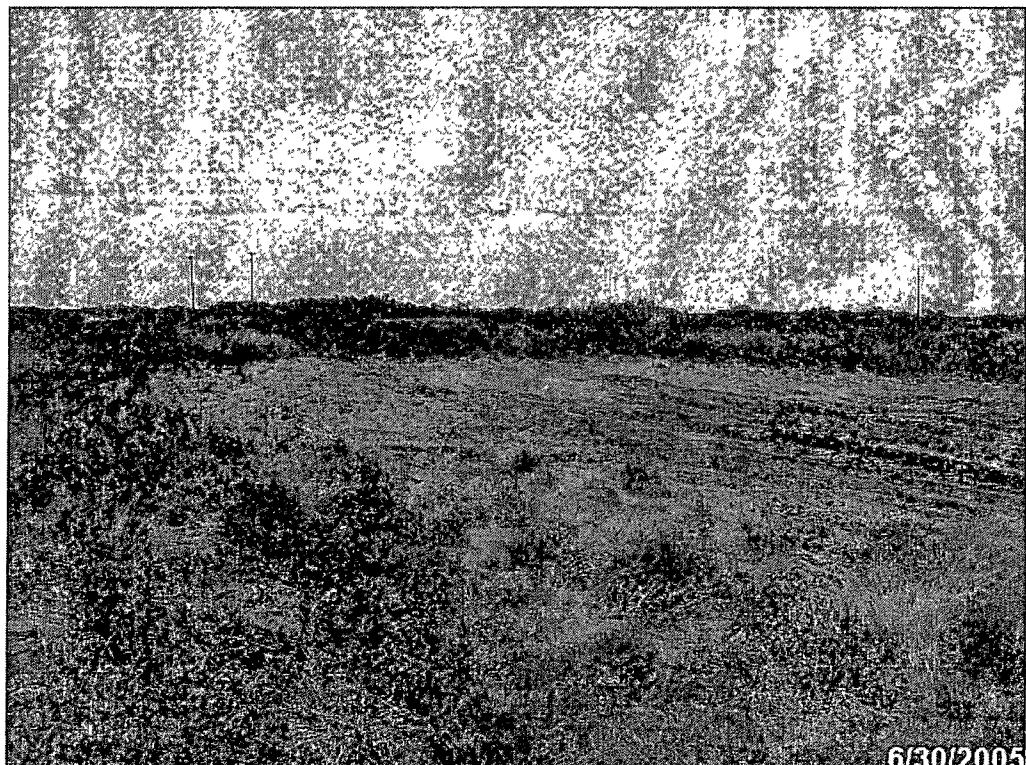
Photograph #4: Looking northwesterly across release area.

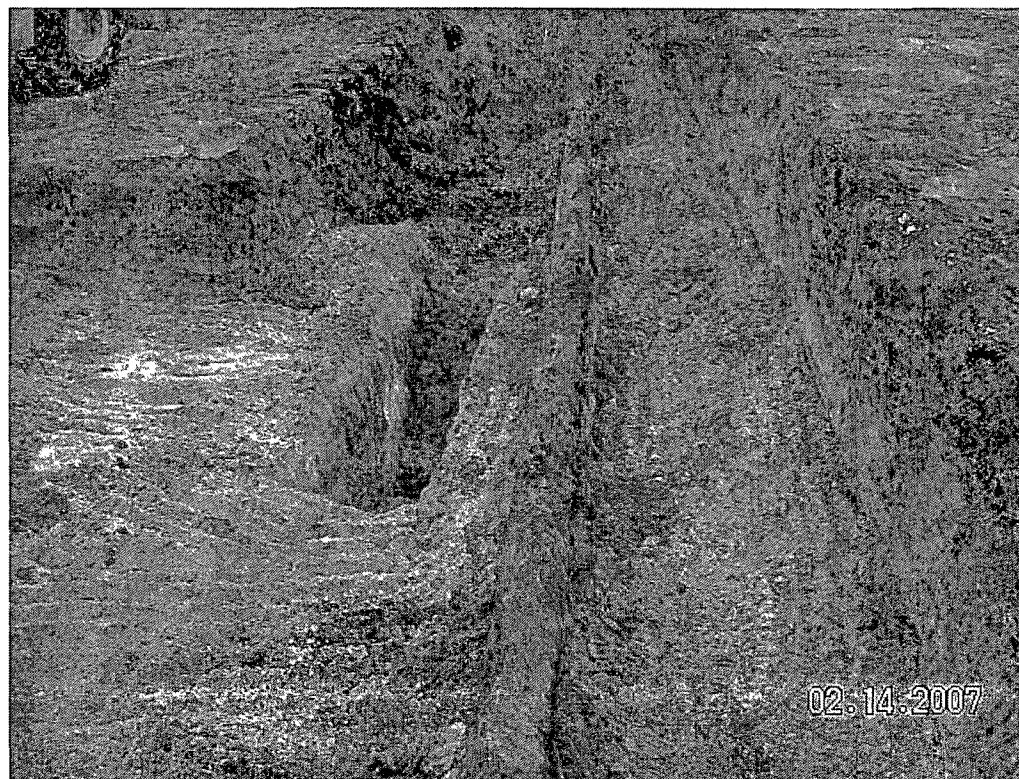
Photograph #5: Looking westerly at excavation and gas line. Dark stained soil indicates impacted soil.

Excavation of NGL impacted soils commenced on 16 February 2007 and continued through 7 March 2007. During initial excavation activities, vertical extent of hydrocarbon impacted soil was determined to exceed depths determined from soil borings. On February 21, 2007, two (2) test trenches were excavated within the release area adjacent and beneath the pipeline to determine vertical extent of impacted soil. Soil samples were collected and analyzed in the field for organic vapor concentrations. Upon discovery of maximum vertical extent of hydrocarbon impacted soil, soil samples were collected for laboratory analyses [i.e., TT-BH-1 (20') and TT-BH-2 (20')].

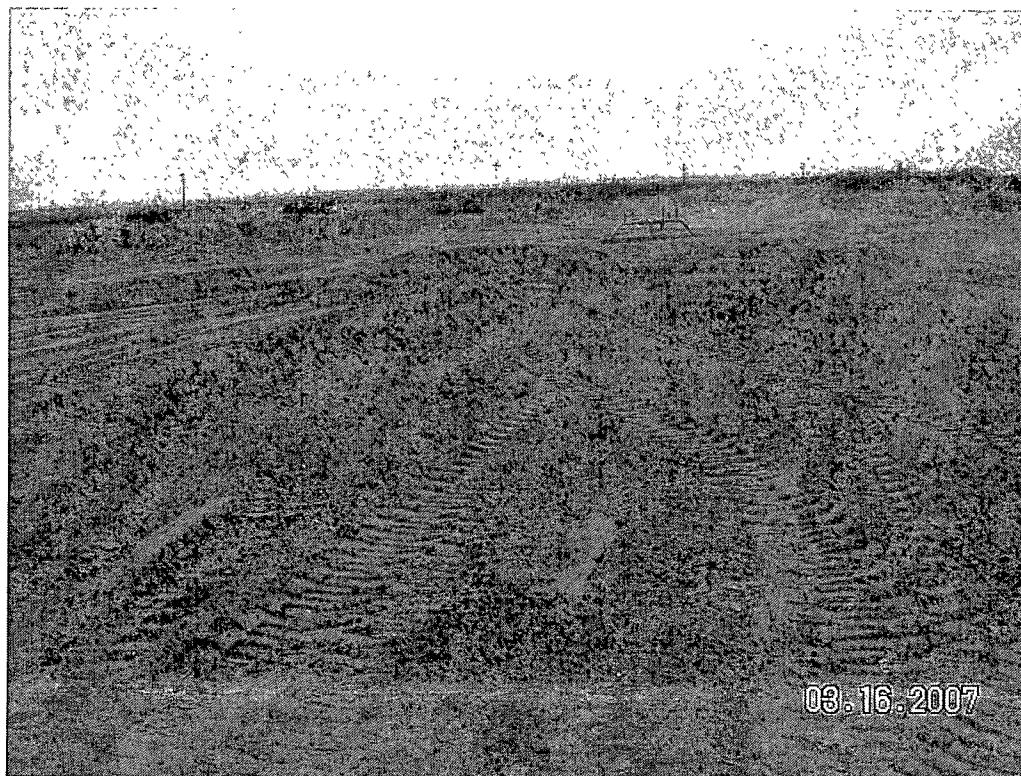
Photograph #9 – Looking northeasterly across site after backfilling.

Upon receipt of laboratory analytical data indicating NMOCD remedial goals had been achieved, the excavation was backfilled with previously blended/aerated native soil and clean soil. With completion of backfilling activities, the site was graded/contoured to promote natural drainage.

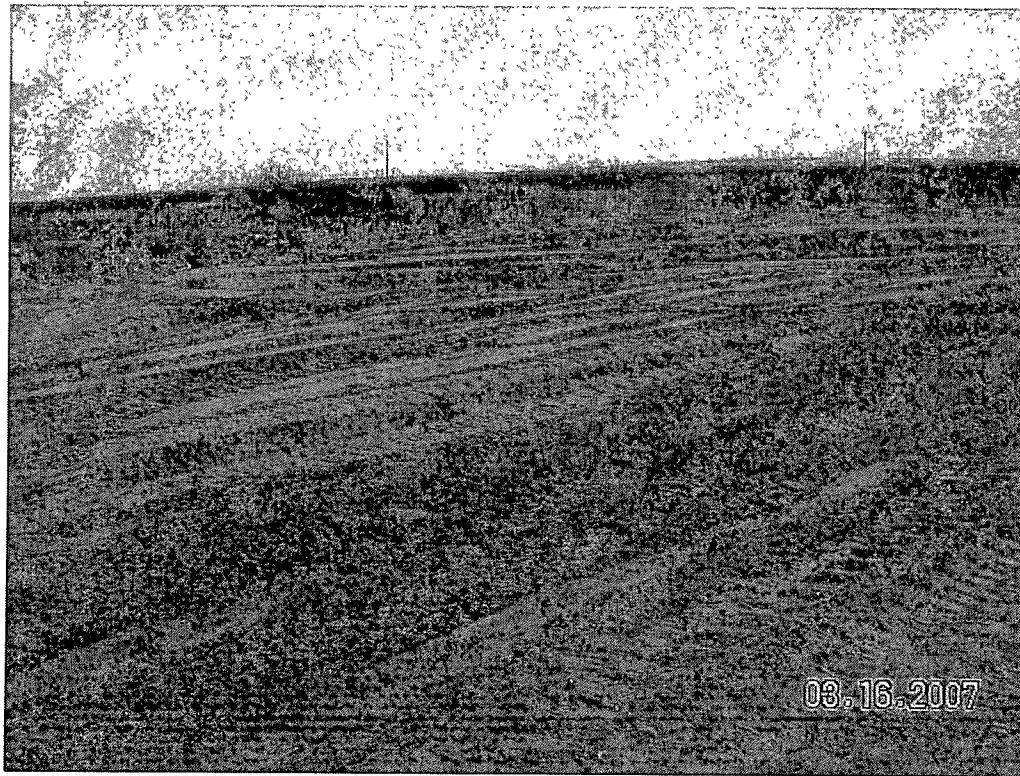
Photograph 10 – Looking northerly across remediated site.
