From: L. Peter Galusky, Jr. P.E. [lpg@texerra.com]
Sent: Wednesday, August 27, 2008 2:22 PM
To: Hansen, Edward J., EMNRD
Cc: Hack Conder; Lara Weinheimer
Subject: Fw: Rice Operating Company - EME State Q EOL OCD Case Number: 1R427-174
Attachments: 2600157797-EME State Q ICP Report & Closure Request.pdf; EME State Q EOL 8.15.08 revegetation 1.JPG; EME State Q EOL 8.15.08 revegetation 2.JPG

**RE: Investigation and Characterization Plan Report
Rice Operating Company – EME SWD System
State Q EOL (UL Q Sec 16 T 20S R 37E)
OCD Case Number: 1R427-174**

**RE: Investigation and Characterization Plan
Rice Operating Company – EME SWD System
State Q EOL (UL Q Sec 16 T 20S R 37E)**

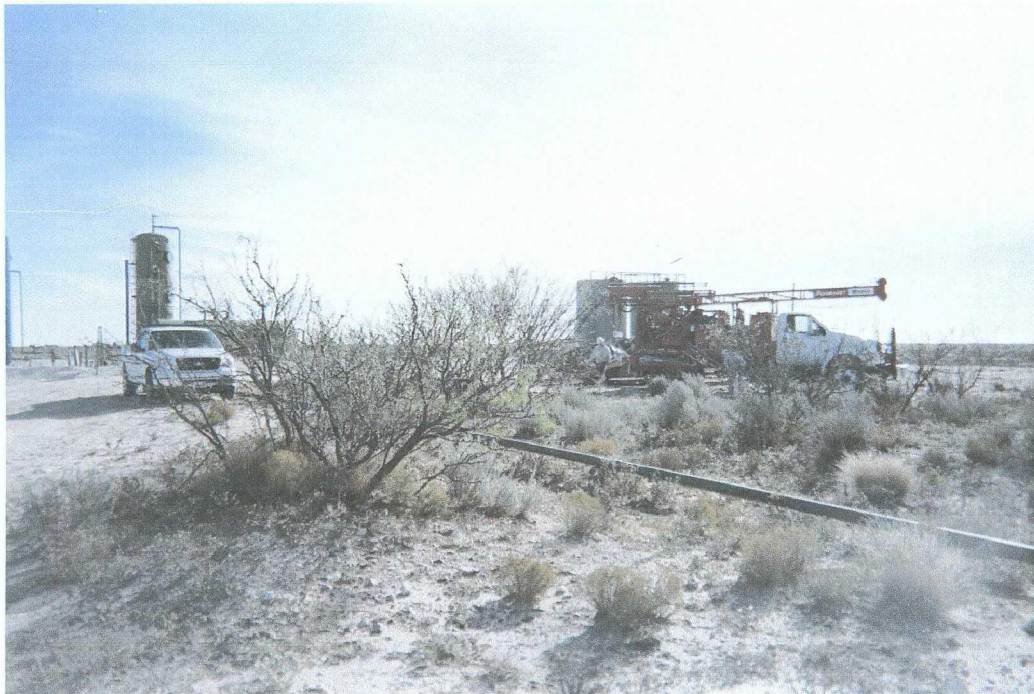
Figure 1 – Atkins Engineering Associates drill rig at EME State Q EOL on November 29th, 2007, drilling at/near former junction box location. View looking east/southeast.

A soil boring was advanced at/near the former junction box location¹ using a rotary auger drill on November 29th of last year (Figures 1 & 2). Samples were analyzed at five foot increments and field titrated for chlorides and tested for organics using a portable PID instrument (Table 1). Two sub-samples were sent to Cardinal Laboratories for a quality-check of the field results (Figures 3a & 3b).

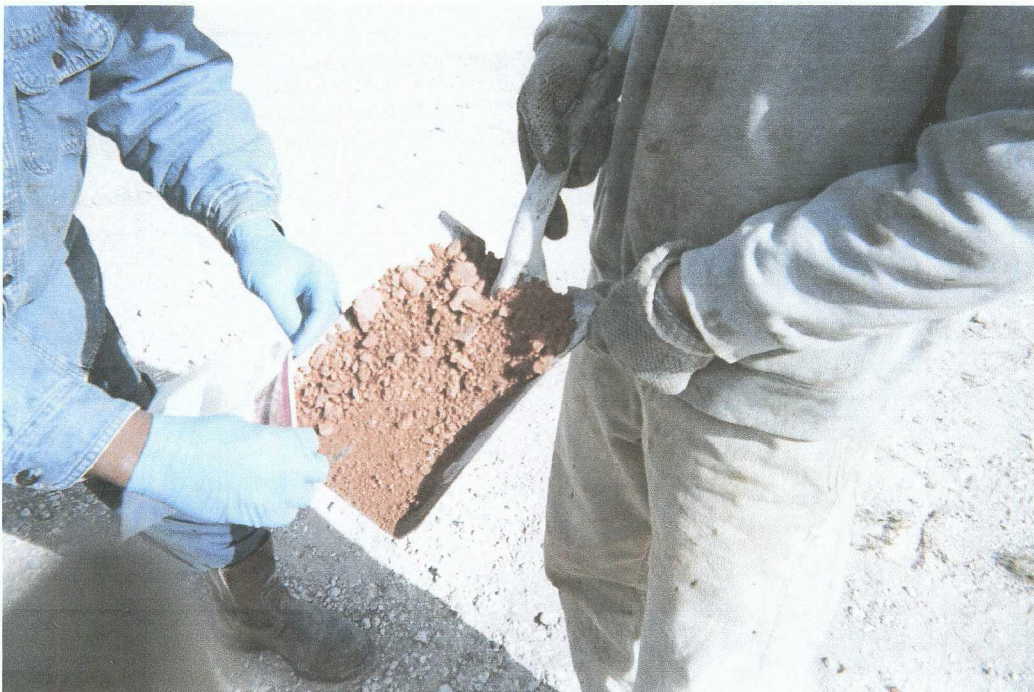
Figure 2 – View of “stiff red clay” substratum, encountered at/near former junction box location.

Chlorides were somewhat elevated (880 ppm) at a depth of 15-20 ft bgs, but dropped to insignificant levels (< 350 ppm) below 20 ft depth, where stiff, red sandy clay was encountered and continued to the limit of evaluation at 35 ft. No groundwater was encountered, nor were measurable levels of organics detected.

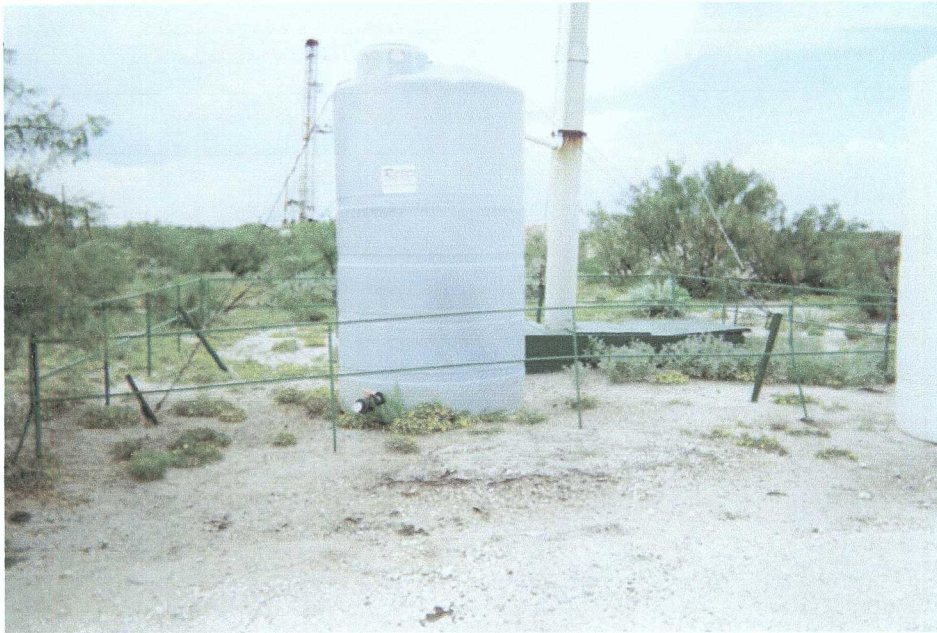
Photograph 1 – Undisturbed junction box with boot.

The surface (ecological) impact of this junction box was limited, as visual observation indicated that vegetation was not affected beyond approximately 25 ft from the former junction box; (Photograph 1). However, as some potential for groundwater contamination may exist, further evaluation is warranted for petroleum hydrocarbons, the primary constituent of concern. Therefore, ROC proposes additional investigative work, as outlined below, to determine if groundwater was impacted by the former junction box.

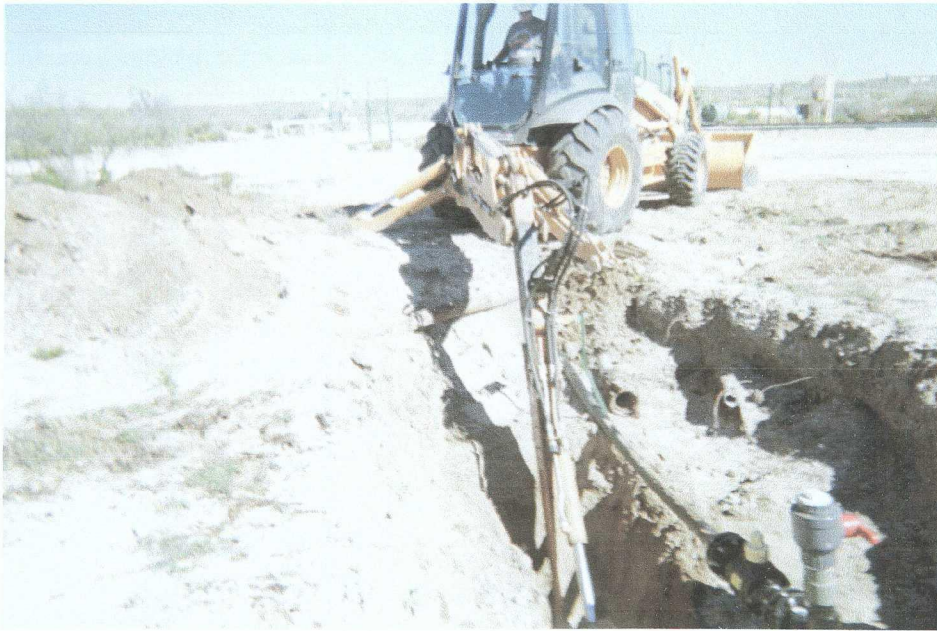
Photograph 1 – Delineation and excavation.

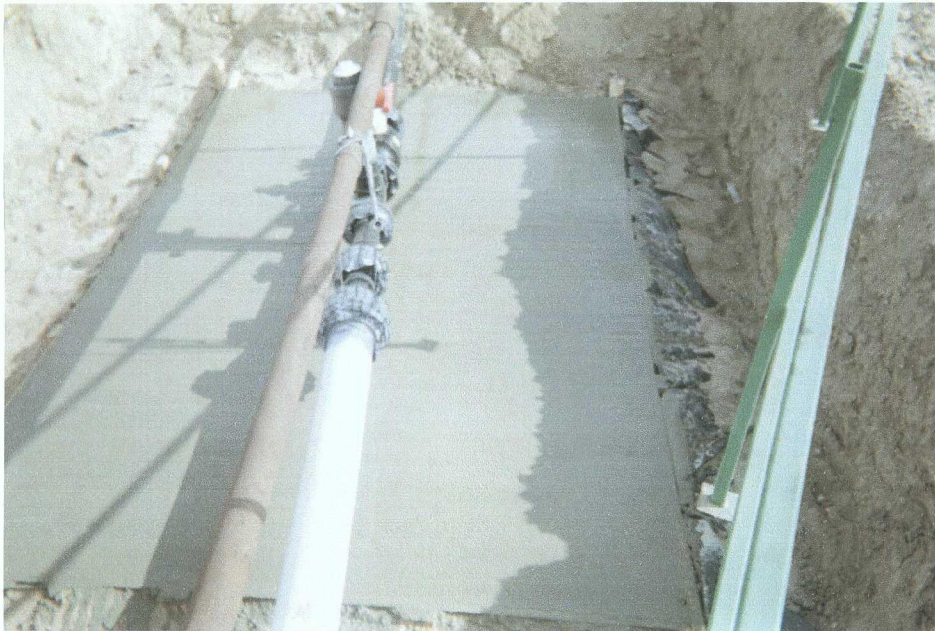
Photograph 2 – Floor of new concrete junction box.

As part of their on-going SWD facility upgrades, Rice removed a wooden junction box (associated with a boot) at this location, and replaced it with a concrete junction box in November of 2004. The site was re-graded to natural contours and seeded to native grasses in June of 2005.

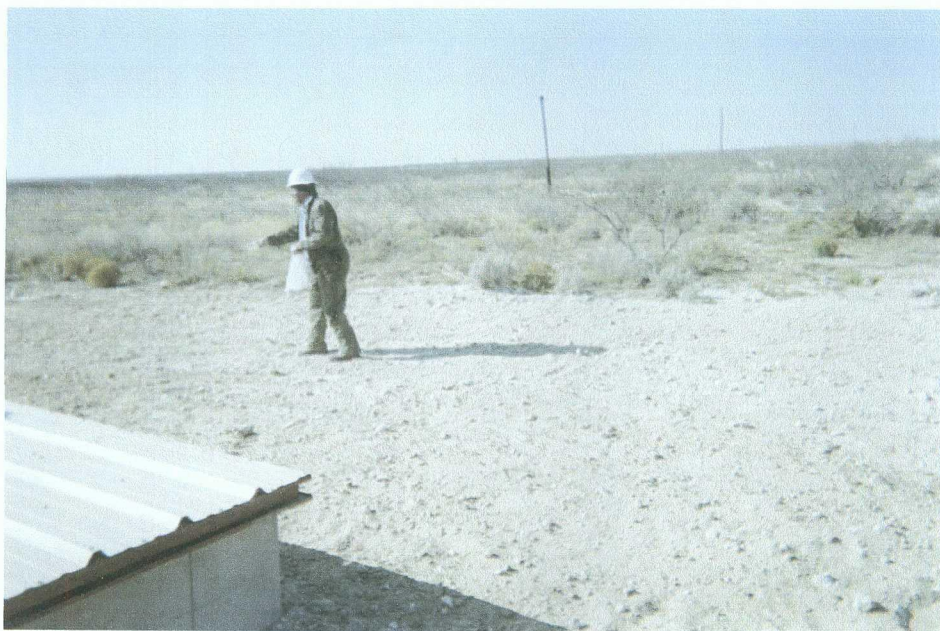
Photograph 3 – Reseeding around new junction box.
