RICE OPERATING COMPANY JUNCTION BOX FINAL REPORT

BD jct. F-17-1

unit 'F', Sec. 17, T21S, R37E

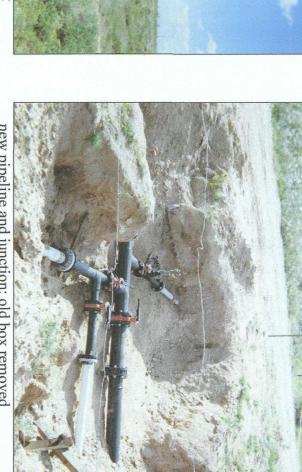
9/16/2005

new pipeline and junction; old box removed

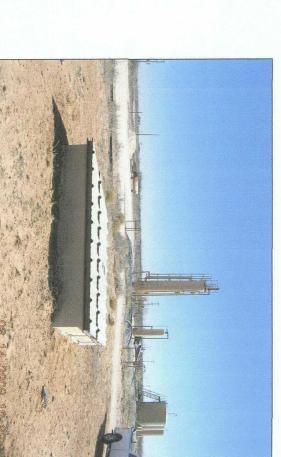
10/24/2005

completed new box

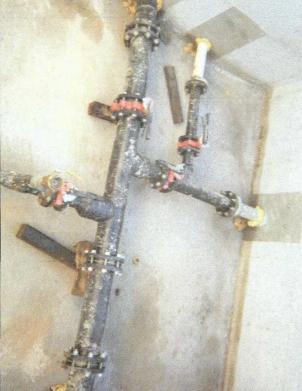
3/14/08

inside new, watertight, concrete junction box
