## RICE OPERATING COMPANY JUNCTION BOX FINAL REPORT

# BD jct. G-30 Unit G, Section 30, T21S, R37E

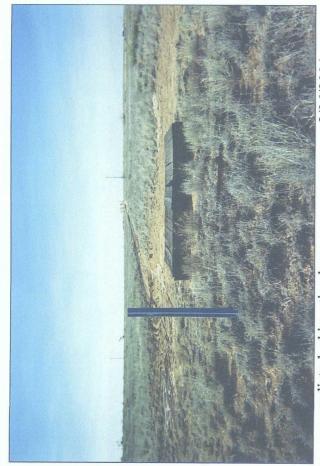
2/26/2004

undisturbed junction box

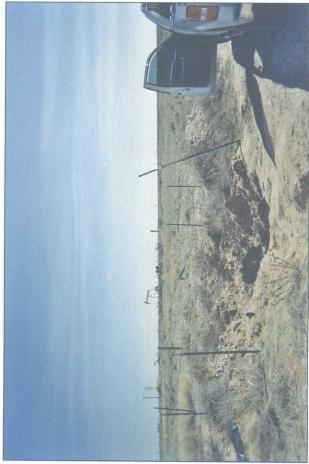
junction box removed; pipeline replaced
