Closure

RICE OPERATING COMPANY
JUNCTION BOX FINAL REPORT

BD Falby EOL

Unit M, Section 8, T22S, R37E

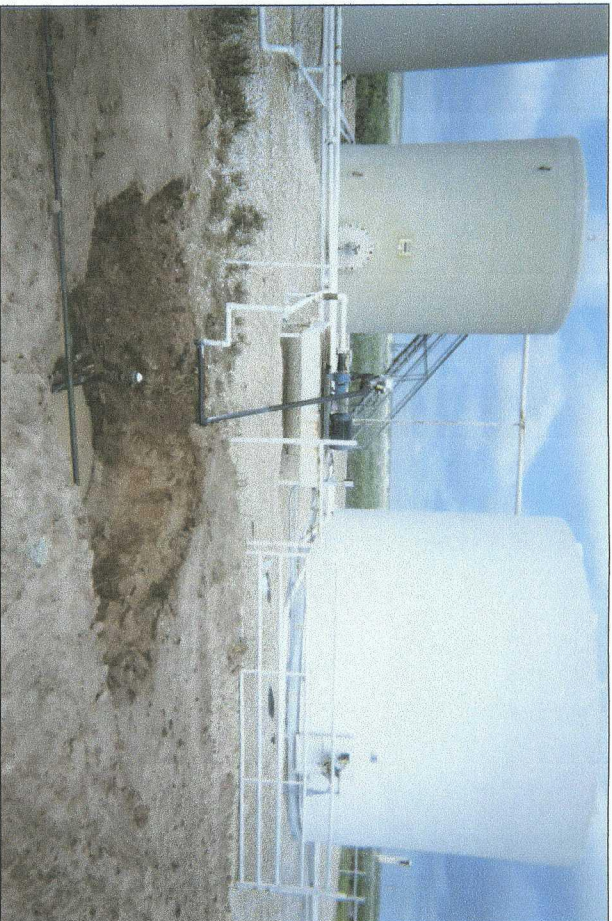
pipeline and junction replaced

9/14/2007

This junction was upgraded with the ongoing pipeline replacement program. After the old box location was cleared of NORM, the pipeline and junction were upgraded with poly pipe. The site was then inspected for evidence of chloride and hydrocarbon impact. The soils at and surrounding the site did not exhibit any signs of adverse effects from this junction. Soil samples at the junction were collected using a hand auger to 8 ft BGS. The samples were field tested for chloride and yielded very low concentrations. Organic vapors were also measured using a PID and yielded low concentrations as well. The deepest sample was sent to a commercial laboratory to confirm field tests. Laboratory analysis confirmed that neither TPH nor chloride was present within the laboratory's detection limits. No further environmental investigation was warranted. A new concrete, watertight junction box was built over this junction in the same location.

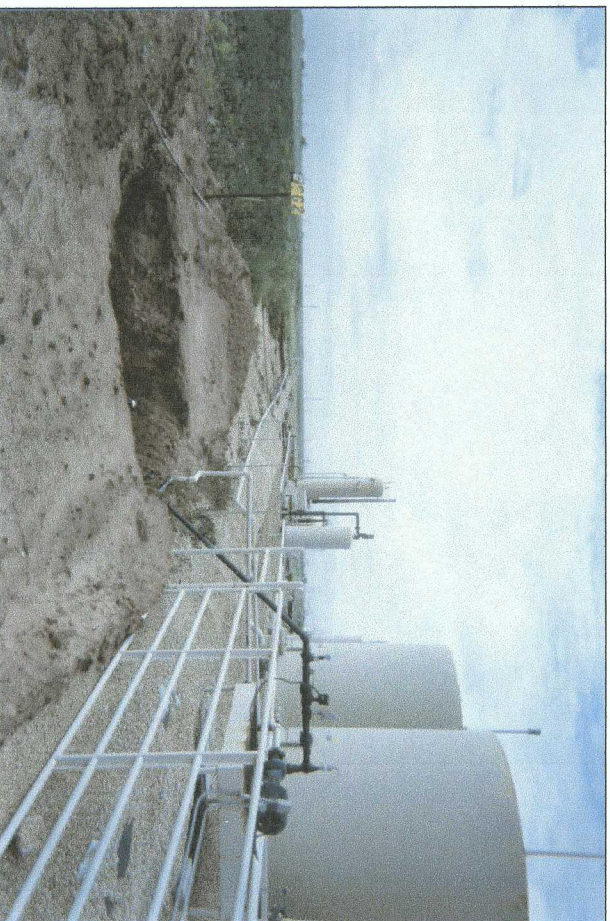
initial investigation and hand auger sampling

9/14/2007

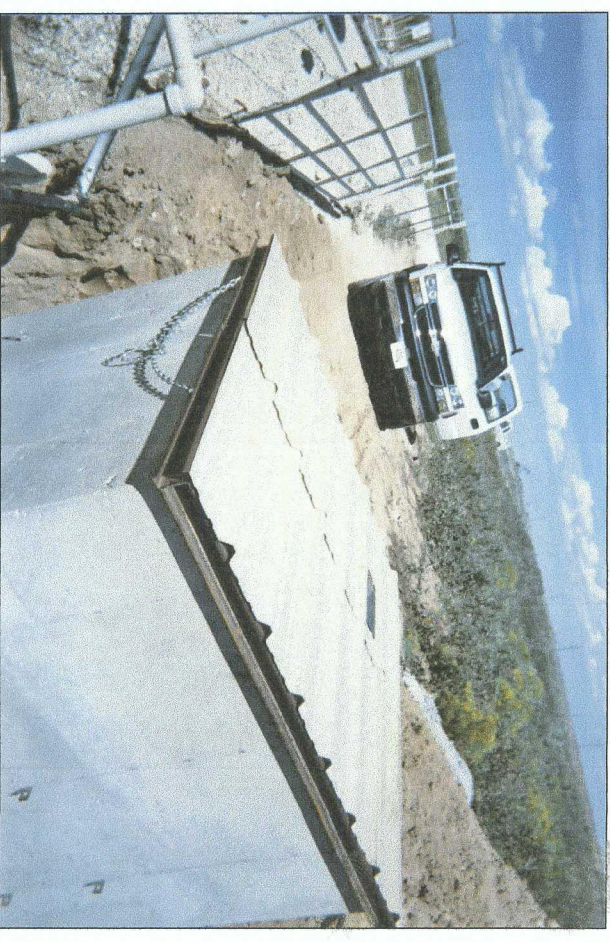
new concrete junction box completed in same location

10/2/2007
