BD Chevron Texaco Baker 'B' EOL

RICE OPERATING COMPANY
JUNCTION BOX FINAL REPORT

BD Baker 'B' EOL

Unit N, Section 10, T22S, R37E

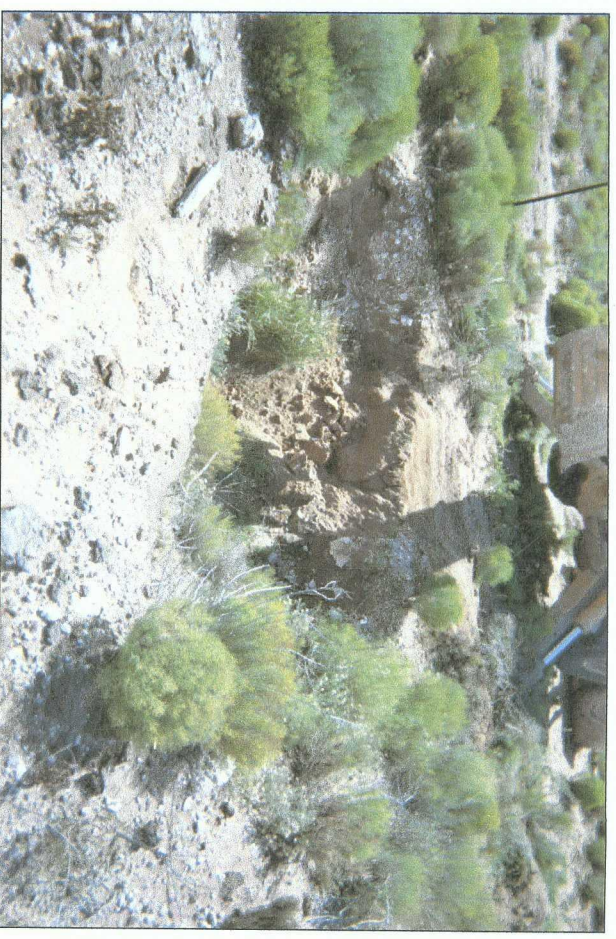
7/9/2007

former junction site (box removed); collecting soil samples

backhoe was used to collect soil samples at the site. Each sample was field tested for chloride and resulting concentrations were very low.

Organic vapors were also measured using a PID and yielded low concentrations as well. The deepest sample (6ft BGS) was sent to a commercial

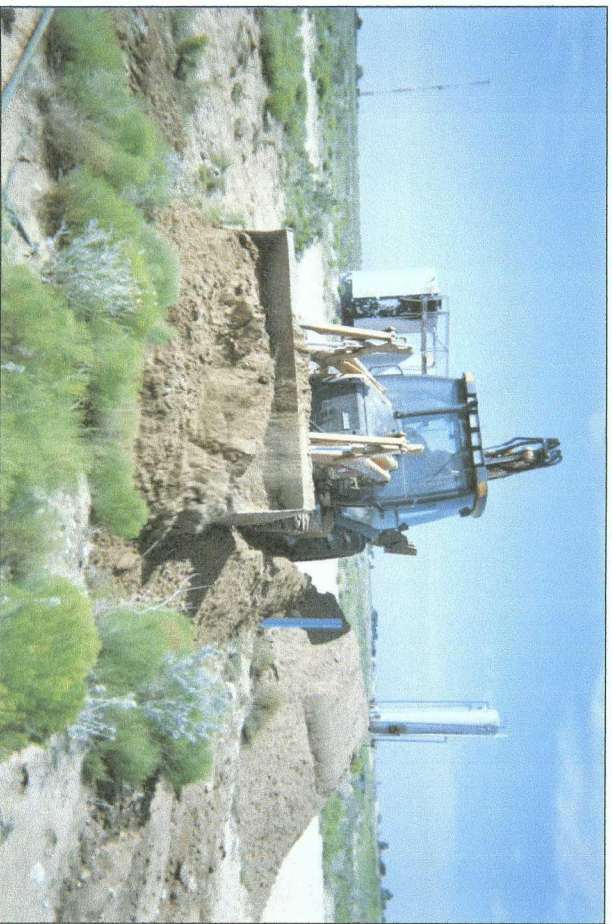
7/10/2007

backfilling former junction site with clean, imported soil

laboratory for confirmation of field tests. TPH concentrations met NMOCD guidelines. The hole from the old box was backfilled with clean,

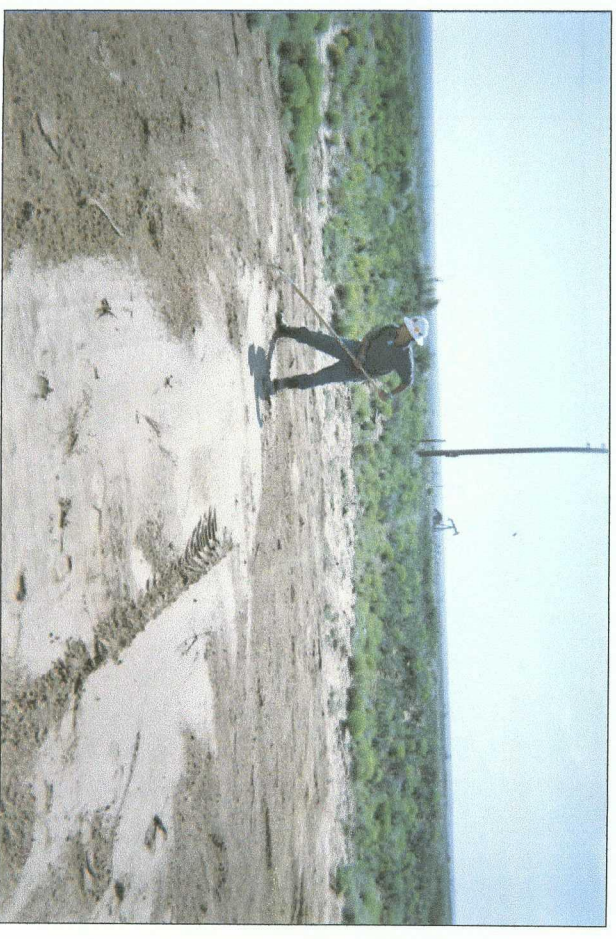
7/10/2007

seeding backfilled site

imported soil. The backfilled site was then seeded with a blend of native vegetation and the surface is expected to return to productive capacity

at a normal rate.
