**1R - 426-37**

1R426-37

RICE OPERATING COMPANY  
JUNCTION BOX CLOSURE REPORT

## **Closure Report: Junction N-29**

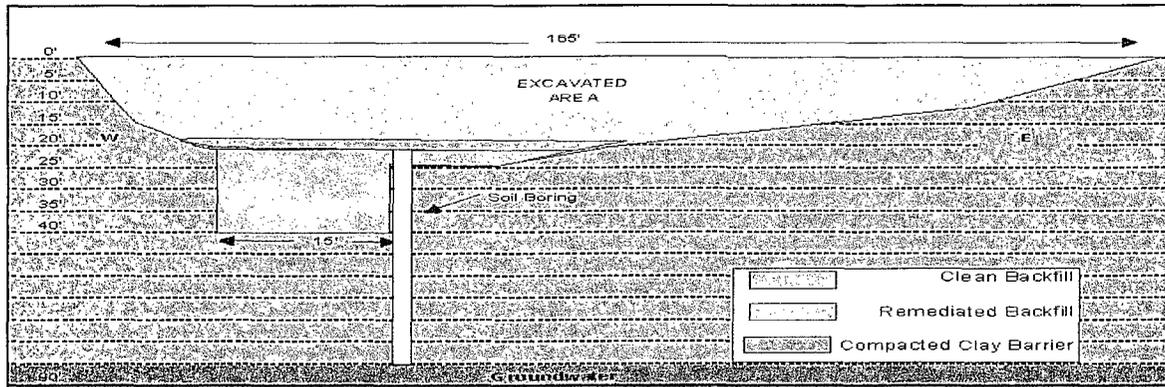
**Figure 1: Profile View of Impact Area**

Imported backfill placed in the deep excavation from 40 feet to 20 feet bgs was overlain by a compacted clay liner and additional backfill to ground surface to create a vadose zone remedy. The ground surface was graded to drain rainwater away from the area above the cap. The surface was then reseeded. Figure 1 presents a schematic of the excavation, backfill and clay layer installed at the site.

The Disclosure Report detailing all of the above-referenced work was completed on December 27, 2002, and forwarded to the NMOCD in early 2003. The work completed in 2002 concluded the vadose zone remedy for the site.

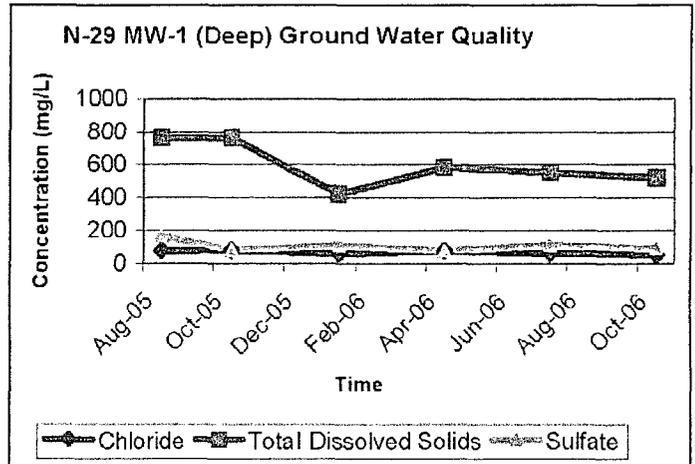
**Figure 2: N-29 Ground Water Quality at MW-1**

Total depth of well is 118.2 feet.

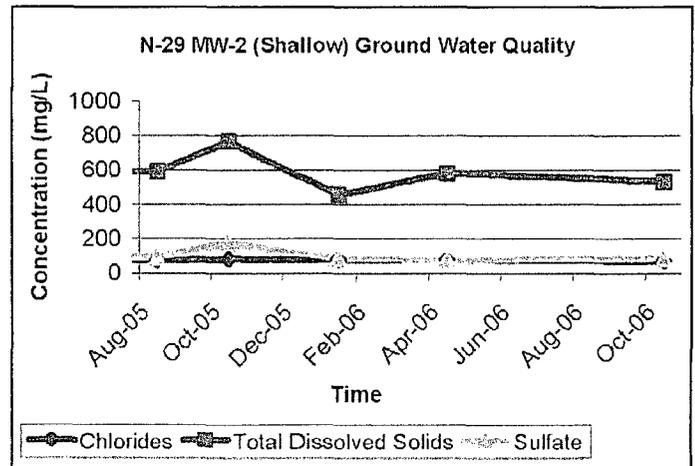
**Figure 3: N-29 Ground Water Quality at MW-2**

Depth To Water (ft.)	Sample Date	Chloride (mg/L)	TDS
89.50	8/30/05	73.1	590
89.90	10/18/05	82.8	766
89.30	1/17/06	78.8	454
89.42	4/17/06	79.2	584
89.17	7/12/06	89.2	566
89.11	10/5/06	70.1	534

Total depth of well is 104.1 feet.

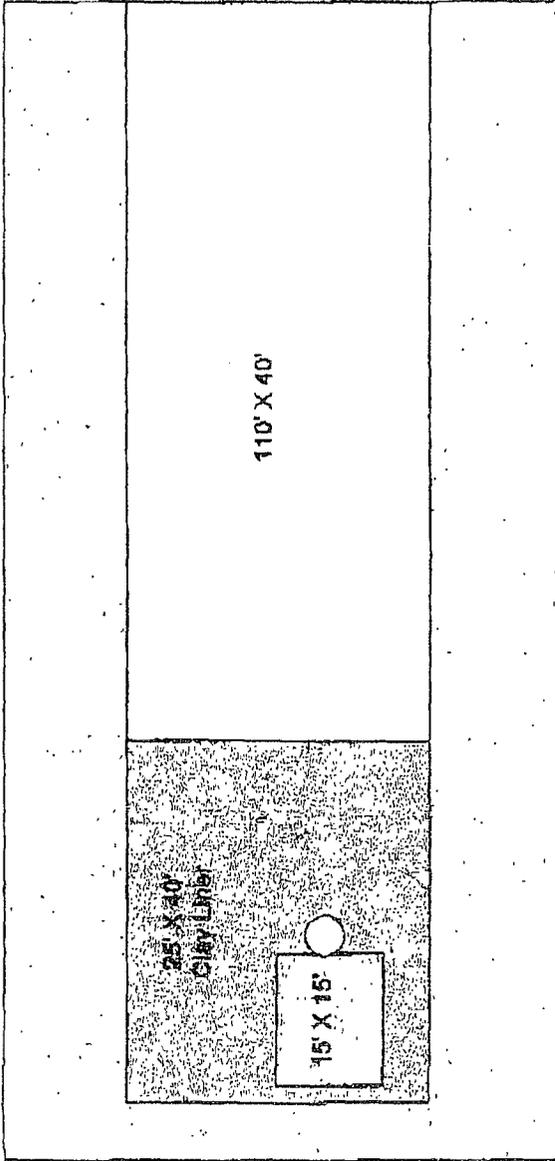
**AERIAL VIEW OF EXCAVATION**

165'

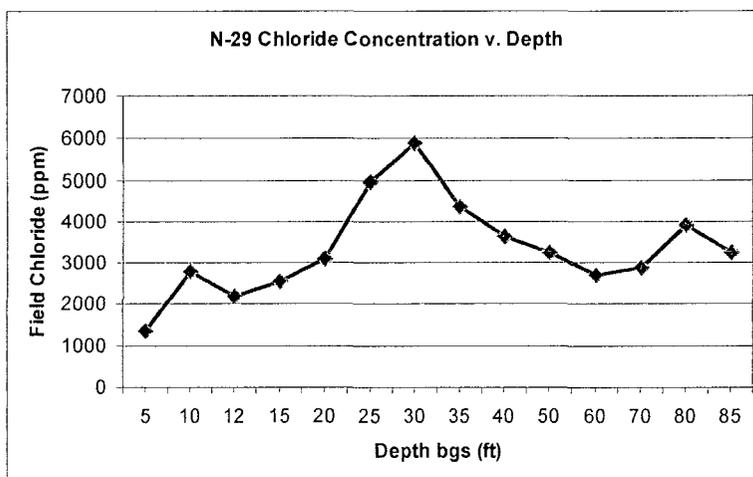
Rice Operating Company (ROC) prepared a Release Notification report and a Disclosure Report that summarizes activities to date. The Disclosure Report, which is part of the 2002 submission to NMOCD, is dated January 2, 2003. The soil borings show relatively constant chloride and TPH concentrations from near surface to a depth of 85 feet (ground water). As Figure 1 shows, consistent chloride concentrations suggest that the release created saturated conditions in the vadose zone. Saturated conditions distribute chloride relatively evenly throughout the vadose zone. Unsaturated flow conditions create different chloride distributions in the vadose zone.

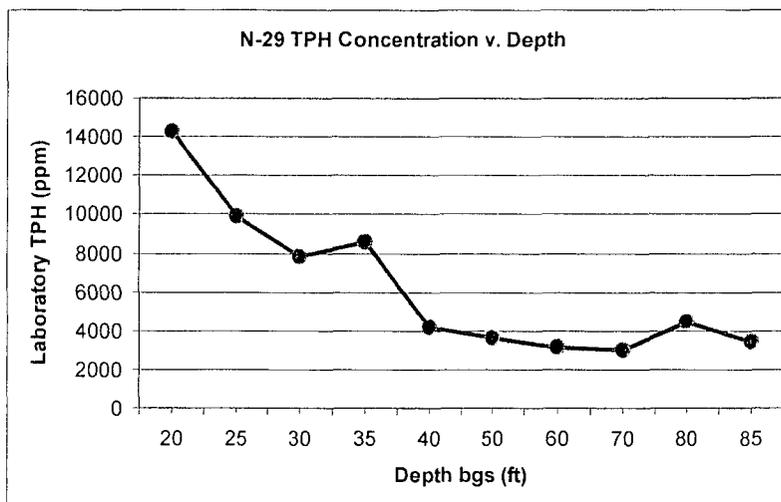
TPH decreases from 14,000 ppm at 20 feet below grade to about 4000 ppm at 40 feet (Figure 2), a 75% decrease. Because the release consisted of produced water from oil wells, laboratory analysis of soil samples detected volatile hydrocarbons in only one sample (less than 0.1 ppm of toluene and xylene). Volatile hydrocarbons are not commonly associated with crude oil as they are with refined products or water produced from natural gas wells. Regulated hydrocarbon constituents may not be present in ground water.

The soil boring data suggests potential ground water impairment by chloride. We propose installation of a ground water monitoring well, reclamation of the surface to its original productive capacity, and evaluation of the threat to ground water quality posed by the residual chloride and any hydrocarbon mass in the vadose zone.

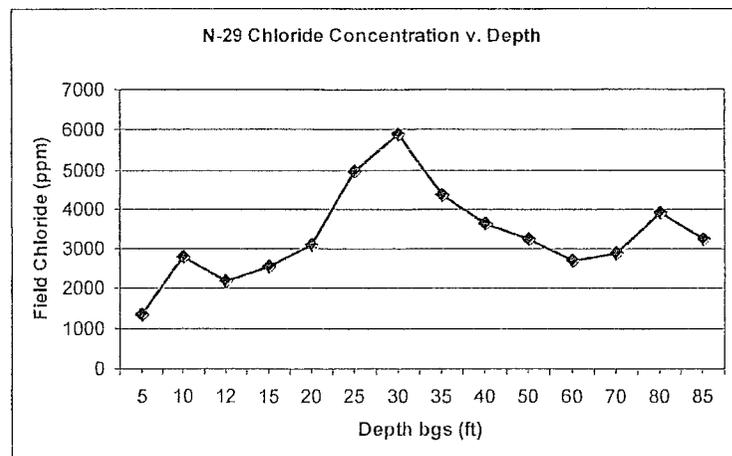
Rice Operating Company (ROC) prepared a Release Notification report and a Disclosure Report that summarizes activities to date. The Disclosure Report, which is part of the 2002 submission to NMOCD, is dated January 2, 2003. The soil borings show relatively constant chloride and TPH concentrations from near surface to a depth of 85 feet (ground water). As Figure 1 shows, consistent chloride concentrations suggest that the release created saturated conditions in the vadose zone. Saturated conditions distribute chloride relatively evenly throughout the vadose zone. Unsaturated flow conditions create different chloride distributions in the vadose zone.

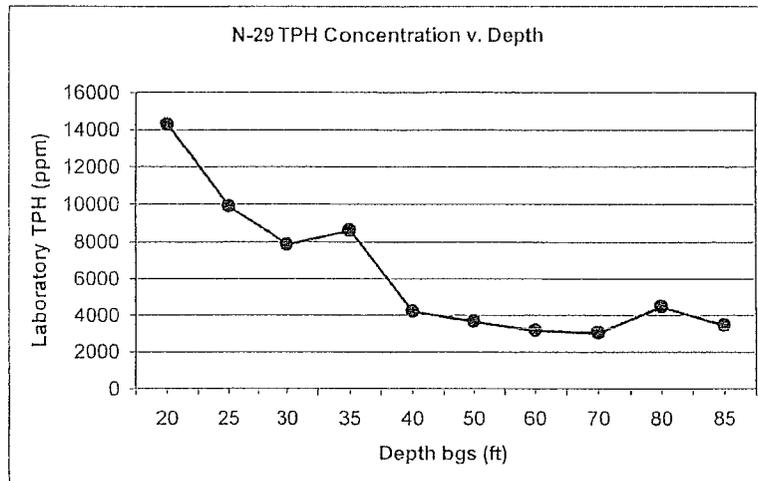
TPH decreases from 14,000 ppm at 20 feet below grade to about 4000 ppm at 40 feet (Figure 2), a 75% decrease. Because the release consisted of produced water from oil wells, laboratory analysis of soil samples detected volatile hydrocarbons in only one sample (less than 0.1 ppm of toluene and xylene). Volatile hydrocarbons are not commonly associated with crude oil as they are with refined products or water produced from natural gas wells. Regulated hydrocarbon constituents may not be present in ground water.

The soil boring data suggests potential ground water impairment by chloride. We propose installation of a ground water monitoring well, reclamation of the surface to its original productive capacity, and evaluation of the threat to ground water quality posed by the residual chloride and any hydrocarbon mass in the vadose zone.
