EME G-4 Boot

RICE OPERATING COMPANY  
JUNCTION BOX FINAL REPORT

## EME G-4 boot

T21S, R36E

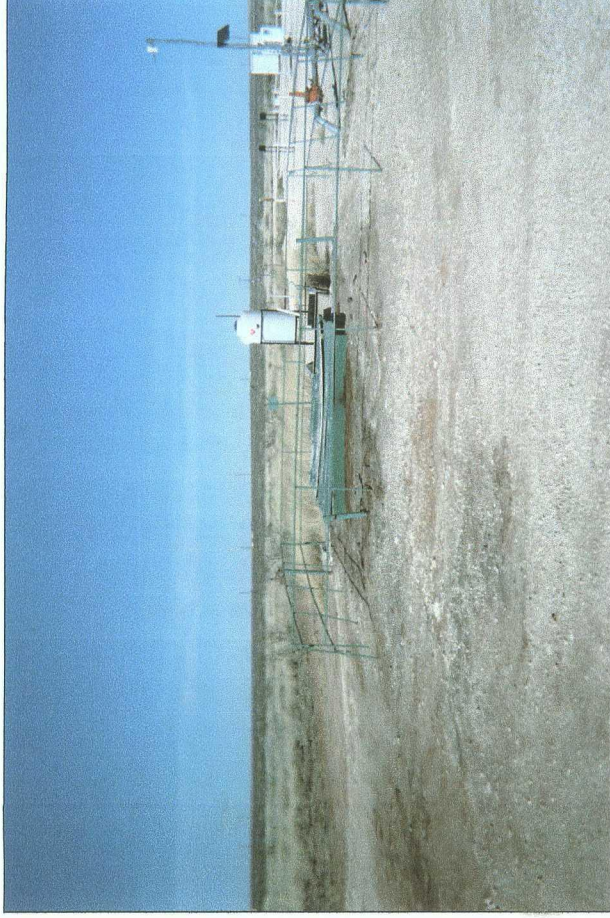
2/7/2006

undisturbed junction box

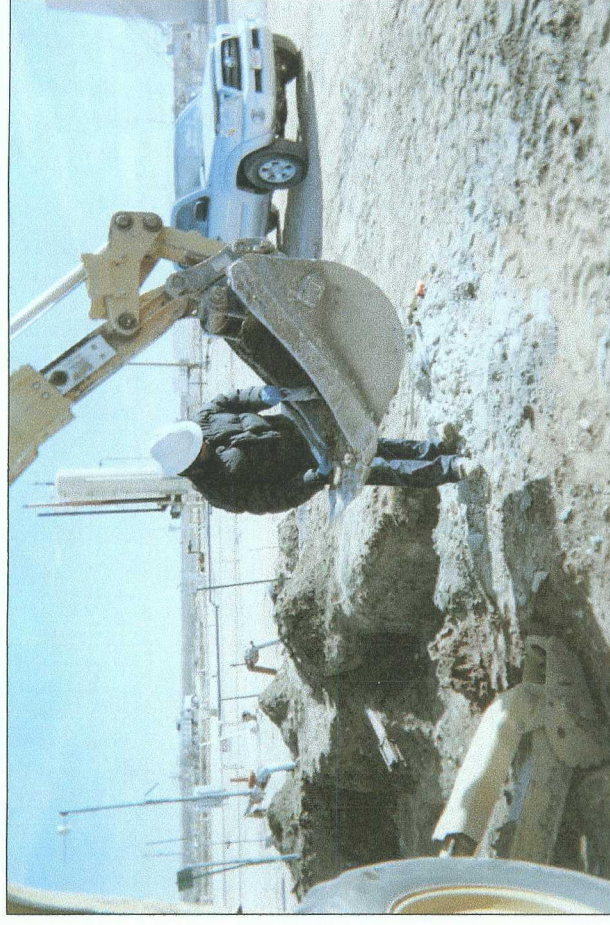
11/29/2006

collecting soil samples from former box site

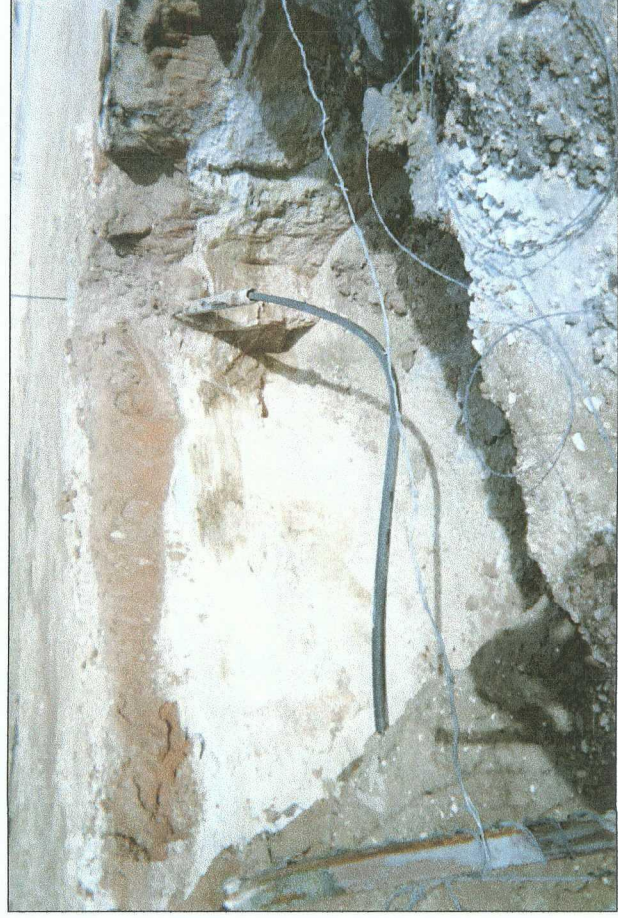
1/15/2007

final 25 x 25 x 12-ft excavation

with the pipeline replacement/upgrade program. This old junction box was replaced with a new, concrete box 270 ft northeast of this subject site. On the old box was removed, the site was delineated using a backhoe to collect soil samples creating a 25 x 25 x 12-ft-deep excavation. Chloride field tests were conducted on these samples and yielded concentrations that generally declined with depth and breadth. Organic vapors were measured on each sample using a PID. Representative composite samples from the excavation floor, walls, and excavated soil were submitted for laboratory analysis. Lab results confirmed TPH concentrations meet NMOCD guidelines. The excavated soil was blended on site and then returned to the hole. Additional fill was needed so 72 cubic yards of clean soils were imported to complete the final 3 ft of backfill. The disturbed surface area was seeded with a blend of native vegetation on 1/18/2007.

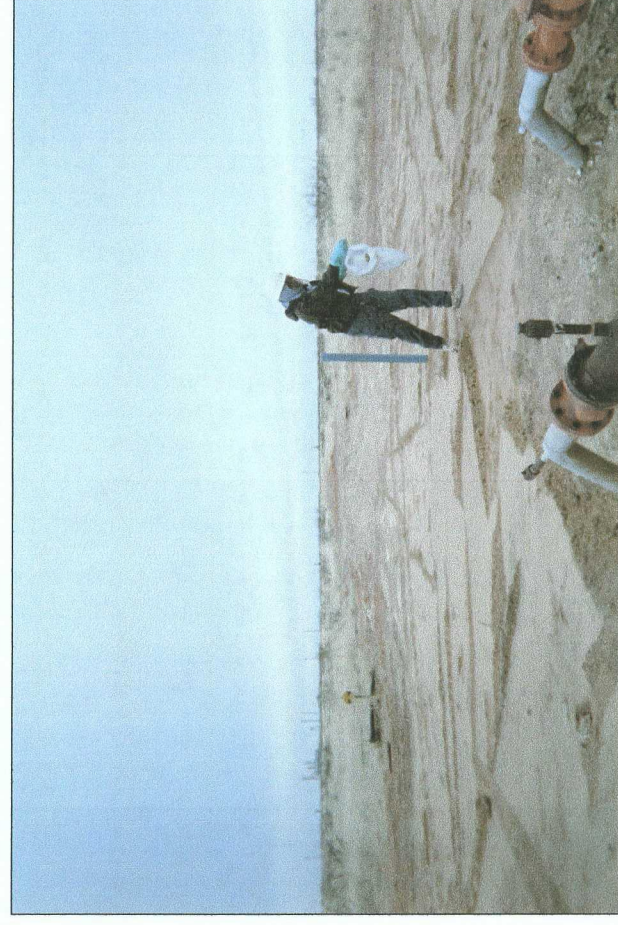
1/18/2007

seeding site; clean, imported soil spread on surface

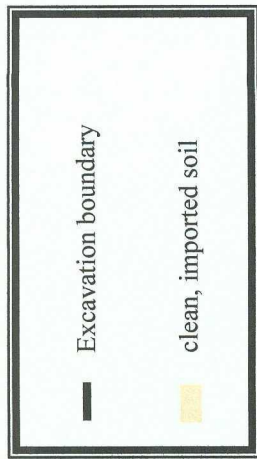
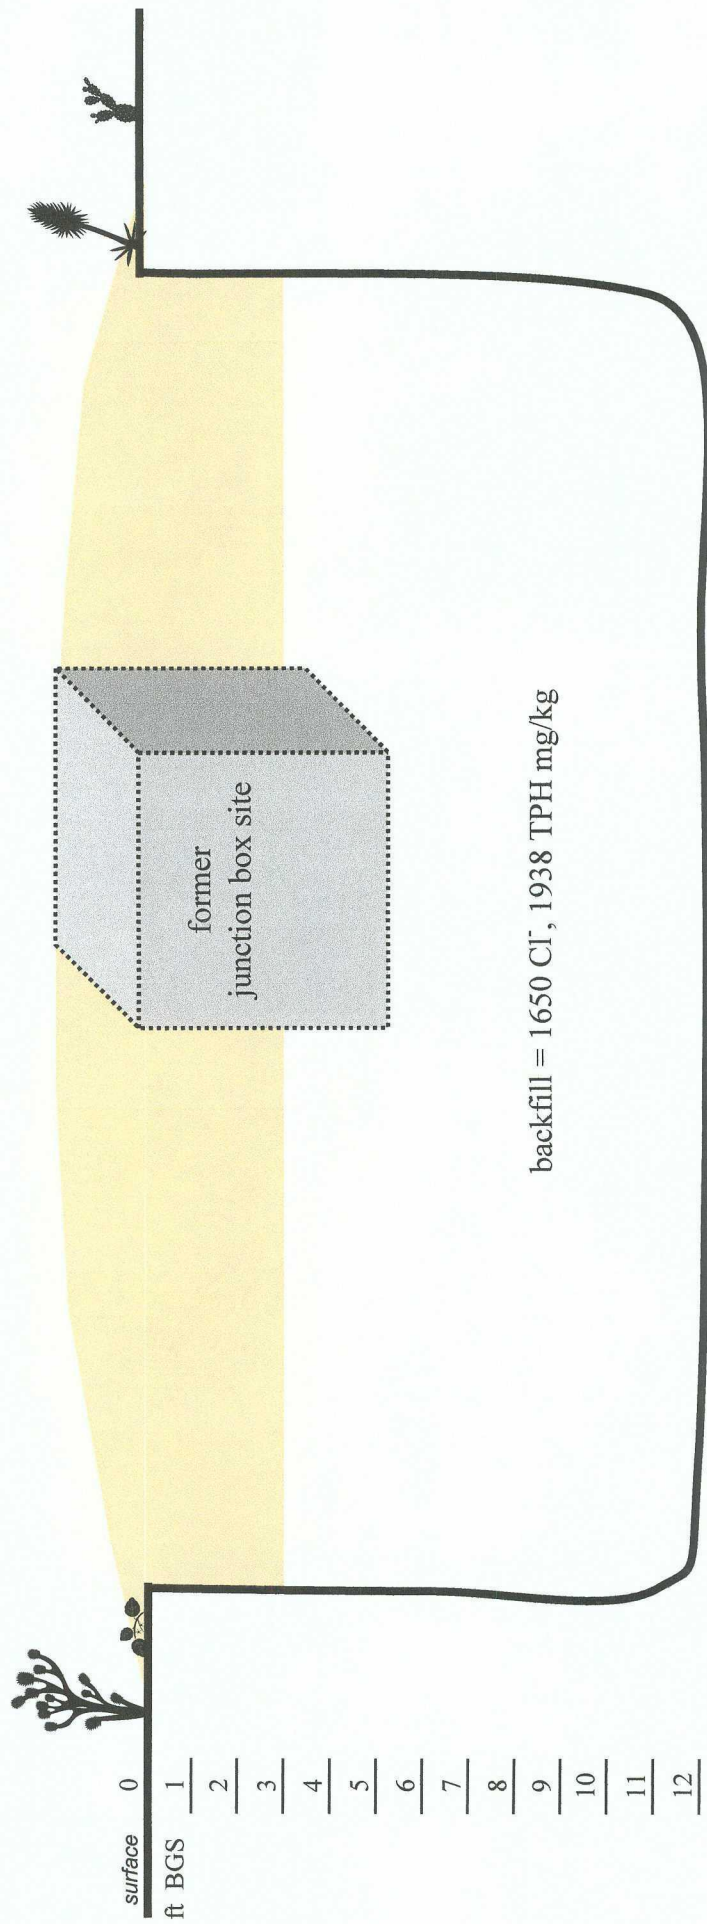
Excavation Cross-Section

25 x 25 x 12-ft-deep

25 ft

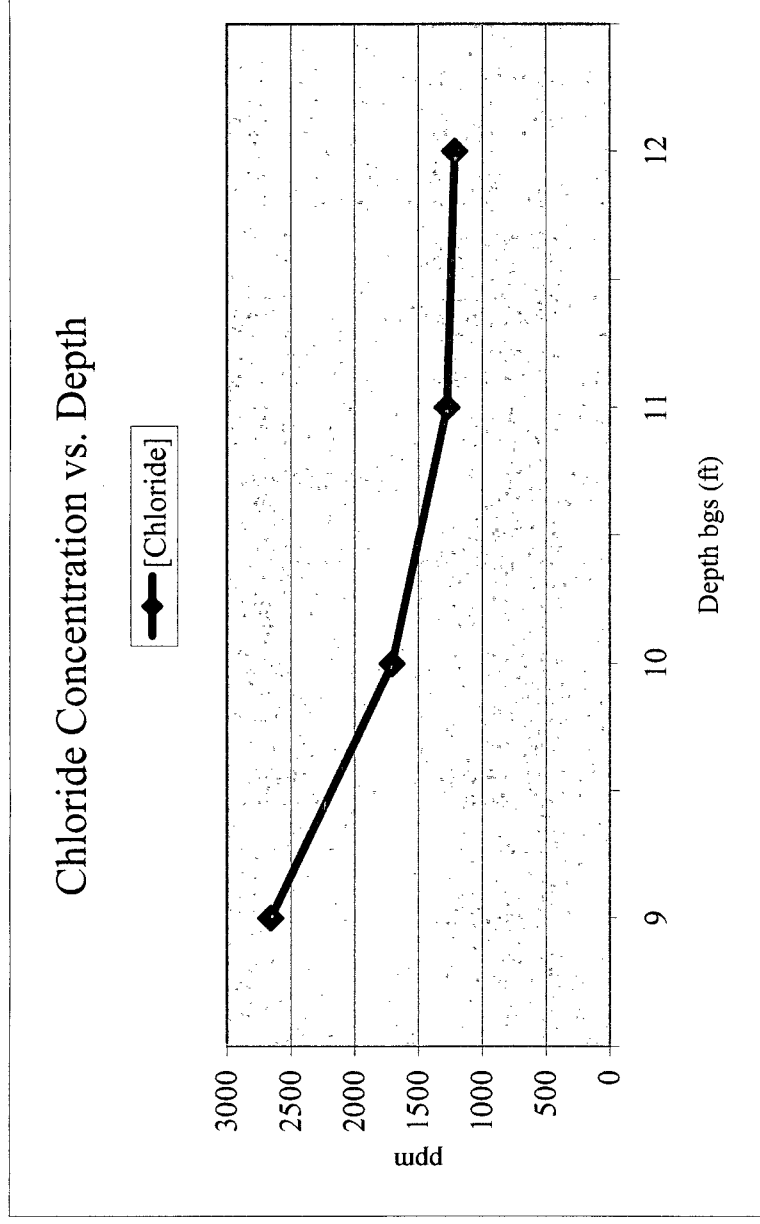
10 ft NORTH of former junction

Depth bgs (ft)	[Cl <sup>-</sup> ] ppm
9	2657
10	1706
11	1275
12	1215

Groundwater = 190 ft

LOCATION	DEPTH (ft)	ppm
10 ft NORTH of junction	9	2657
	10	1706
	11	1275
	12	1215
15 ft NORTH of junction	9	523
	10	583
	11	425
	12	590
4-wall comp.	n/a	815
bottom comp.	12	1234
backfill comp.	n/a	693
