EME Jct S-3

**RICE OPERATING COMPANY
JUNCTION BOX FINAL REPORT**

EME jct. S-3

Unit S, Sec. 3, T21S, R37E

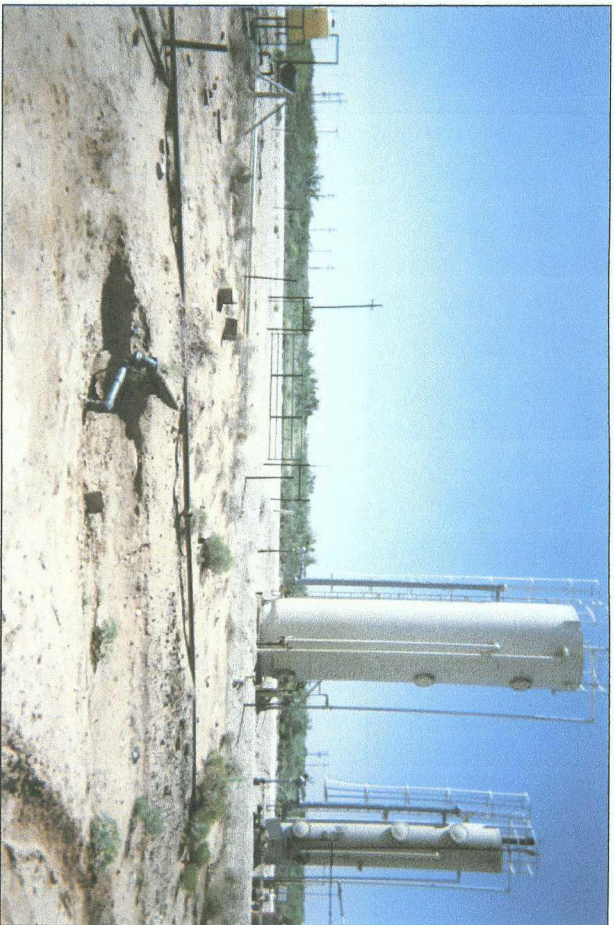
former junction box site at the time of hand auger samples 8/10/2007

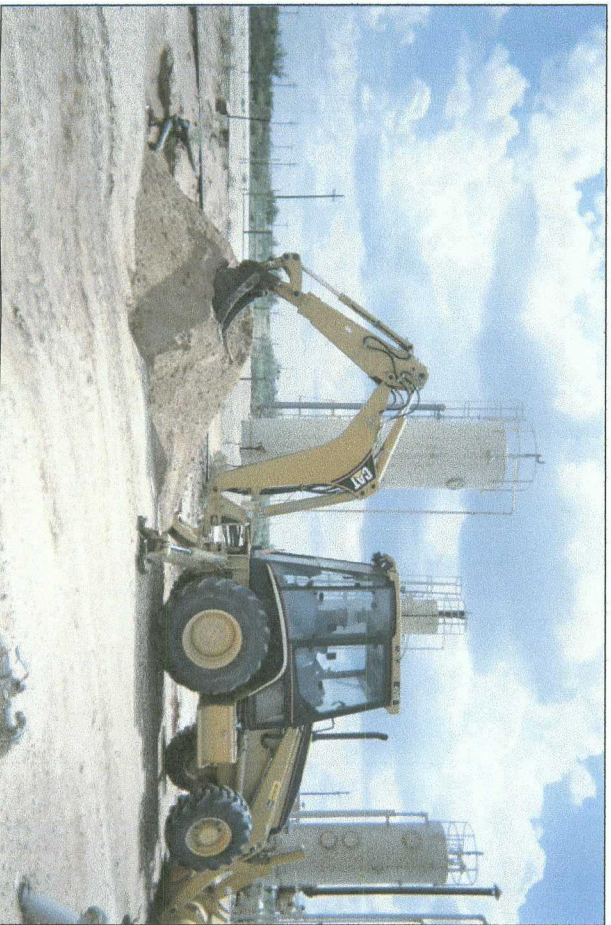
8/31/2007

backfilling and spreading imported soil

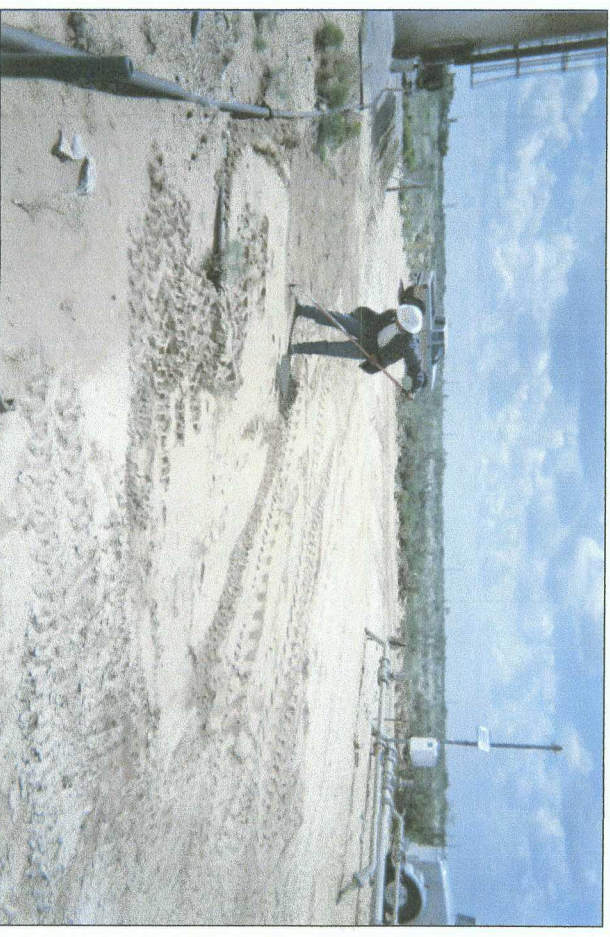
8/31/2007

seeding backfilled area
