Bell Lake Unit Federal #27
(Located in SECTION 5, T24S, R34E of Lea County, NM)
(GPS Reading of 32°-14'-42.3"-N & 103°-29'-54.5"-W)
(API # 30-025-38562)

Spill Remediation Report

Bold Energy, LP
415 W. Wall Ste. 500
Midland, Texas 79701

Phoenix Environmental, LLC.
P.O. Box 1856
Hobbs, New Mexico 88240

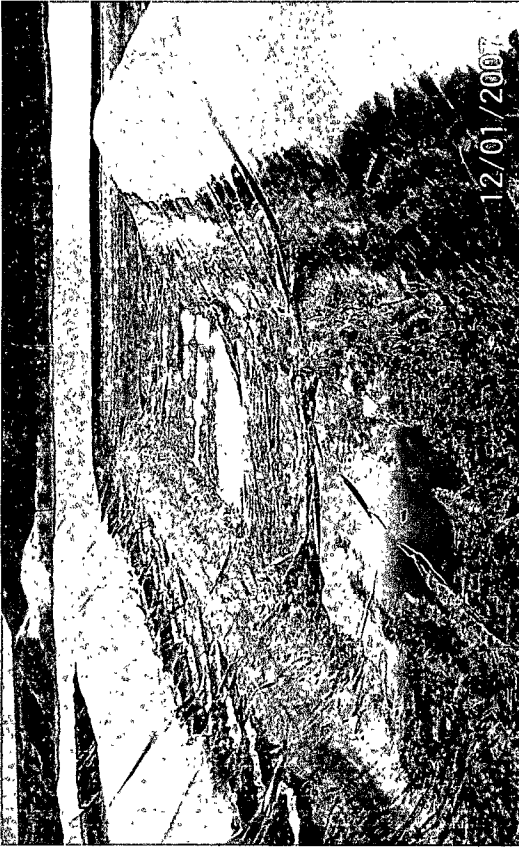
Photo #1 View of Reserve Pit after Brine been Removed

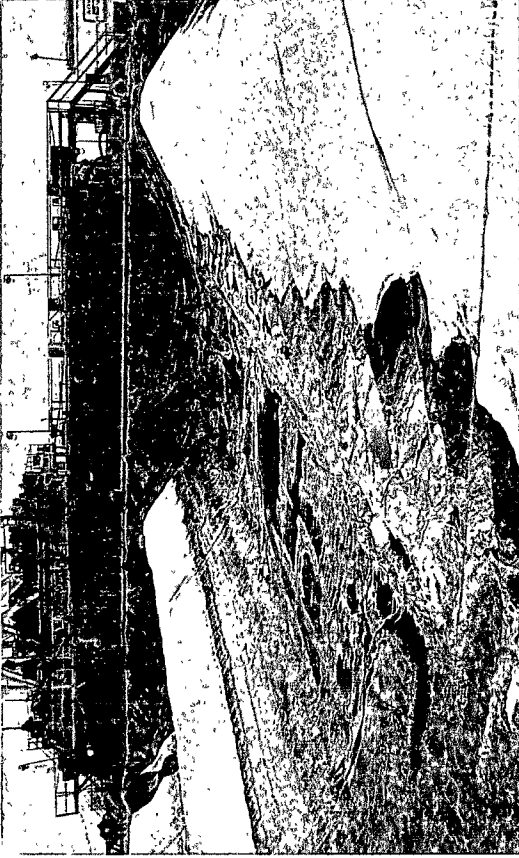
Photo #2 Liner Damage below Steel Pit

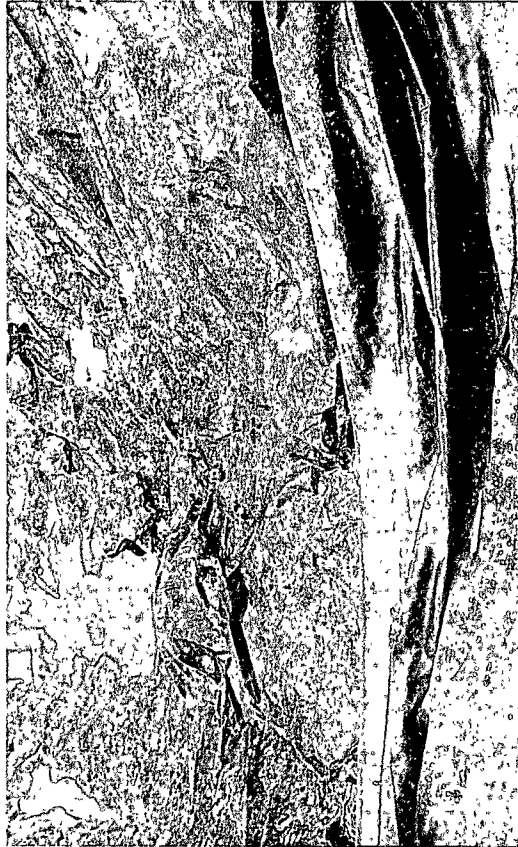
Photo #3 View of Liner Hole Damage

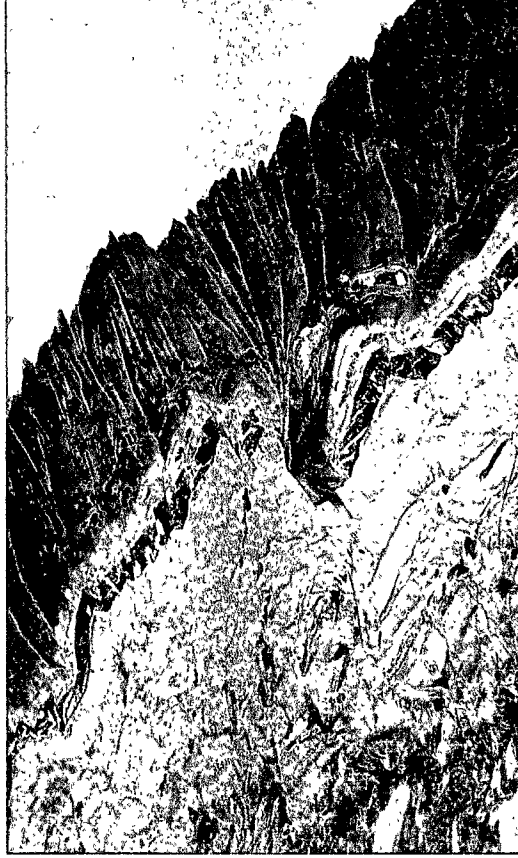
1. Sweatt Construction, Inc., (the service company who built the location and pits), did not inspect the pits for large rocks laying within and protruding from the floor and walls of the pits. The owner indicated to Mr. Castillo that his quality assurance person was unable or failed to visit the location for a final inspection before lining the pits.

Photo #4 Rocks pushing Through Liner

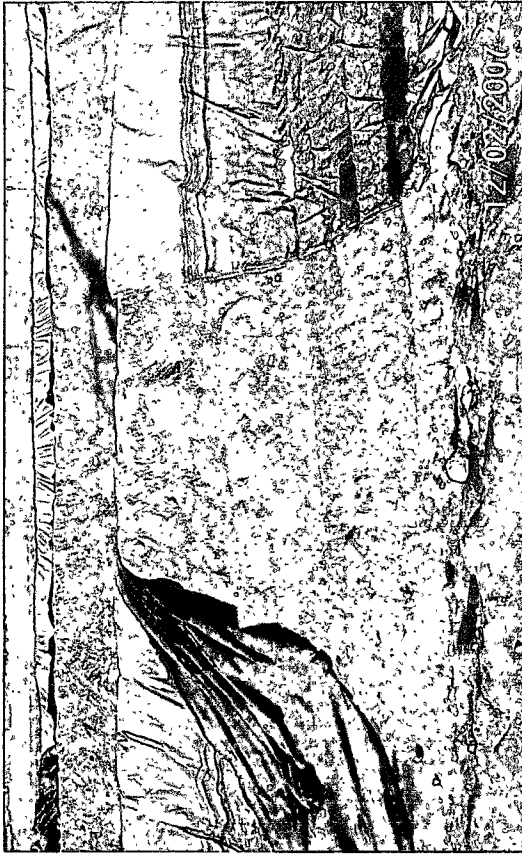
Photo # 5 Liner being Removed

Photo # 6 Liner being Removed

Photo # 7 Liner being Removed

Photo # 8 Liner being Removed

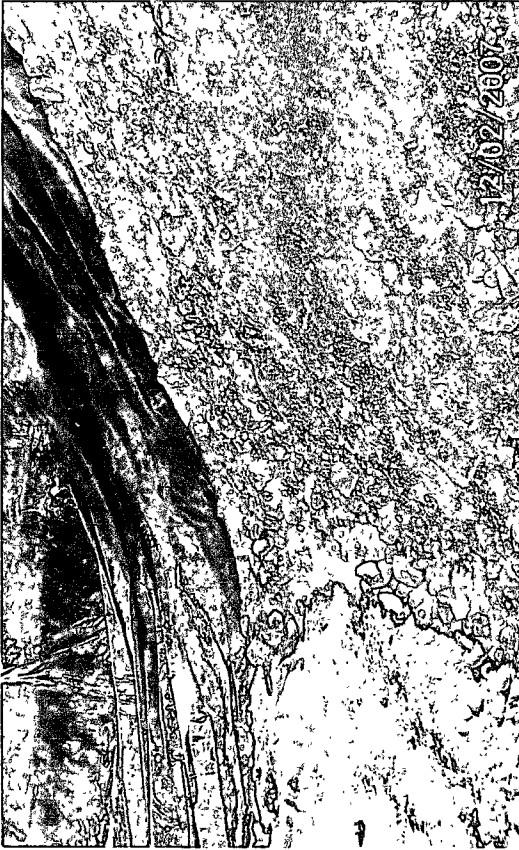
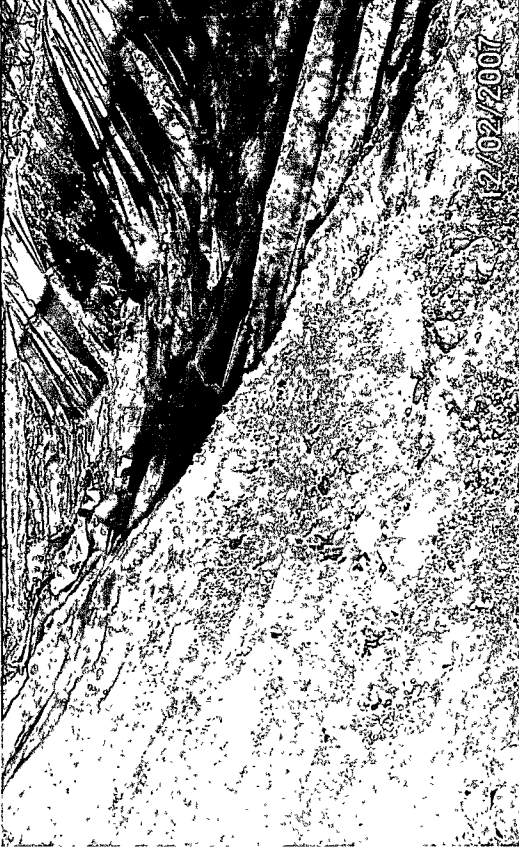
Photo # 9 Rocks Under Liner

Photo # 10 Rocks Under Liner

Photo # 11 Rocks Under Liner

Photo # 12 Rocks Under Liner

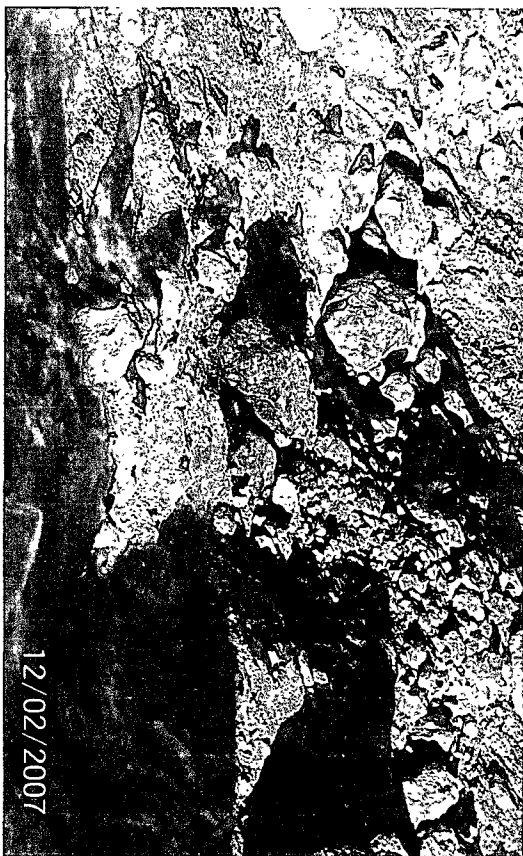
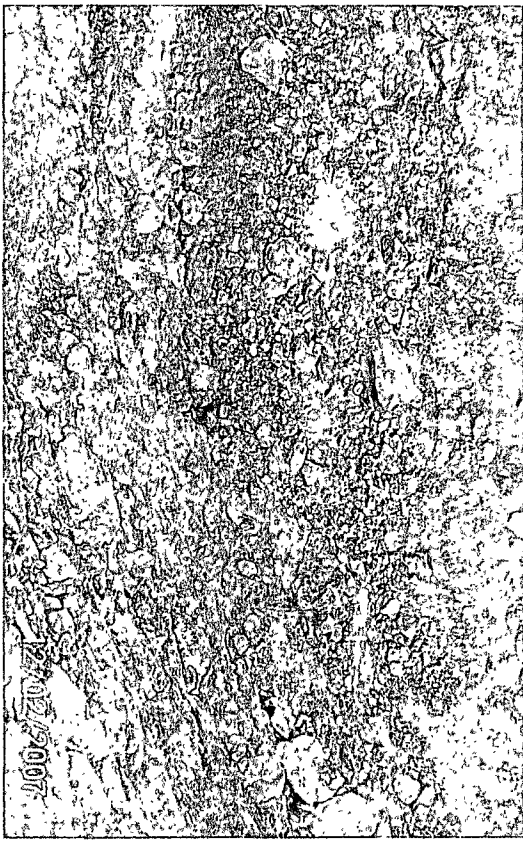
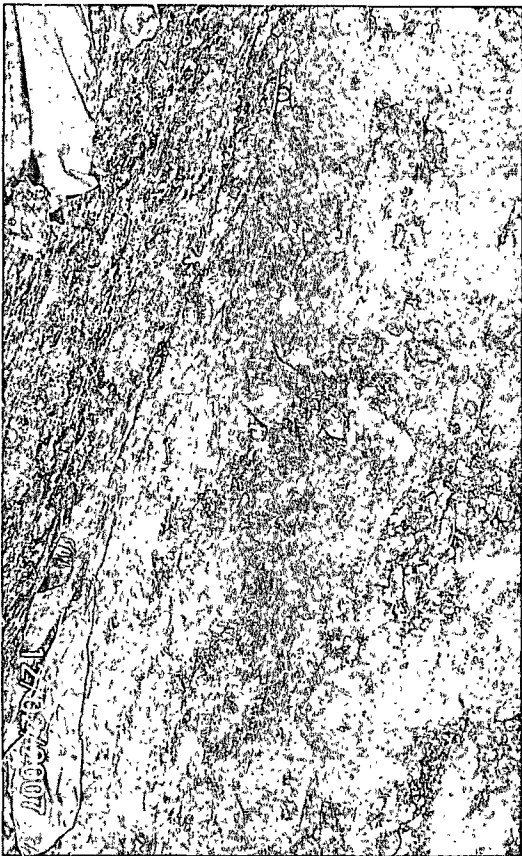
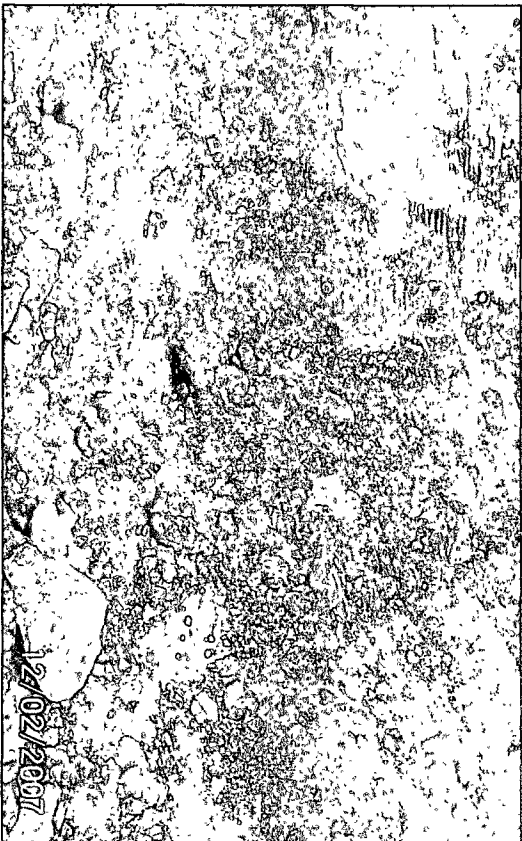
Photo # 13 Rocks Under Liner at Point of Leak

Photo # 14 Rocks Under Liner at Point of Leak

Photo # 15 Rocks Under Liner at Point of Leak

Photo # 16 Rocks Under Liner at Point of Leak

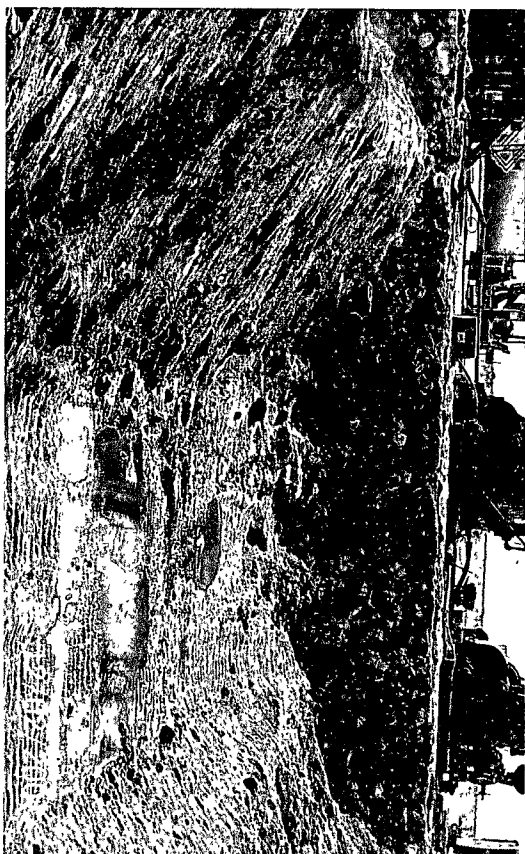
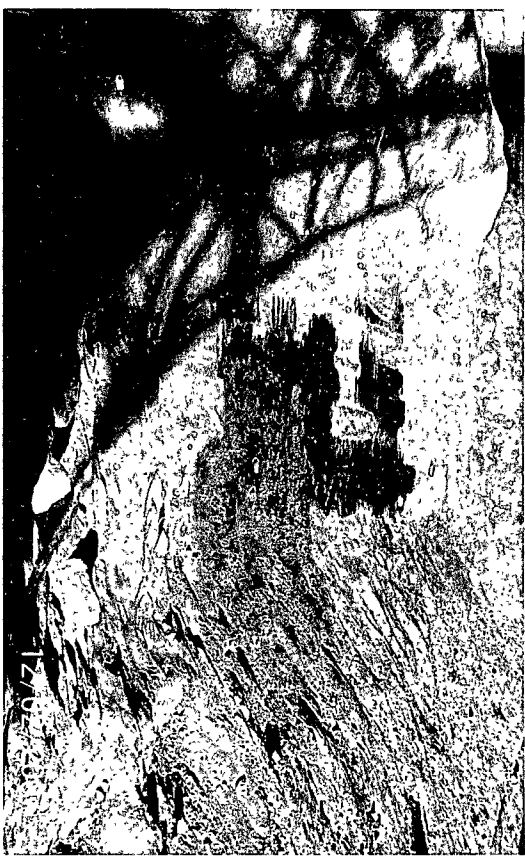
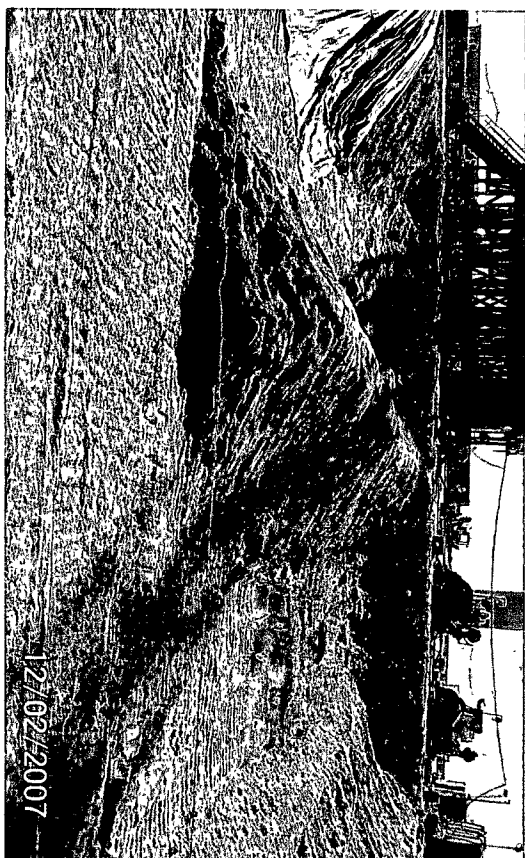
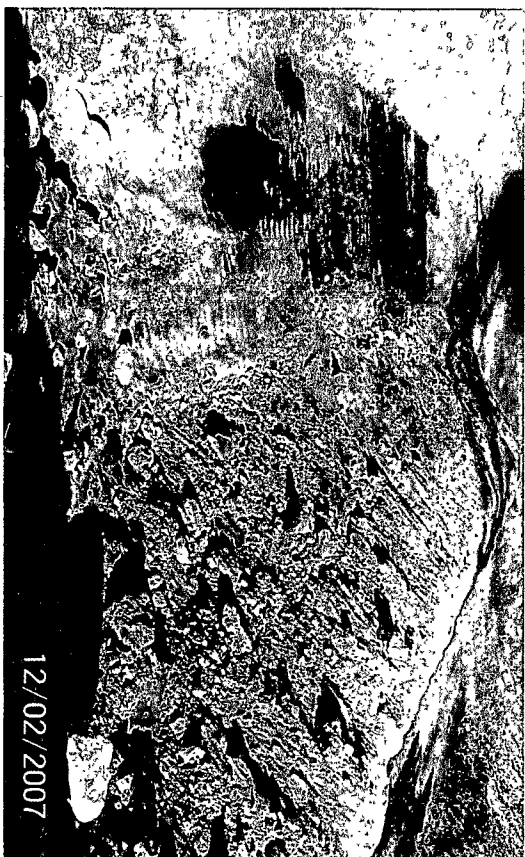
Photo # 17 Saturated Impacted Soil Under Liner

Photo # 18 Saturated Impacted Soil Under Liner

Photo # 19 Saturated Impacted Soil Under Liner

Photo # 20 Saturated Impacted Soil Under Liner

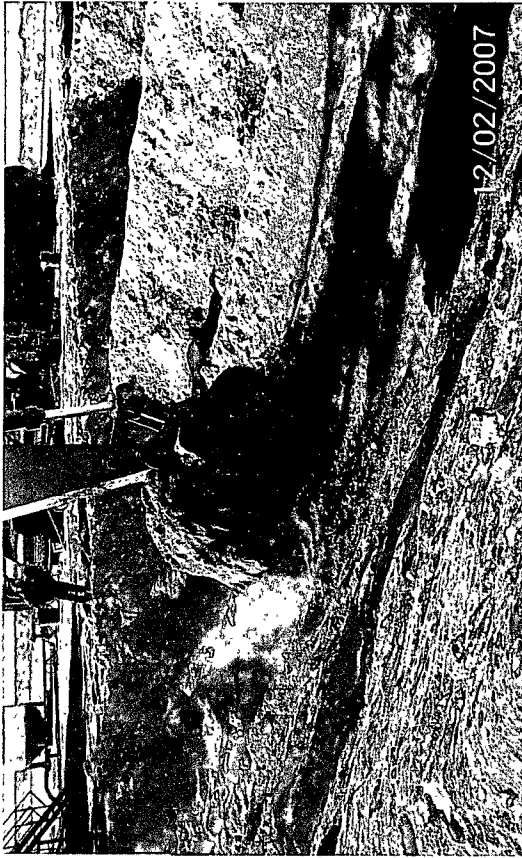
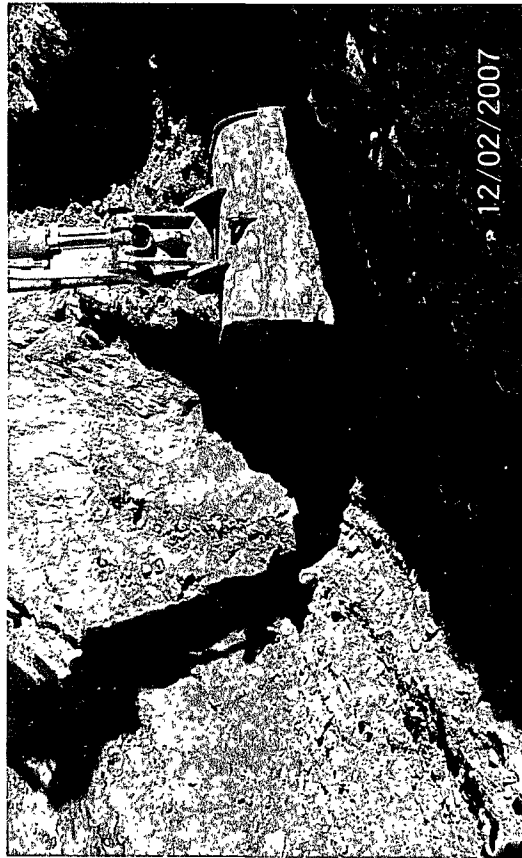
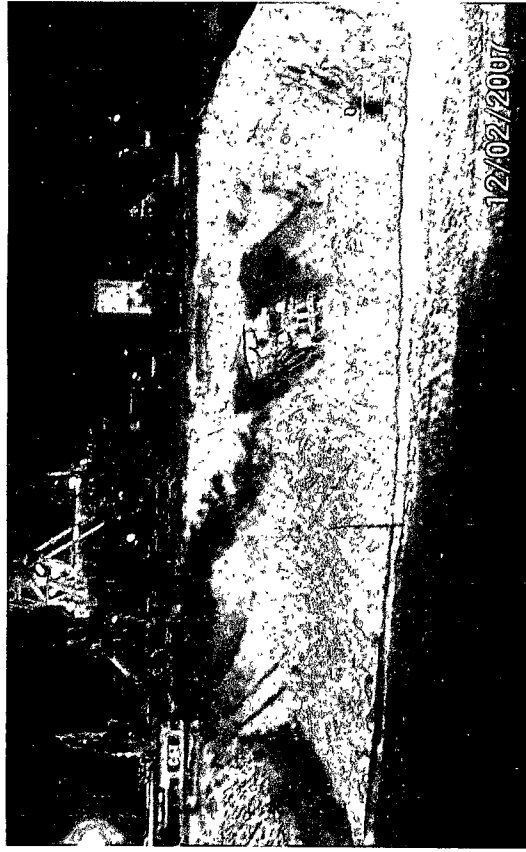
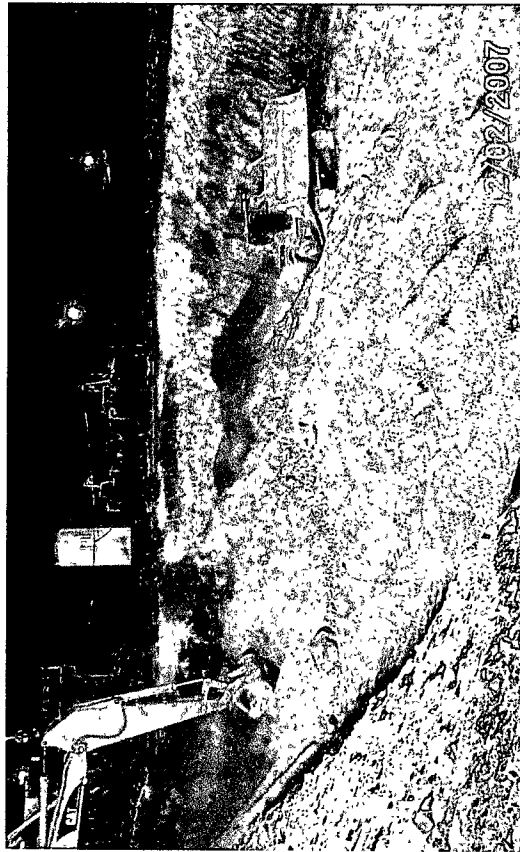
Photo #21 Excavating Impacted Soil

Photo #22 Excavating Impacted Soil

Photo #23 Excavating Impacted Soil

Photo # 25 Excavating Impacted Soil

Photo # 26 Excavating Impacted Soil

Photo # 27 Excavating Impacted Soil

Photo # 28 Excavating Impacted Soil

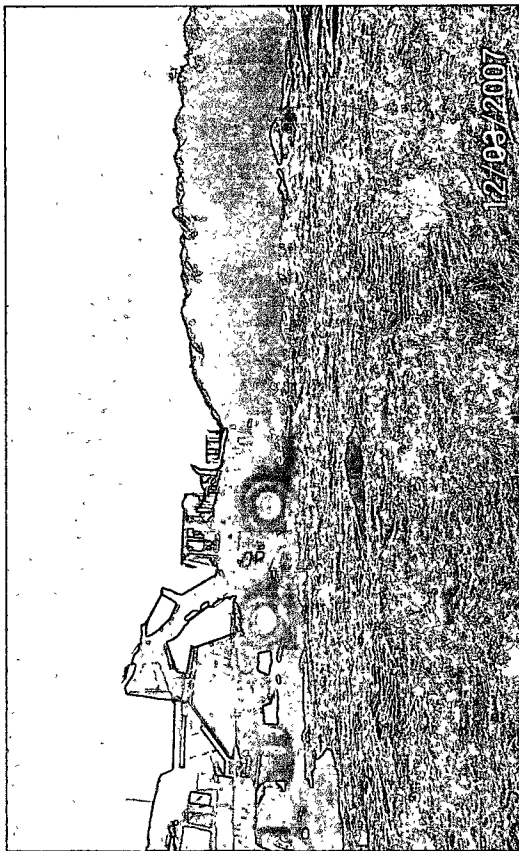
Photo # 33 Loading Trucks Out For Disposal

Photo # 34 Loading Trucks Out For Disposal

Photo # 35 Loading Trucks Out For Disposal

Photo # 36 Loading Trucks Out For Disposal

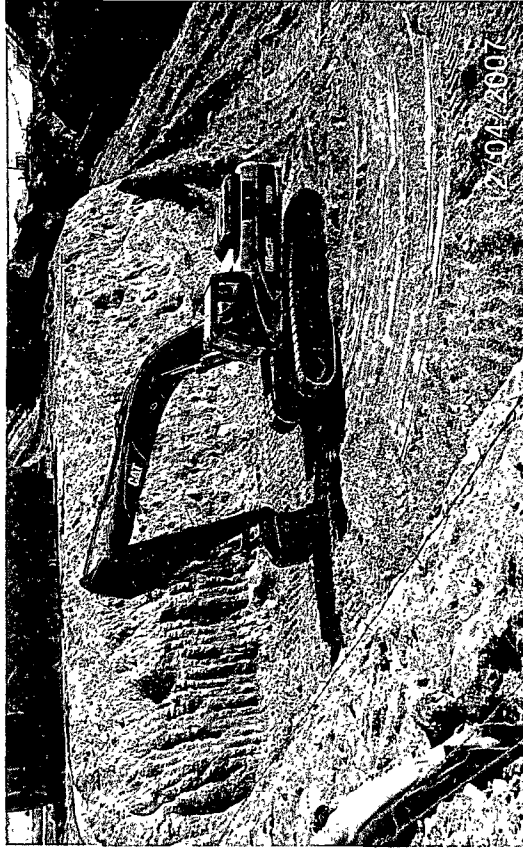
Photo # 37 Cleaning Bottom of Pit

Photo # 38 Cleaning Bottom of Pit

The bottom of the excavation at (approximately 27 feet) was tested for Chlorides to make certain that the target limits had been met prior to backfilling, compaction for rebuilding drilling pits. The site cleaned up very well with the vertical depth of impact, listed above at 27 feet and not impacting groundwater. All of the final lab analysis was below the NMOC guidelines for leaks and spills (refer to attached laboratory analysis report for actual levels).

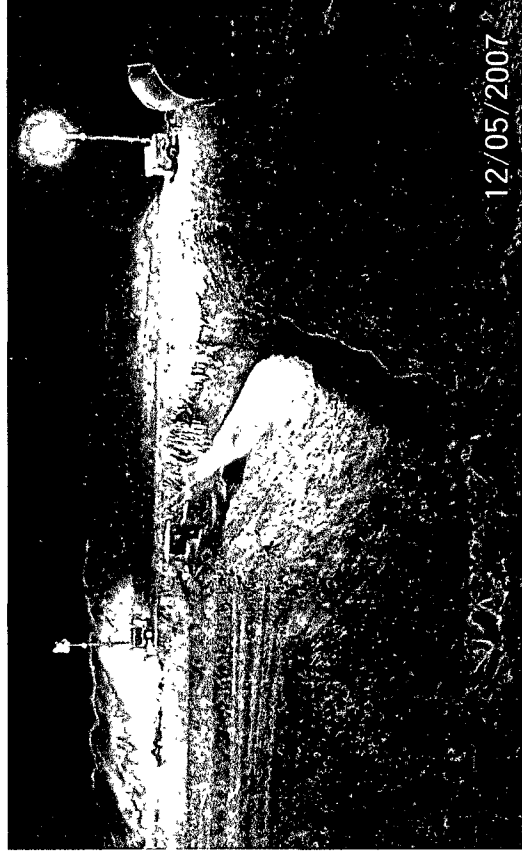
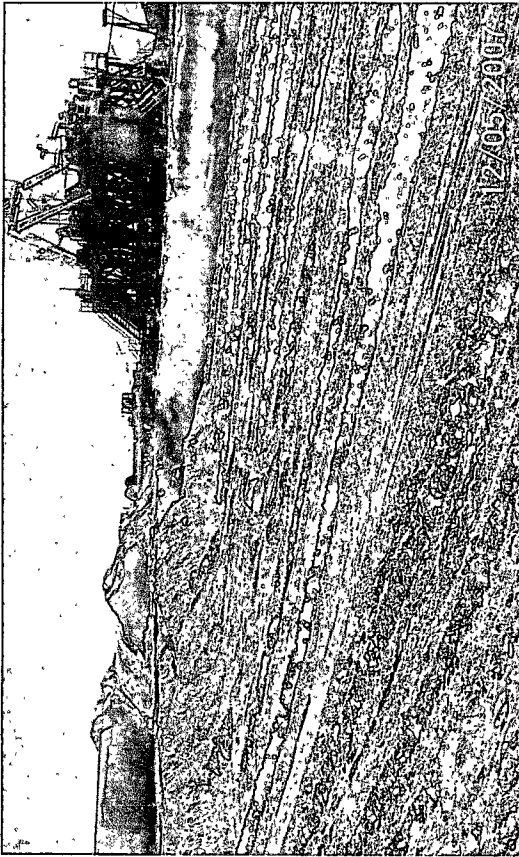
Photo # 39 Backfilling Pit

Photo # 40 Backfilling Pit

Photo # 41 Backfilling Start of New Pit

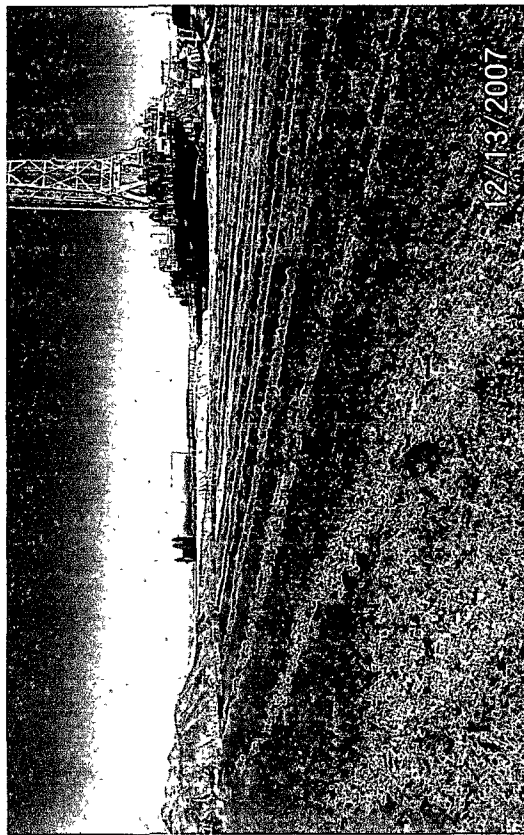
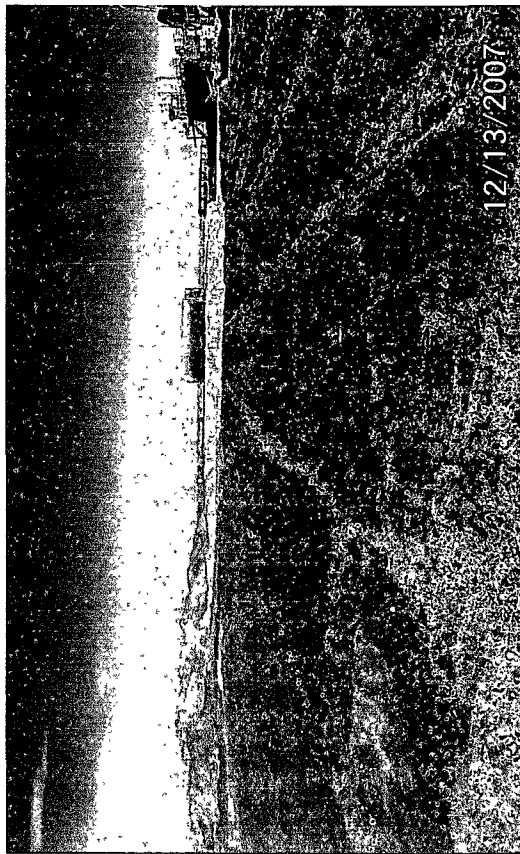
Photo # 53 View of Completed Job

Photo # 54 View of Completed Job

Photo # 55 View of Completed Job

Photo # 56 View of Completed Job
