RE: **Closure Report**
Chesapeake Operating, Inc.
Keller 27 Federal No. 2
UL-K (NE ¼ of the SW ¼) of Section 27, T23S, R34E
Longitude: N32° 16' 25.45"; Latitude: W103° 27' 35.28"
Lea County, New Mexico
NMOCD Ref. 1RP #1846; EPI Ref. #160097A

On behalf of Chesapeake Operating, Inc., EPI submits the attached *Closure Report Letter* describing remedial activities undertaken to remediate the release area into conformity with New Mexico Oil Conservation Division (NMOCD) requirements. For clarity and cross reference elimination purposes, the *Closure Report Letter* offers Site Background history, Site Delineation, Remediation Activities and Conclusion.

Figure 3
Site Map
Chesapeake Operating Inc.
Keller 27 Federal #2

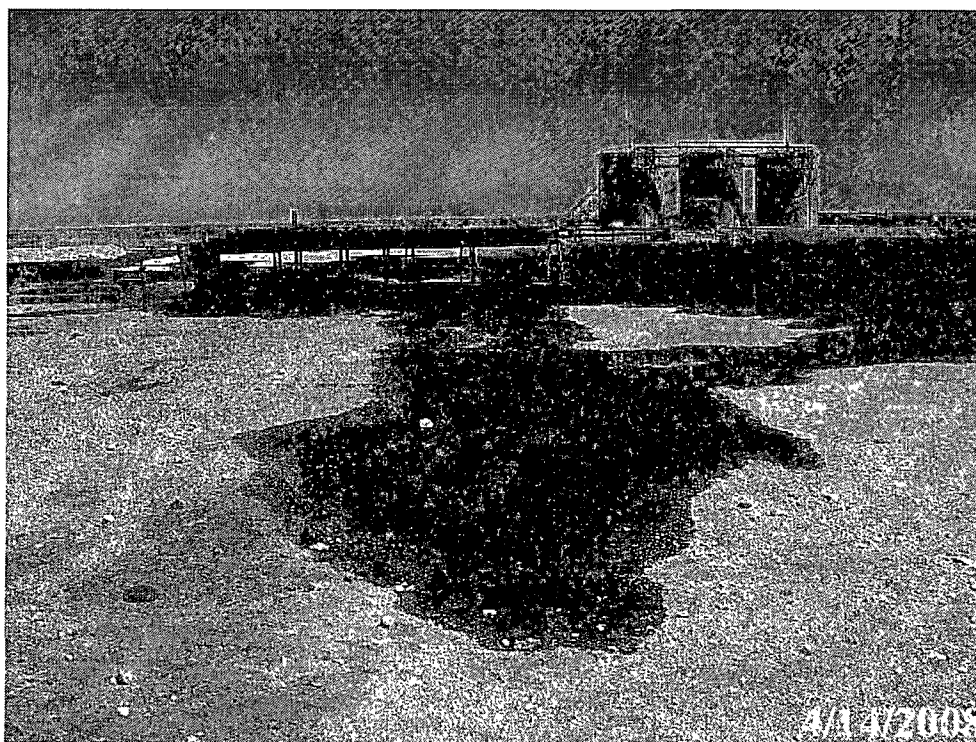
Photograph No. 2 – Looking southeasterly across release area.

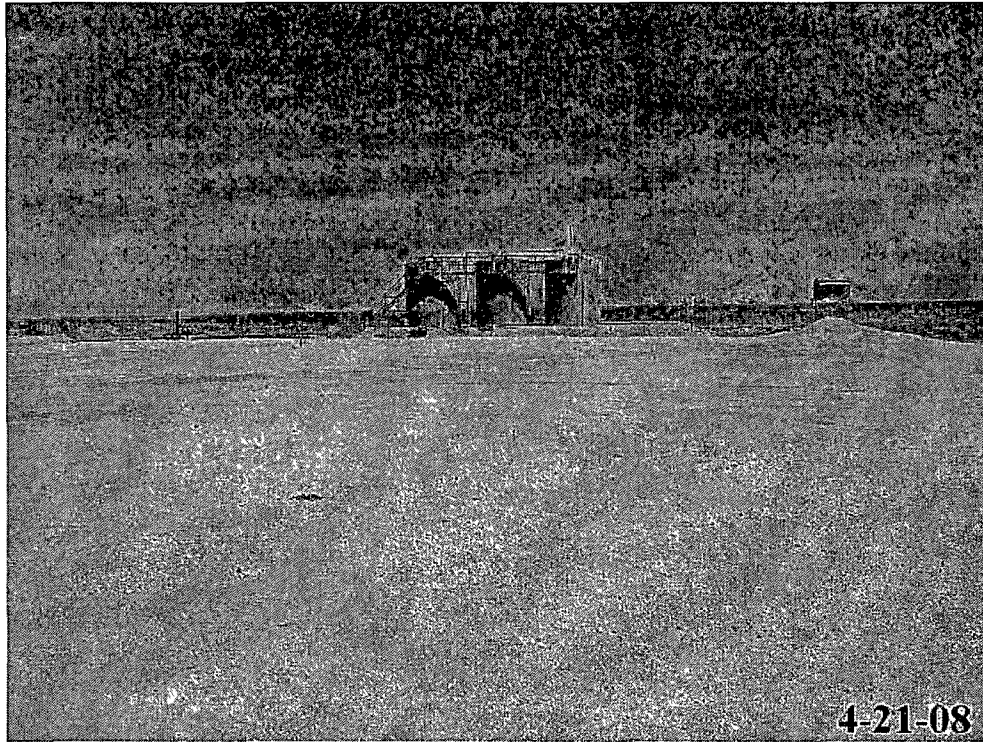
Photograph No. 3 – Looking southeasterly across excavation area.

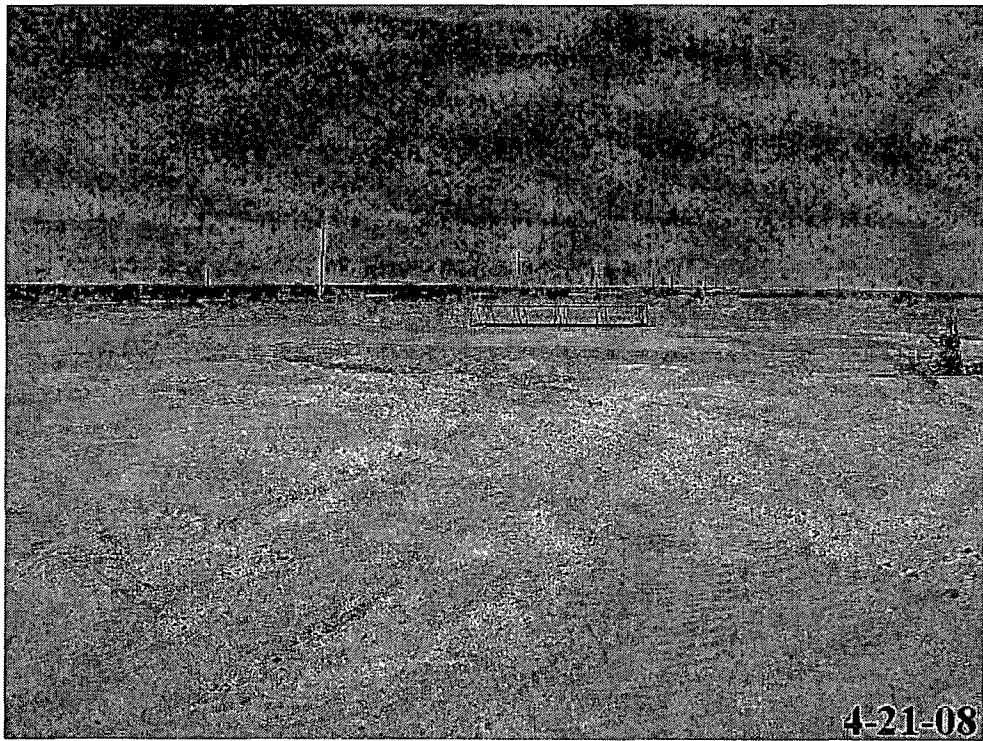
Photograph No. 4 – Looking northwesterly across excavation area.

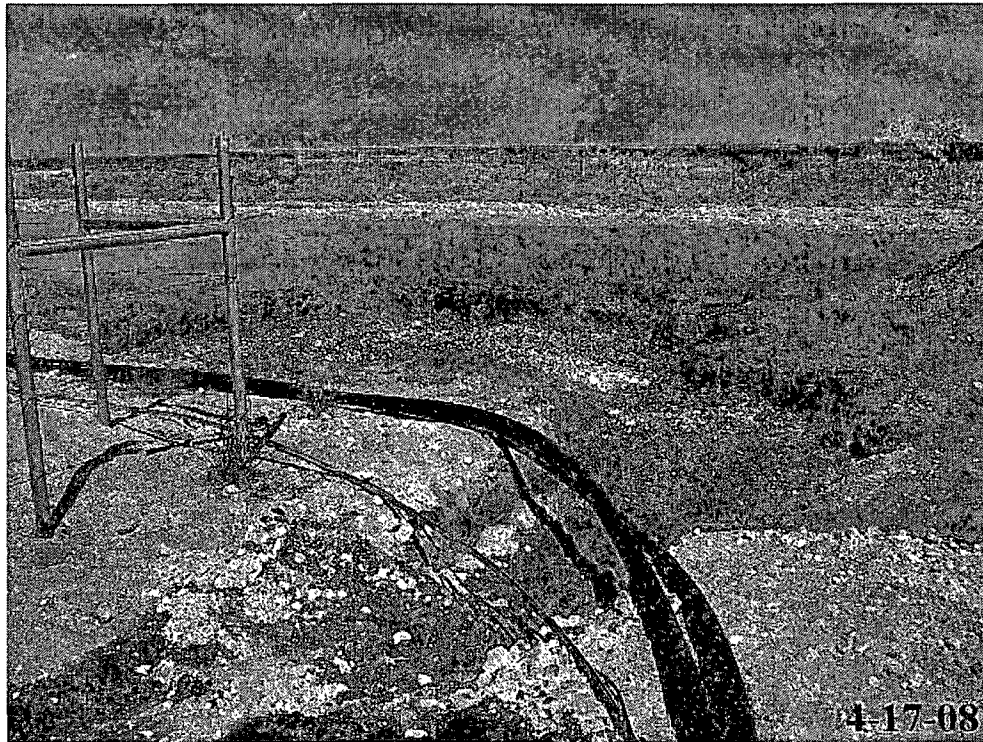
Photograph No. 5 – Looking northerly across excavation area.

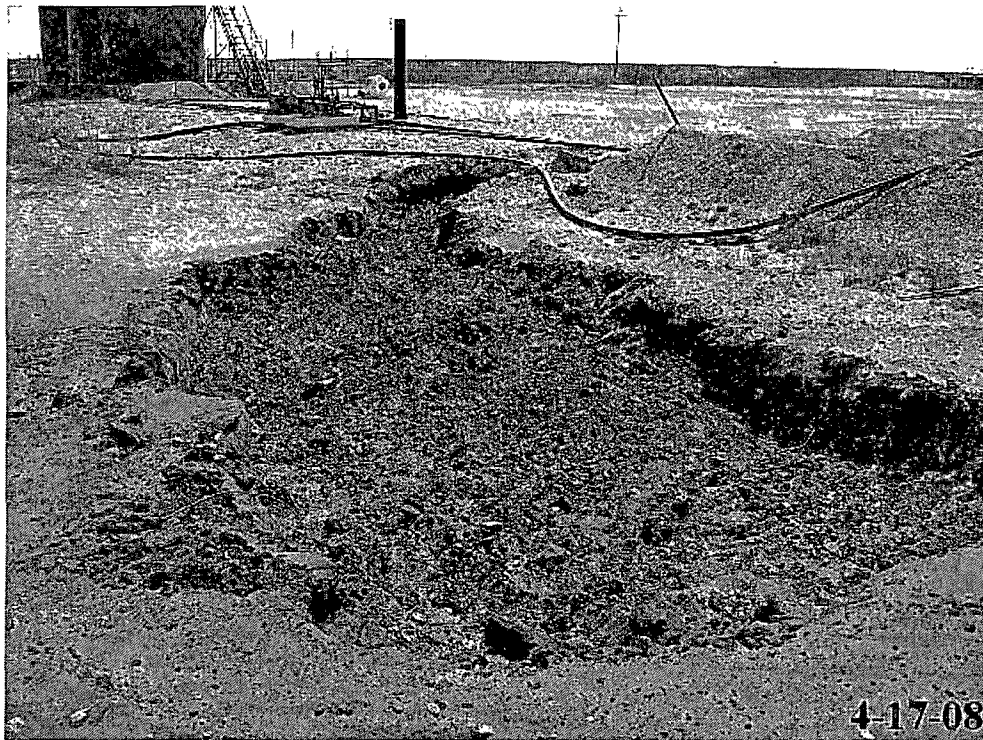
Photograph No. 6 – Looking northeasterly across excavation area.

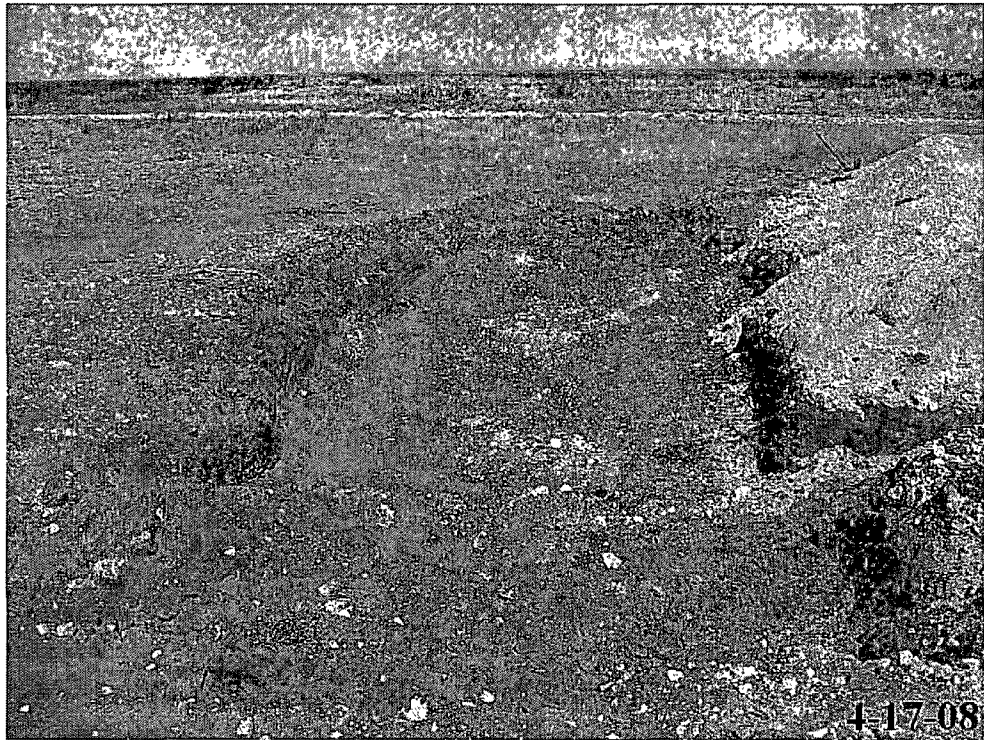
Photograph No. 7 – Looking easterly across excavation area.

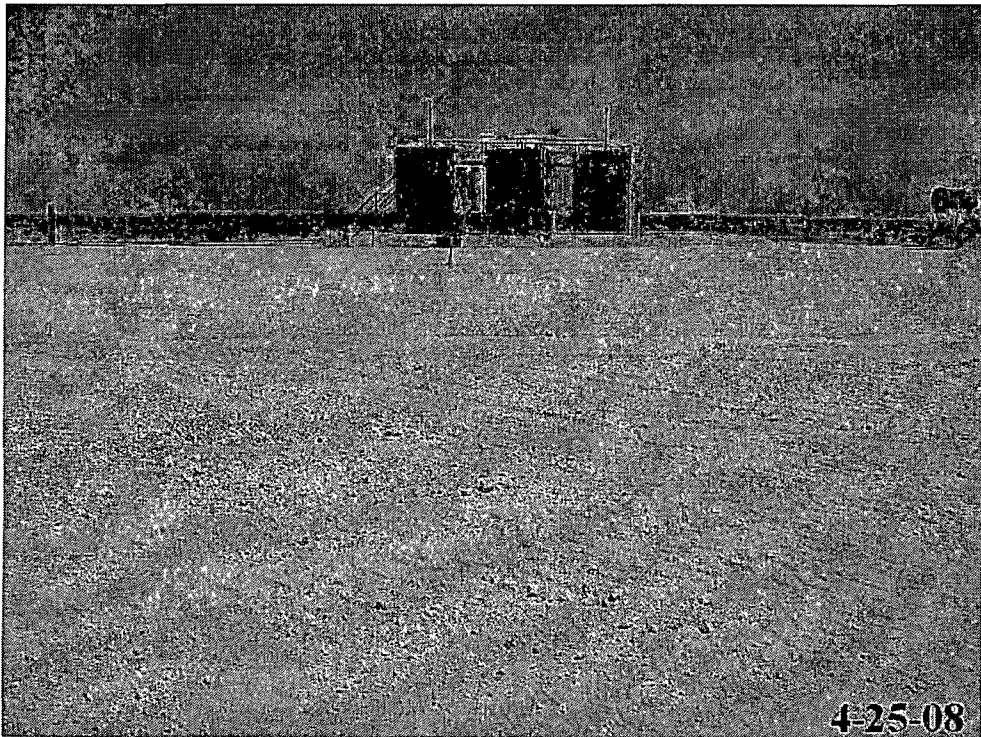
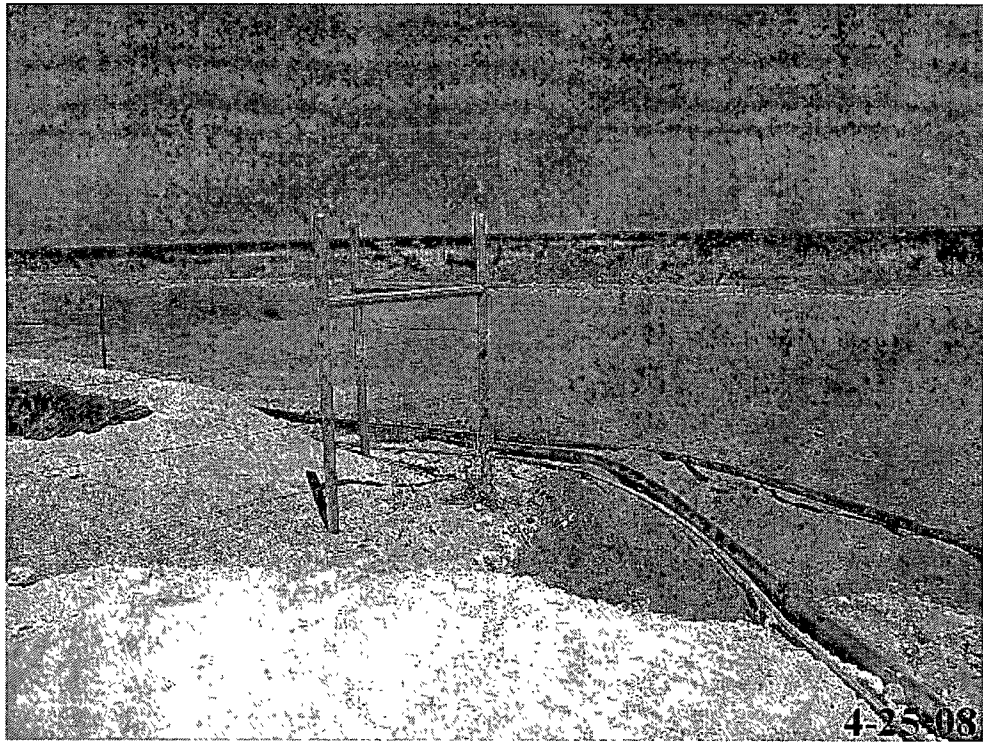
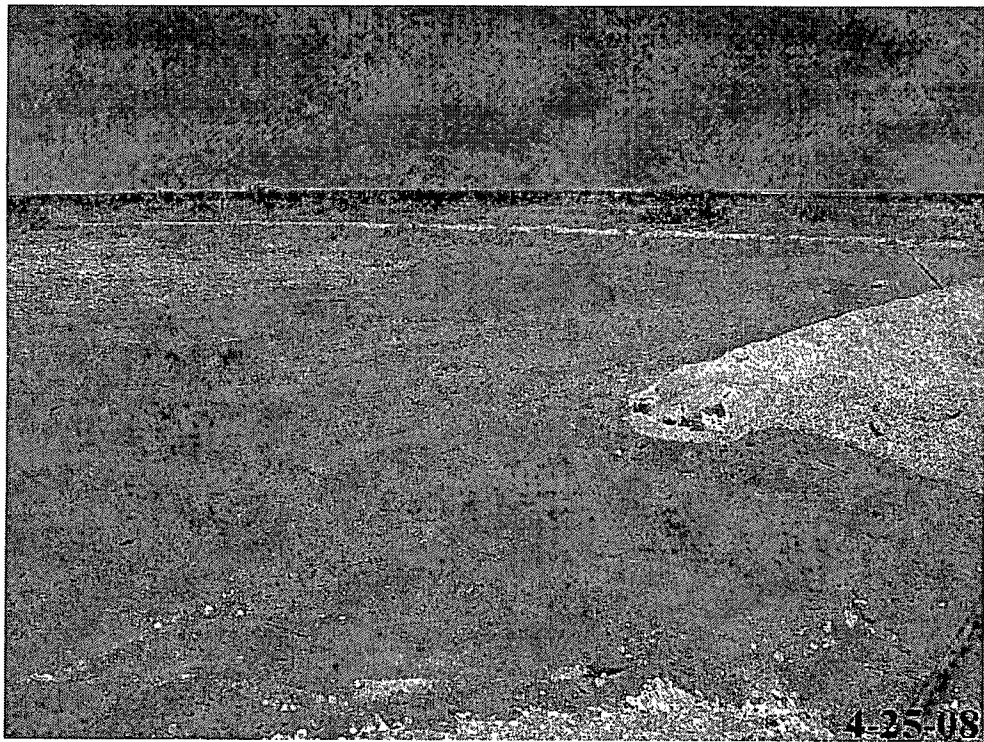
Photograph No. 8 – Remediated site.

Photograph No. 9 – Remediated site.

Photograph No. 10 – Remediated site.

On April 23, 2008 excavation located on the caliche production pad was backfilled with clean caliche (~462 yds³). Backfilling activities continued through April 25, 2008 with excavated areas outside the caliche production pad filled with native topsoil (154 yds³). Both caliche and topsoil material were transported to the site from a private pit. Disturbed areas within the caliche production pad were contoured to allow vehicular traffic and promote controlled natural drainage. Contiguous areas outside the caliche production pad were similarly contoured to allow natural drainage and will be disked and seeded with a blend preferred by the BLM.
