**ERS METX Artesia
Unit Closure
Report (5/2/2005)**

**Navajo Refining Company
ERS METX Artesia Unit
Amended Closure Report
Section 30, Township 18S, Range 28E
Eddy County, New Mexico**

May 2, 2005

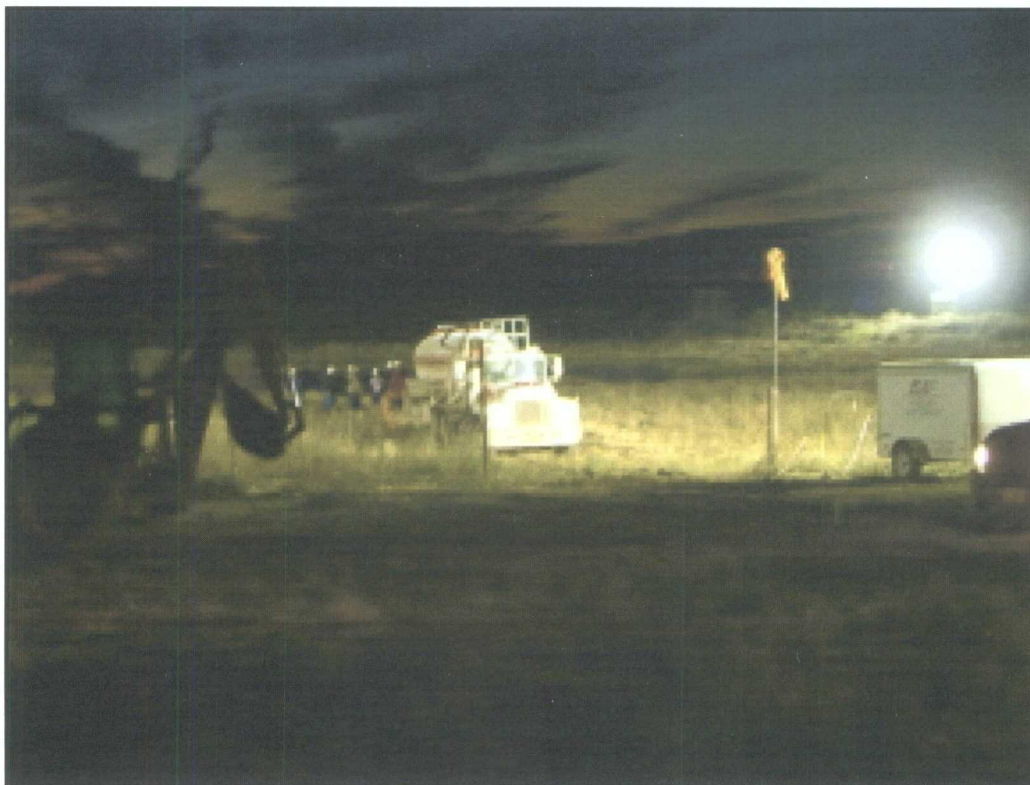
Initial Response

On November 19, 2004 SESI responded to the leak site and instructed the crew to began to pick up the oil from the water with a skimmer. The oil was transported and released back into production. Containment booms were used to encircle the pond and the oil soaked grass around the perimeter was burned off.

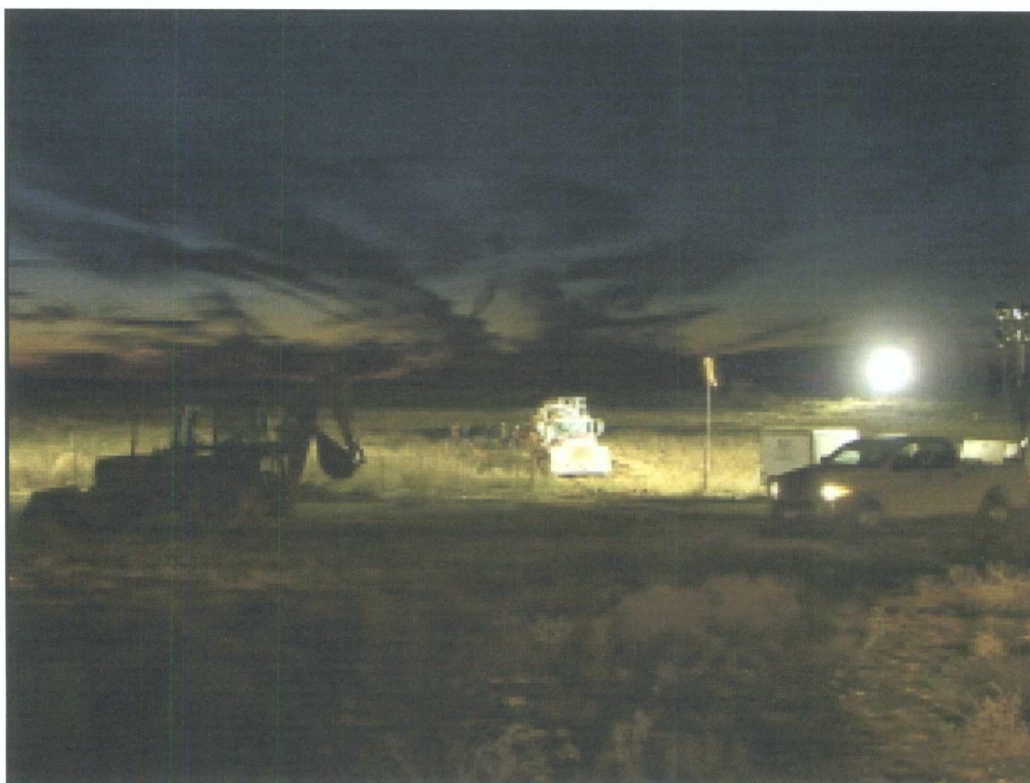
Initial Response

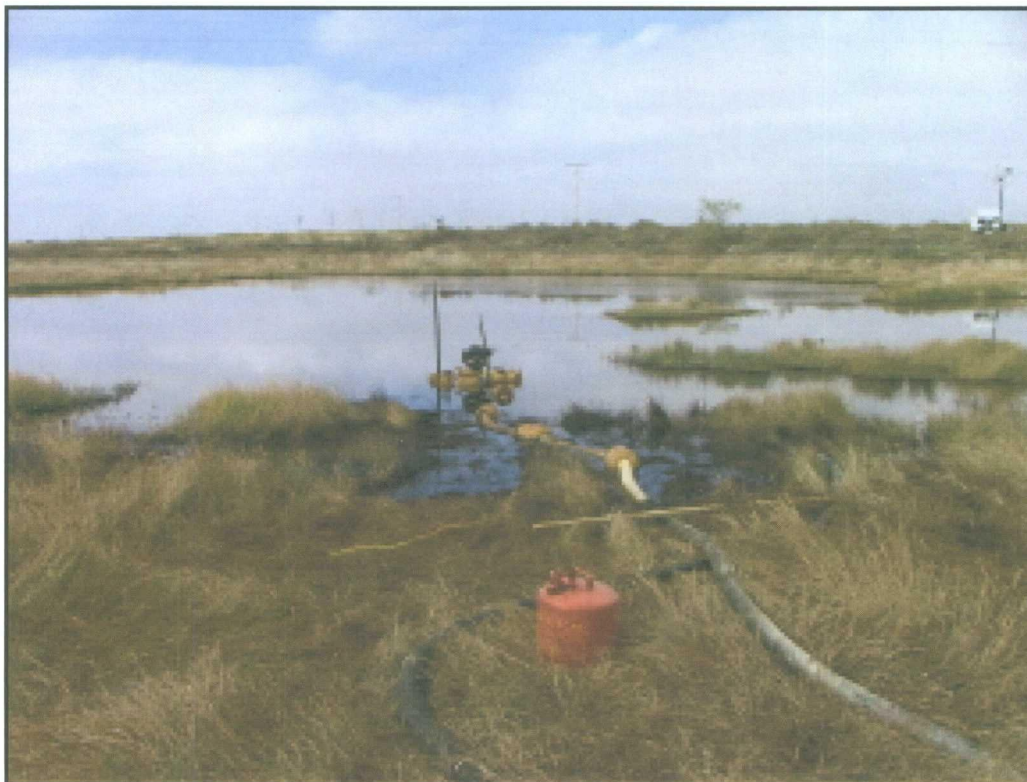
Skim Operation East of Pond

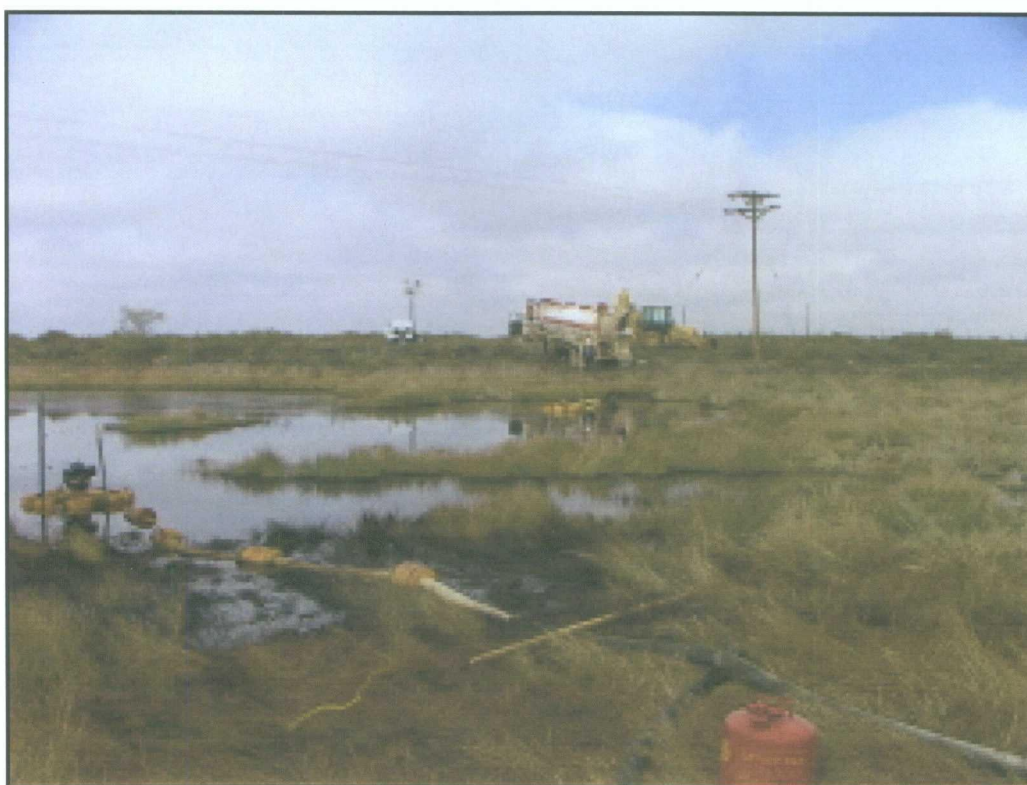
Skim Operation East Side of Pond

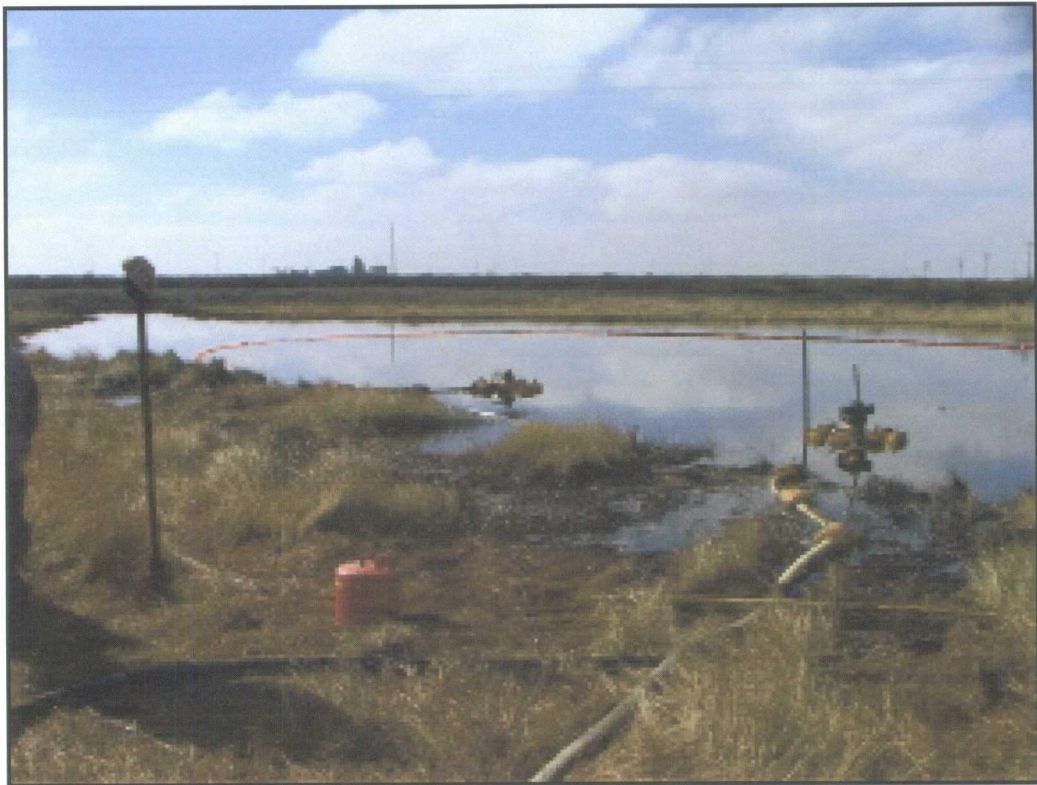
Skim Operation, Boom East Side of Pool

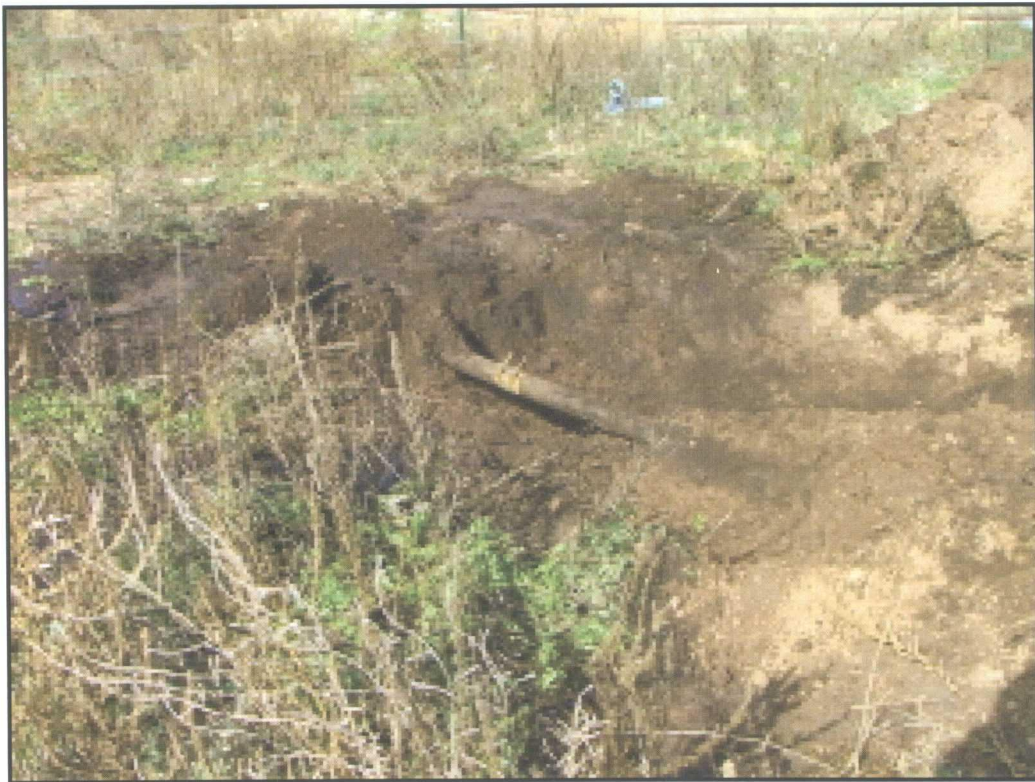
Leak Site

The path, which the leak took from the site of the leak to the pond, was excavated to a depth of approximately 3'. The excavation was backfilled with clean soil supplied by the landowner from off-site. Approximately 6 to 8" of soil was removed from the area immediately adjacent to the pond. Approximately 300 cubic yards of contaminated soil was transported to Artesia Aeration, a NMOC approved disposal facility, for disposal.

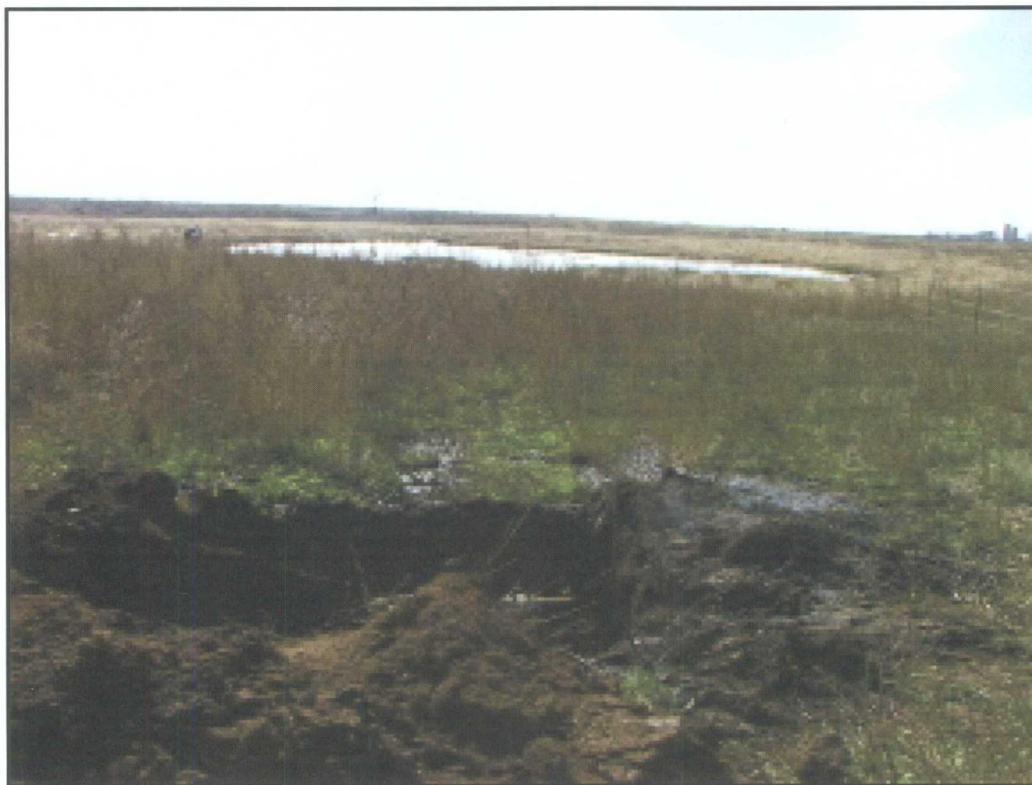
Leak Site & Pond Looking Southwest

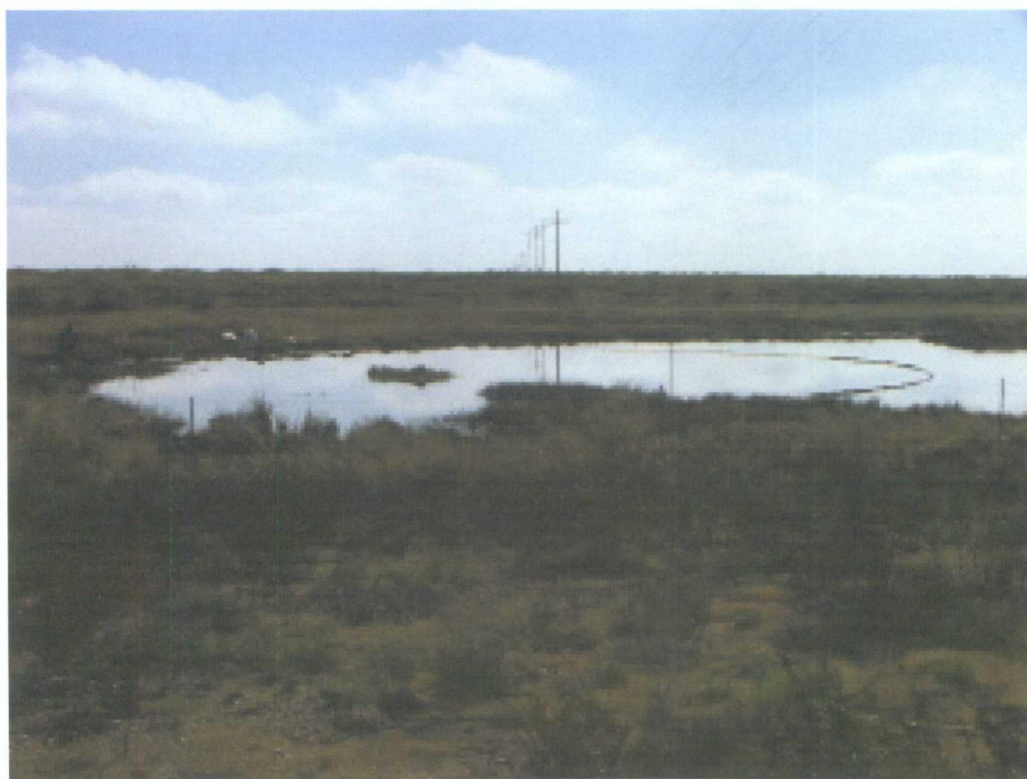
Pond w/Boom

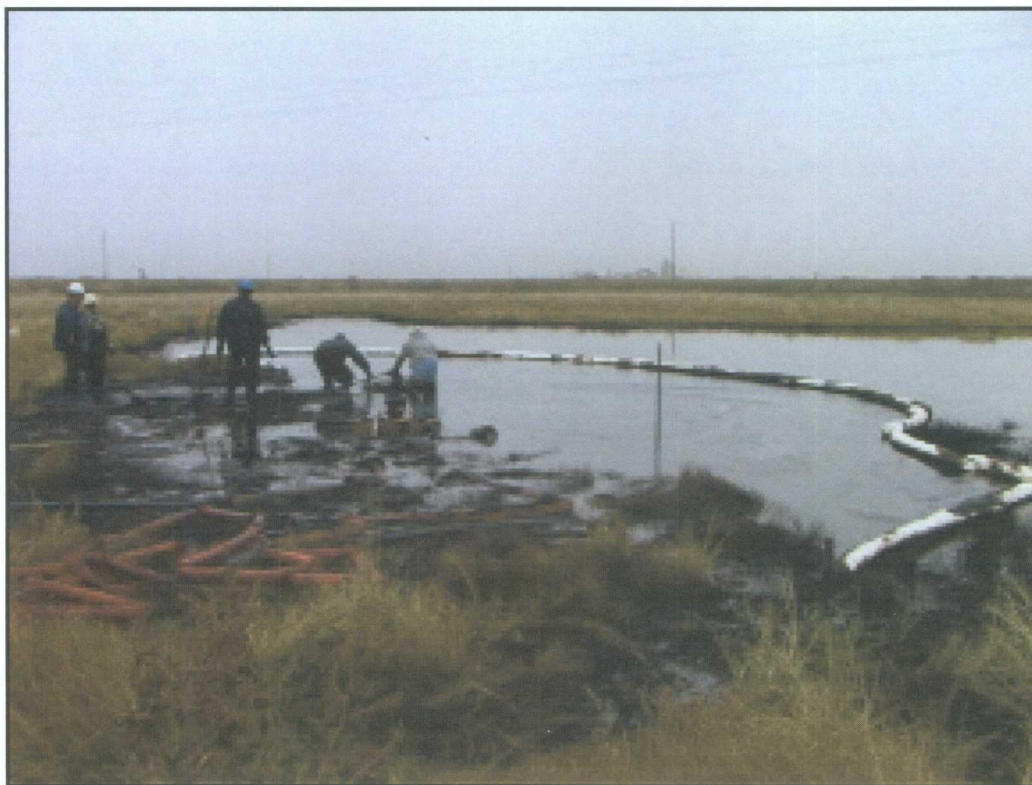
Skim Operation

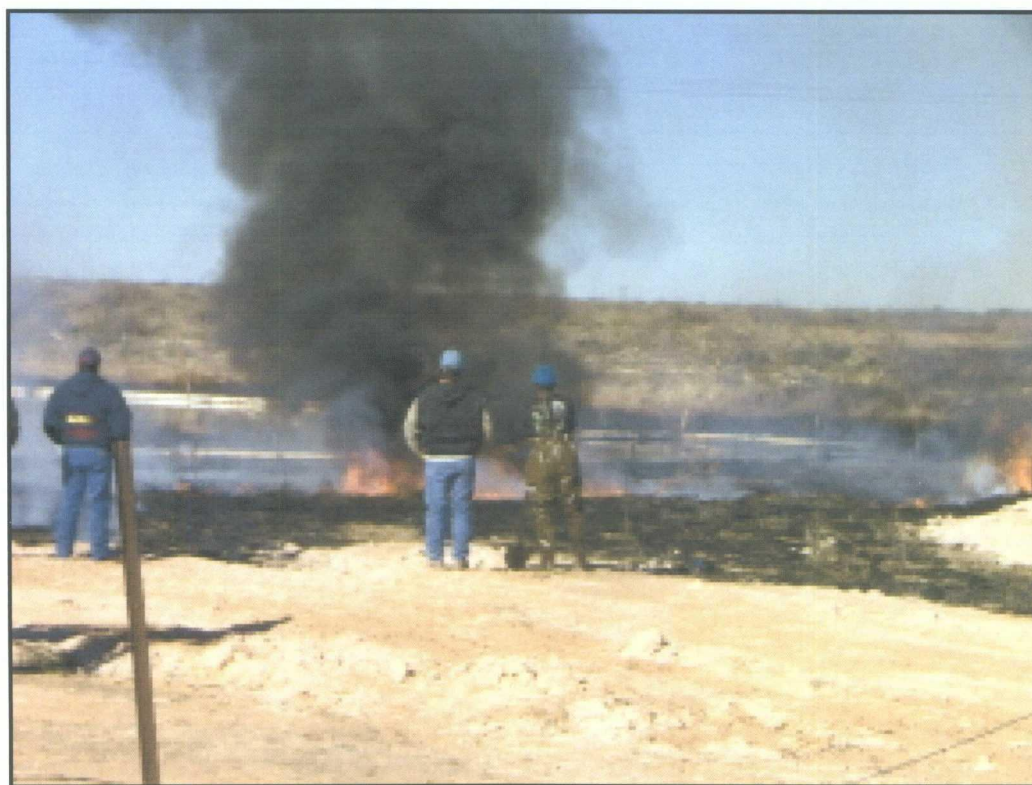
Burning Operation

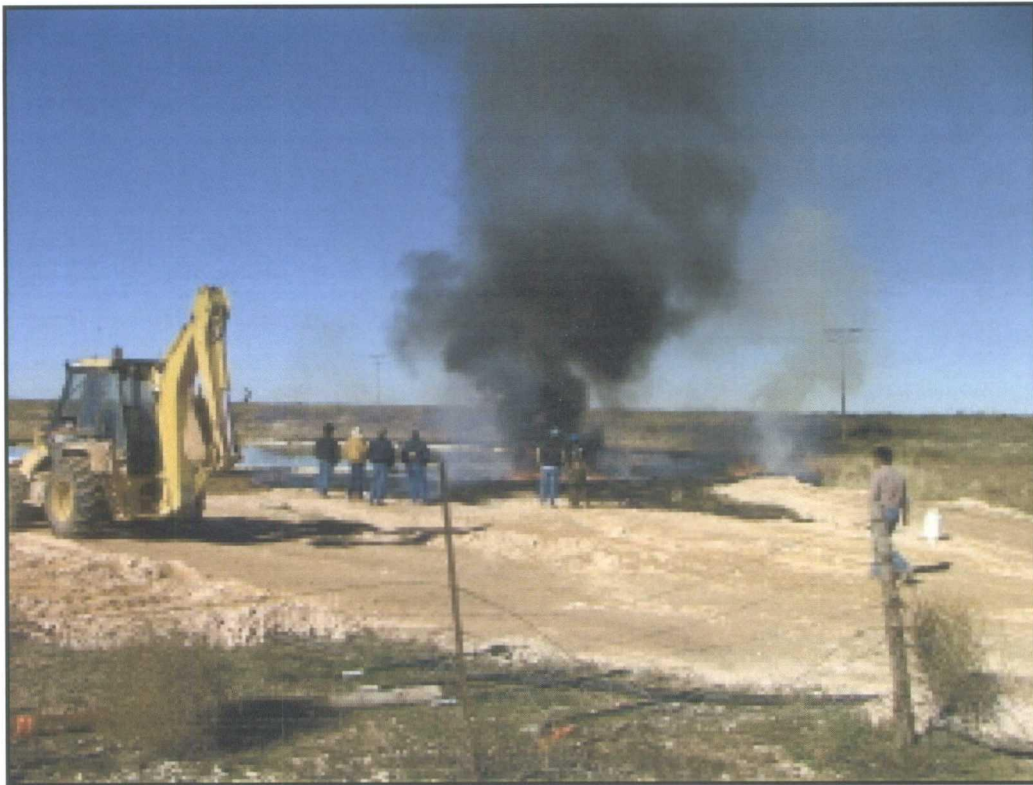
Burning Operation

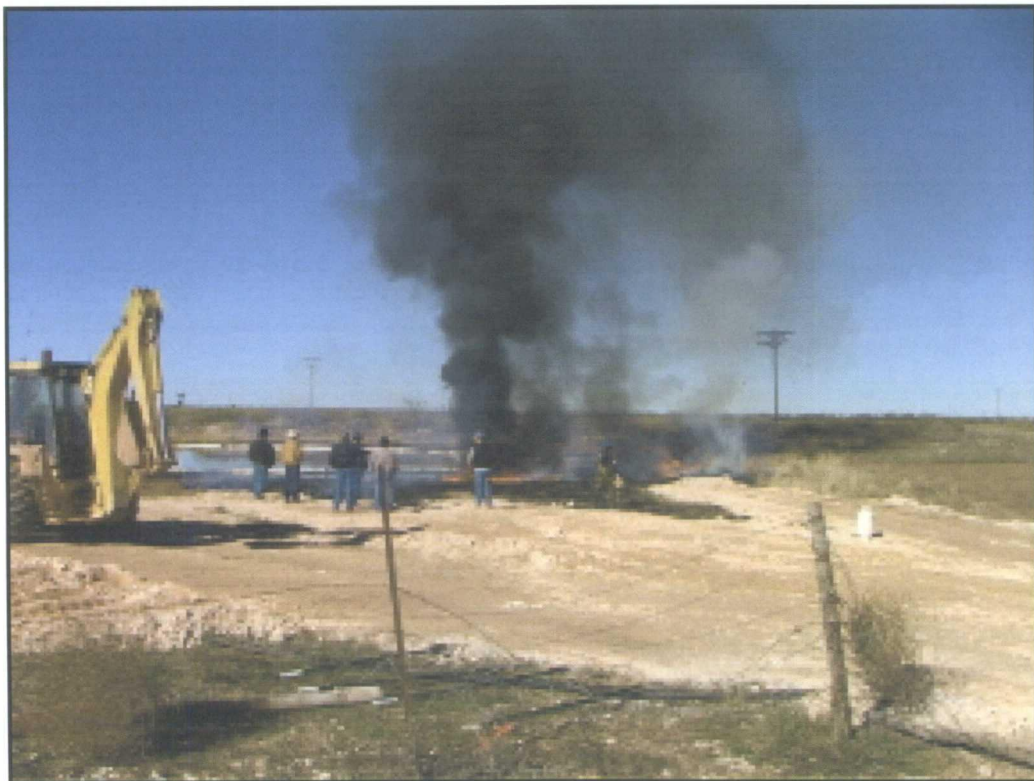
Burning Operation

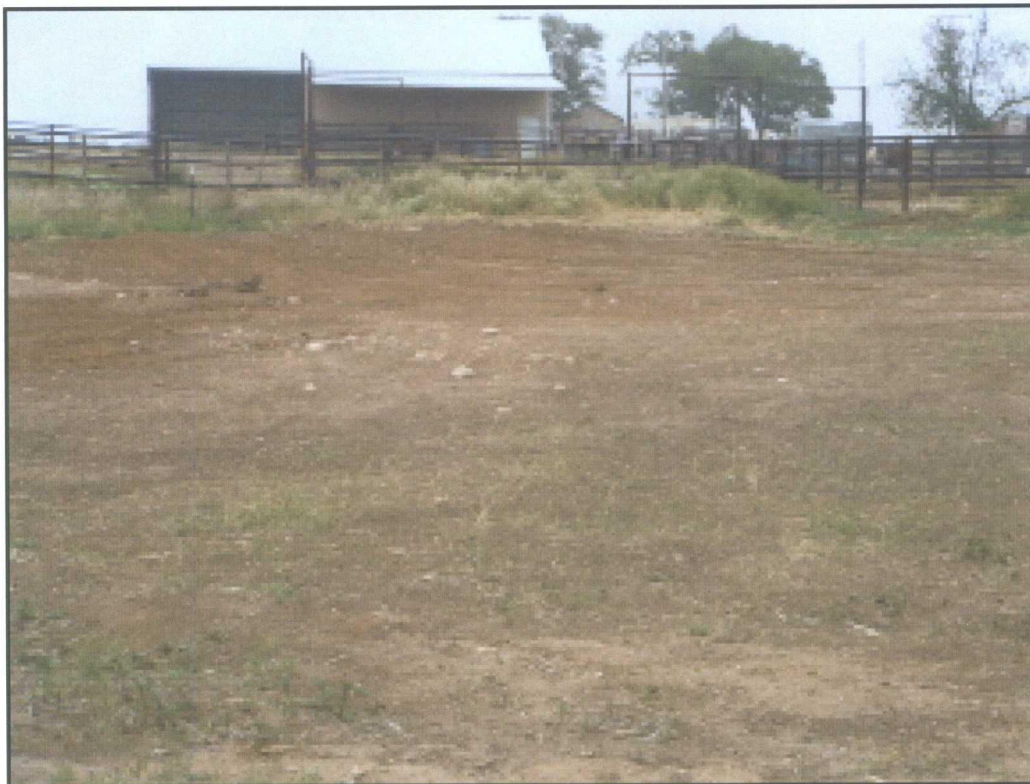
Site Facing North

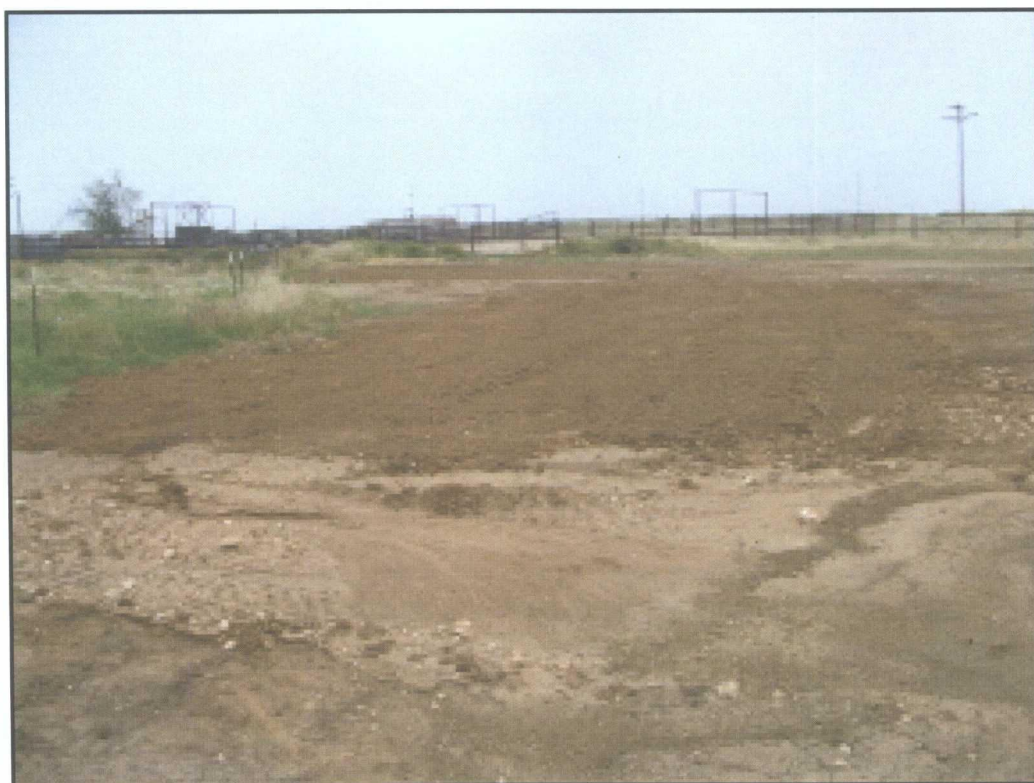
Site Facing Northeast

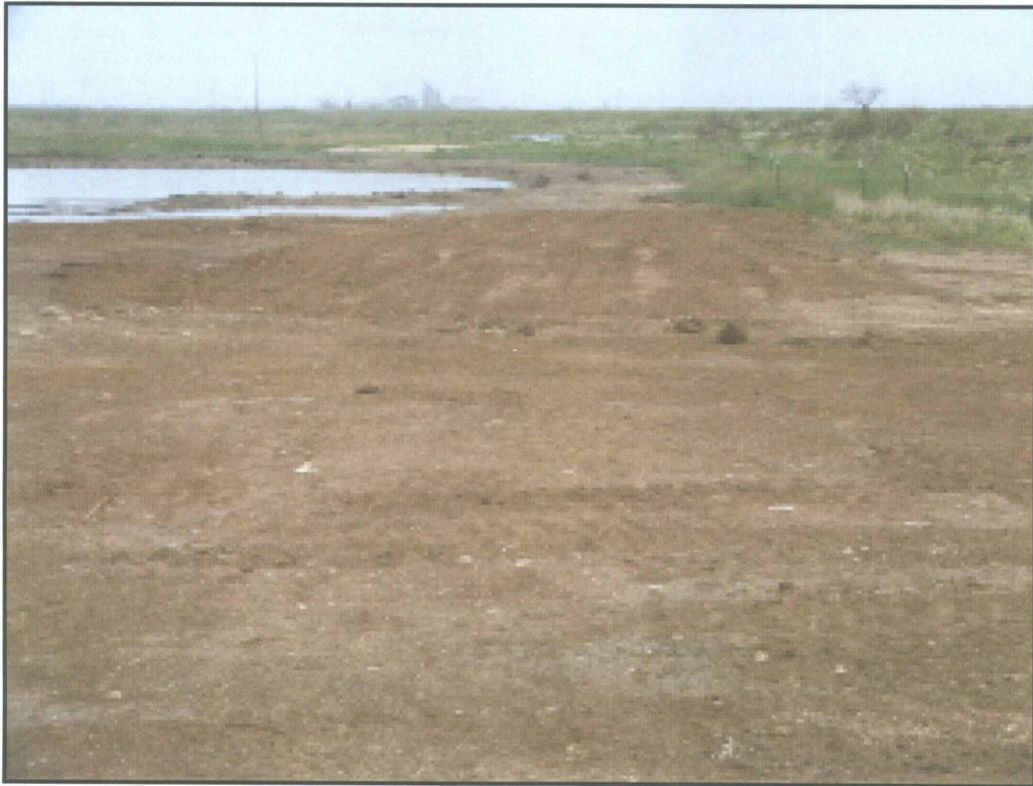
Site Facing West
