WORKPLANS

RE: **CORRECTIVE ACTION PLAN
EME JUNCTION L-6 BOOT SITE
T20S-R37E-SECTION 6, UNIT LETTER L
NMOCD CASE No.: 1R-0427-09**

EME Jct. L-6 Boot Site
T20S - R37E - Section 6 - Unit L
RICE Operating Company

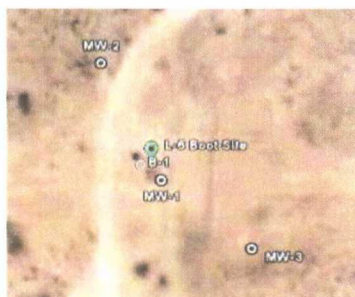
SOIL BORING LITHOLOGIC LOG

BOREHOLE NO.: B-1 TOTAL DEPTH: 30 Feet
 SITE ID: EME Jct. L-6 Boot CLIENT: RICE Operating Company
 CONTRACTOR: Harrison & Cooper, Inc. COUNTY: Lea
 DRILLING METHOD: Air Rotary STATE: New Mexico
 START DATE: 10/29/07 LOCATION: T20S-R37E-Sec 6-Unit L
 COMPLETION DATE: 10/29/07 FIELD REP.: G. Van Deventer
 COMMENTS: Boring located at former junction box (2 feet west of plate marker)
Photo at left shows boring activities at B-1 (facing northwest).

Sample		Chloride (ppm)	PID (ppm)	USCS	LITHOLOGIC DESCRIPTION: LITHOLOGY, COLOR, GRAIN SIZE, SORTING, ROUNDING, CONSOLIDATION, DISTINGUISHING FEATURES
	Depth	Type				
3/8 Bentonite Hole Plug 5"	Surface	Surface				Sandy loam (dune sand), light brown (5 YR 6/4), fine-grained, well-sorted, sub-to well-rounded grains, unconsolidated, dry.
	5					
	0850	Split Spoon	442	196	SW	Fine-grained sand, dark grayish, moderately well-sorted, subrounded, unconsolidated, slightly moist, moderate hydrocarbon odor. Sample submitted for laboratory analysis with results as follows: Benzene = 0.02 mg/kg, Toluene = 0.17 mg/kg, Ethylbenzene = 0.33 mg/kg, Xylenes = 1.89 mg/kg GRO < 16.9 mg/kg, DRO = 379 mg/kg, TPH = 379 mg/kg
	10					
	0855	Split Spoon	173	39		Fine-grained sand, light brown (5 YR 6/4), moderately well-sorted, subrounded, unconsolidated, dry.
	15					
	0900	Split Spoon	179	50	SM/CAL	Fine-grained sand, moderate orange pink (5YR 8/4) with some very pale orange (10YR 8/2) calcium carbonate in matrix. Sand grains are moderately well-sorted, subrounded, unconsolidated, dry.

20					
	0905	Split Spoon	1452	1		Fine-grained sand, moderate orange pink (5YR 8/4) with some very pale orange (10YR 8/2) calcium carbonate in matrix. Sand grains are moderately well-sorted, subrounded, unconsolidated, dry. Sample submitted for laboratory analysis with results as follows: Chloride = 4470 mg/kg
	25					
	0910	Split Spoon	976	31	SW	Fine-grained sand, moderate orange pink (5YR 8/4), moderately well-sorted, subrounded, unconsolidated, dry.
	0920	Split Spoon	1000	2		Fine-grained sand, moderate orange pink (5YR 8/4), moderately well-sorted, subrounded, unconsolidated, damp.
	30					Bottom of boring at 30 ft below ground surface.
	35					
	40					
	45					
	50

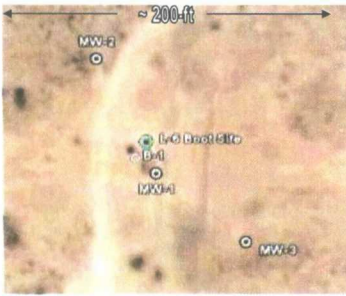
MONITOR WELL NO.: MW-3

COMMENTS: Monitoring well located approximately 75 feet southeast of former junction box (marker plate).

Cement	Sample	Depth	Time	Type	Chloride (ppm)	PID (ppm)	USCS	LITHOLOGIC DESCRIPTION:
								LITHOLOGY, COLOR, GRAIN SIZE, SORTING, ROUNDING, CONSOLIDATION, DISTINGUISHING FEATURES
Cement	Surface						CL/CAL	Imported clay-caliche pad constructed to allow access for drilling rig.
							SW	Fine- and medium-grained dune (loamy) sand, light brown (5YR 5/6), well-sorted, sub-to well-rounded grains, loose, unconsolidated, dry.
Cement		5						
			0833	Split Spoon	358	0		Fine- and medium-grained sand, light brown (5YR 5/6), well-sorted, sub-to well-rounded grains, loose, unconsolidated, dry.
Cement		10						
			0838	Split Spoon	171	0		Fine-grained sand, light brown (5YR 5/6), well-sorted, sub-to well-rounded grains, loose, unconsolidated, dry.
Cement		15						
			0844	Split Spoon	609	0	SM/CAL	Very fine and fine-grained sand, grayish orange (10YR 7/4) with some very pale orange (10YR 8/2) calcium carbonate in matrix. Sand grains are moderately well-sorted, subrounded, unconsolidated, dry. Sample submitted for laboratory analysis with results as follows: Chloride = 109 mg/kg

Cement		20						
			0853	Split Spoon	604	0	SW	Fine-grained sand, light brown (5 YR 6/4), moderately well-sorted, subrounded, unconsolidated, dry.
Cement		25						
			0856	Cuttings	324		SW/CAL	Fine-grained sand, light brown (5 YR 6/4) with slight calcium carbonate in matrix, moderately well-sorted, subrounded, unconsolidated, dry.
Cement		30						
			0858	Cuttings	413			Very fine and fine-grained sand, grayish orange (10YR 7/4), moderately well-sorted, subrounded, unconsolidated, dry.
Cement		35						
			0859	Cuttings	436		SW	Fine-grained sand, grayish orange (10YR 7/4), moderately well-sorted, subrounded, unconsolidated, slightly moist.
Cement		40						
			0904				SW/CAL	Fine and medium-grained sand, grayish orange (10YR 7/4), slight calcium carbonate content in matrix, moderately well-sorted, subrounded, unconsolidated, slightly moist.
Cement		45						
			0906					Fine and medium-grained sand, grayish orange (10YR 7/4), with some indurated intermittent sandstone streaks, moderately well-sorted, subrounded, unconsolidated, slightly moist.

Cement		50						
			0910				SW/SS	Fine and medium-grained sand, grayish orange (10YR 7/4), with some indurated intermittent sandstone streaks, moderately well-sorted, subrounded, unconsolidated, slightly moist.
Cement		55						
								Bottom of boring at 52 ft below ground surface.

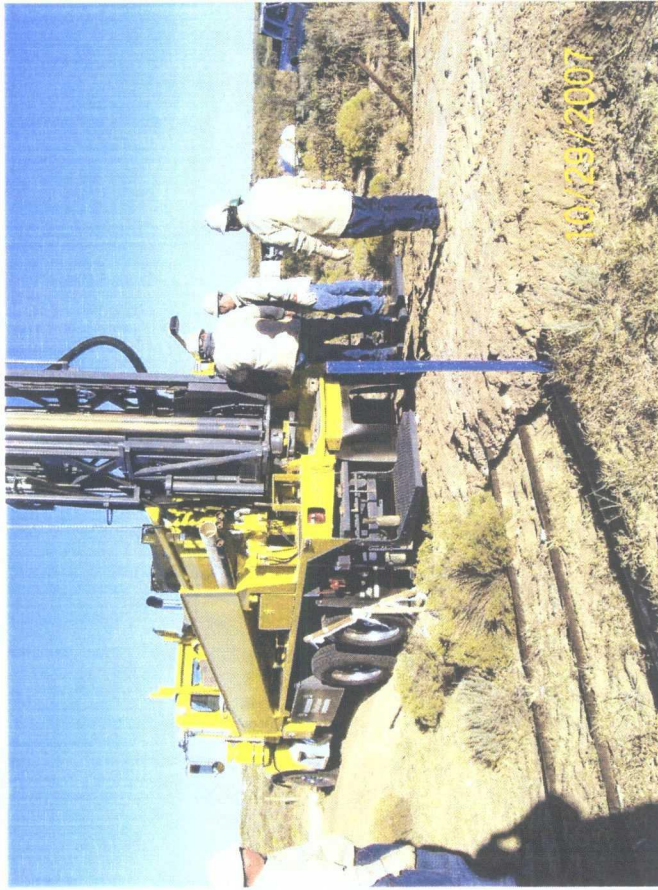
View facing northwest showing sampling activities at B-1.

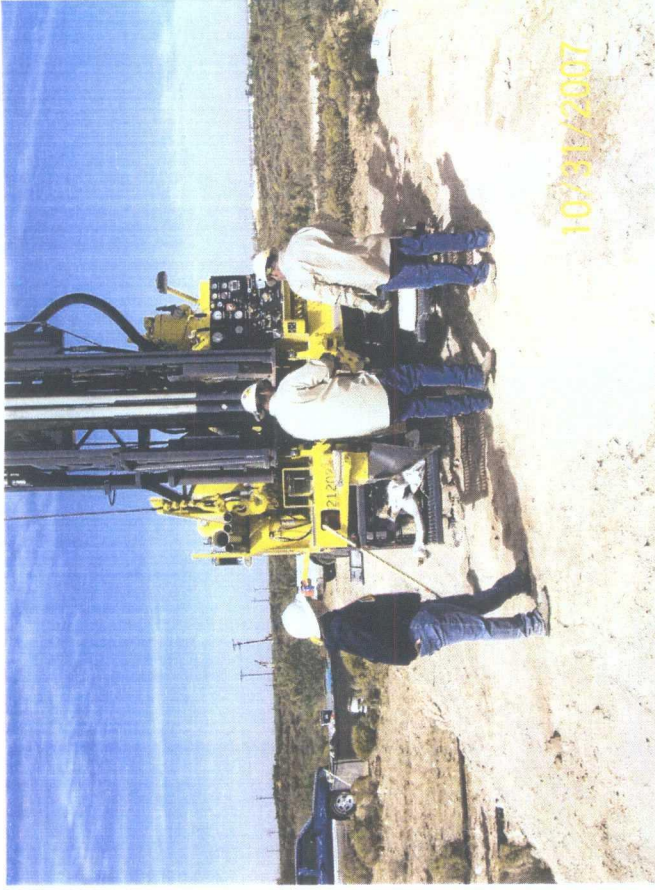
View facing northwest showing sampling activities at MW-1.

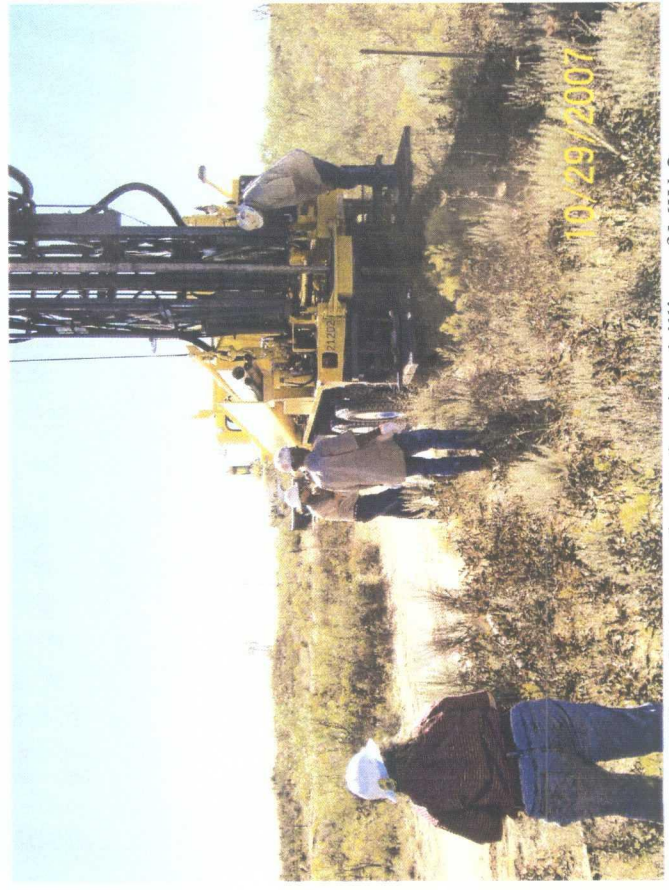
View facing southeast showing drilling of MW-2.
