Release Notification and Corrective Action

Name of Company ConocoPhillips	Contact Tom Samarripa
Address: ConocoPhillips/ Attn: Celeste Dale/ 3300 N. "A" St. Bldg. 6 #247/ Midland, Tx. 79705	Telephone No. 432.368.1263
Facility Name MCA Well 391	Facility Type Oil Well

ConocoPhillips Co.
 MCA Well #391
 Release Site
 Lease No.
 30-025-38853
 T-17-S, R-32-E,
 Sec. 25 (H)
 Lea County, NM

Delineation Sampling Plan

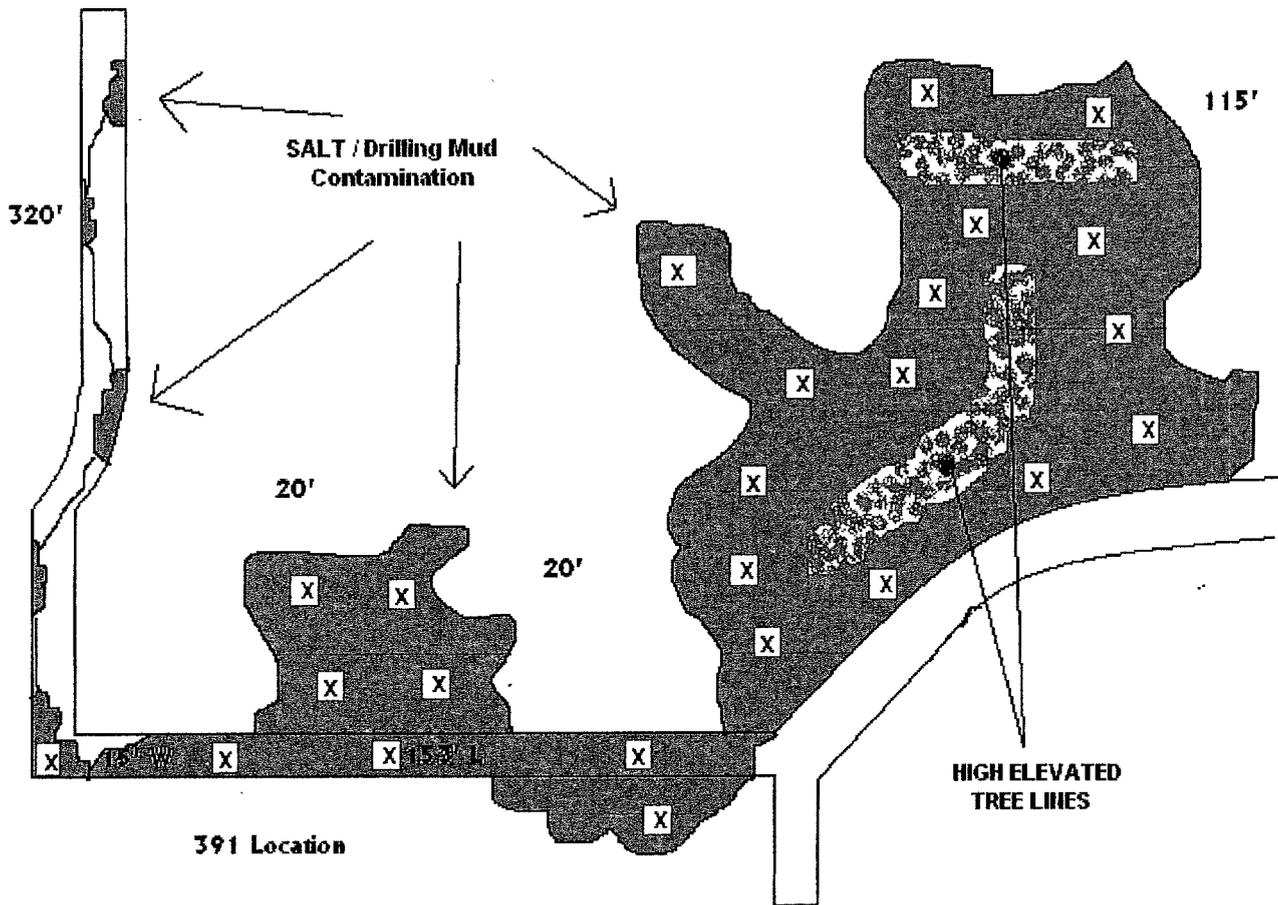
Affected area (see remediation plat) was to lease road and pasture land. No livestock was present. Area will be remediated per NMOCD & BLM guidelines.

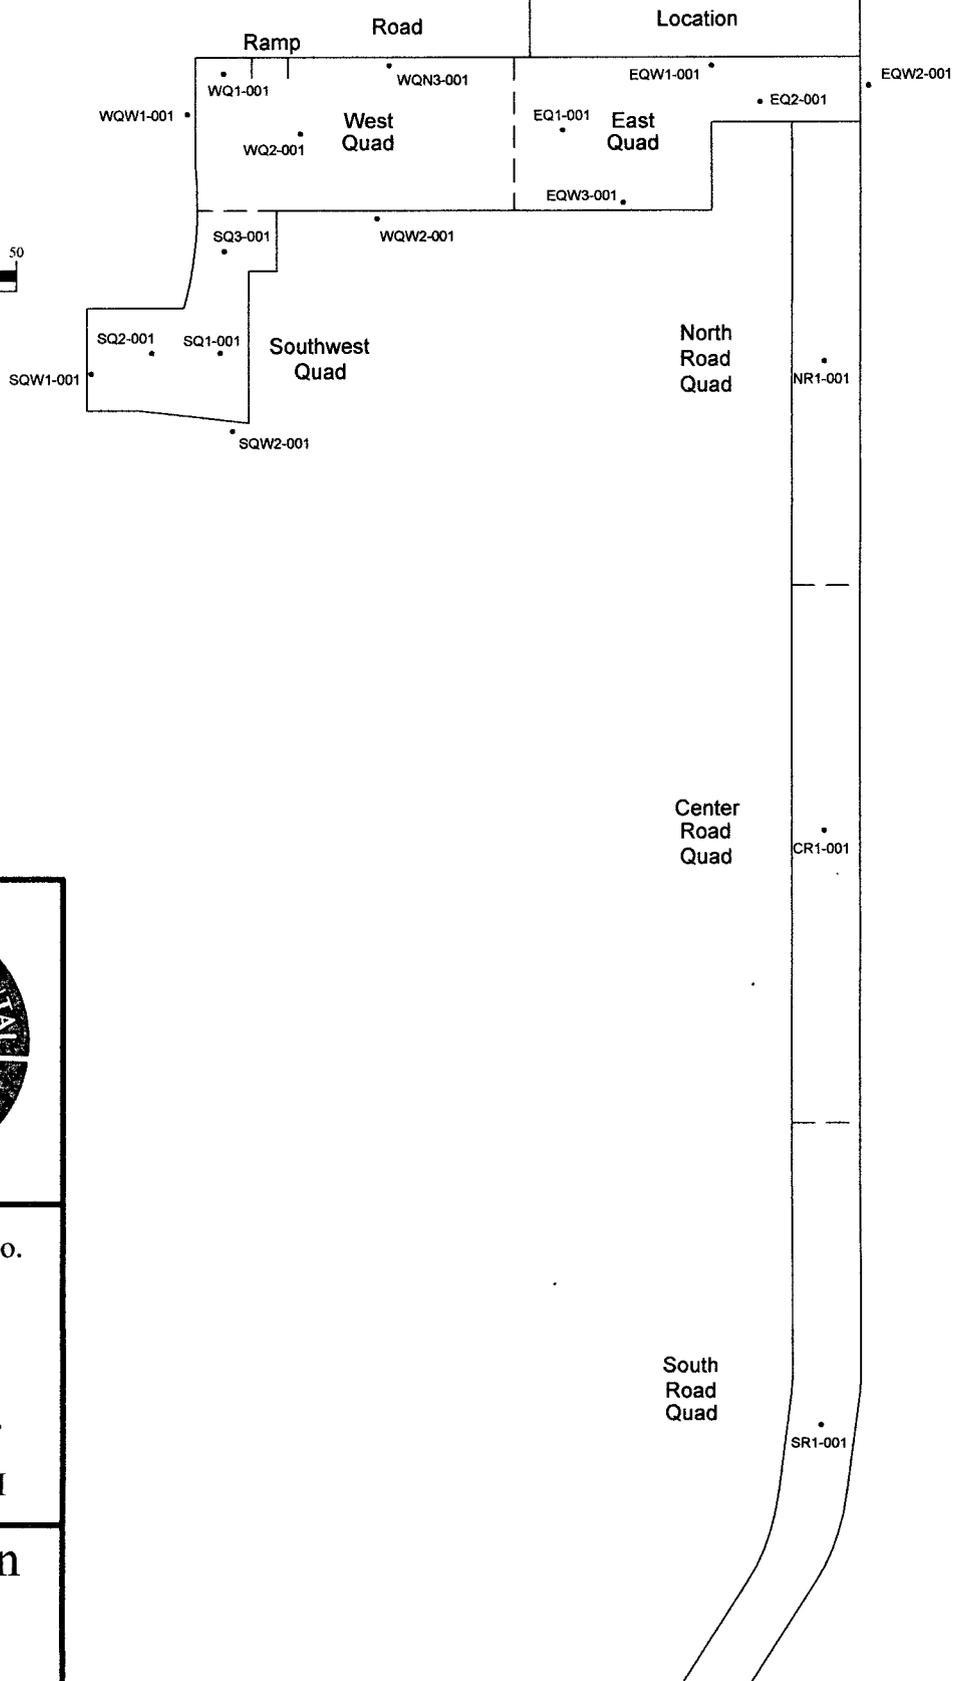
- X - 6" Depth Soil Samples
- X - 18" Depth Soil Samples
- - Salt/Drilling Mud Contamination
- ▨ - Elevated Treeline

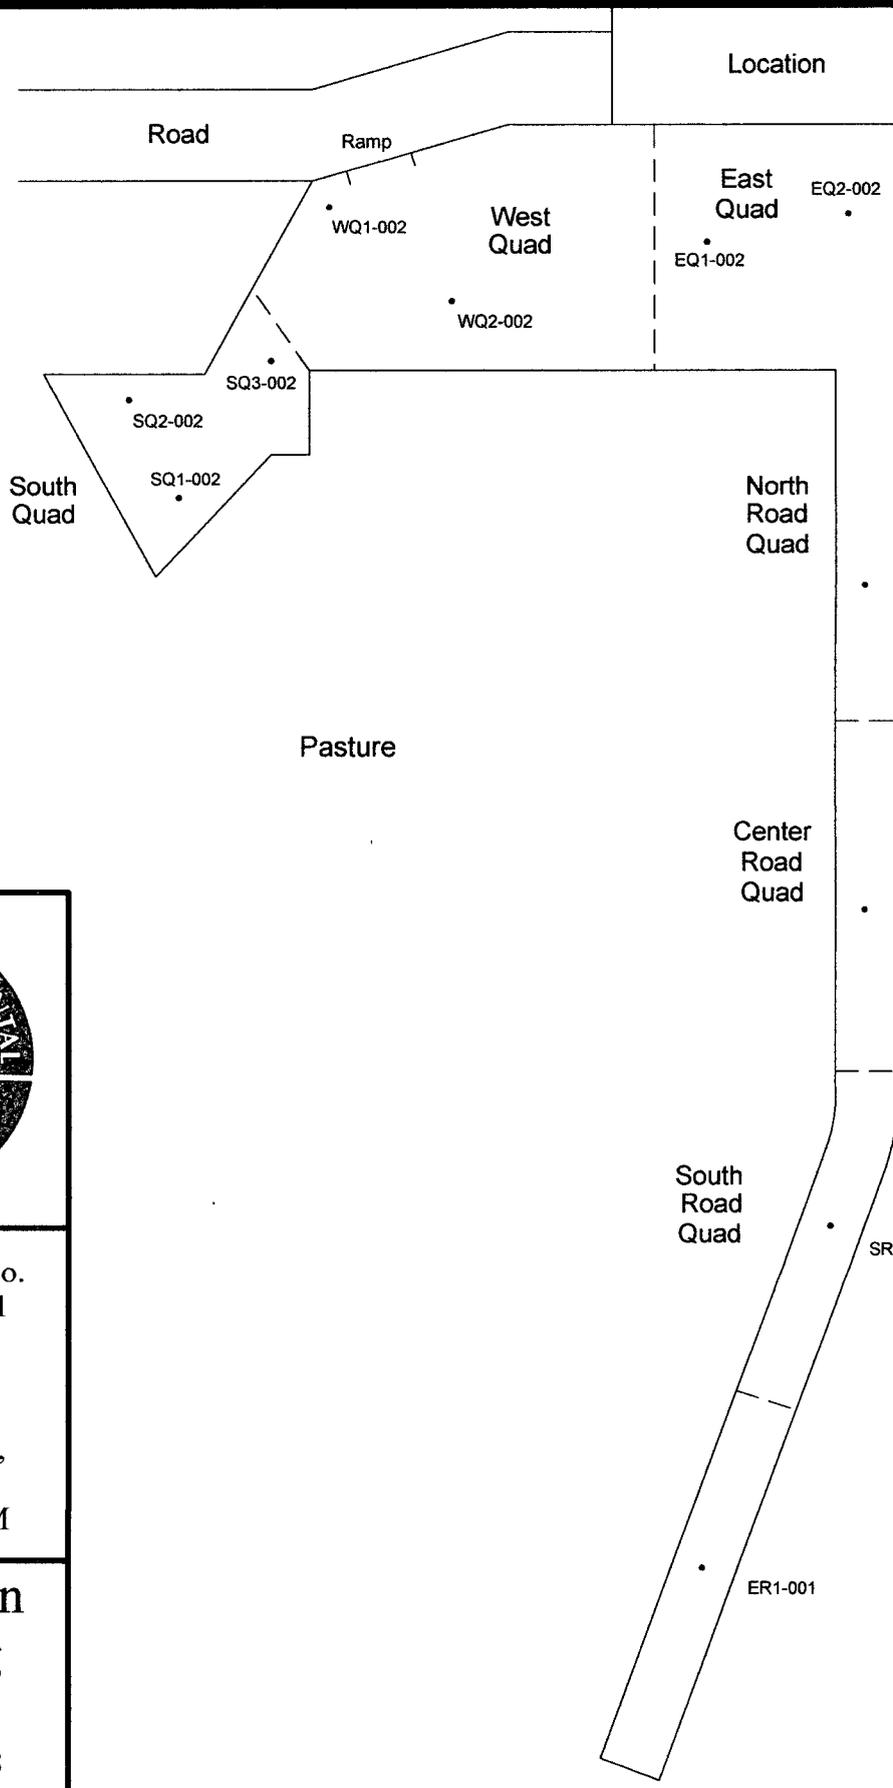
Delineation Sampling Plan

ConocoPhillips Co.
MCA Well #391
Release Site
Lease No.
30-025-38853
T-17-S, R-32-E,
Sec. 25 (H)
Lea County, NM
