LOCKHART B-14 004 BATTERY

C141 CLOSURE REPORT

API 30-025-06576

September 29, 2008

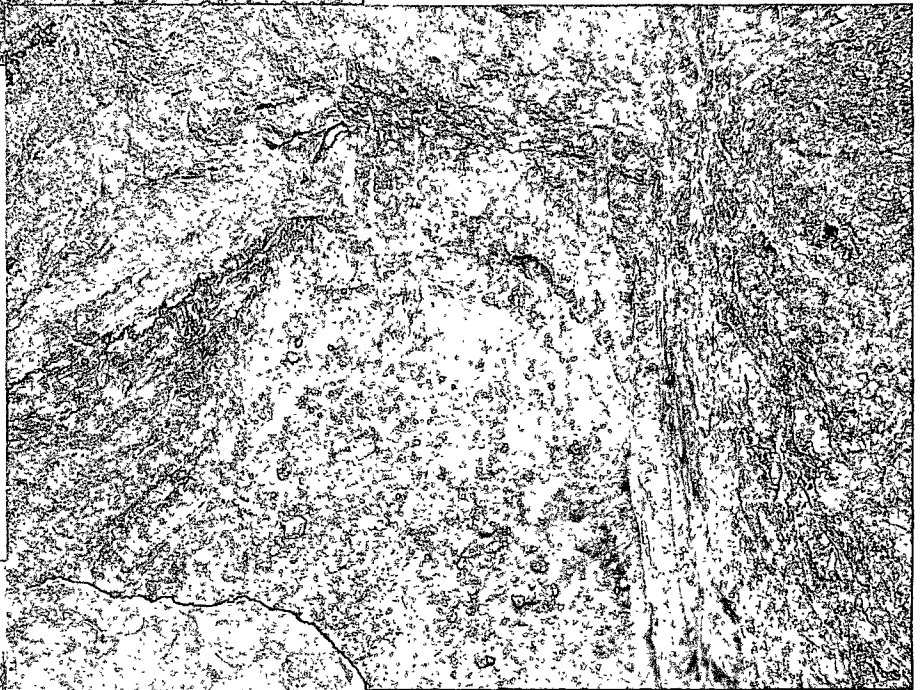
Deep contamination at
west release area

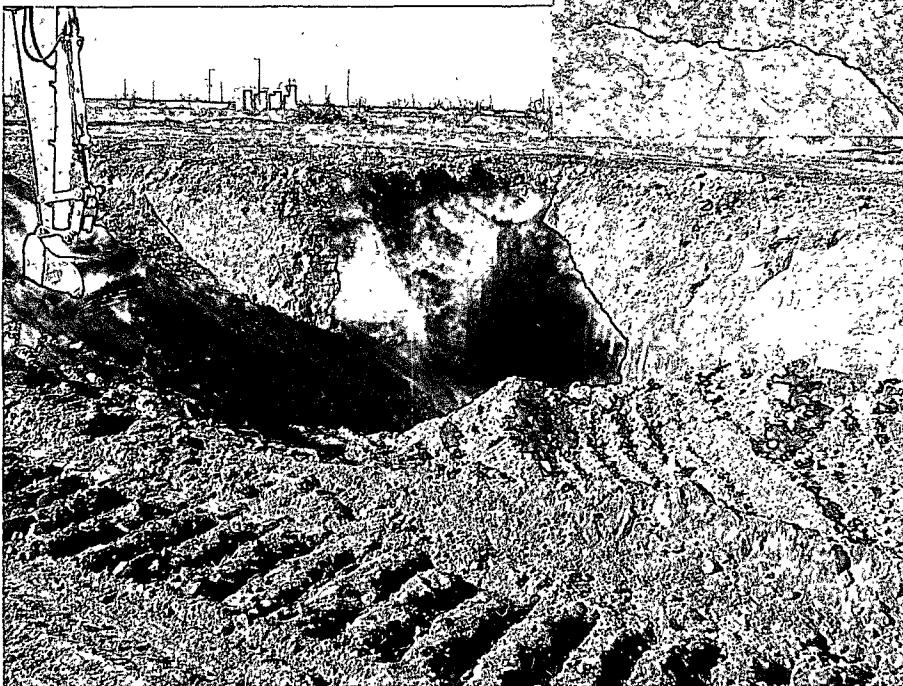
Excavation of west release

highly contaminated center of the west release area (50' X 50' X 20' depth) and disposed of at J&L Land Farm. After field analyses of the bottom and sides of the 20-ft excavation, it was extended to a depth of 24-ft bgs with a 75' X 75' surface dimension. The 24-ft bottom was sampled at 2 points and the sidewalls were sampled at 6 points. Analytical results indicated that the TPH had been eliminated from the bottom and sidewalls, the chlorides had been eliminated from the sidewalls. The chlorides, however, had increased at the 24-ft bottom to 3600-ppm. This excavated soil was stockpiled and blended with clean backfill (2320-yd³) obtained from J&L Land Farm. Six (6) random samples of this blended backfill material were submitted to Cardinal Laboratories and analyzed for TPH and chlorides. Results were consistent in the ranges 1400 to 2000-ppm TPH and 500 to 600-ppm total chlorides. With NMOCD approval, the excavation was backfilled with the blended material and then lined with an 85' X 85' (5-ft overlap on all sides) 20-mil polyethylene liner at the 4-ft bgs level. The liner was then covered up to surface level with clean topsoil salvaged from the east portion of the location.

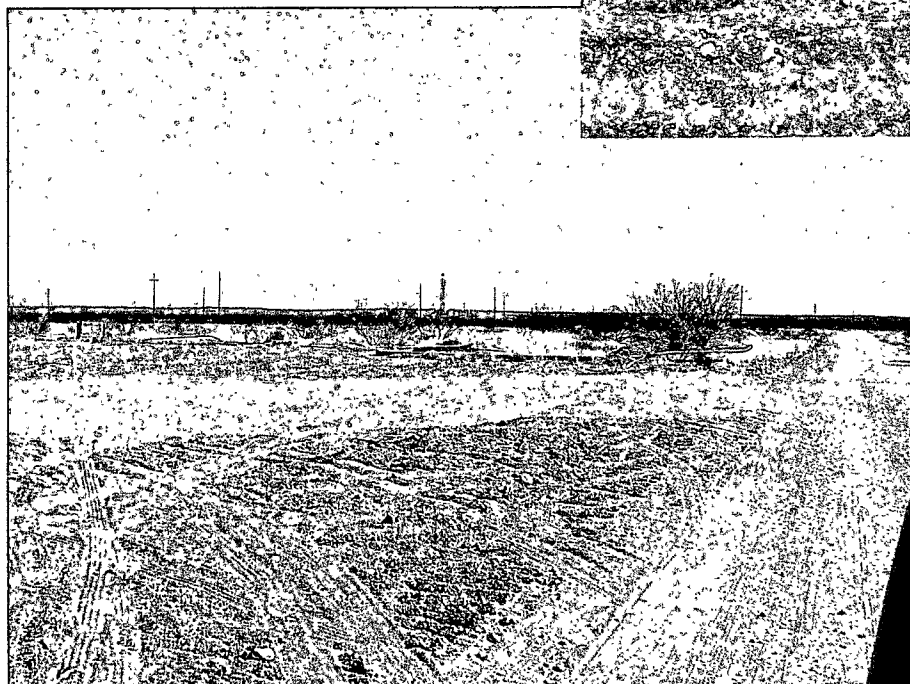
Installing 20-mil liner at 4-ft
bgs level

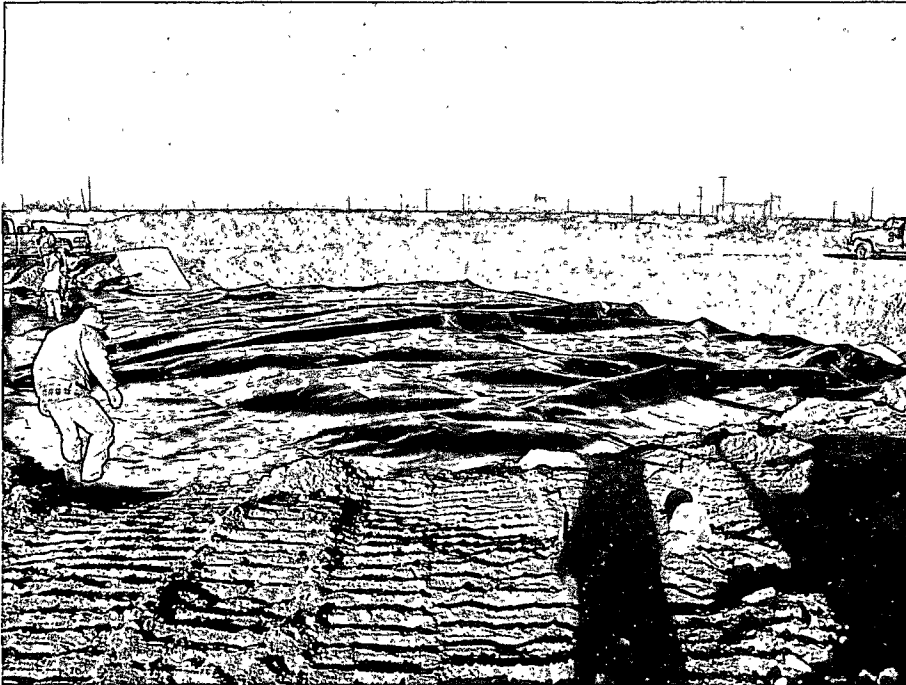
Covering installed liner with
topsoil

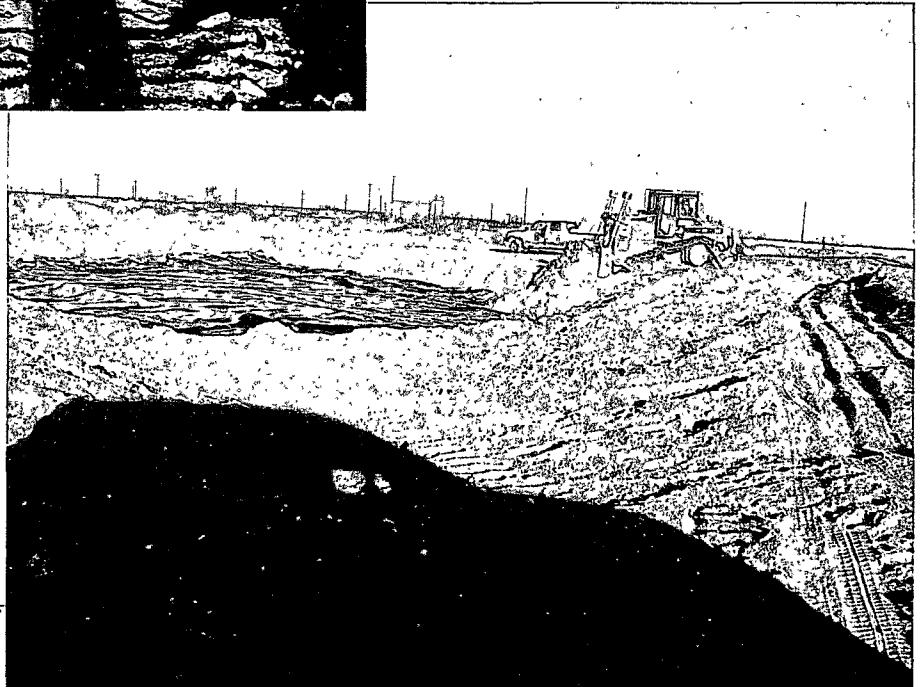
Project completed
