Release Notification and Corrective Action

Name of Company	SOUTHWEST ROYALTIES, INC.	Contact	DAWN M. HOWARD
Address	6 DESTA DRIVE, STE 2100, MIDLAND, TX 79705	Telephone No.	432/688-3267
Facility Name	WILDERSPIN FEDERAL	Facility Type	BATTERY – closest to well #1

Southwest Royalties, Inc.
Wilderspin Federal Battery
Sec. 11, T-21-S, R-27-E,
Eddy County, New Mexico

Site
Excavation
April 9, 2009

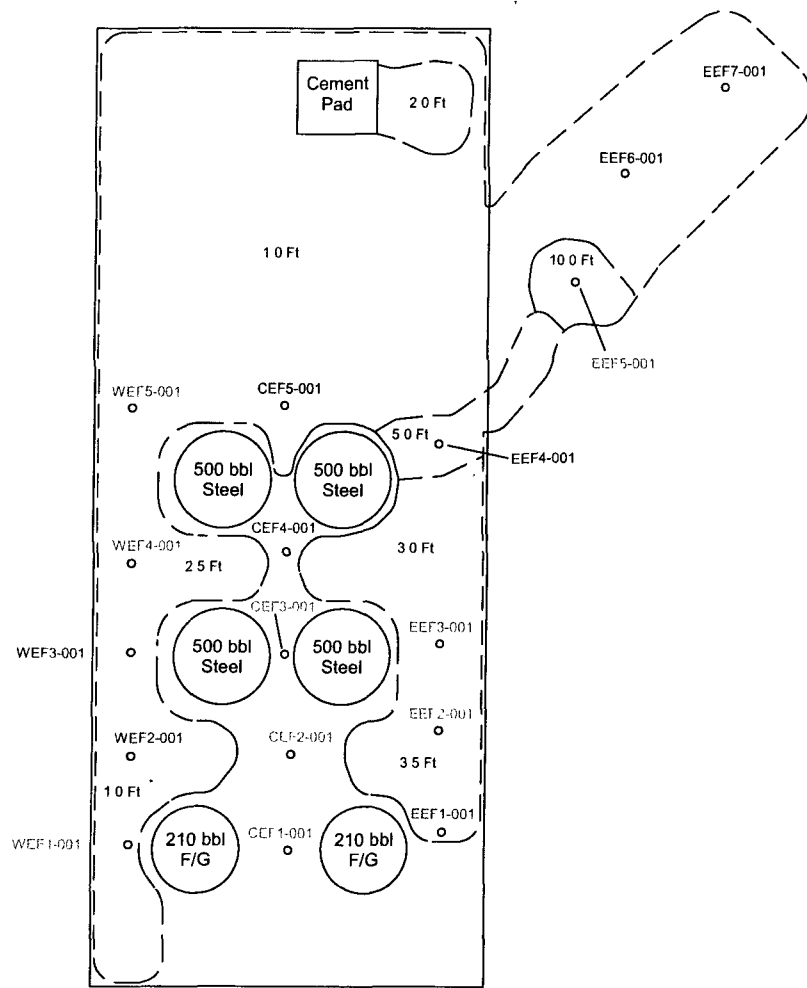
Attached is a diagram of the battery with hot spots. The client is going to remove the tanks from the battery so we can further delineate the spill. As soon as we get to that point and receive our analysis back we will send in a C-141. I just wanted to keep you updated on the status of the battery.

The following denotes one or more elevated contaminants:
Chlorides only sample ID
BTEX only sample ID
TPH only sample ID
Chlorides and TPH sample ID
TPH and BTEX sample ID
