**Release Notification and Corrective Action**

# Closure Report

**Antelope Ridge #4 SWD Facility**  
**Lea County, NM**

1RP-09-4-2153

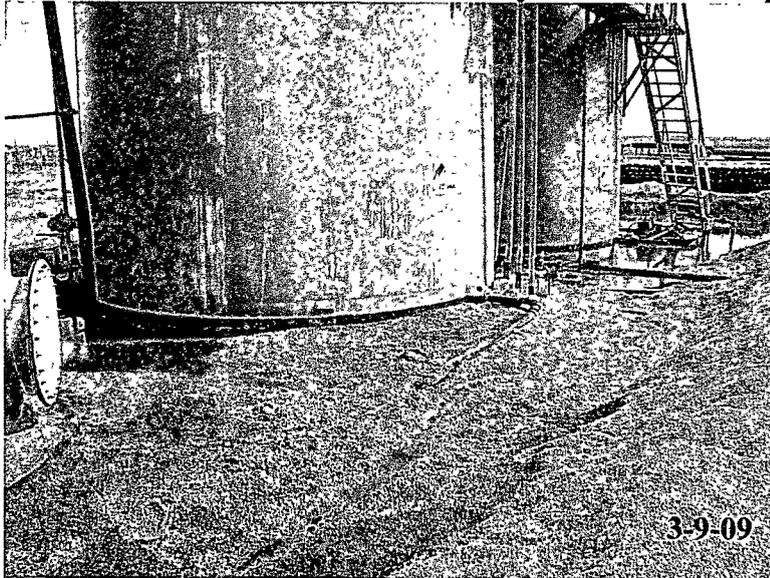
TP1, TP2, TP3 and TP4 before remediation of spill.

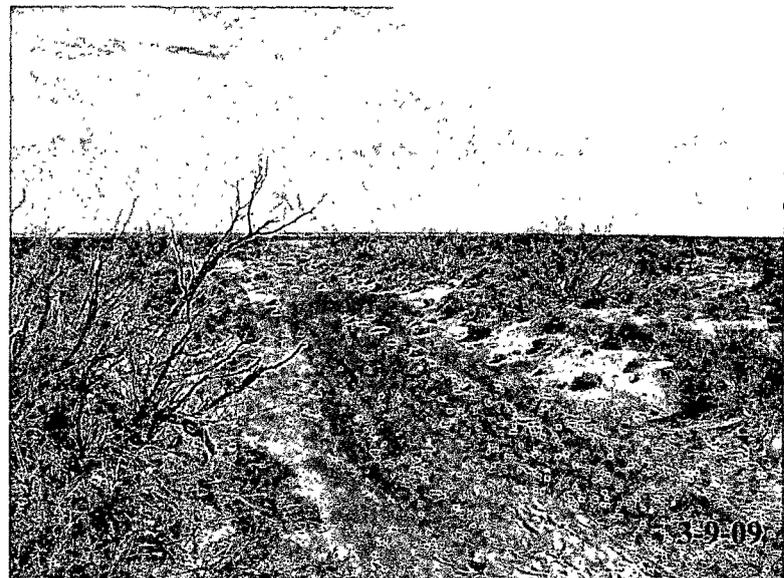
TP9, TP10 and TP11 before remediation of spill.

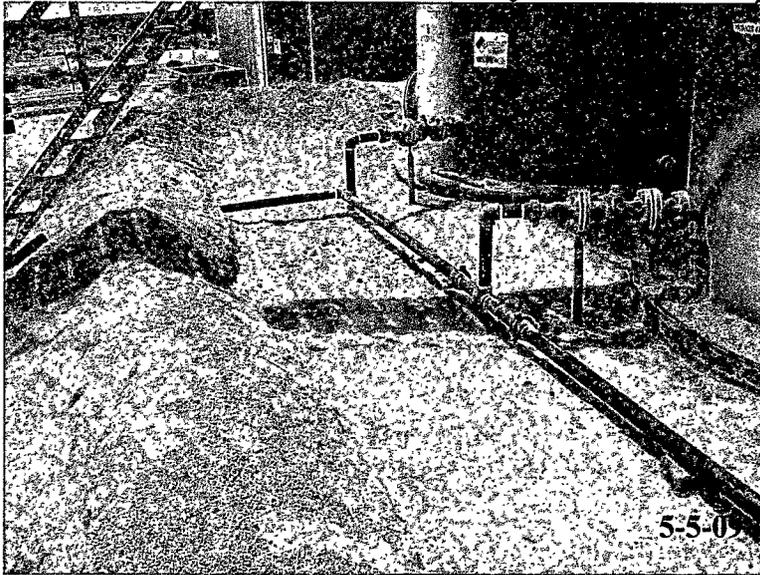
Inside battery after excavation of 1' of impacted soil.

As per the approved workplan 1' of impacted soil was excavated, a 4 oz Geotextile liner was installed then a 20 mil poly liner. The battery area was covered with a layer of pea gravel. The area of impacted soil outside the berm was excavated 4' then a 20 mil poly liner was installed at 4' bgs with 4 oz geo-textile liner above and below the poly liner. Clean native soil was backfilled and contoured to the surrounding area. The site was seeded with BLM Seed Mixture #2. All impacted soil was hauled to Sundance Disposal. Enclosed is the final report of the remediation project including pictures, disposal tickets and a Final C-141. If you have any questions about the enclosed report please contact me at the office.

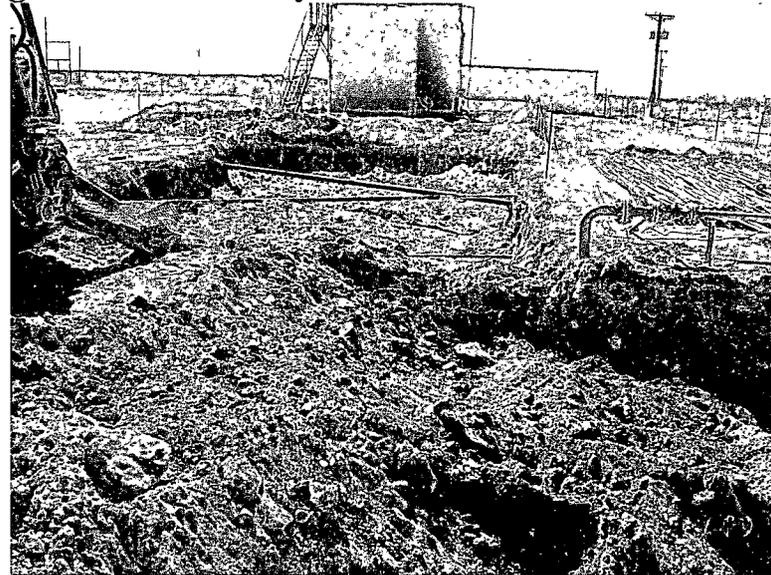
TP5 after excavation of 4' of impacted soil.

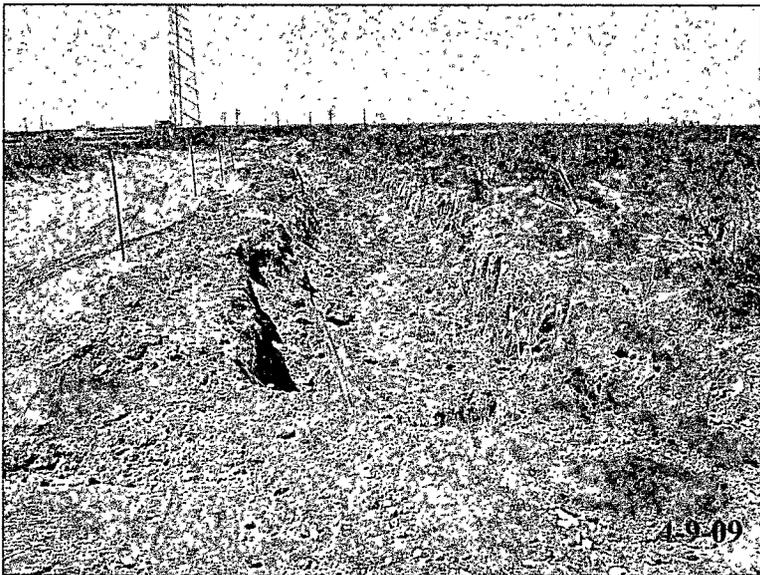
TP6, TP7, TP8 and TP9 after excavation of 4' of impacted soil.

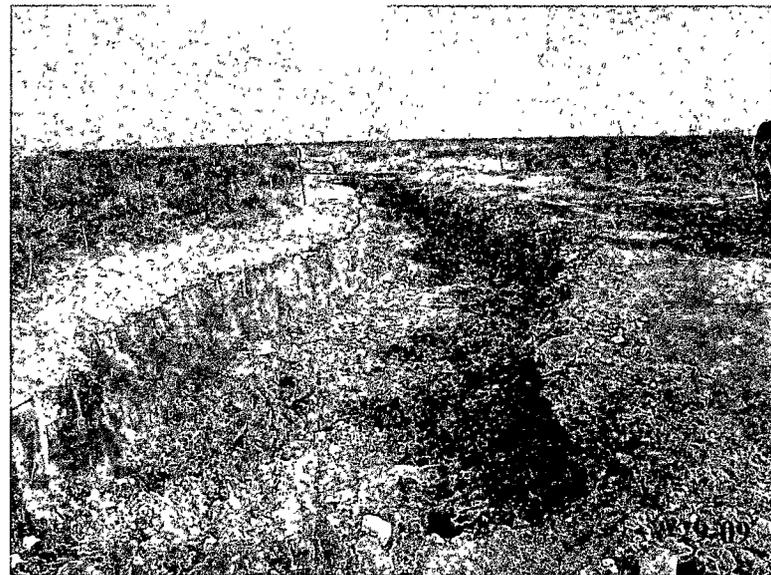
TP10 and TP11 after excavation of 4' of impacted soil.

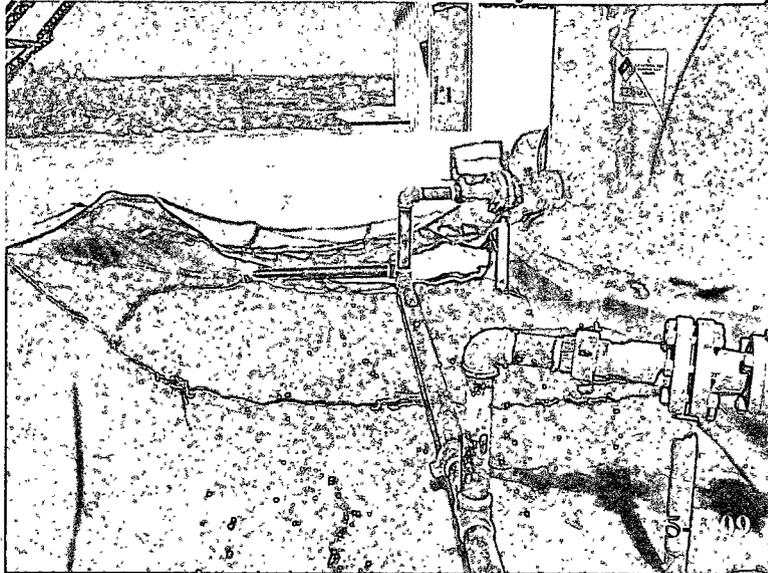
Battery during installation of 20 mil poly and Geotextile liner.

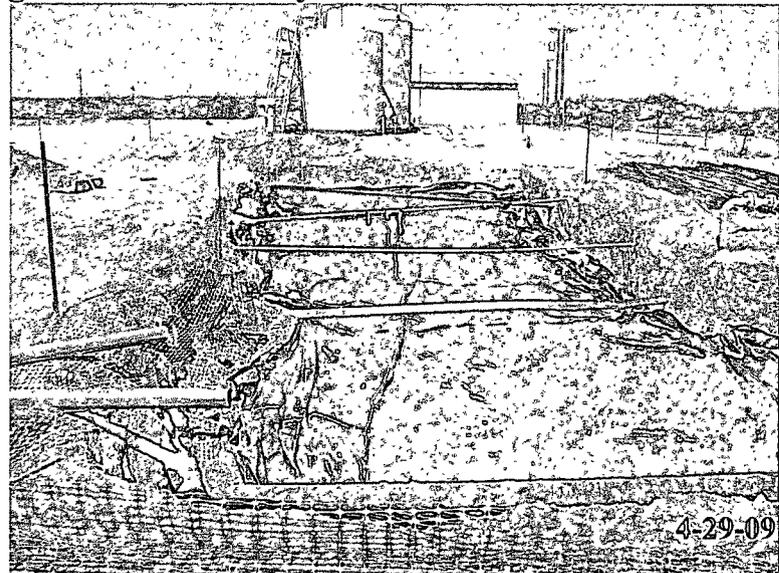
TP5 during installation of 20 mil poly and Geotextile liners.

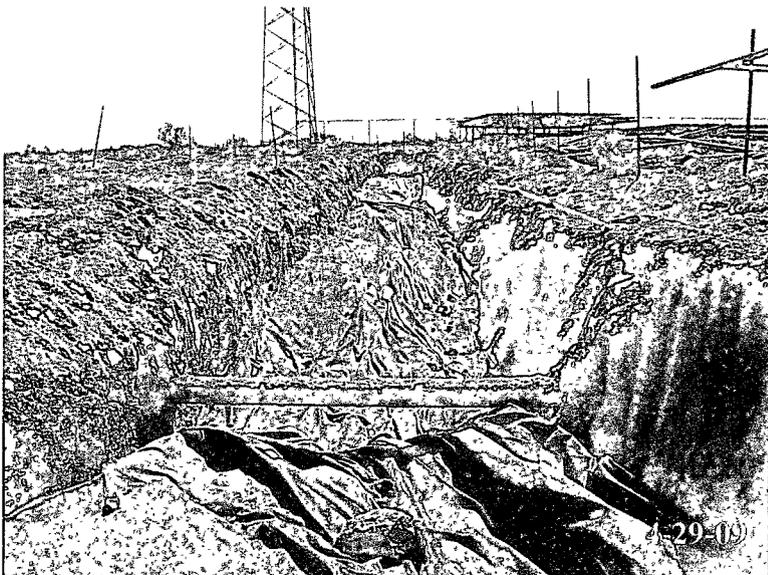
TP6, TP7, TP8 and TP9 after installation of 20 mil poly liner with a 4 oz. Geotextile liner above and below the poly.

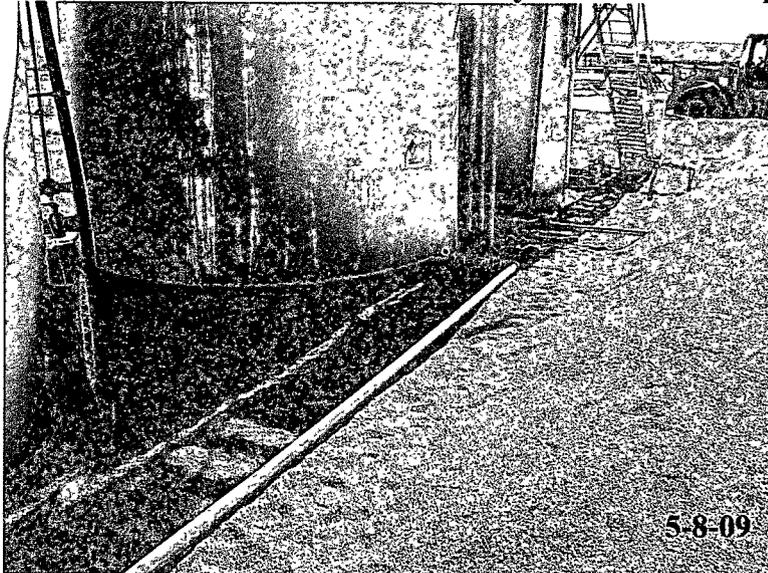
Battery after remediation of spill.

As per the approved remediation plan, the impacted soil was excavated 1' inside the battery, backfilled with clean native soil, a 4 oz. Geotextile liner then a 20 mil poly liner was installed and a layer of pea gravel spread over the battery. The area outside the berm was excavated 4' deep, then a 4 oz. Geotextile liner then a 20 mil poly liner, then another 4 oz. Geotextile liner was installed. The excavation was then backfilled with clean native soil and seeded with BLM Seed Mixture #2. Attached is the Final Closure Report for the project.

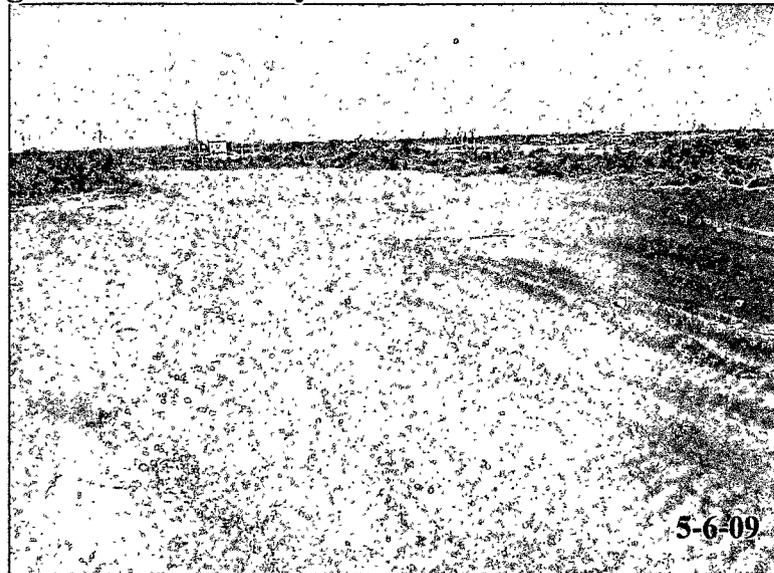
TP5 and TP6 after backfill of clean soil and seeding.

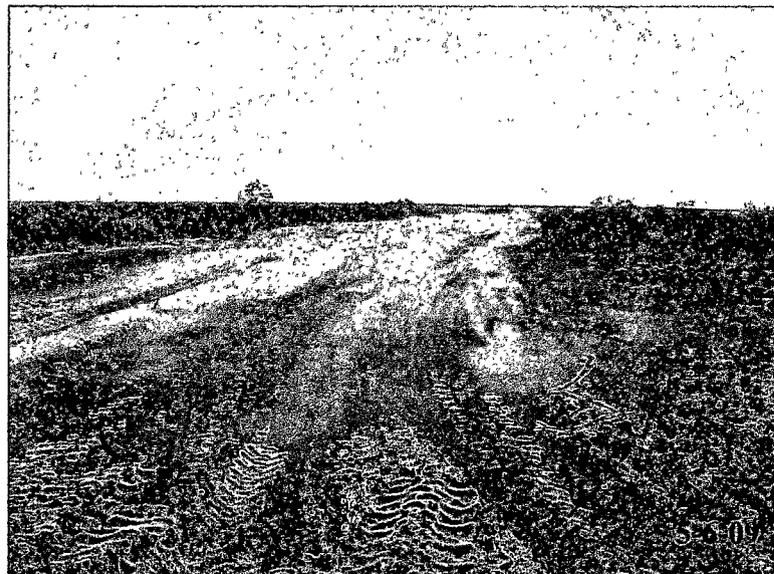
TP10 and TP11 after backfill of clean soil and seeding.
