STAGE 2 REPORTS

Attention: Edward Hansen, New Mexico Oil Conservation Division - Environmental Bureau Subject: Termination Request Site Name: EME Jct. K-6 Site (AP- 46) Site Agent: RICE Operating Company (ROC)Site Location: T20S-R37E-Section 6, Unit Letter K, Lea County, New Mexico

RE: Stage 2 Final Report and Termination Request EME Jct. K-6 Site (AP-46) T20S-R37E-Section 6, Unit Letter K Lea County, New Mexico

Stage 2 Final Report and Termination Request EME Jct. K-6 Site (AP-46) T20S-R37E - Section 6, Unit Letter K

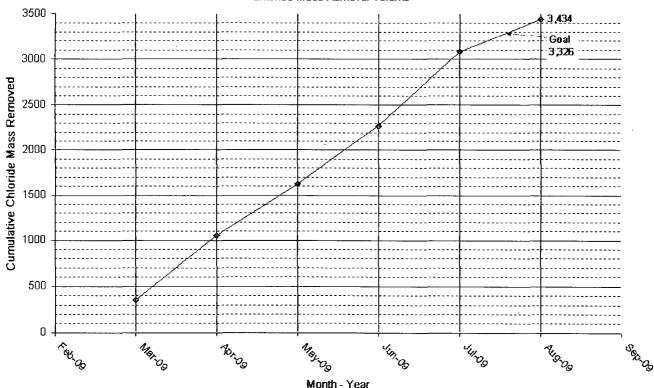
Chloride Mass Removal Volume

As of August 13, 2009, a total of 83,065 gallons (1,978 barrels) of groundwater with an average chloride concentration of 10,920 mg/L has been recovered at the site. The most recent laboratory analytical results for the groundwater recovered from recovery well RW-1 are attached. The groundwater recovered at this site has resulted in the femoval-of 3,434 kg of chlorides. As stated in the NMOCD-approved Stage 2 Abatement Plan, the goal of groundwater recovery was to remove 3,326 kg of chloride mass. The graph below depicts the cumulative chloride mass removed at the site since recovery operations began on February 18, 2009.

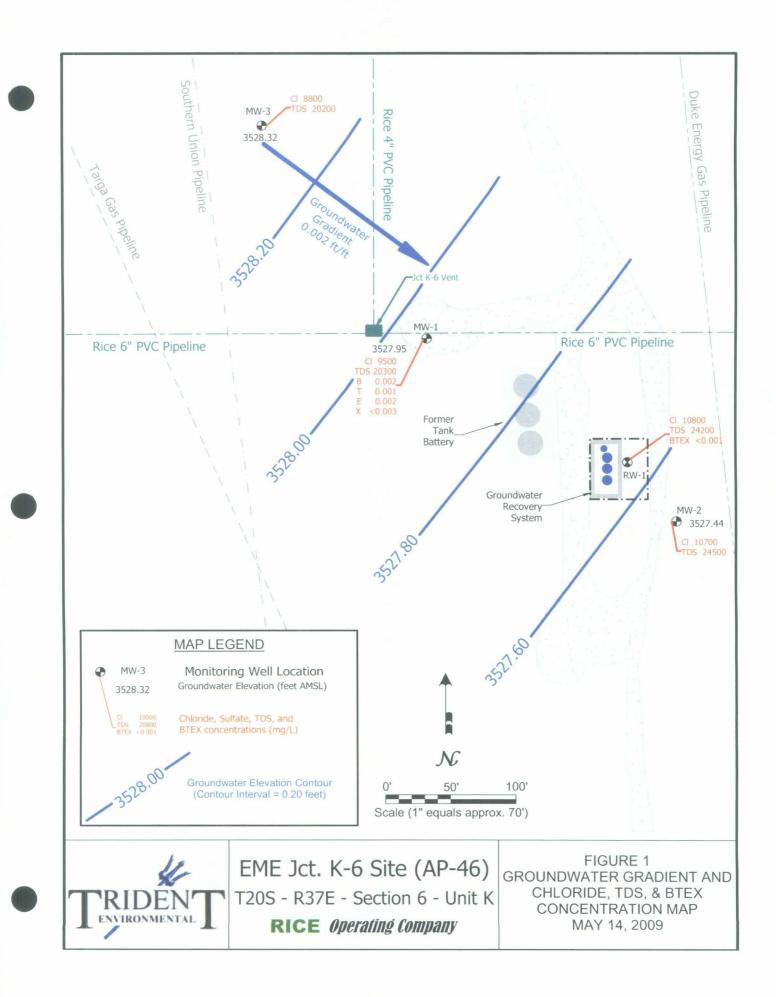
Photographs of the groundwater recovery system are included in Attachment B. A total of 67,872 gallons (1,616 barrels) of water and 2,813 kg of chlorides were recovered from the well over a five month period. Recovered groundwater was either utilized for pipeline maintenance or treated with a reverse osmosis system and pumped to a livestock watering tank located approximately 650 ft east of the groundwater recovery system within the right-of-way. During groundwater recovery operations, four groundwater recovery samples were collected for laboratory analysis of chloride concentrations (Attachment C) which averaged 10,950 mg/L. An estimated 1,853 bbls will need to be removed in order to remove a chloride mass of 3,326 kg. The remaining 237 bbls will be removed by mid August. NMOCD will receive an email notification when the appropriate number of barrels has been removed. A site map with the most recent sampling results is depicted in Figure 1.

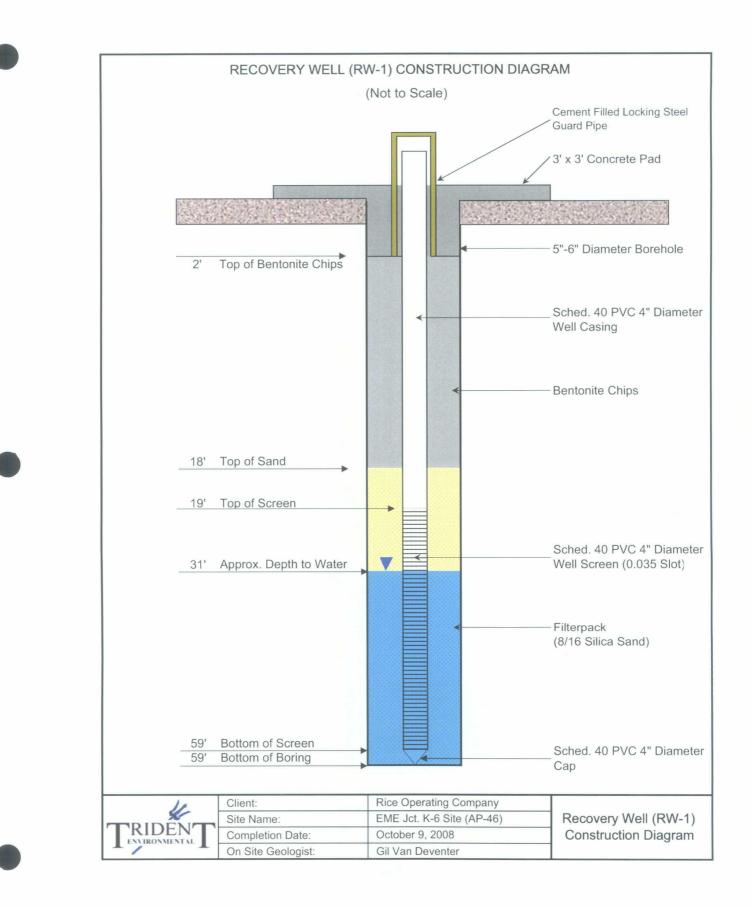
Recovery Well Construction Diagram

A four-inch diameter recovery well (RW-1) was installed at the site on October 9, 2008 (Attachment A) and groundwater recovery operations were initiated on February 18, 2009. The groundwater recovery system consists of the following major components:

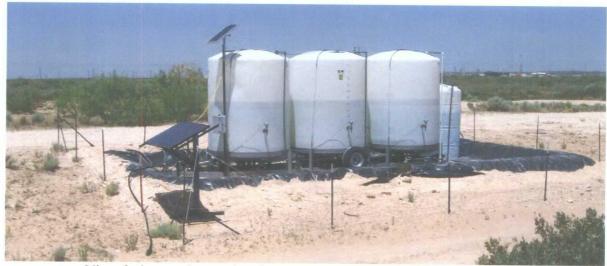
View facing northwest showing groundwater recovery system at RW-1

- A solar-powered submersible pump installed in RW-1,
- Three 3,000 gallon (gal) polyethylene bulk storage tanks,
- One 1,200 gal. water tank for reverse osmosis-treated water
- One 1,200 gal. water tank and a 200 gal. trough for livestock watering
- Plastic-lined earthen berm for secondary containment
- Associated polyethylene piping, valves, metering devices, and telemetry

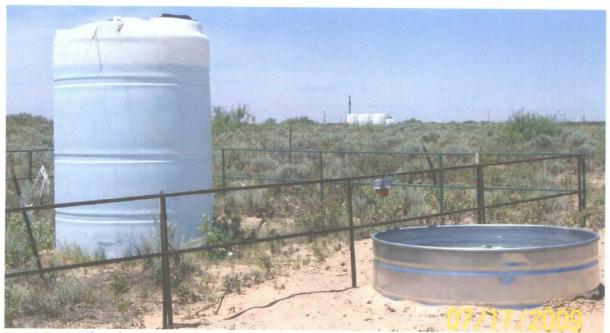
View facing west showing livestock water tank and trough in foreground and groundwater recovery system in background.

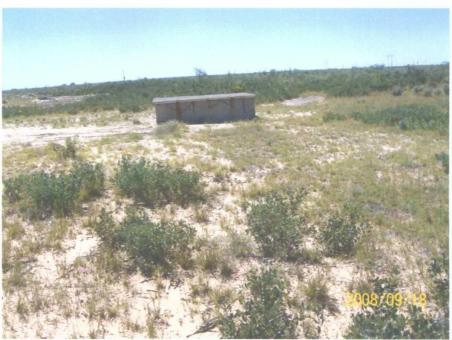
View facing south showing healthy growth of native vegetation.

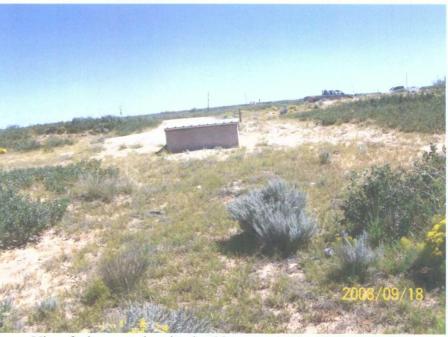
View facing east showing healthy growth of native vegetation.
