**RE: Stage 2 Final Report and Termination Request
EME Jct N-5 Site (AP-66)
T20S, R37E, Section 5, Unit Letter N
Lea County, New Mexico**

Stage 2 Final Report and Termination Request
EME Jct. N-5 Site (AP-66)
T20S-R37E - Section 5, Unit Letter N

**RE: Request for Closure
Amended Stage 2 Abatement Plan
EME Jct N-5 Site (AP-66)
T20S, R37E, Section 5, Unit Letter N
Lea County, New Mexico**

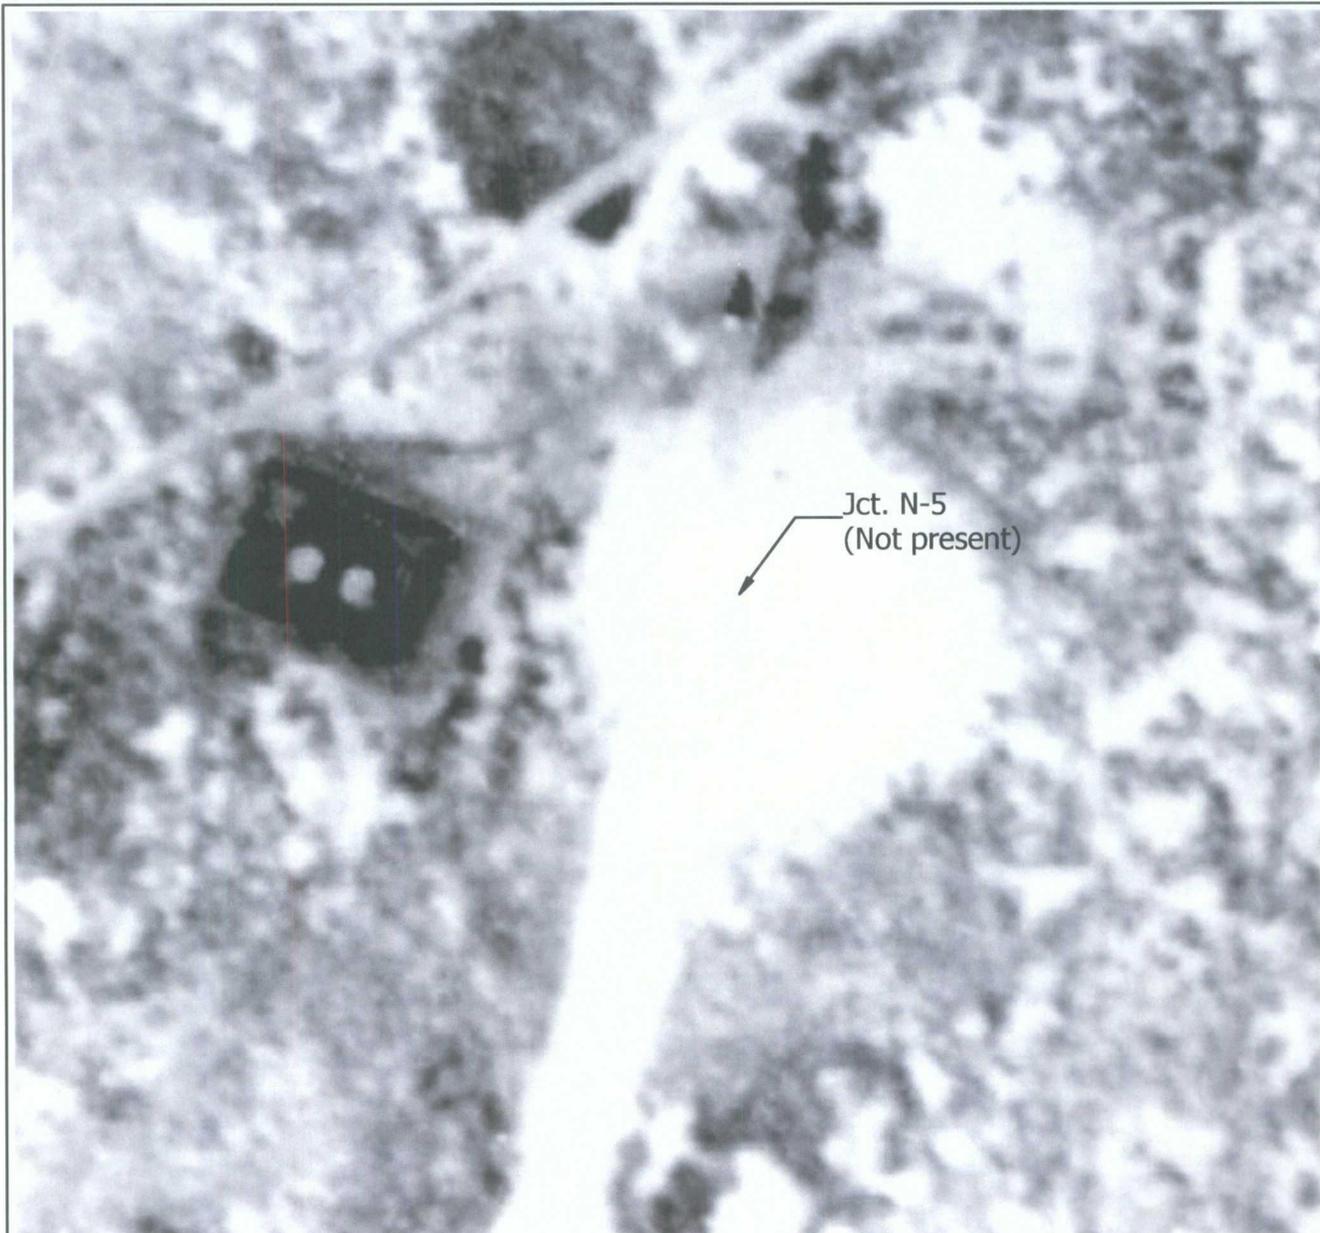
Anderson Prichard Oil Company tank battery in place with at least two tanks and dark-stained soil. Large barren area at center is apparent and might be the location of where the original drilling pit for the H. M. Britt B #1 well was. The Britt B #1 was put into oil production by Anderson Prichard Oil Company in 1937 according to OCD well records. The well was approved for dual completion and commenced gas production in 1957 along with oil production.

Ownership of Britt B #1 changed from Anderson Prichard Oil Company to Union Texas Natural Gas Corp in 1961 and then to Union Texas Petroleum Corp in 1962. There are no OCD well records for Britt B #1 between 1962-1976.

Date of photo: 1949 (Quality: Fair):

- Anderson Prichard Oil Company tank battery in place with at least two tanks.
- Large barren area at center is apparent and might be the location of where the original drilling pit for the H. M. Britt B #1 well (API # 30-025-05923) was. The Britt B #1 was put into oil production by Anderson Prichard Oil Company in 1937 according to OCD well records. The well was approved for dual completion and commenced gas production in 1957 along with oil production.
- Ownership of Britt B #1 changed from Anderson Prichard Oil Company to Union Texas Natural Gas Corp in 1961 and then to Union Texas Petroleum Corp in 1962. There are no OCD well records for Britt B #1 between 1962-1976.

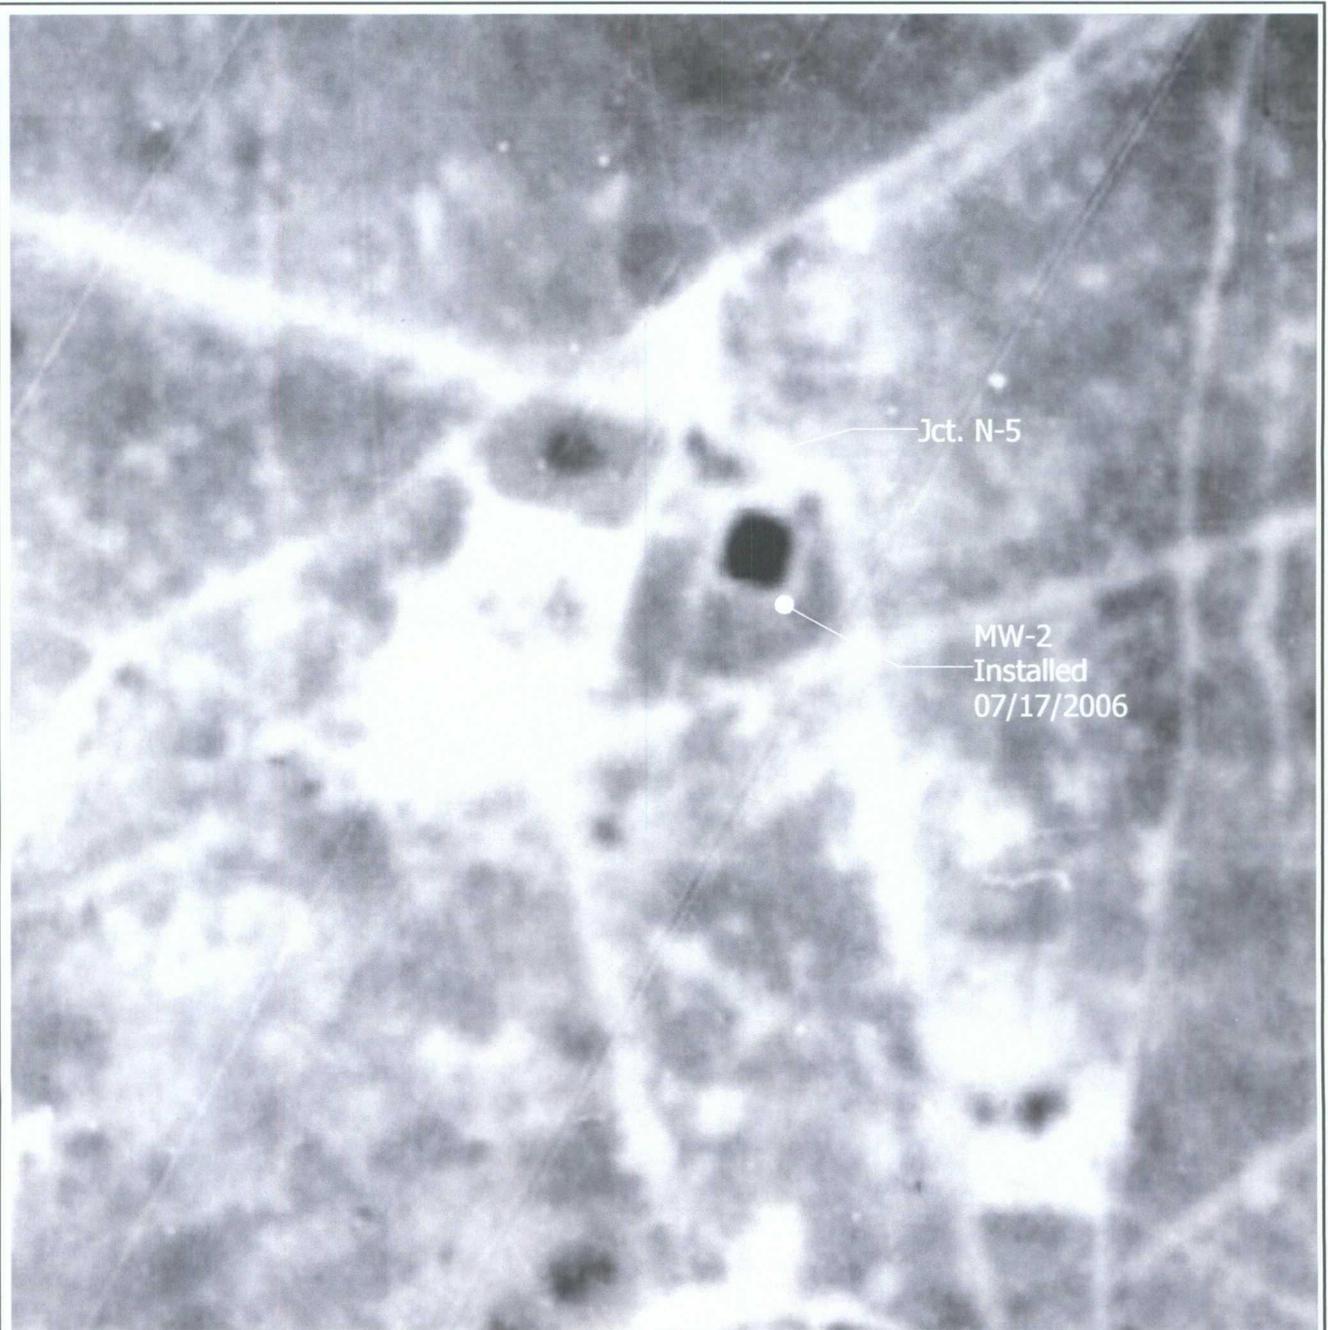
Union Texas Petroleum Corp tank battery in place
 Britt B #1 oil & gas well is present (no OCD well records between 1962-1976)
 First evidence of a large pit located southeast of tank battery and the N-5 junction box
 Northwest-Southeast trending ROC pipeline along north side of tank battery and pit
 According to ROC records the N-5 junction box was constructed in 1959
 Other non-ROC pipelines present (stressed vegetation)

Date of photo: 1964 (Quality: Poor):

- Union Texas Petroleum Corp tank battery in place
- Britt B #1 oil & gas well is present (no OCD well records between 1962-1976)
- First evidence of a large pit located southeast of tank battery and the N-5 junction box
- Northwest-Southeast trending ROC pipeline along north side of tank battery and pit
- According to ROC records the N-5 junction box was constructed in 1959
- Other non-ROC pipelines evident (stressed vegetation)

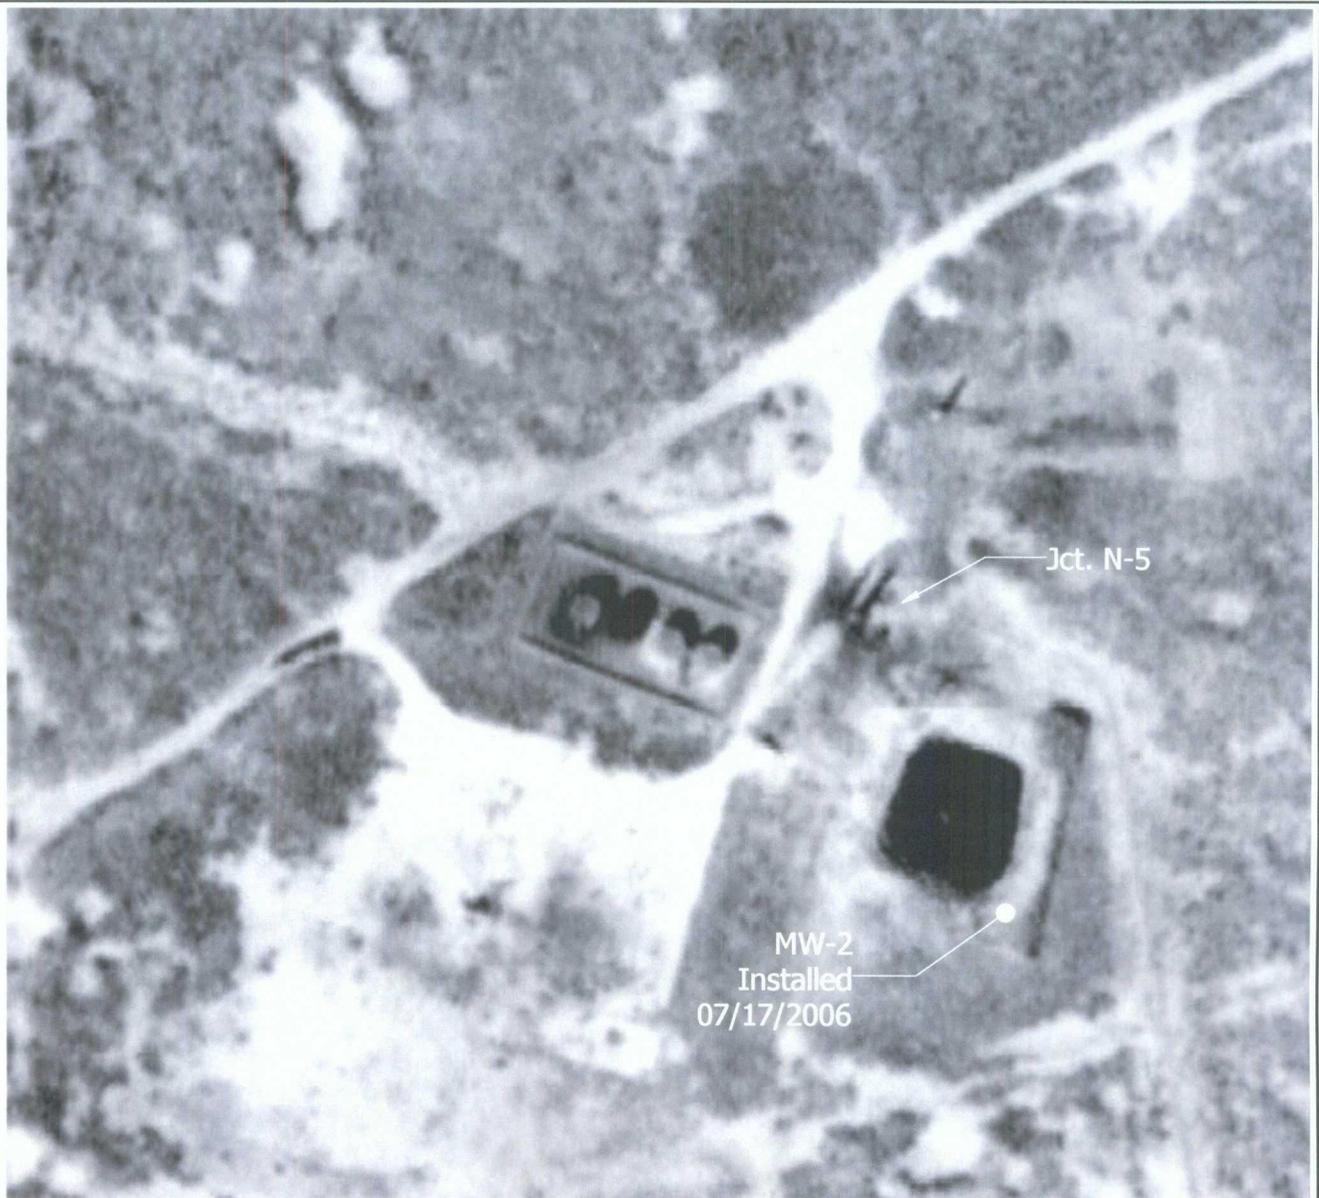
- Union Texas Petroleum Corp tank battery in place with four tanks.
- Britt B #1 oil & gas well is present and active
- Large pit located southeast of tank battery and the N-5 junction box is in use.
- The future location of MW-2 is noted at the southeast edge of the pit.
- Unknown structure between tank battery and large pit
- Northwest-Southeast trending ROC pipeline along north side of tank battery and pit
- Non-ROC pipelines present (stressed vegetation)

Date of photo: 1966 (Quality: Good):

- Best quality photo and the same one used in the Lea County Soil Survey (Sheet No. 125)
- Union Texas Petroleum Corp tank battery in place with four tanks.
- Britt B #1 oil & gas well is present and active
- Large pit located southeast of tank battery and the N-5 junction box is in use. The future location of MW-2 is noted at the southeast edge of the pit.
- Unknown structure between tank battery and large pit
- Northwest-Southeast trending ROC pipeline along north side of tank battery and pit
- Other non-ROC pipelines evident (stressed vegetation)

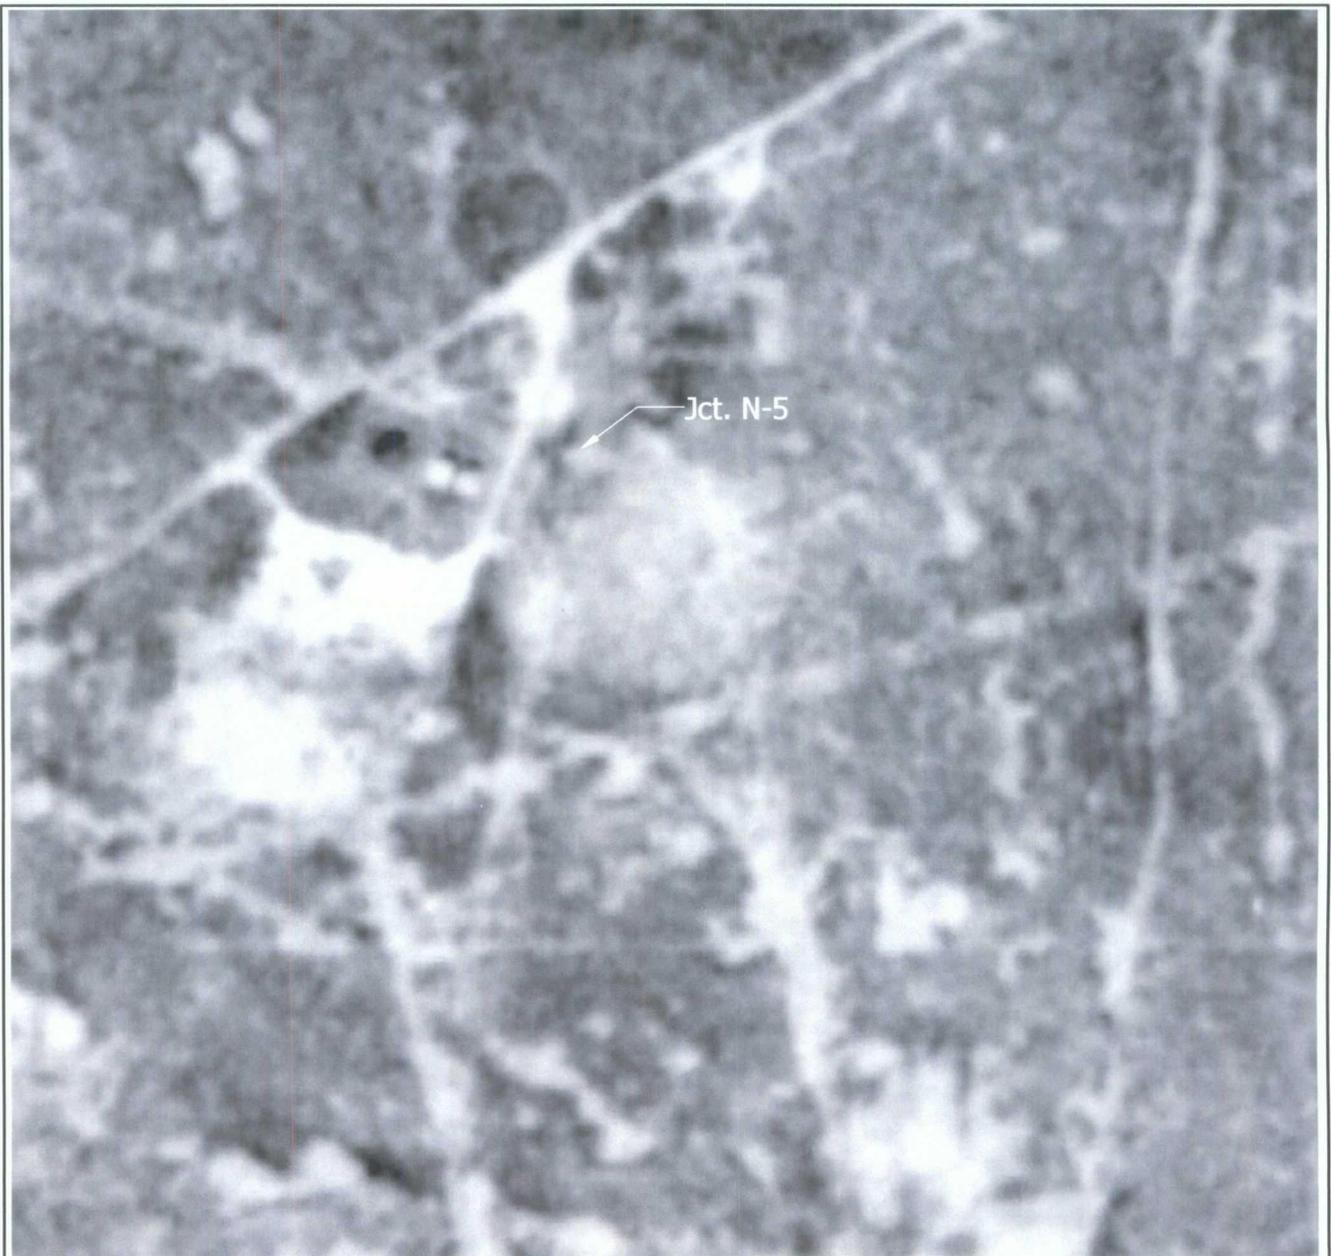
Union Texas Petroleum Corp tank battery still in place with three tanks

Britt B #1 oil & gas well is present and active

Large pit located southeast of tank battery has been backfilled (stressed vegetation)

Non-ROC pipelines present (stressed vegetation)

Date of photo: 1975 (Quality: Poor):

- Union Texas Petroleum Corp tank battery still in place with three tanks.
- Large pit located southeast of tank battery has been backfilled
- Other non-ROC pipelines evident (stressed vegetation)

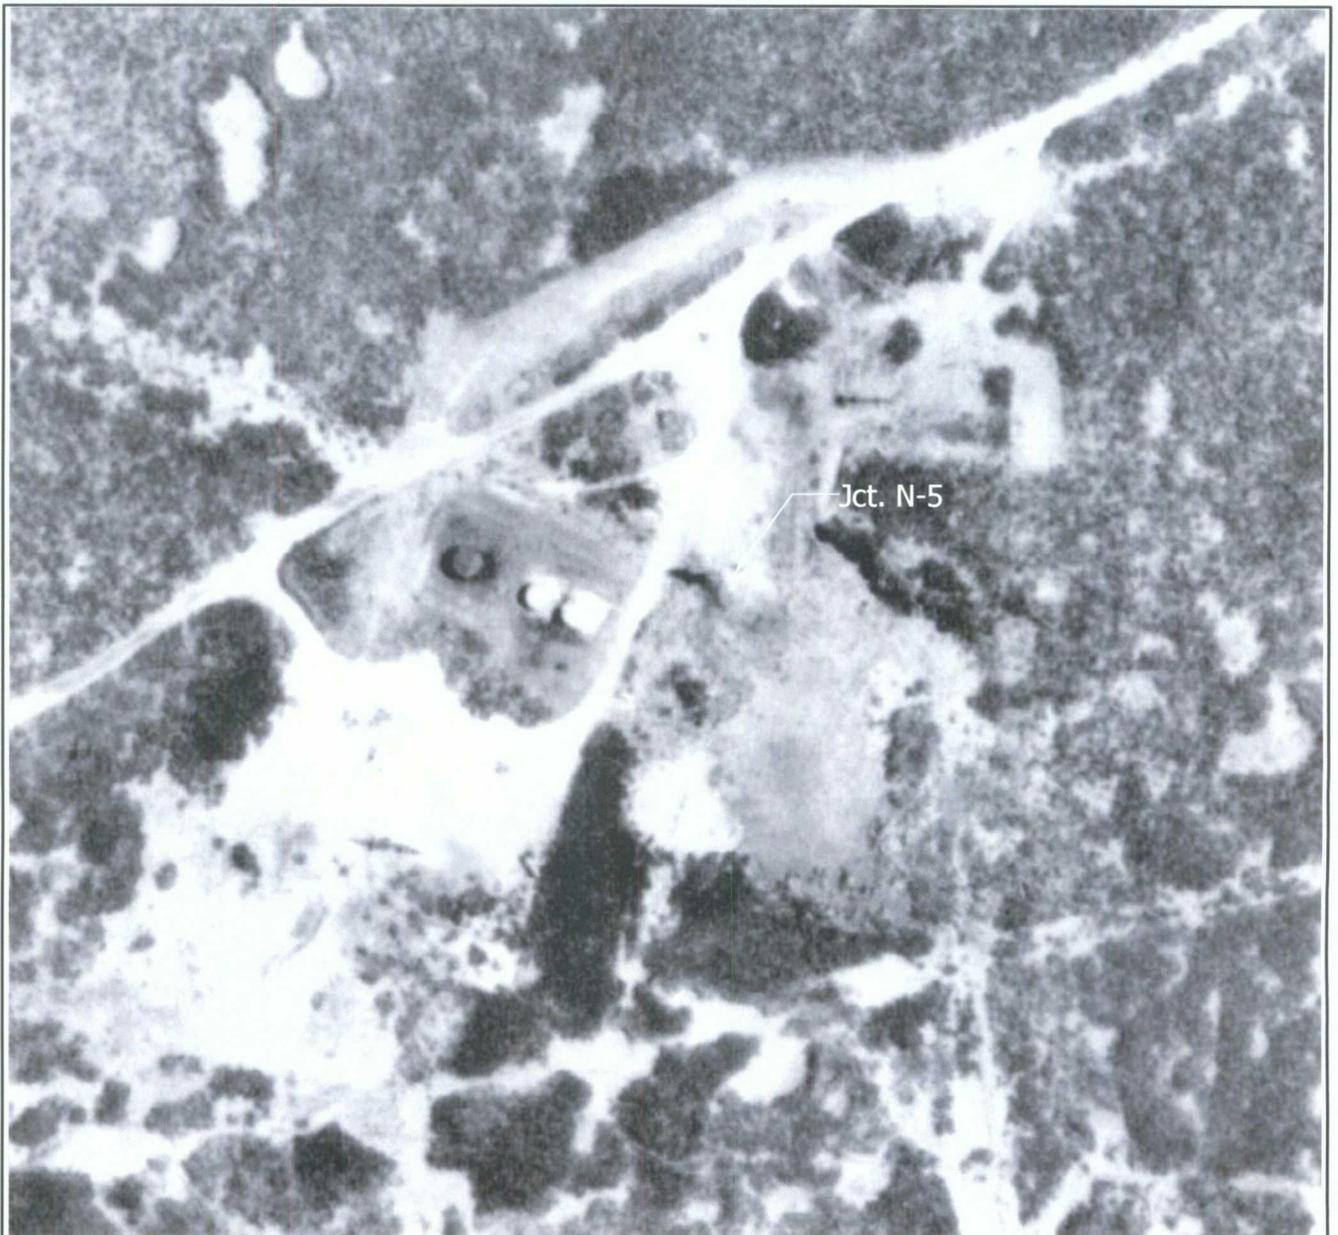
Observations:
Union Texas Petroleum Corp tank battery in place with three tanks.
According to OCD well records the Britt B #1 oil & gas well was plugged in 1977
Several non-ROC pipelines present (stressed vegetation)

Date of photo: 1978 (Quality: Fair):

- Union Texas Petroleum Corp tank battery in place with three tanks.
- According to OCD well records the Britt B #1 oil & gas well was plugged in 1977 (just previous to this photo)
- Other non-ROC pipelines evident (stressed vegetation)

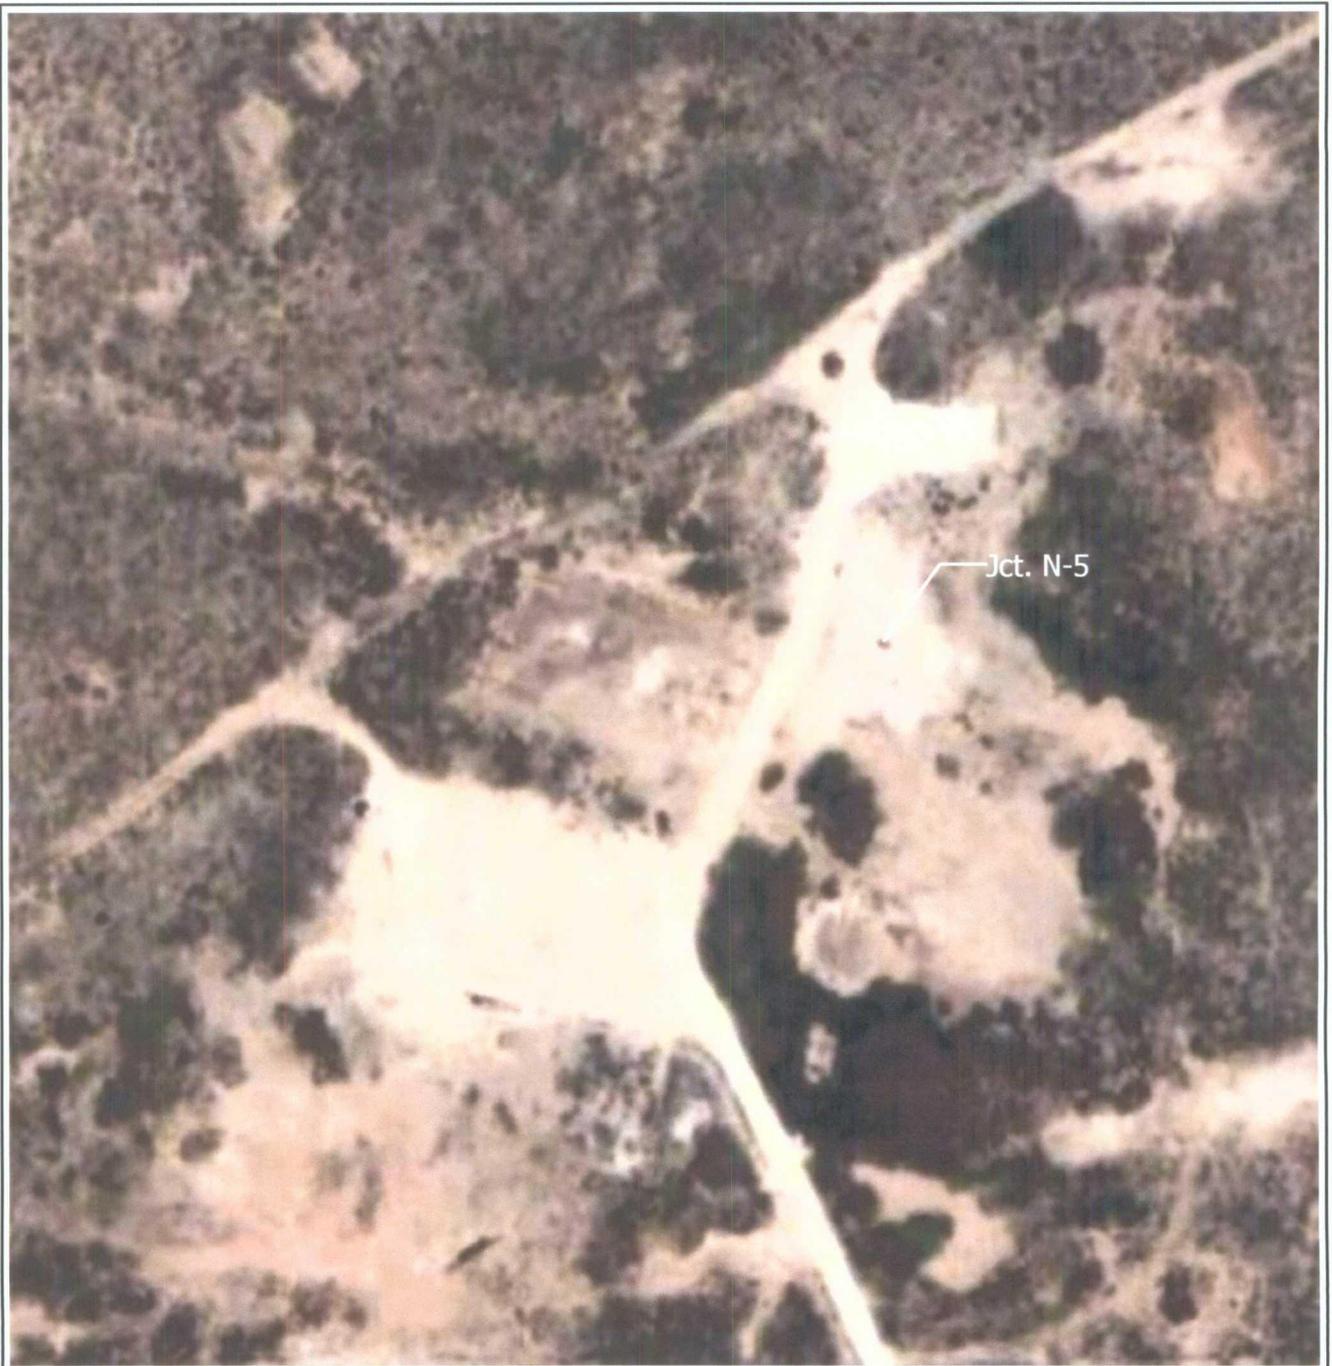
Observations:
Union Texas Petroleum Corp tank battery removed sometime after 1978 (stressed vegetation).
Outline of large pit still evident (stressed vegetation).
Outline of Britt B #1 well site still evident (stressed vegetation).
Non-ROC pipeline with circular outline of spill evident (stressed vegetation).

Date of photo: 2003 (Quality: Good):

- Union Texas Petroleum Corp tank battery removed sometime after 1978.
- Outline of large pit still evident
- Outline of Britt B #1 well site still evident
- Non-ROC pipeline with circular outline of spill evident (stressed vegetation).

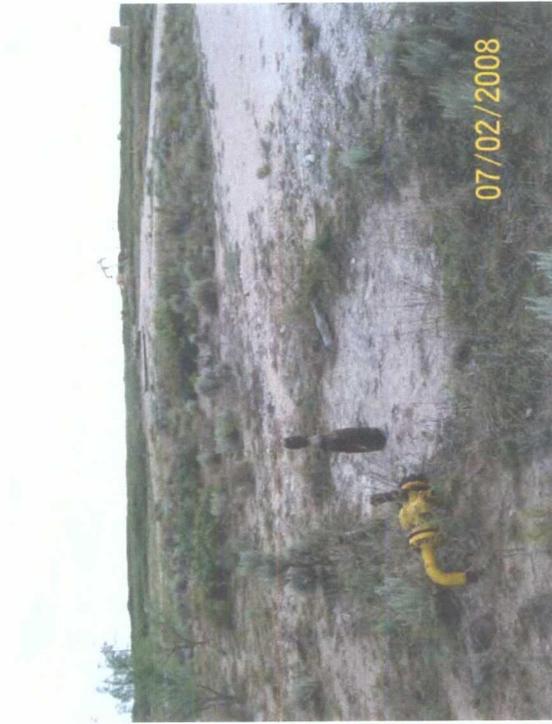
1: Southwest view showing plugged Britt B #1 well (foreground) ~140 ft NNW of the N-5 junction box (background, top-center).

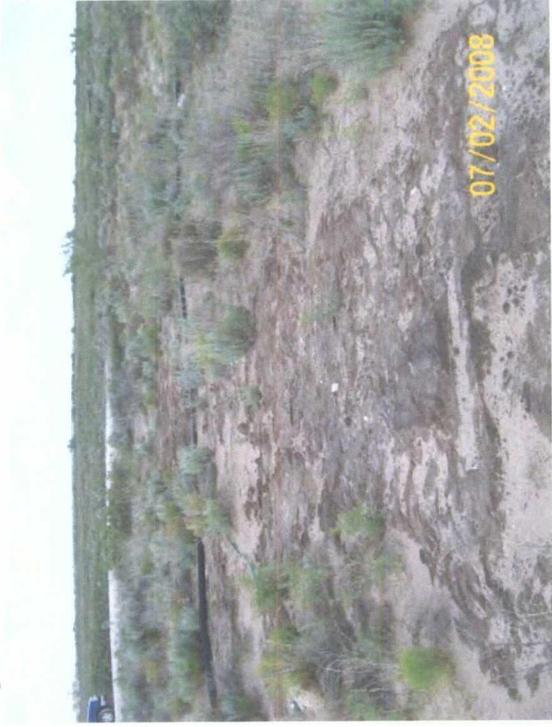
2: View facing north in direction of Britt B #1 well (top-center) showing encrusted crude oil-impacted surface soil.

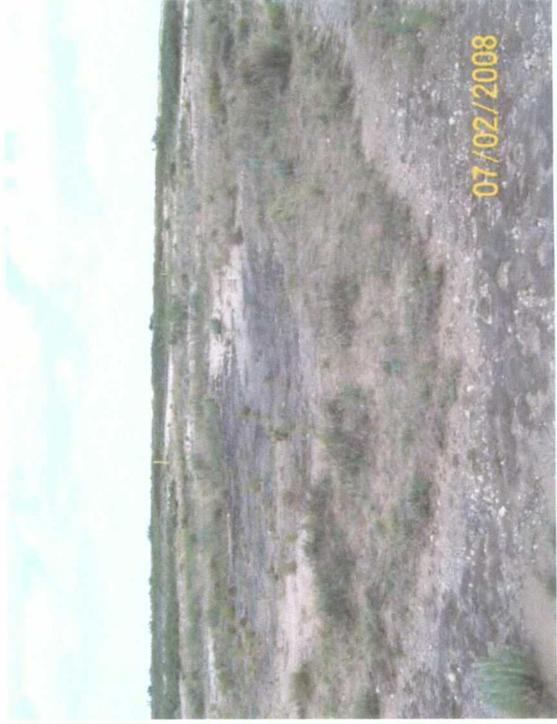
3: View facing northeast showing old crude-impacted surface soil at former tank battery (~120 ft west of N-5 junction box).

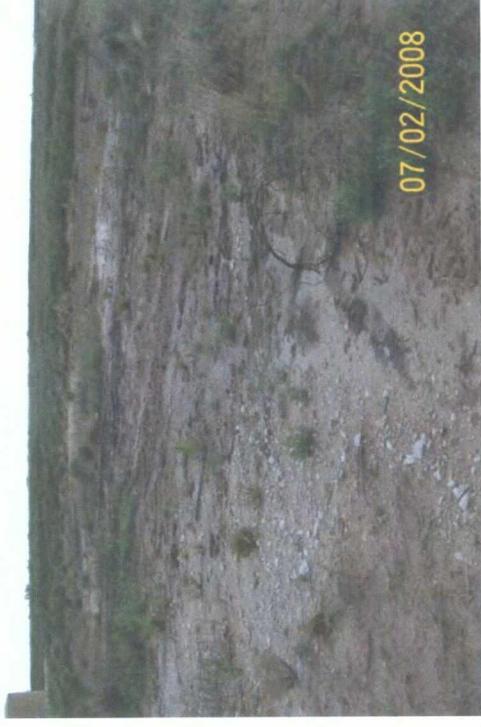
4: View facing southwest showing old crude-impacted surface soil at former tank battery (~60 ft west of N-5 junction box).

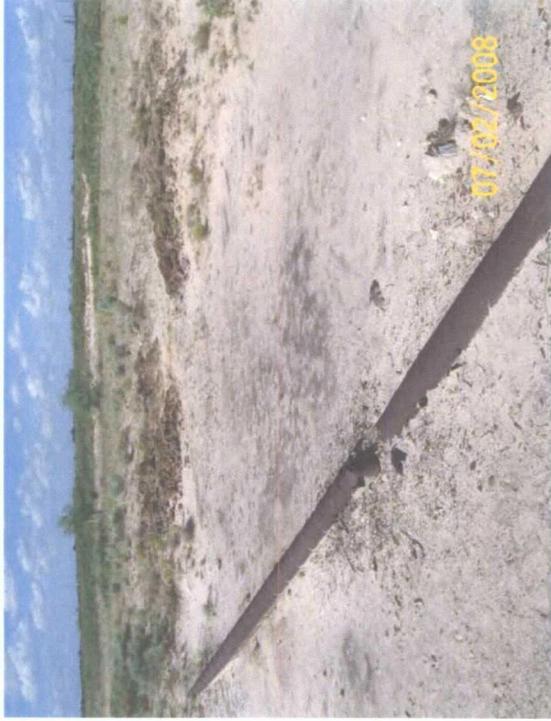
5: View facing northeast showing evidence of historic spill and stressed vegetation caused by non-ROC pipeline (~ 175 ft south of N-5 junction box).

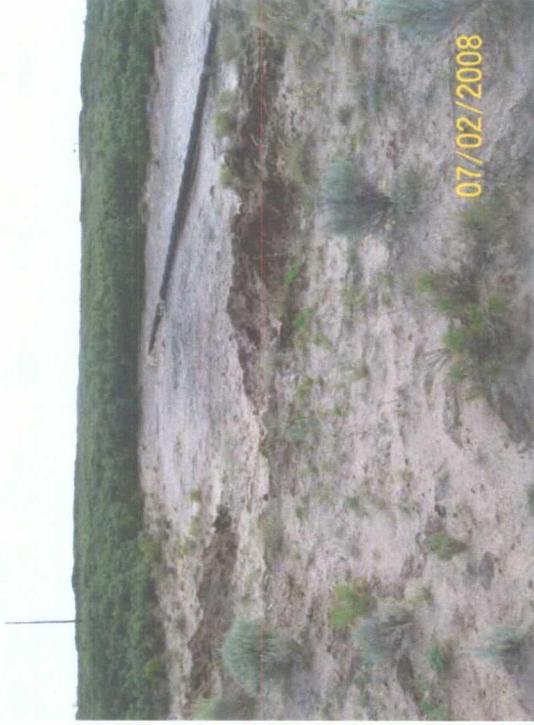
6: View facing southwest showing evidence of historic spill and stressed vegetation caused by non-ROC pipeline (~ 150 ft south of N-5 junction box).

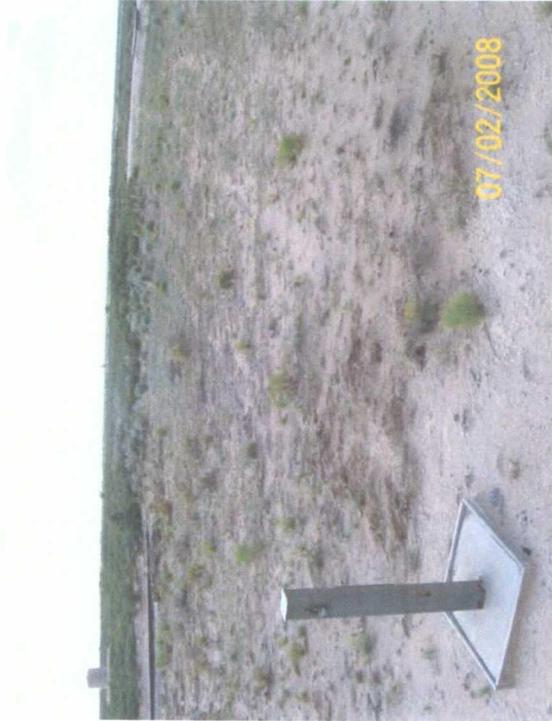
7: View facing northwest showing former pit area (ranging from 50 ft to 200 ft SSE of junction box) with MW-2 in foreground.

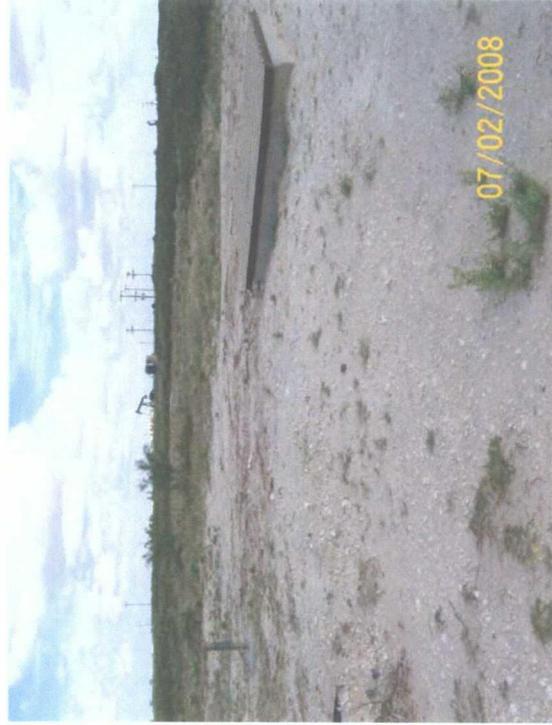
8: View facing southeast showing new N-5 junction box and former pit area in background (top-center) with MW-1 (left-center).
